Numerical analysis of settlement-induced damage to a masonry church nave wall

Abstract. Differential soil settlements can induce structural damage to heritage buildings, causing not only economic but also cultural value losses. In 1963, the Saint Jacob's church in Leuven was permanently closed to the public because of severe settlement-induced damage caused by insufficient bearing capacity of the foundation. Currently, the church is stabilized using a temporary shoring system. This work aims at implementing a practical modelling approach to predict damage on church nave walls subjected to differential settlements. For that purpose, a finite element model of the Saint Jacob's church nave was generated and validated through on-site monitoring data including levelling, damage survey and laser scanning. The model takes into account the non-linear behavior of the masonry by means of continuum smeared cracking. The paper introduces two approaches to model the settlement on the structure. One of them consists in the direct application of vertical displacements underneath the structure according to the deformation profile measured on-site. In the second approach, interfaces with different

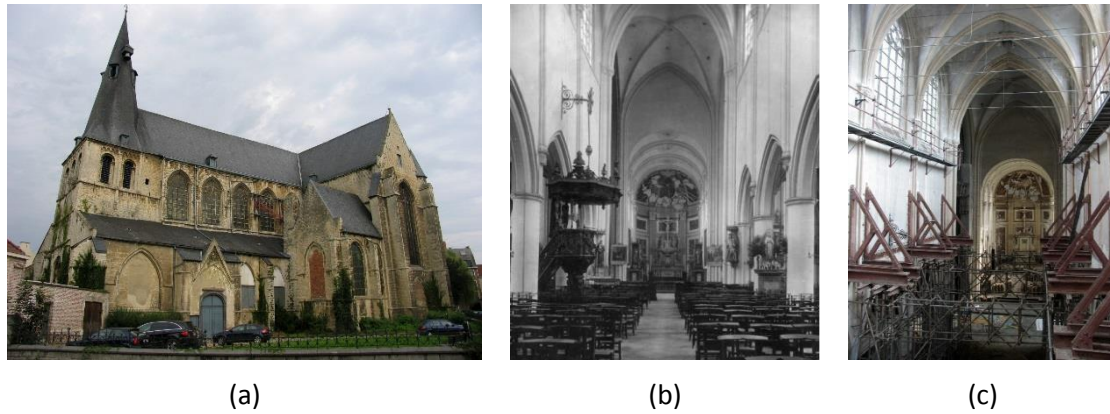
Figure 1. Saint Jacob's church (a), view of main nave with choir in the back, in 1918 (b) and 2016 (c)

This work specifically investigates the mechanical behavior of one of the main nave walls of the church, which has been severely cracked due to differential settlements (**Fig. 2**). In the literature, several numerical assessment methodologies to model settlement-induced damage on masonry have been proposed [4-6]. The current methodology investigated in this paper includes two simplified non-linear numerical models, considering as input the settlement profile that was measured on-site. The absence of on-site measurements may be complemented by satellite data [7]. They are validated through comparison with a damage survey. A second objective of this paper is the assessment of the structural damage in terms of cracking as a function of the settlement profile.

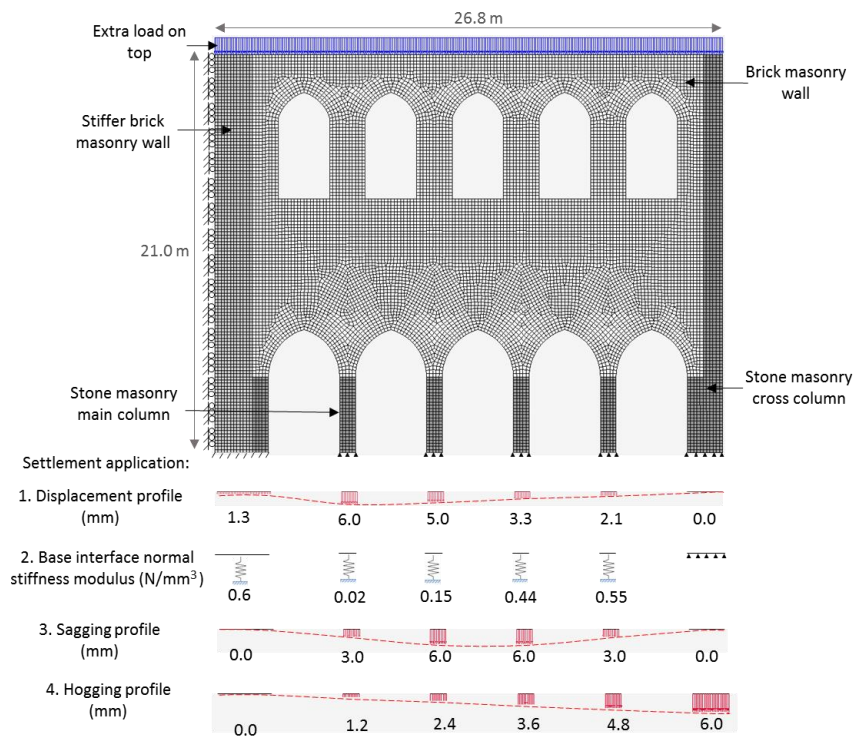
Two approaches for the settlement application were considered. Approach 1 consists in the direct application of vertical displacements in the nodes underneath the structure, equal to the deformation profile measured on-site, as schematically indicated in **Fig. 3** (1. Displacement profile). In this approach, the displacements induced by the self-weight and extra dead load were reset to zero. Then, the displacement profile was applied in 50 steps, so that the damage evolution could be easily tracked until it reached the maximum displacement value, for instance 6.0 mm under the second column.

**Figure 3.** Model of the nave wall with applied settlement profiles and interface stiffness values

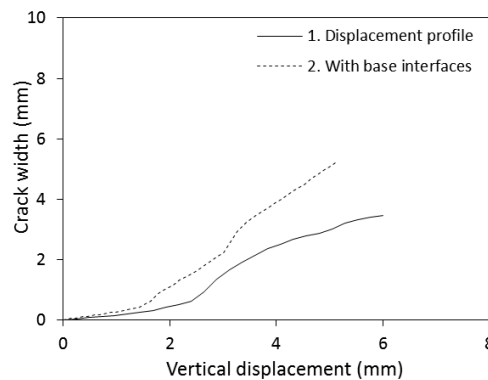
Fig. 5 shows the width of crack 3, located on top of the middle arch, in terms of the maximum vertical displacement at the base of the second column, which presents the highest displacement. This crack width was calculated as the horizontal separation of the nodes indicated with black dots in **Fig. 4**. Even though approach 2 considers a very low normal stiffness at the base of the second column, the vertical displacement did not reach 6.0 mm but only 5.1 mm. The model still exhibits a larger crack width, up to 4.9 mm. Approach 1 induces a maximum crack width of 3.4 mm. Although the crack patterns present very good agreement with the on-site crack survey, the actual crack widths could not be validated as no crack width measurements were done and the initial deformations in 1994 (reference levelling measurement) are unknown.

Figure 5. Width of crack 3 as a function of maximum vertical displacement at the column base

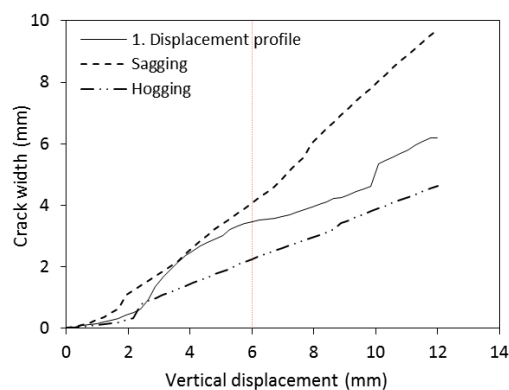
Fig. 7 shows the width evolution of the marked cracks as a function of the maximum vertical displacement at the base for both profile types. It also shows the width of crack 3 obtained with the measured settlement profile (1. Displacement profile). Extra analysis steps were performed to proportionally apply the double settlement profiles at the base up to a maximum settlement of 12 mm. The most critical situation occurred with the sagging profile in which the crack width went up to 9.7 mm. In the hogging profile, the crack width reached 4.6 mm. The crack width for the measured profile remained in between throughout the analysis.

Figure 7. Crack width as a function of the maximum vertical displacement at the base
