A Return to Manning the Post: the Adaptive Reuse of Publically Owned Fire Control Stations from the Second World War

Donald J. Seigny

May 2012

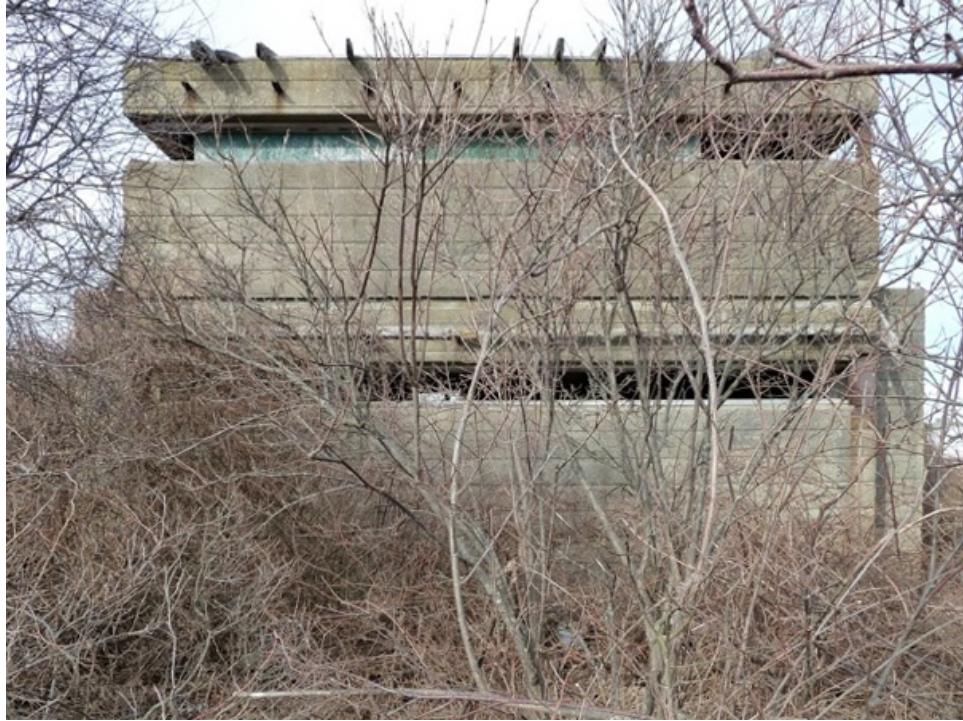
[Fig. 3] South elevation of Station 1-B, looking north. Note dense overgrowth.

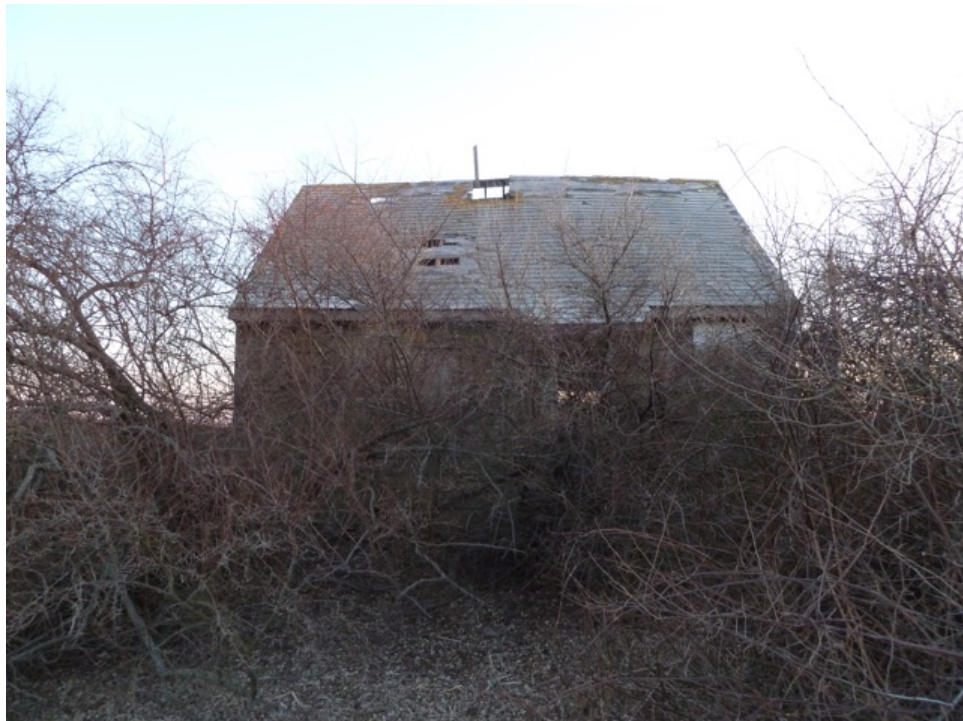
[Fig. 4] North elevation of Station 1-B, looking south. Note the scant remains of a false chimney.

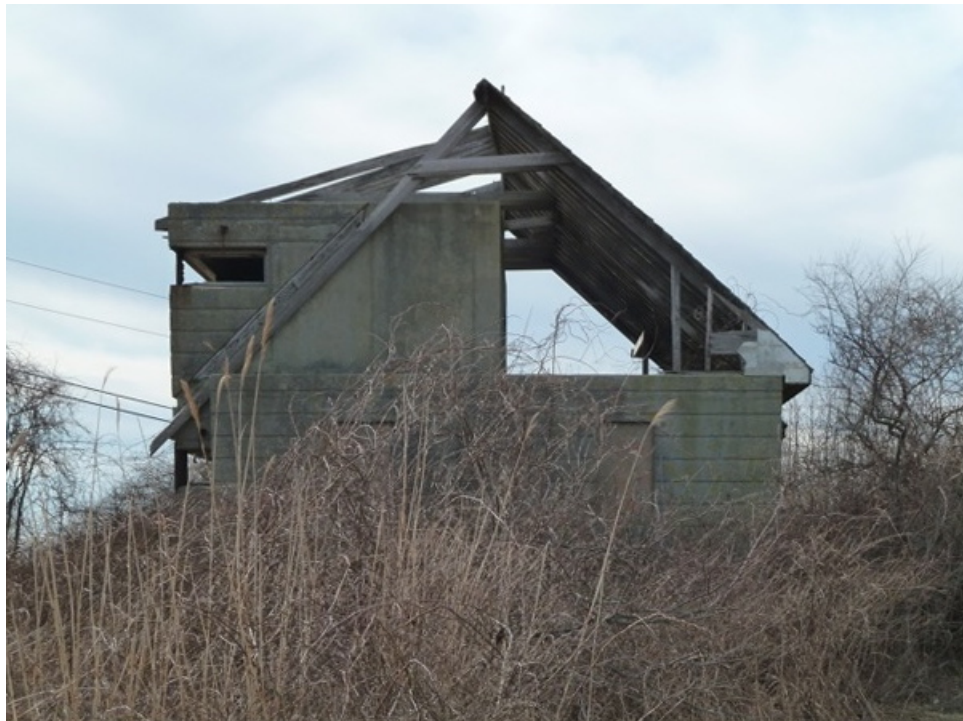
[Fig. 6] East elevation of Station 1-B, looking west. Note remains of the original wooden wall at the northeast corner.

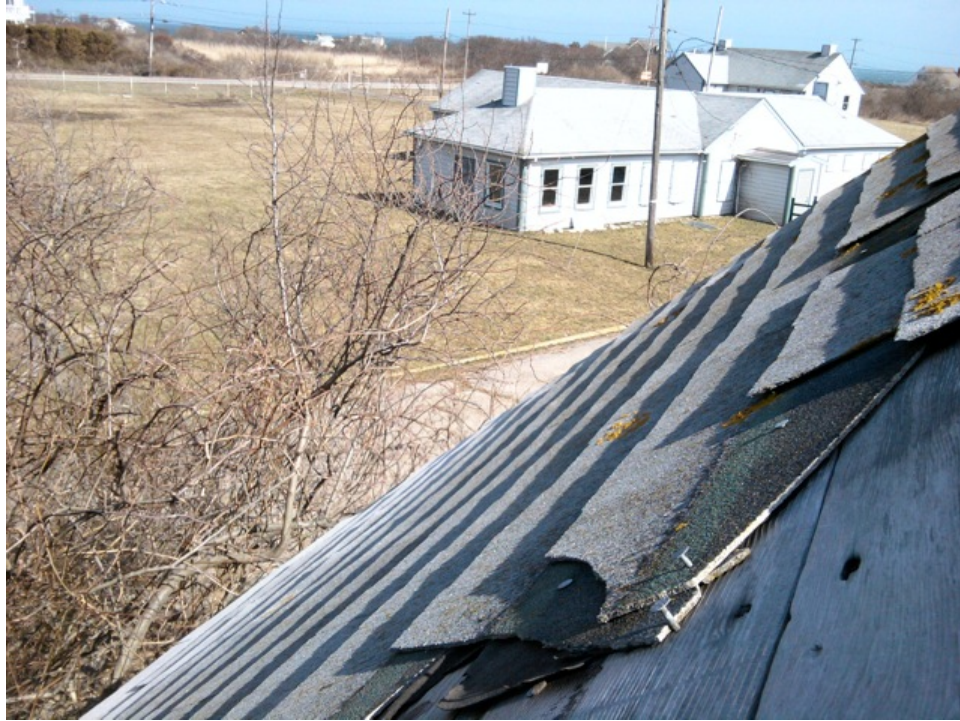
The northern side of the gable roof still retained the roof boards, tarpaper, and asbestos roof shingles [Appendix 6.1.1.1 - Fig. 9]. The two holes located within the eastern center section of the roof had lead to rot on four of the rafters [Appendix 6.1.1.1 - Figs. 10, 11]. About three quarters of the roof retained the original asbestos shingles. Shingles were only absent around the two large holes and a second location approximately two feet below the ridge board up to the gable's peak. All other rafters are weathered, but in good condition. All remaining roof boarding was in good condition [Appendix 6.1.1.1 - Figs. 12, 13]. The sill plate supporting the northern roof section has severely deteriorated, resulting in the structure to become unstable [Appendix 6.1.1.1 - Figs. 14-17]. The absence of the southern gable channeled moisture into this area, resulting in the sill plate to rot. Aside from the sill plate's poor condition, the remaining wooden studs and rafters remained in good condition.

[Fig. 9] View of asbestos shingle roof, looking northeast. Note the two additional buildings on the property. Both were support buildings for Station 1-B and the other two FC stations, Station 1-C and 2-C, within the south reservation. The two stations were torn down in the latter part of the 20th century.¹⁶³

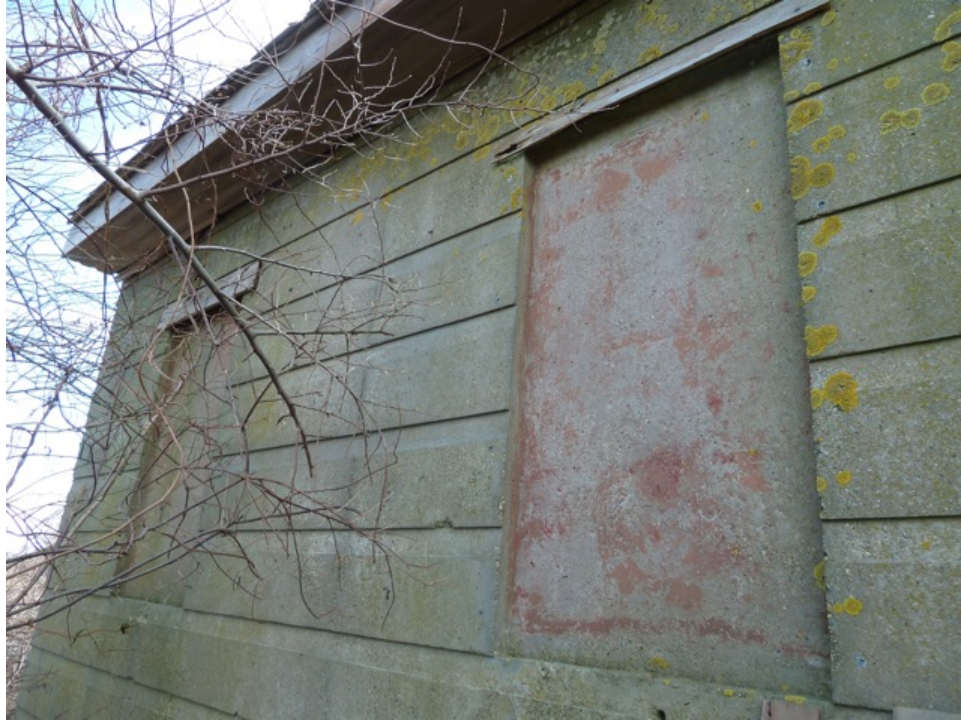
In addition to the false lintels atop the blind windows, a number of soffit boards remained attached under the eave. The boards were tongue and groove bead board. Soffit boards on the western side were in good condition with remaining boards in varying stages of decay [Appendix 6.1.1.1 - Fig. 19].

[Fig. 19] Detail of blind windows on north elevation, looking southeast. Note intact wooden lintels, soffit boards, and reddish-brown paint treatment.

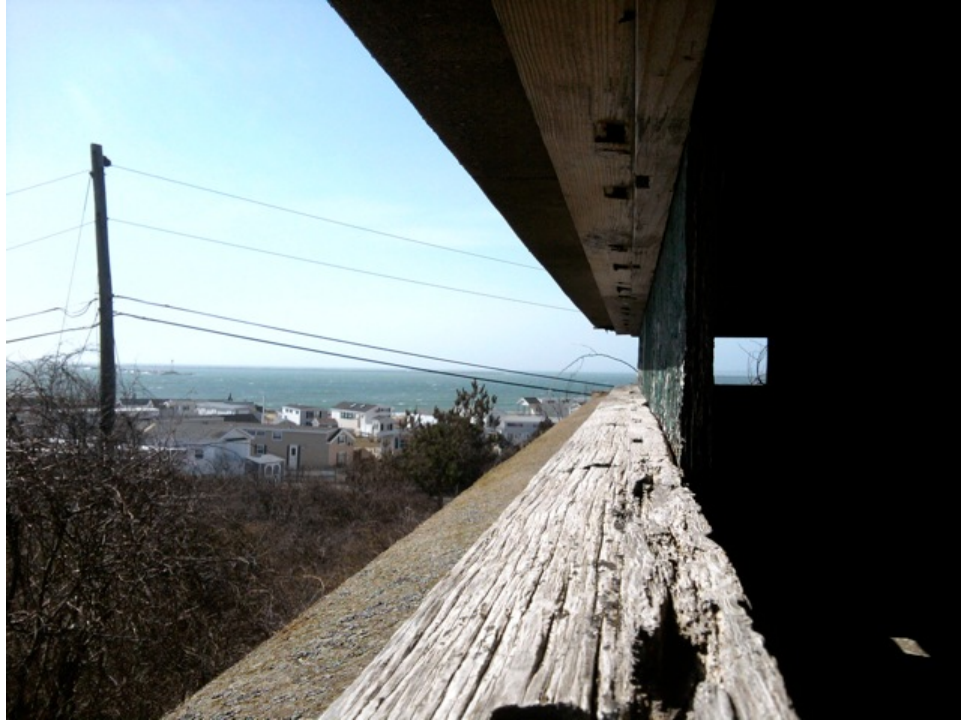
Like the first floor, window frames were present and in fair condition; however no trace of attached window sash remained [Appendix 6.1.1.1 - Fig. 21].

[Fig. 21] Detail of ribbon window frames in Room 2-1. Marks on the upper frame were for the hinges of each awning window.

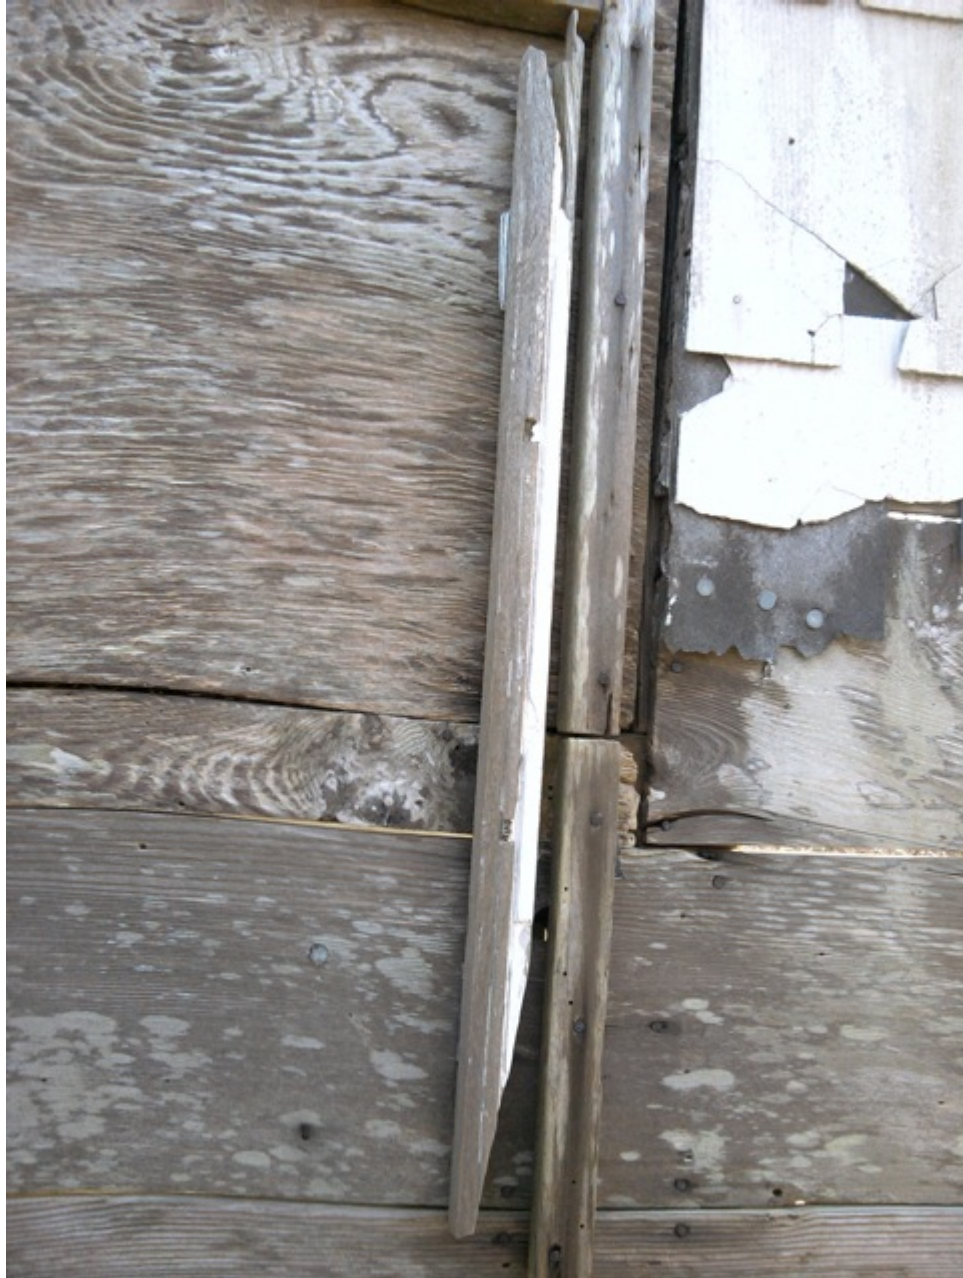
The top rail of an awning window possibly from the station was screwed to hold a piece of plywood to cover the window opening's exterior [Appendix 6.1.1.1 - Figs. 22, 23].

[Fig. 22] View of ribbon window sash remnant on the north elevation, looking south. The remnant is painted white and reused for bracing plywood covering the stair hall window opening.

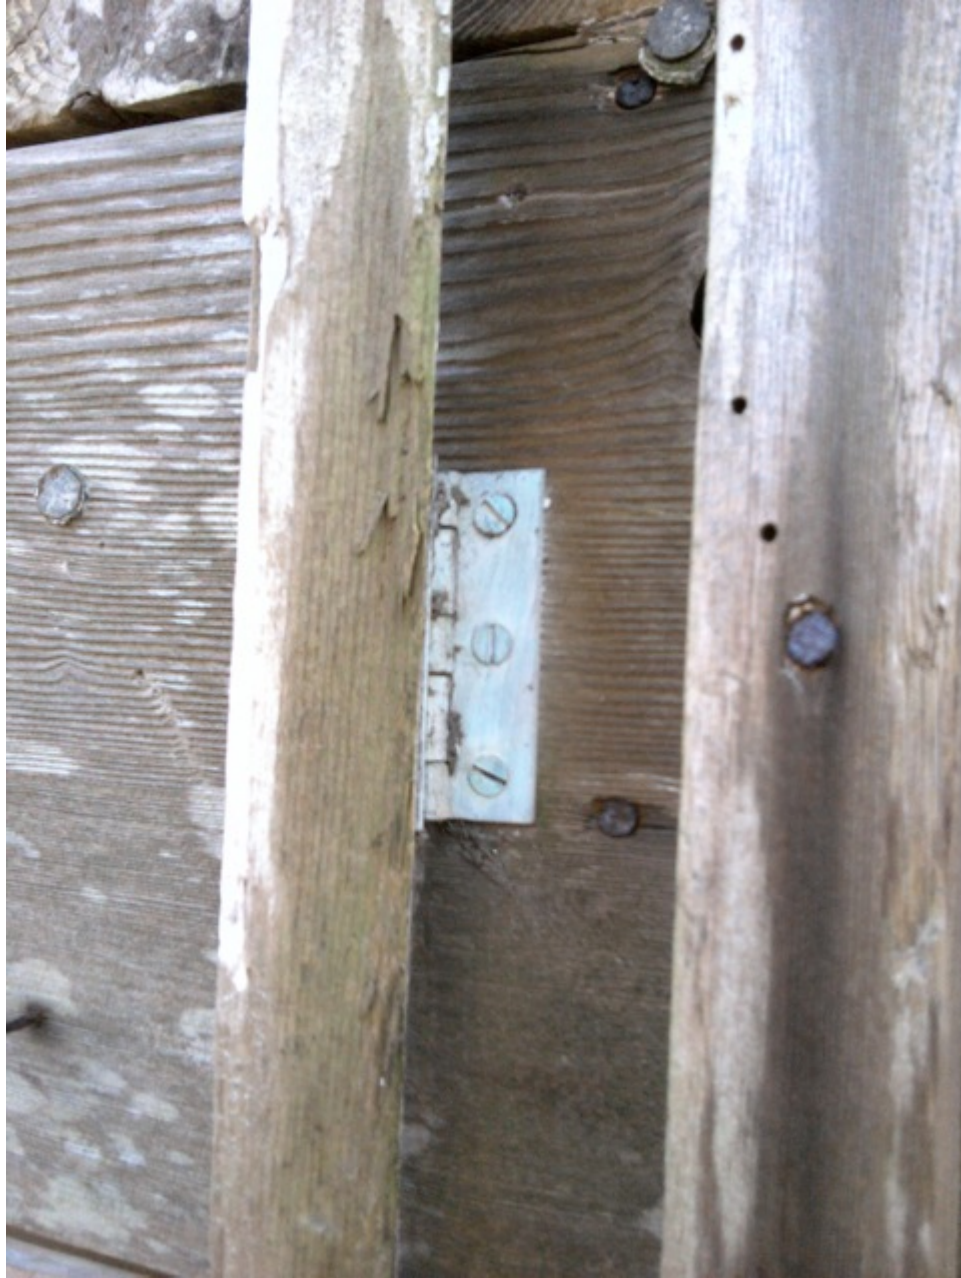
[Fig. 23] Detail of ribbon window sash remnant. Note original hinge and screws, all in good condition.

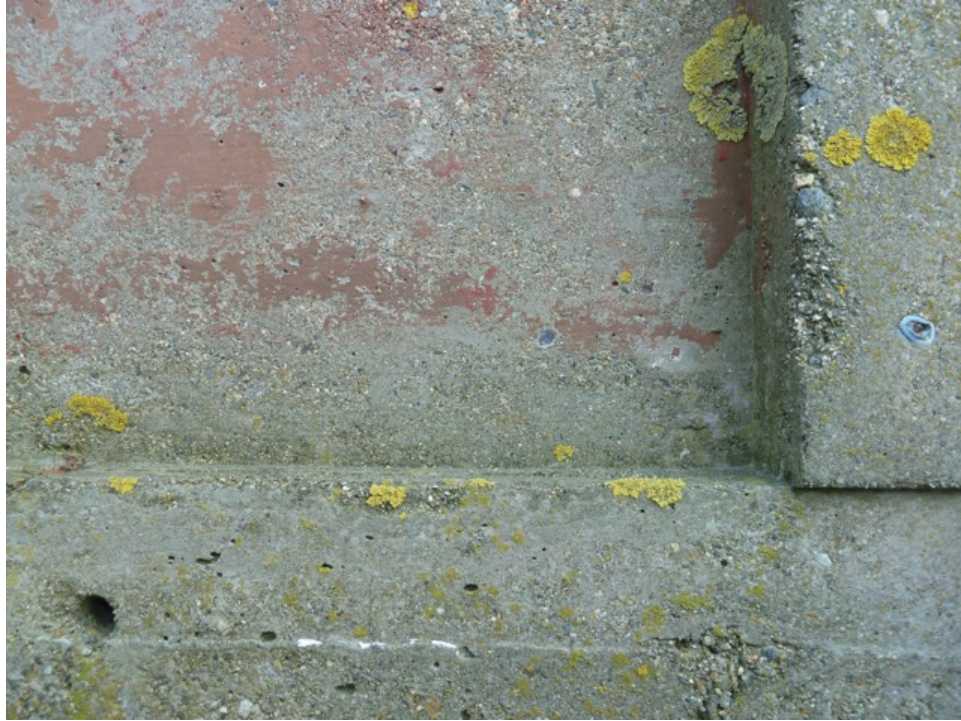
Any remaining finishes were sparse, but did exist. The two blind windows on the north elevation retained their reddish-brown paint color and wooden lintels. Areas of concrete around the blind windows still contained traces of white paint [Appendix 6.1.1.1 - Fig. 24]. The reused top rail of the awning window on the north elevation was also covered in what appeared to be a coat of whitewash.

[Fig. 24] Detail of blind window on the north elevation. Note the plastic screw anchor for a wooden jamb, reddish-brown paint in blind window, and trace of white paint on the concrete area formed to mimic simple drop wooden board.

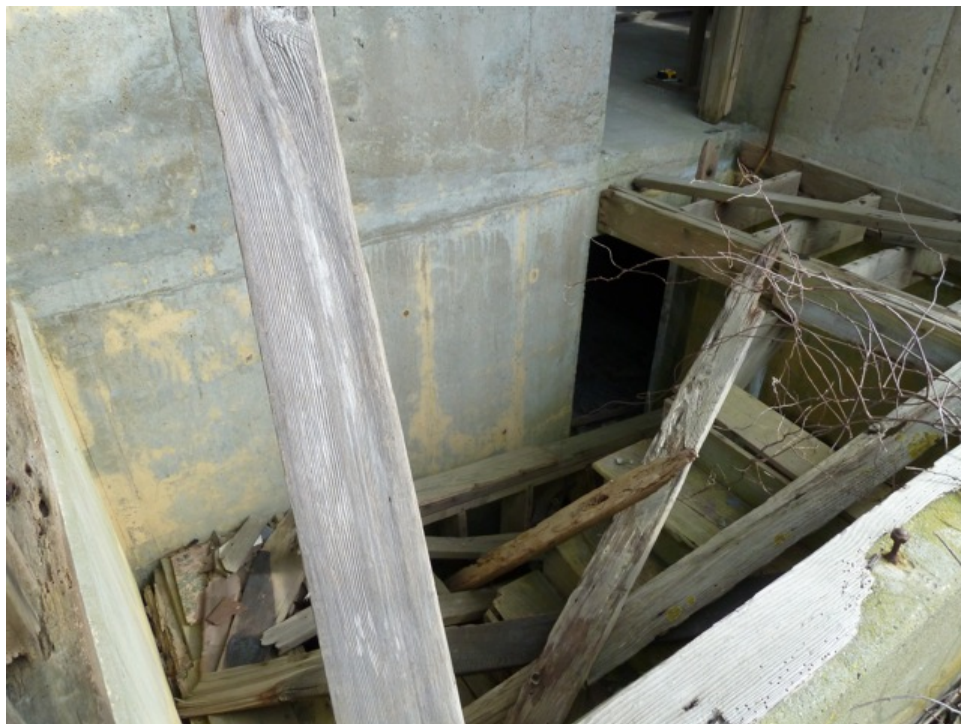
[Fig. 25] Detail of stair hall, looking southeast. Note the original paint treatment on the basement level exposed to the elements.

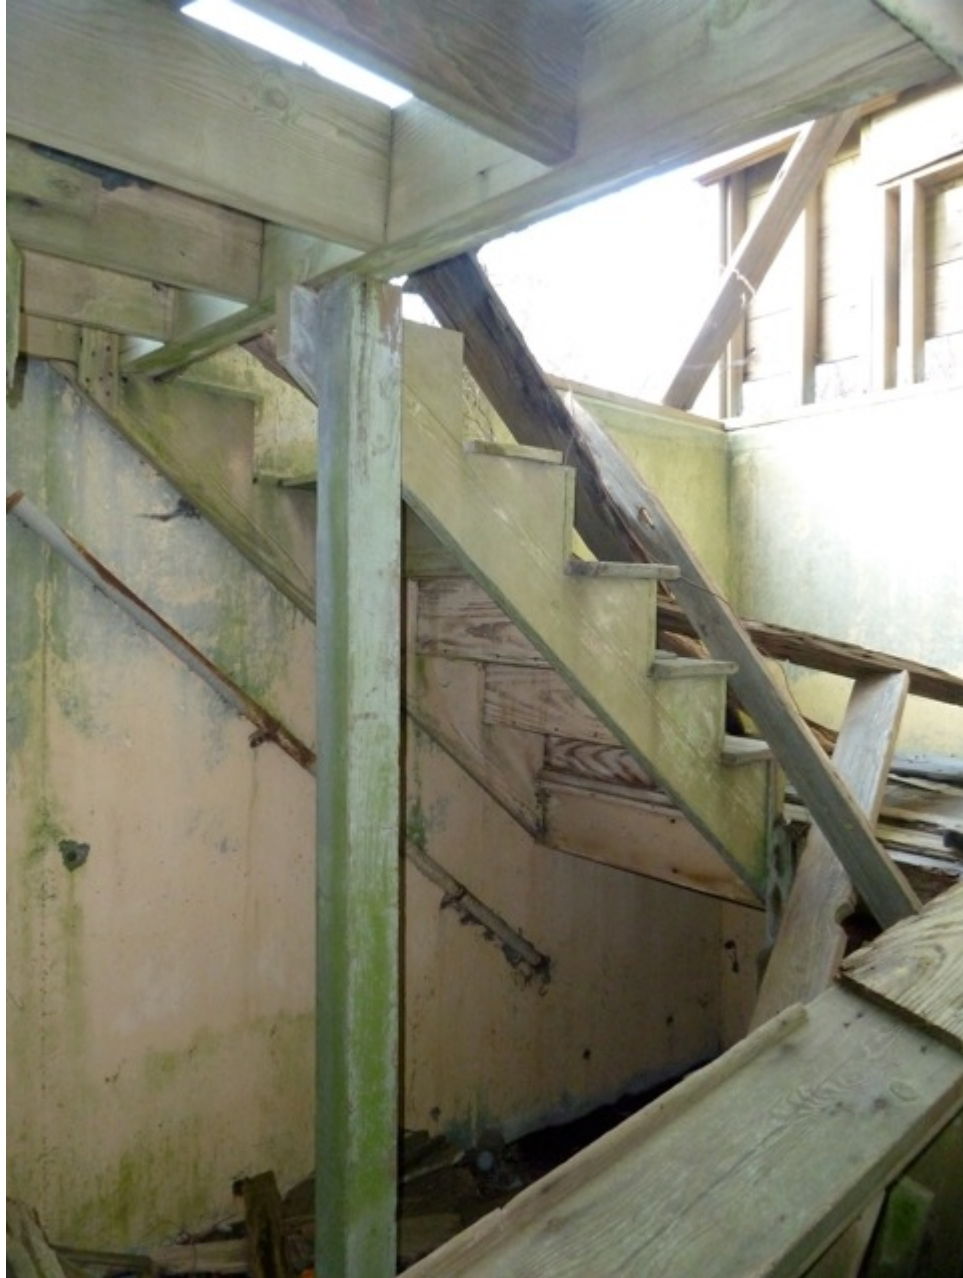
[Fig. 6] View of the stair hall, looking northwest. Note original stair configuration and condition.

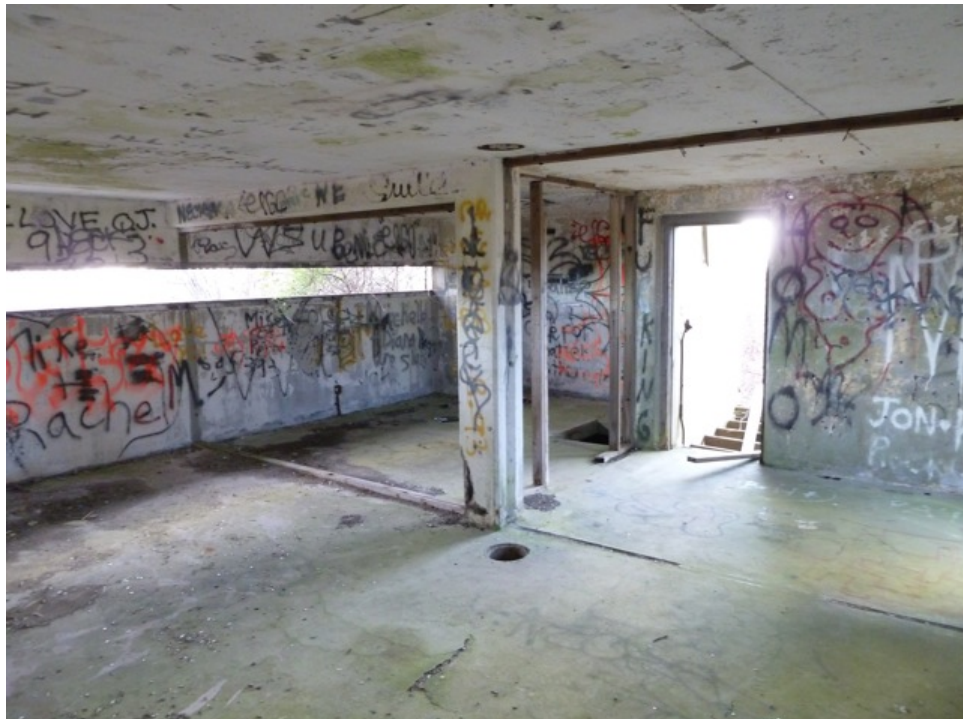
[Fig. 10] View of Room 1-1, looking southwest. Note the hole for a stove ductwork and original paint treatment under graffiti.

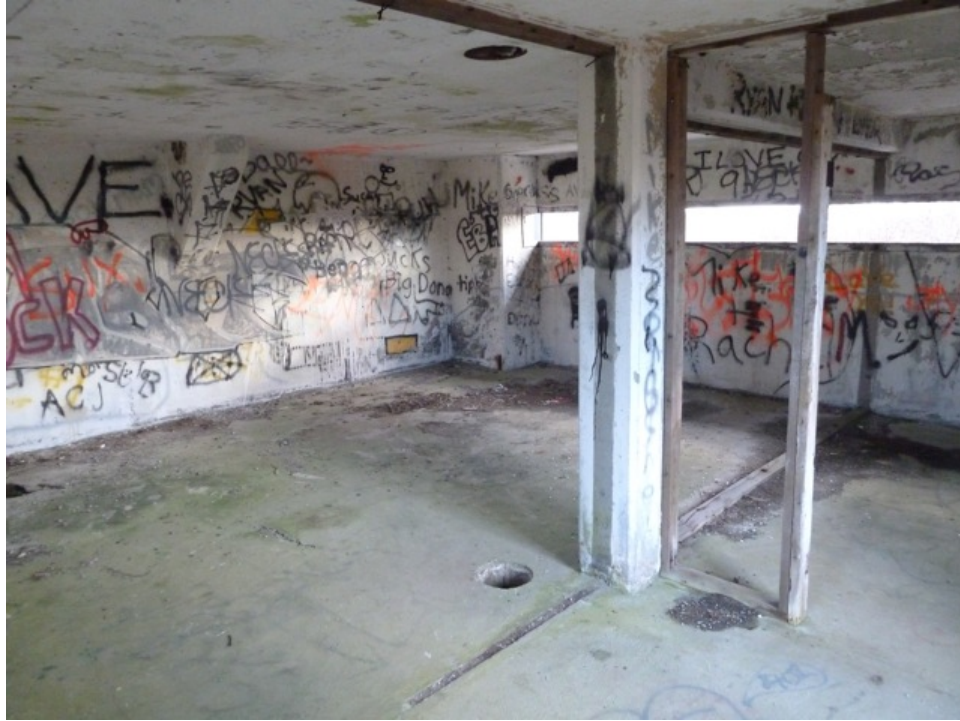
[Fig. 11] View of Room 1-1, looking southeast. Note the hole for a stove ductwork and original paint treatment under graffiti.

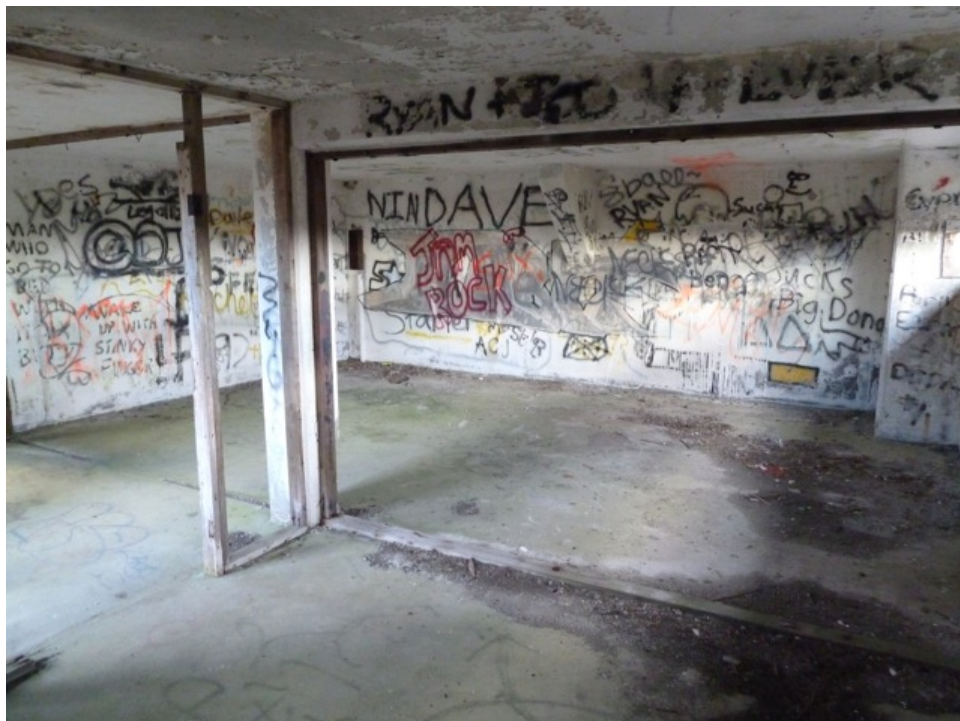
[Fig. 12] View of Room 1-1, looking northeast. Note the wooden framework for partition walls and original paint treatment under graffiti.

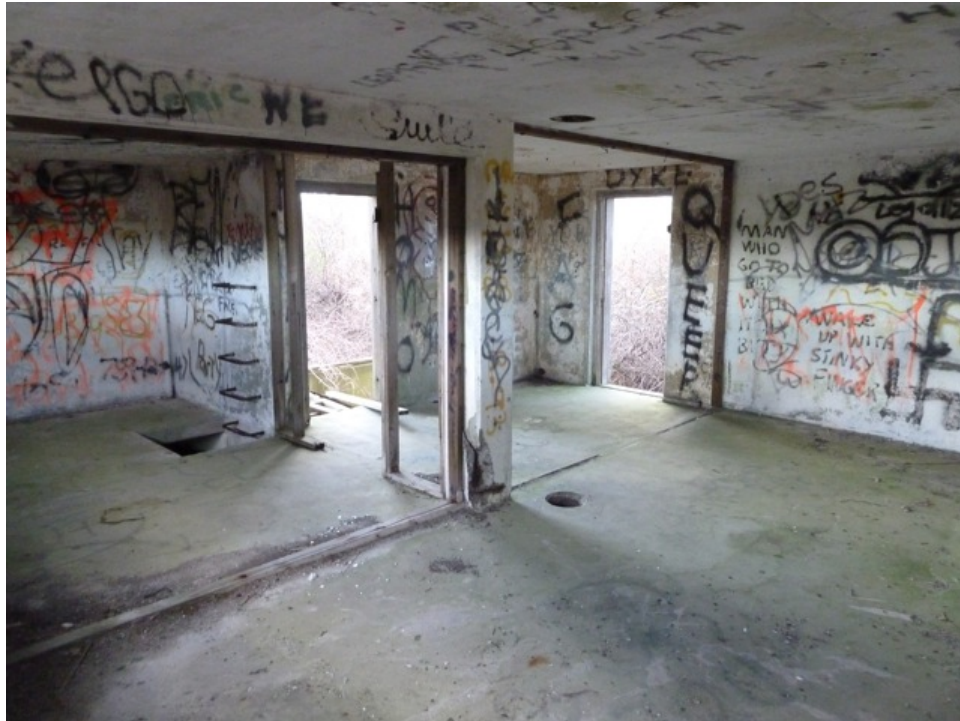
[Fig. 13] View of Room 1-1, looking northwest. Note the wooden framework for partition walls, ladder rungs, and original paint treatment under graffiti.

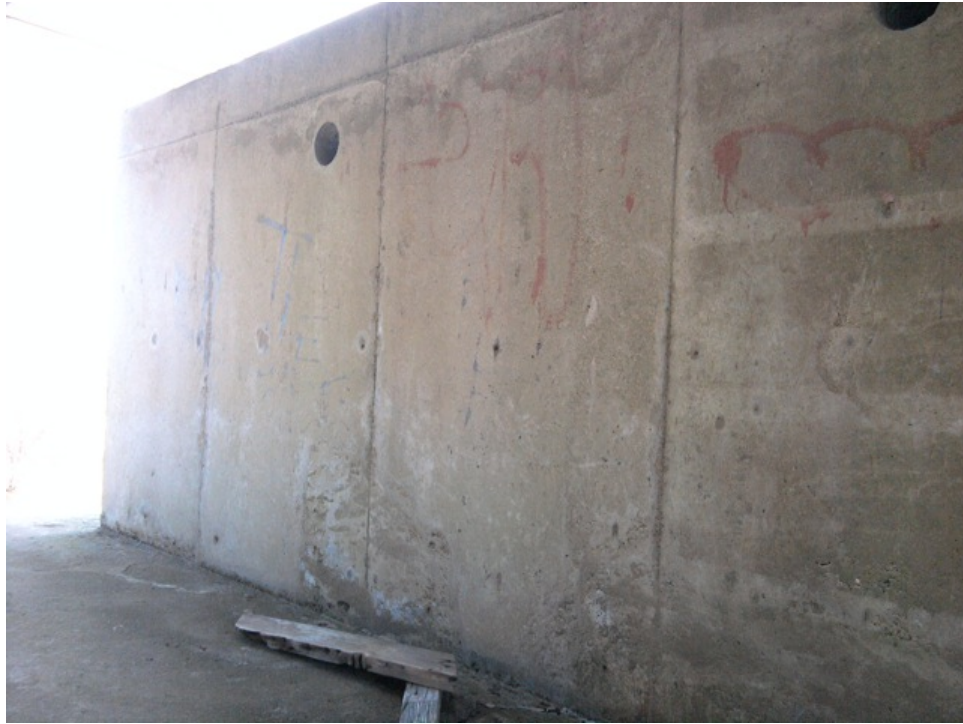
[Fig. 25] The south wall of Room 2-2, looking southeast. Note the false chimney remnant at the base of the wall.

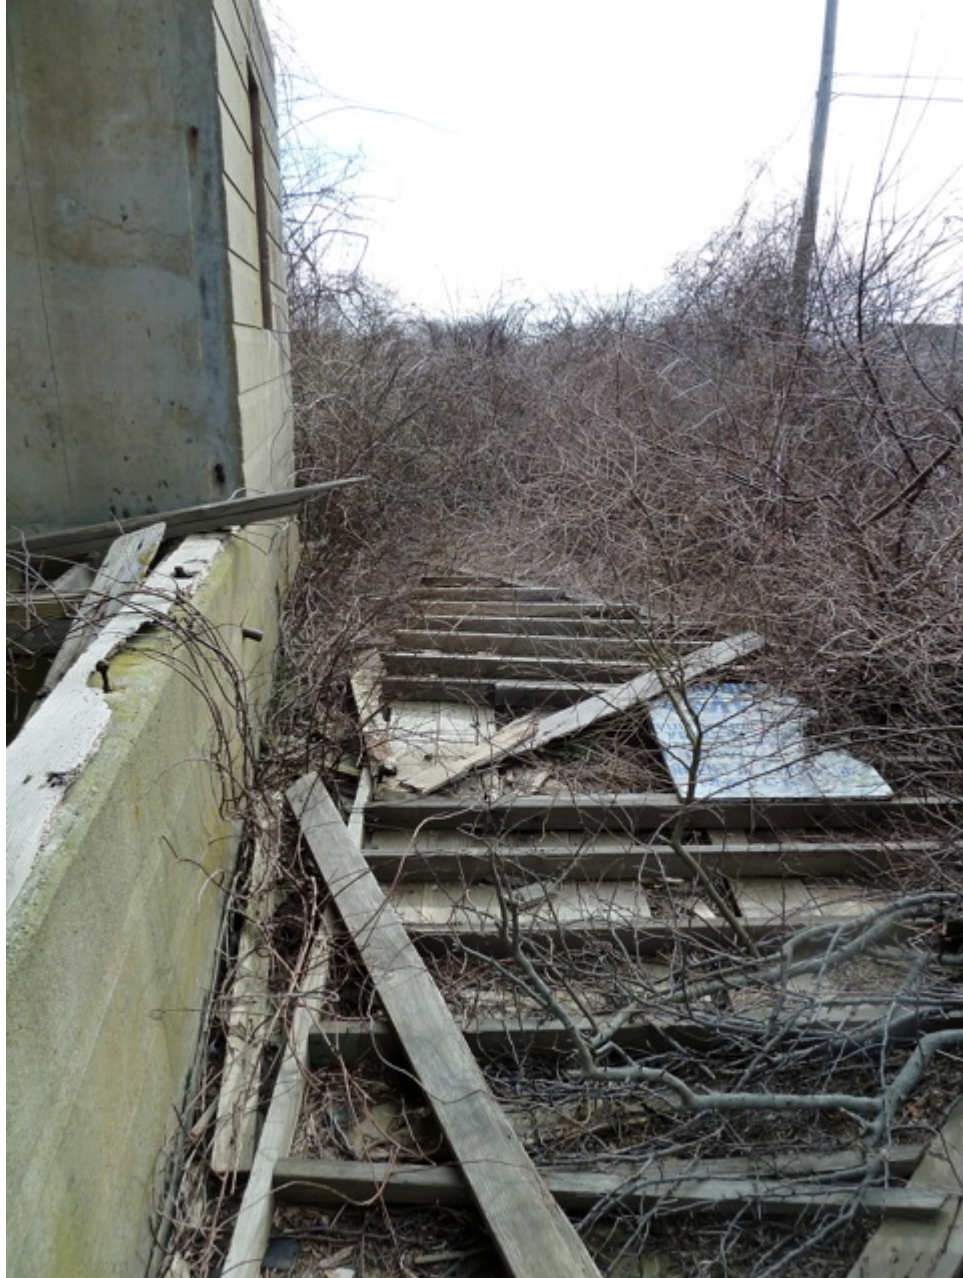
[Fig. 28] Fallen wooden wall for west elevation, looking south.

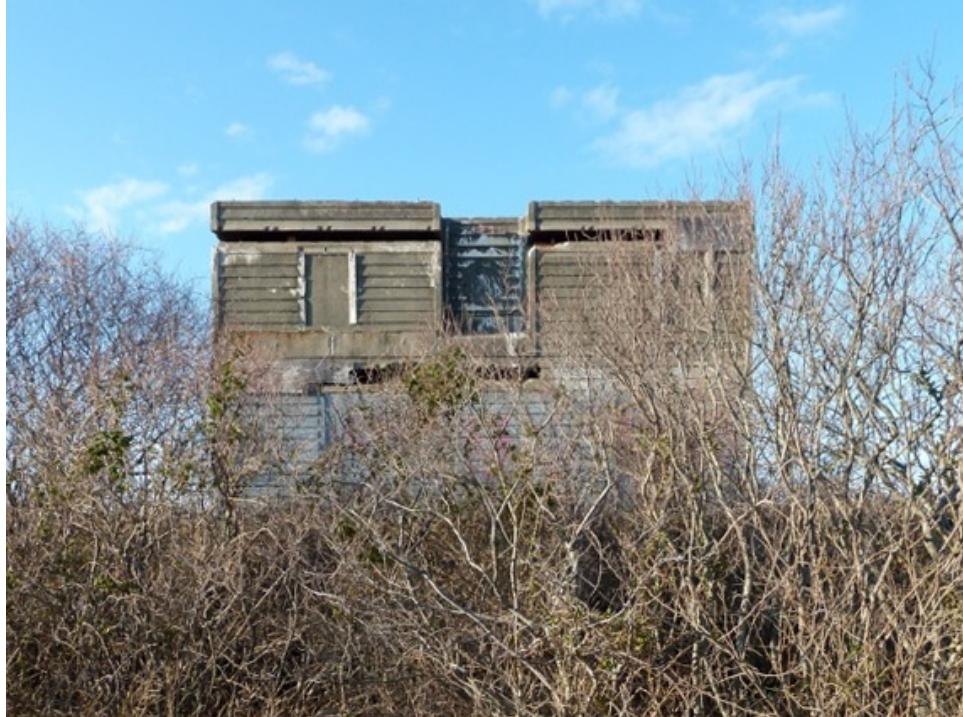
[Fig. 3] South elevation, looking north.

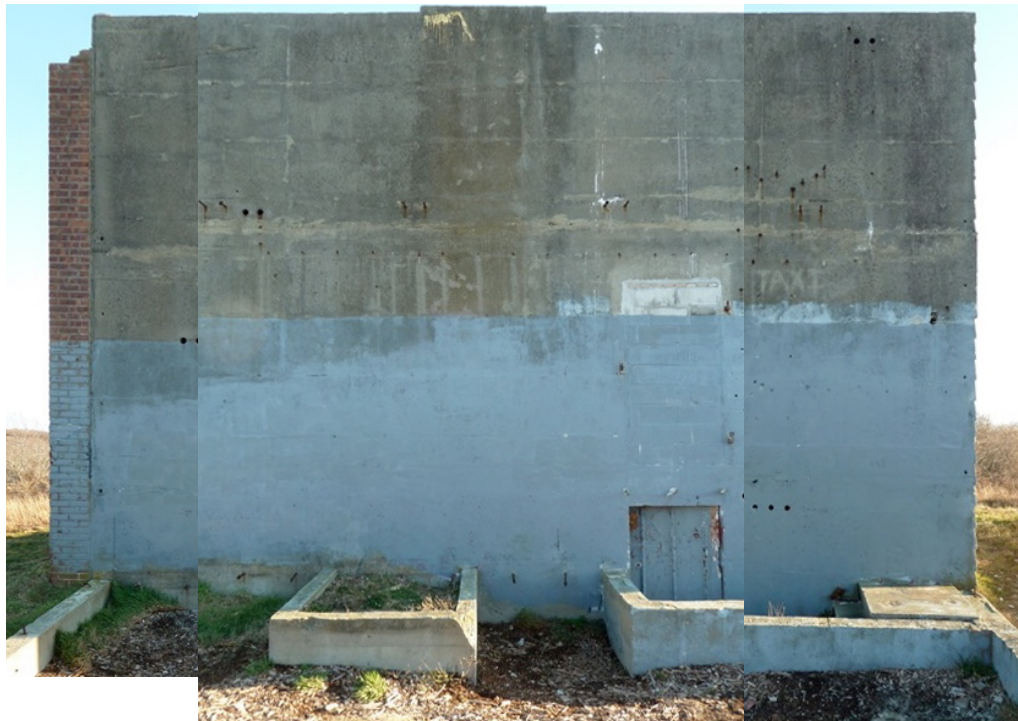
[Fig. 4] Collage of north elevation, looking south. Note the split-level transition between the concrete and foundation levels.

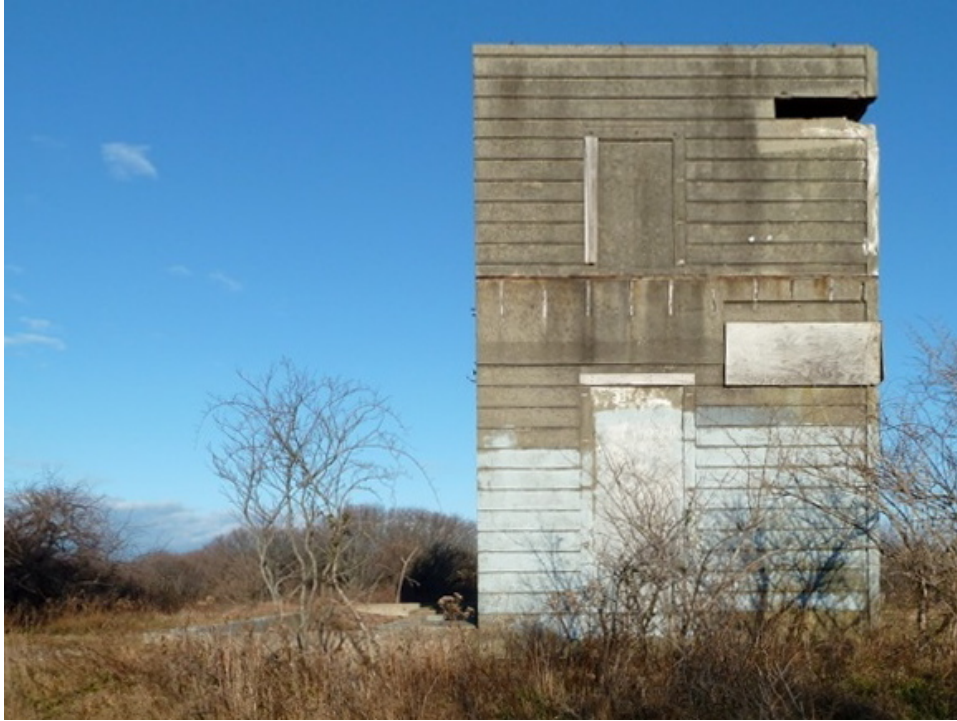
A false lintel had remained in place on top of the blind door, and a false window jamb remained on the northern side of the blind window [Appendix 6.1.2, Figs. 10, 11]

[Fig. 5] West elevation, looking east. Note the remaining door lintel and window jamb.

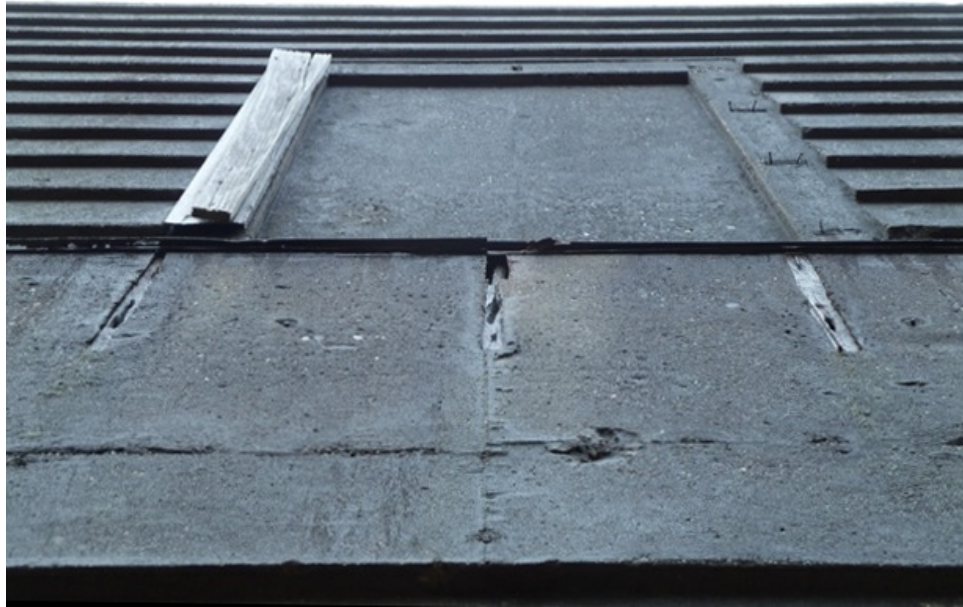
[Fig. 11] Detail of the west elevation. Note the smooth concrete where the porch roof was located, the blind window with associated wooden jamb, and concrete formed to mimic wooden clapboards.

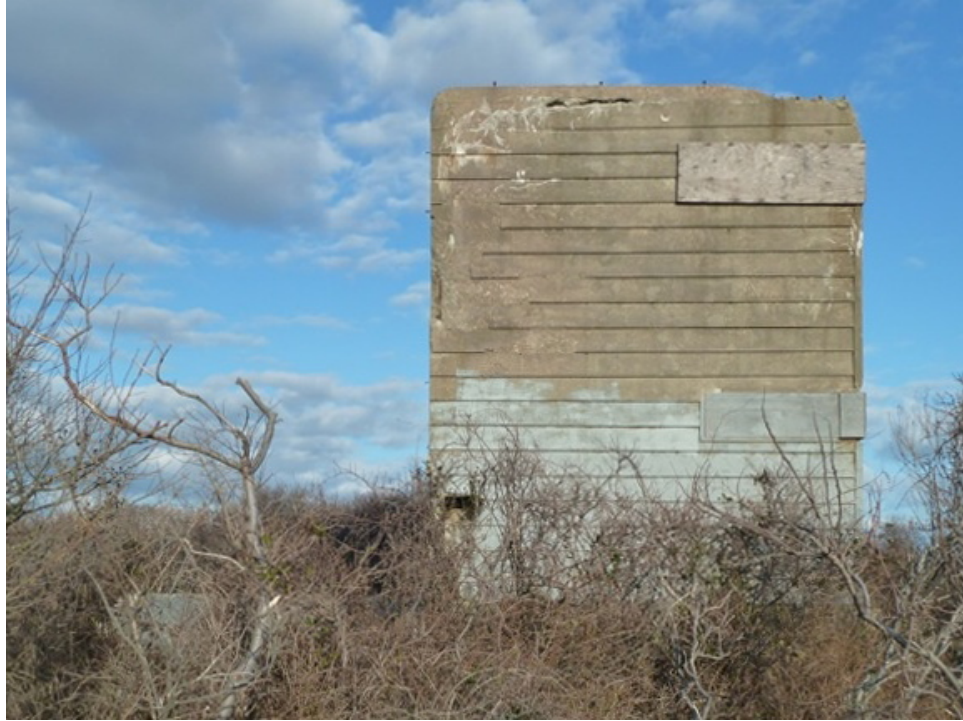
[Fig. 5] View of the southwest elevation, looking southeast. Note the excessive erosion and efflorescence.

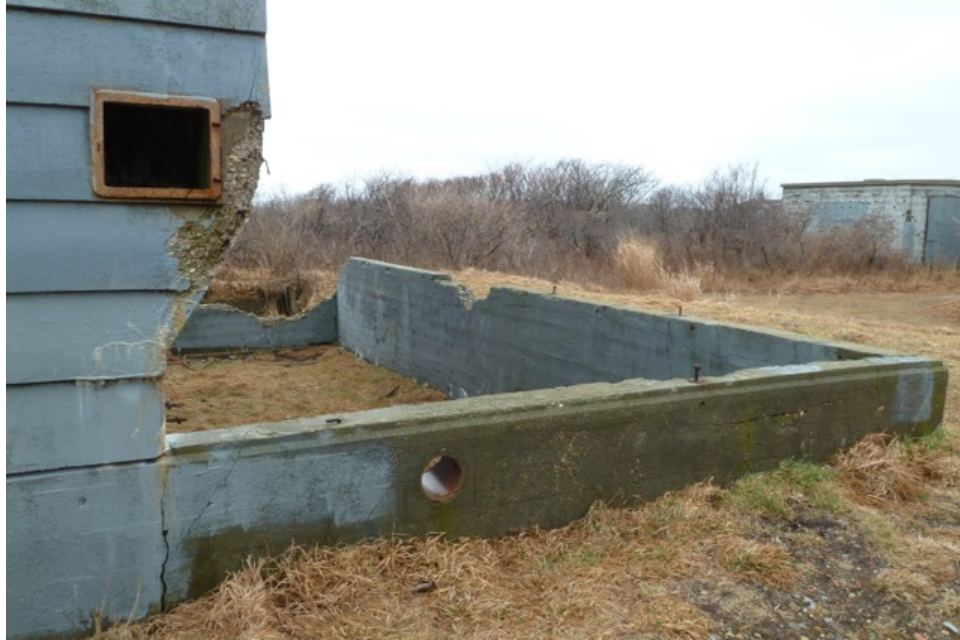
[Fig. 7] View of the foundation, looking west. Note the west generator building in the background.

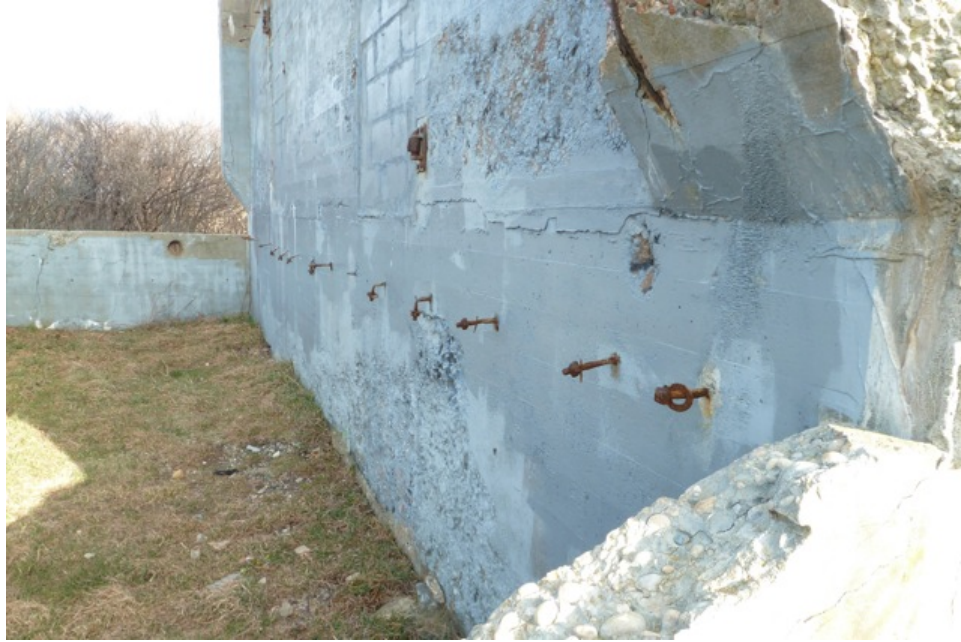
[Fig. 12] Detail of northwest elevation, looking east. Note the numerous steel ties suggesting the location of the now missing wooden floorlevel.

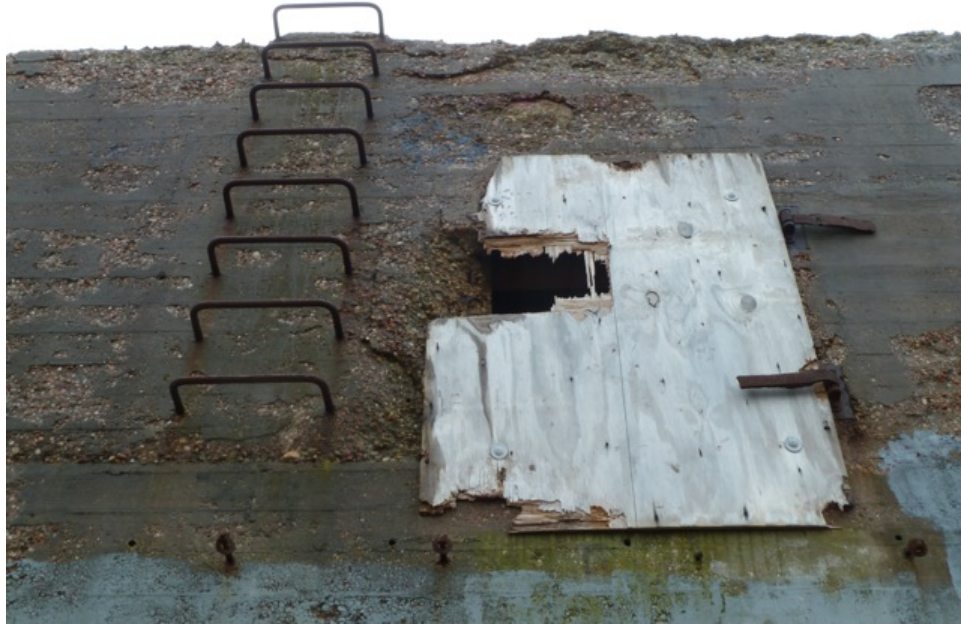
[Fig. 15] Detail of northwest elevation, looking southeast. Note the excessive erosion throughout.

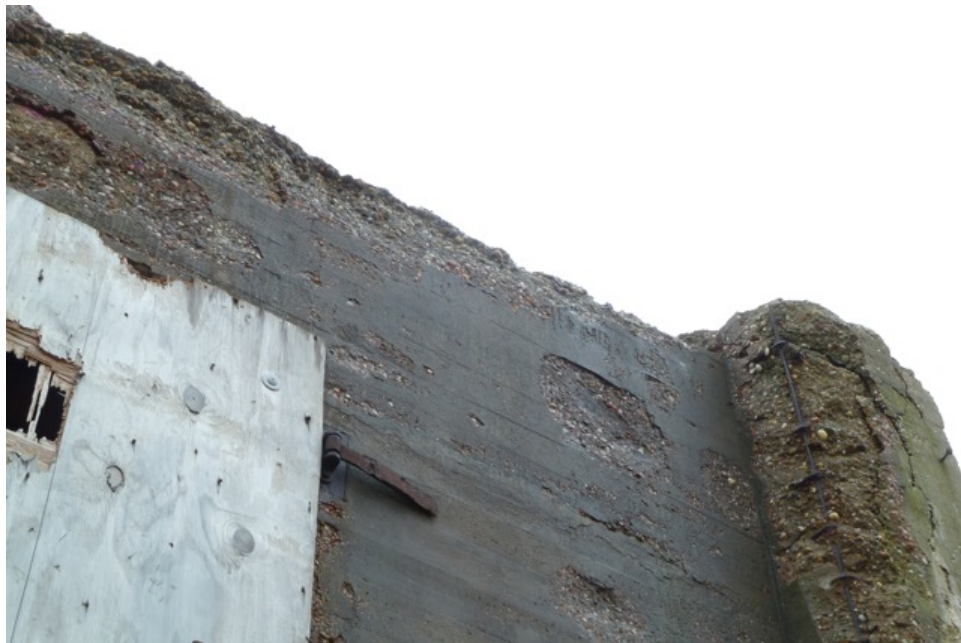
[Fig. 16] Detail of northwest elevation, looking south. Note the excessive erosion and exposed reinforcement bars at the top of the southwest chimney base.
