Pomham Rocks Lighthouse: Reuse and Rehabilitation Feasibility Report

Reuse and Rehabilitation
Feasibility Report

Community Partner:
The Friends of Pomham Rocks Lighthouse

Fall 2012

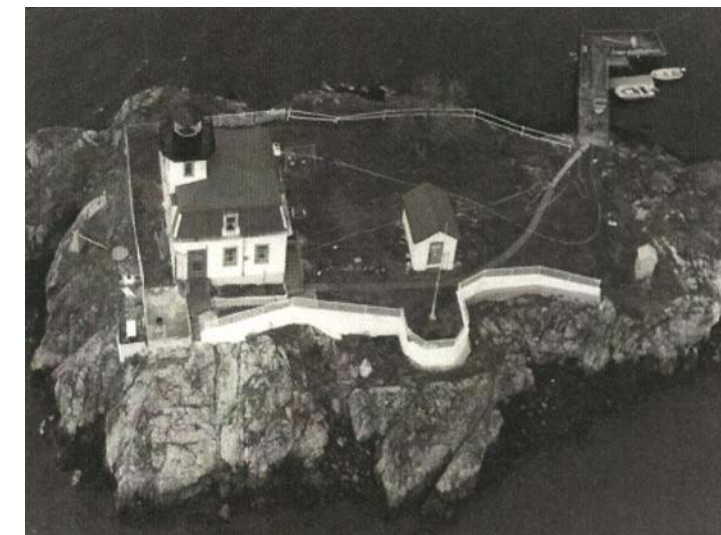
1. Pomham Rocks is located 800 feet off the coast of Riverside in East Providence.

2. Existing aerial shows no well-defined pathway from the boat dock to the lighthouse. Image: Bing Maps, 2012.

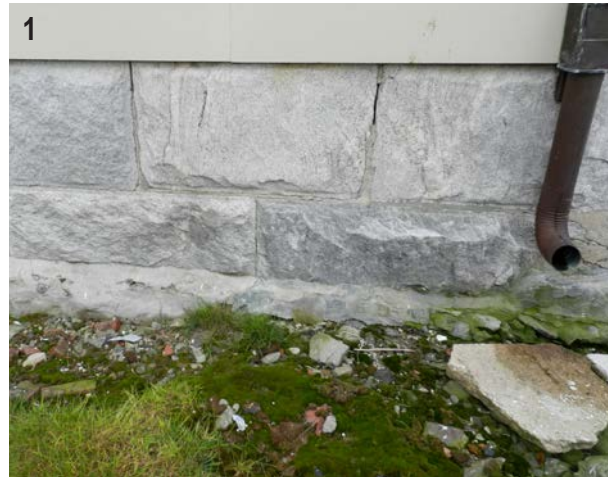
Exterior Granite: The mortar is deteriorating and failing at the mortar joints all along the granite foundation.

1. Granite foundation from north elevation shows missing mortar joints.
2. Lighthouse interior has exposed brick with deteriorating mortar.
3. Door hardware missing and inoperable.

The mortar joints will be repaired using a mortar that matches color and composition of the historic mortar. All work will be done in accordance with the guidance found in Preservation Briefs 2: “Repointing Mortar Joints in Historic Masonry Buildings.”

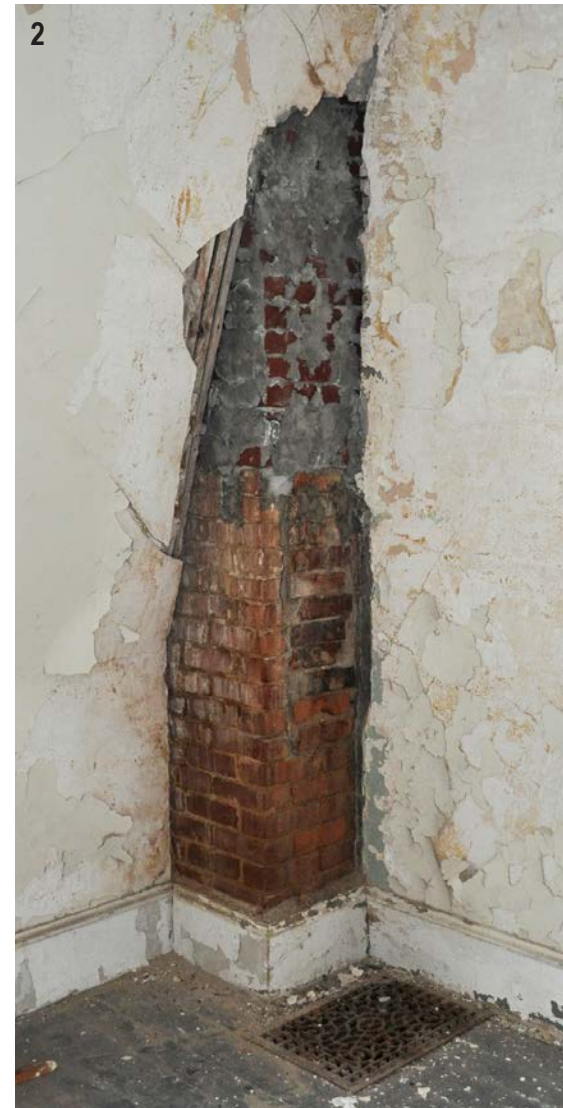
- **Chimney:** The brick chimney is exposed, and the mortar is deteriorating at the mortar joints.

The mortar joints will be repaired using a mortar that matches color and composition of the historic mortar. All work will be done in accordance with the guidance found in Preservation Briefs 2: “Repointing Mortar Joints in Historic Masonry Buildings.”

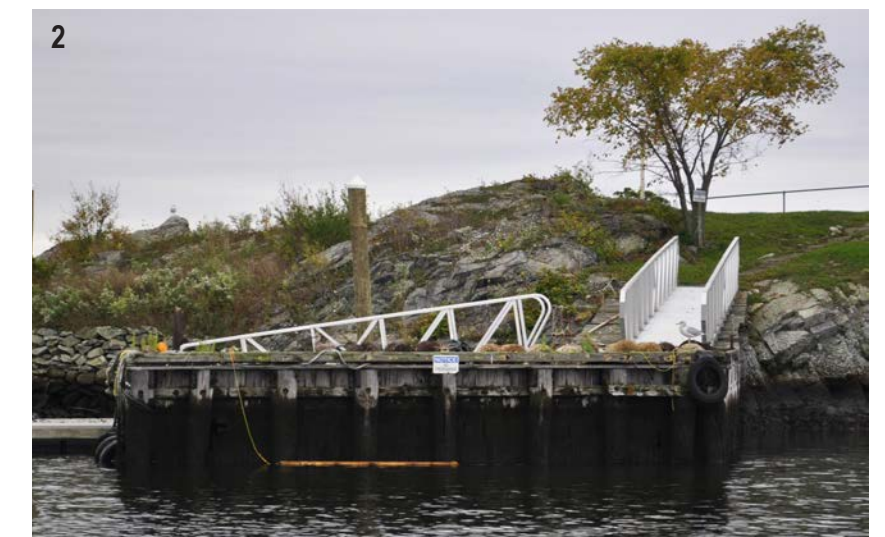
1. Plaster failure and missing sill in this second-story window.
2. Pomham Rocks Lighthouse boat dock, the only way to access the island.
