Charles G. Calder House Rehabilitation Plan

22 Whitmarsh Street | Providence | RI

Existing Conditions

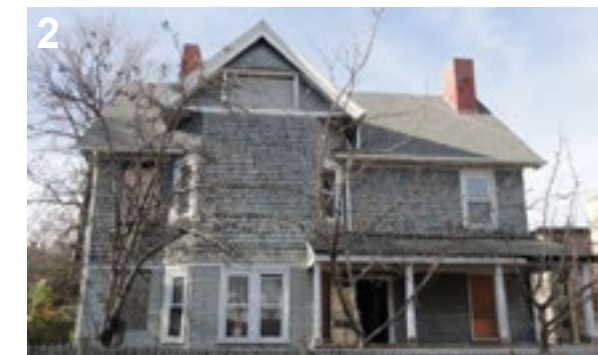
Foundation: The primary foundation for the house is constructed of brick, which has been painted in most areas. There is minor spalling on the brick throughout the foundation, but most of the brick has been protected by the paint and is in good condition.

The mortar in many areas of the foundation is either highly deteriorated or missing. Several basement windows are missing. There is significant damage to the foundation at the northwest corner due to the missing downspout and resulting water/freezing damage.

In recent years, a partially constructed concrete block bulkhead has been added to the foundation. This has resulted in a haphazard removal and reconstruction that appears to be structurally inadequate.

- 1. South elevation
- 2. East elevation
- 3. Brick foundation

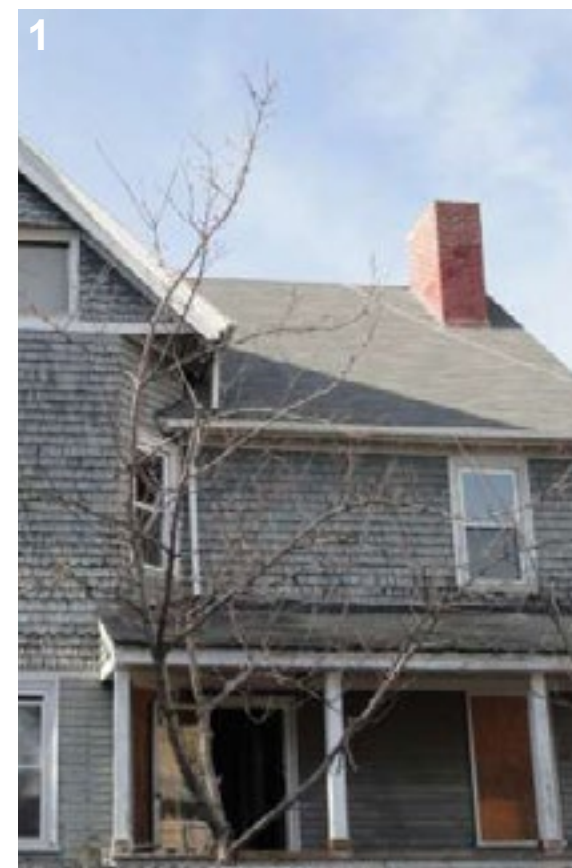
- 1. East elevation
- 2. North chimney and south chimney
- 3. Shingle siding

In general, the shingles are in relatively good condition. Damage is limited to single or missing shingles. Shabby appearance is mostly due to a lack of paint. The shingles in the worst condition are above the porch, where water has been splashing back onto the lower rows of shingles, and the eastern bay, where exposure has caused the shingles to warp.
