Fuller Farmstead: Reuse & Rehabilitation Feasibility Report

Reuse and Rehabilitation
Feasibility Report

Community Partner:
The Barnstable Land Trust,
Barnstable, MA

Fall 2013

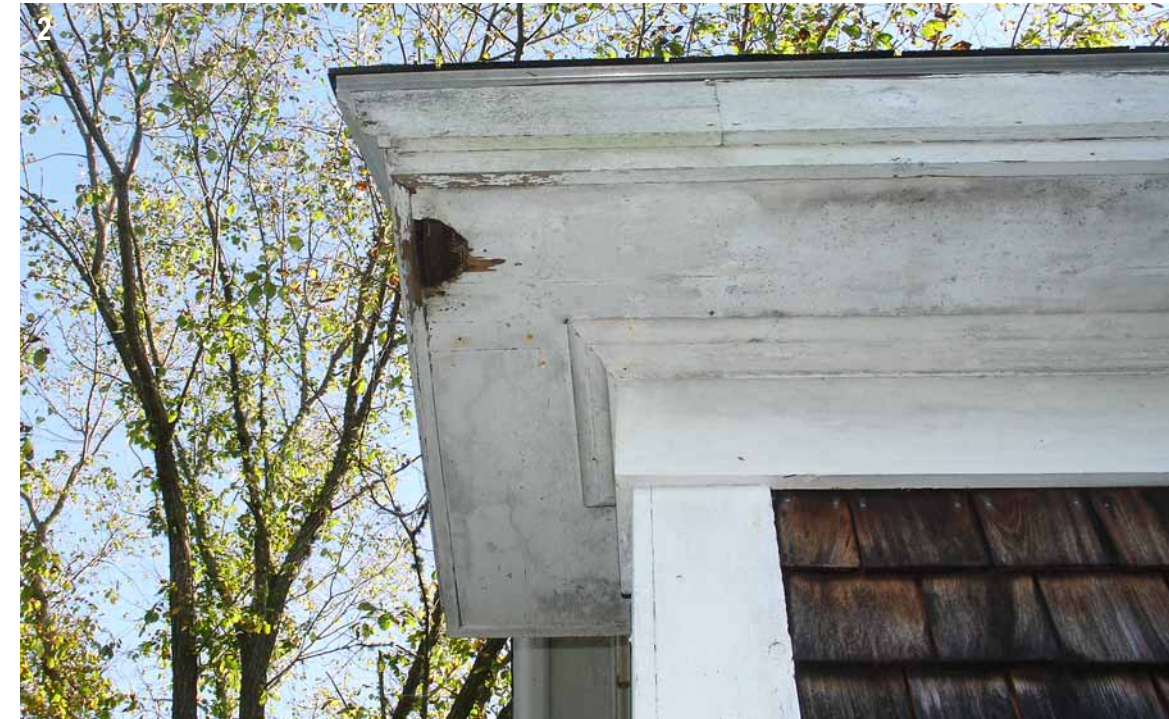
2. Animal nesting holes to be sealed.

- If section has more than 20% rot, remove the damaged portion, attach new material with replacement wood – either salvaged or new.
- Seal all animal nesting and bird holes with Dutchman Patch.
- Remove loose, flaking or checking paint by removing surface edges. Using two coats of primer, apply a white final coat with latex satin finish paint.
