St. Mary's Parish House: Reuse and Rehabilitation Feasibility Report

Reuse and Rehabilitation
Feasibility Report

Academic Partner:
School of Architecture, Art
and Historic Preservation

Community Partner:
Island Commons

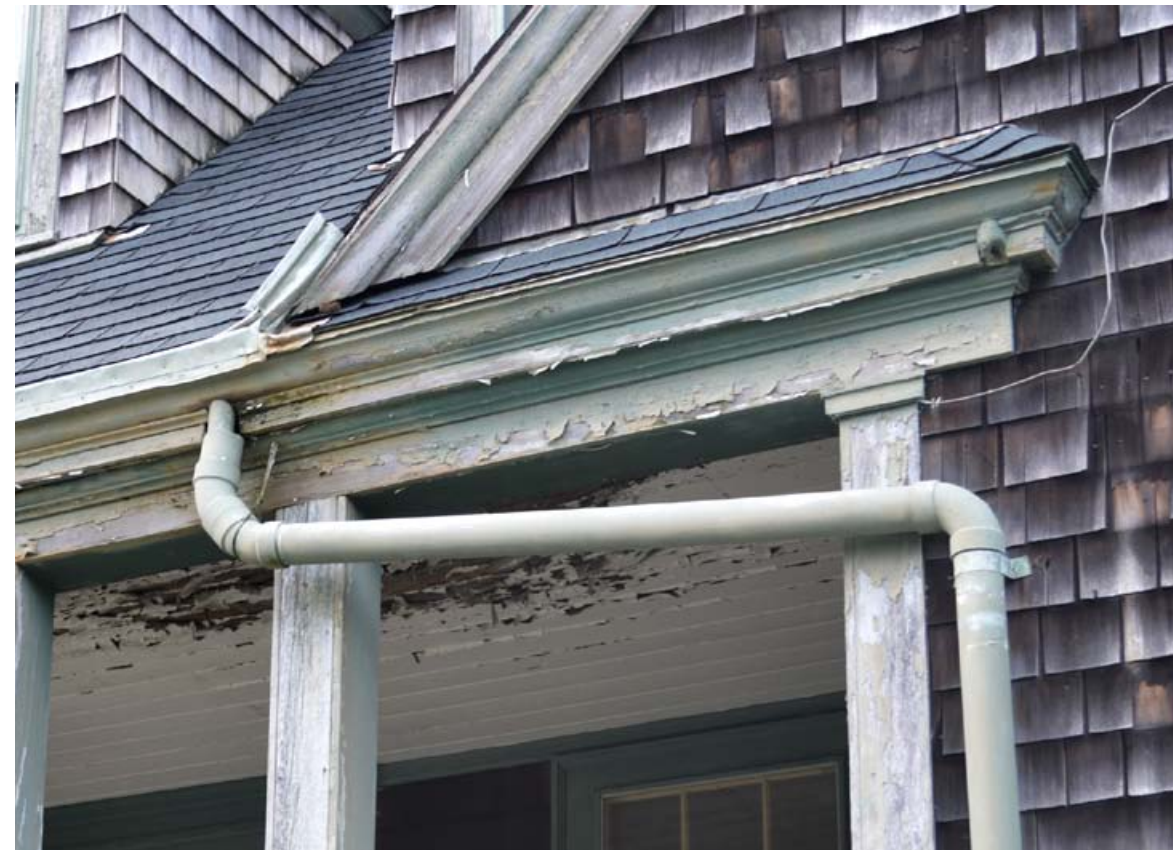
Cornice

- **Problem:** The exterior of the cornice is slightly deteriorated, showing signs of weathering

and cracking. There is paint loss and chipped paint throughout. Additionally, the cornice contains internal wooden gutters lined with copper. These gutters are in poor condition, with the copper lining deteriorating and the wood beneath rotting. They are undersized for the large roof of the parish house.

- **Solution:** Replace the original wood gutters with wider aluminum gutters with a historic molding profile that approximates the existing profile. Retain the existing molding beneath the gutter where possible. Areas of rot must be

replaced with new wood of the same dimensions and profile. Areas of cornice molding to be retained should be scraped and repainted with an exterior grade paint to protect the wood.

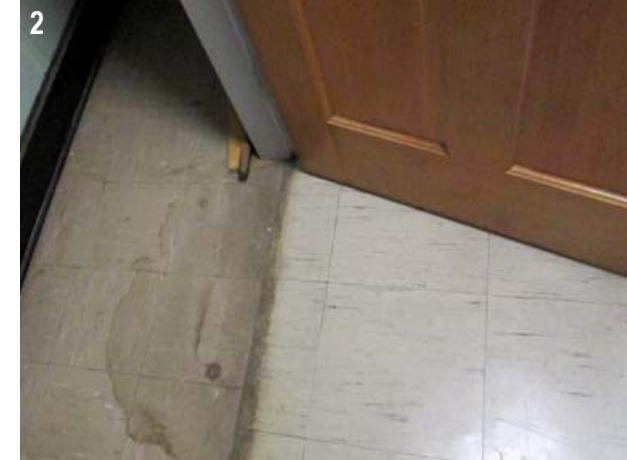
Exterior Paint Finishes

- **Problem:** Paint throughout the exterior of the structure is in poor condition. Paint on the front entry door is cracked. Paint on the porch ceiling is peeling off in large flakes

1. Original wood floors are in good condition, requiring just a light refinishing.

2. The kitchen, upstairs bathrooms and classroom addition contain asbestos tiles that can be covered with another floor material such as poured concrete.

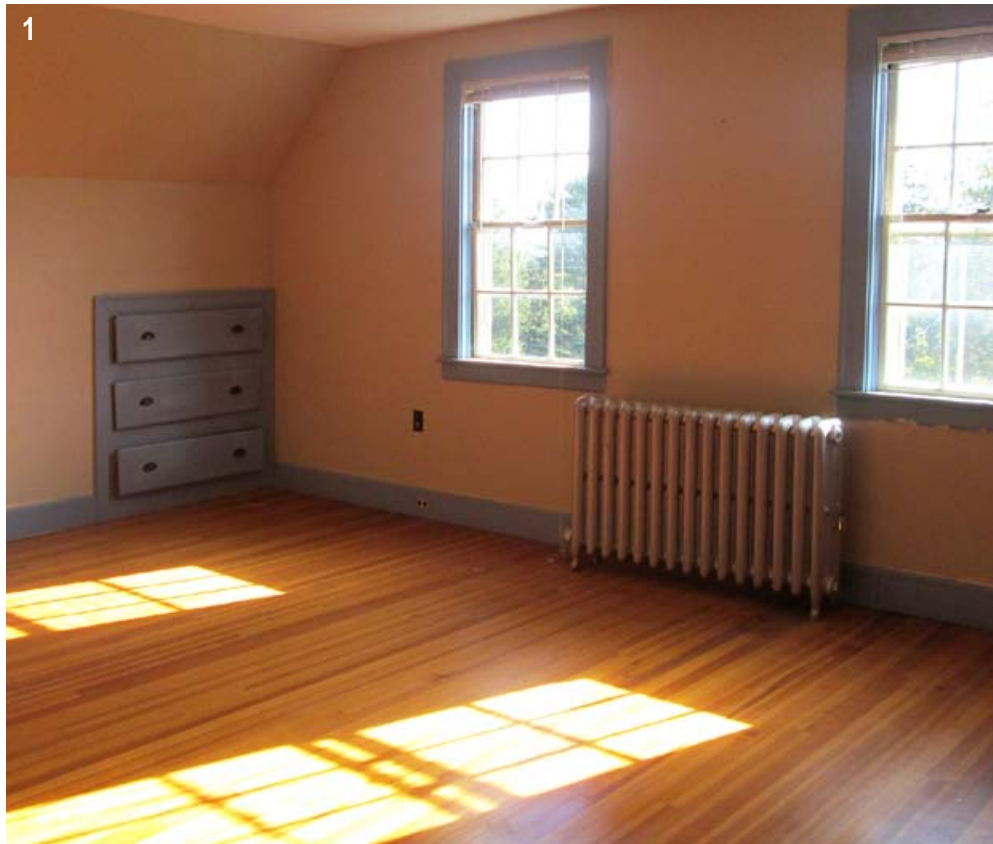
Plaster Finishes

- **Problem:** Plaster condition varies throughout the structure. The plaster is in generally fair condition throughout the first floor, with some holes, missing plaster and hairline cracks. The plaster textured finish on the walls in the upstairs classrooms and particularly in the stair hall is in poor condition, including cracking, bulging and separation from the walls in some areas.
- **Solution:** The plaster shall be retained and repaired. Holes shall be patched with new plaster that matches the historic material in color and texture. Areas of plaster that are bulging shall be reattached to the lathe using mechanical fasteners or chemical adherents.

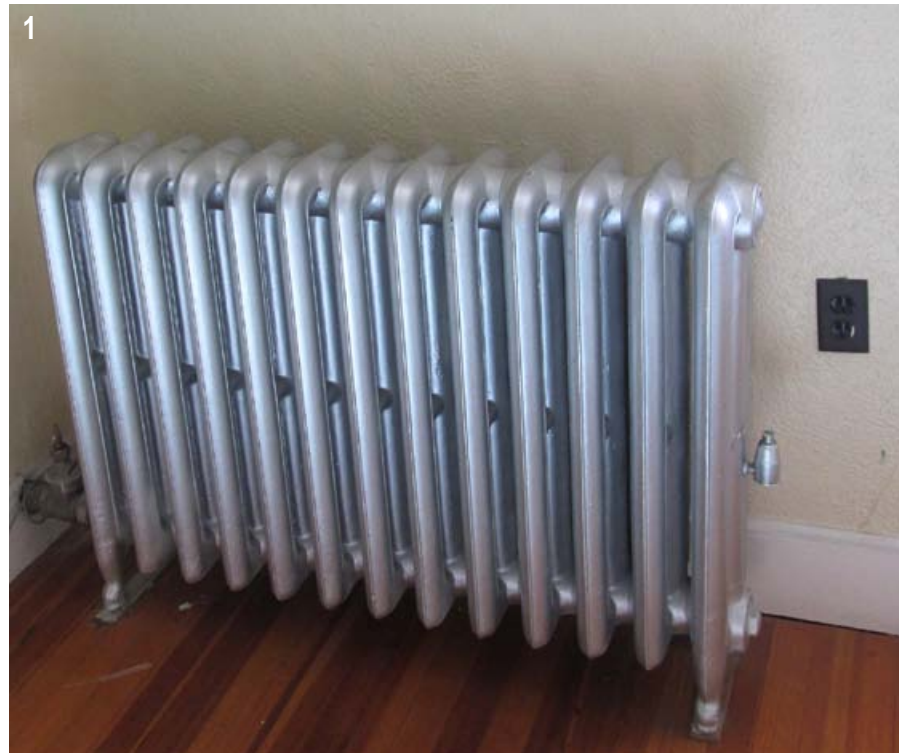
Radiators

- **Problem:** The cast iron radiators throughout building are in good condition. The only observable issue is some minor paint chipping on several radiators, though some have more chipped paint than others.

1. The cast iron radiators are in good condition, though some require minor scraping and repainting.
2. An historic light switch plate in one of the classrooms. Electrical wiring behind it needs to be examined.

- **Solution:** Loose paint may be scraped and removed. In the case of lead paint, this must be carried out by a professional. The surfaces shall be repainted.
