The Baptist Church in Warren: Rehabilitation and Preservation Report

Rehabilitation and Preservation Report

Community Partner:
The Baptist Church in Warren

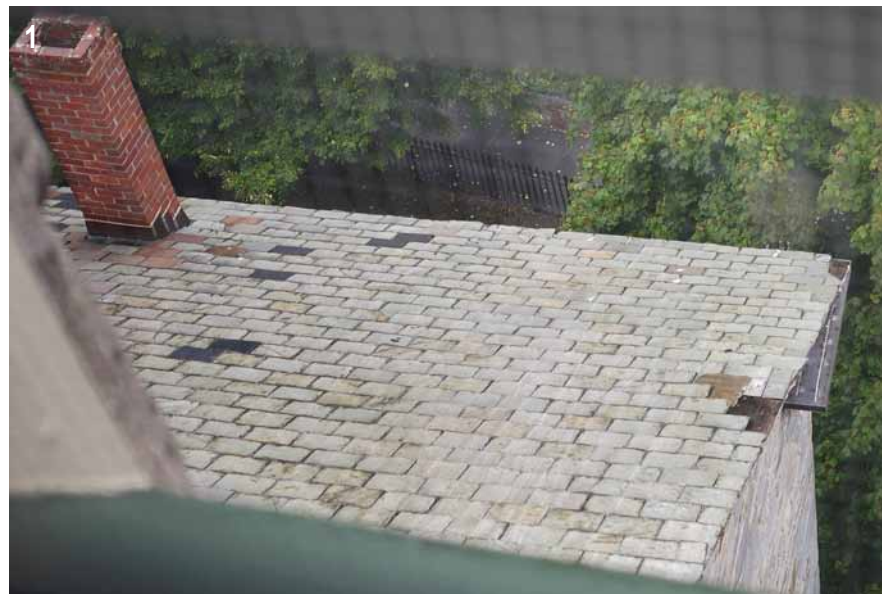
The roof covering the church's tower is bi-colored with grey and red slate forming a striped pattern. Overall, the roof is in fair condition, however, the slate shingled areas are in need of repair. Many slates are missing or hanging by one hanger. This is a failure of the hangers, which only last about a hundred years. These hangers are probably made of brass or copper, since they were the leading hangers of the 1840's. The copper ridge cap looks to be in fair condition, however, after 100 years of service, the roof is showing inevitable signs of age. The framing for the tower roof is in good condition and shows no visible signs of water damage or rot associated with insects or environmental effects.

The gable roof of the main structure is covered in green slate. Overall, the main roof is in poor condition. The existing slate roof was installed over a wooden shingled roof. The condition of the wooden shingles is unknown and could be a cause of the roof's poor condition. As with the tower roof, slates are sliding out of position, which could be caused by failing ferrous fasteners. Certain slates are exhibiting breakage, which could be the result of impurities in the slate. Numerous dark-colored slates show prior maintenance; yet there are missing slates throughout. The copper ridge cap is in good condition. Recently, Renaissance Roofing of Woonsocket, Rhode Island replaced over 400 slate tiles on the main roof.

1. A view of the roof from the tower window. The dark patches are missing slate shingles.
2. The tower roof, showing the red and grey slate striped pattern of the tiles.

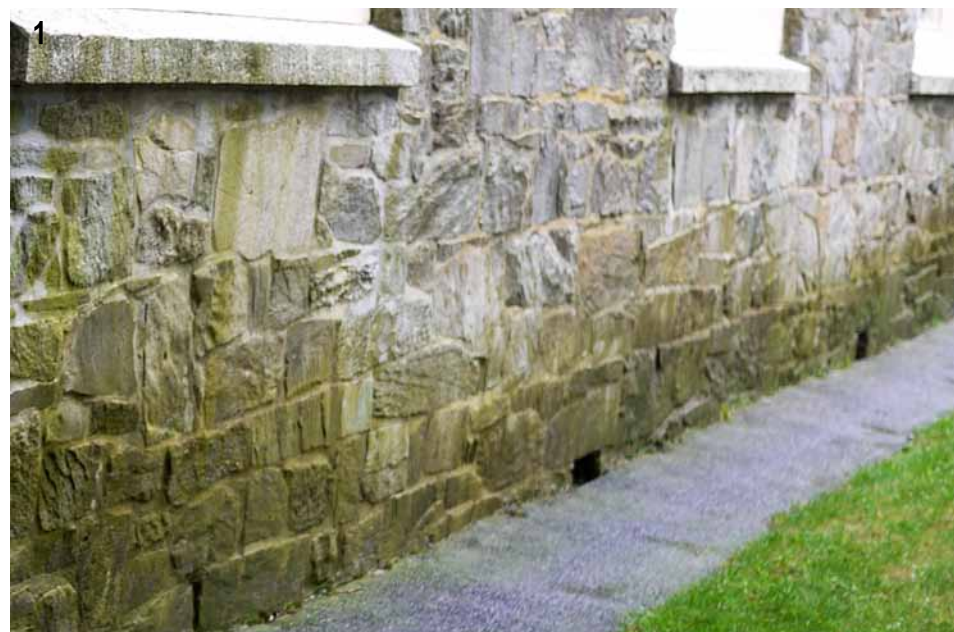
The masonry along the west elevation appears to be in good condition, displaying no structural concerns or material pathologies. There is some staining of the stone due to the bleeding of the rusted iron fittings designed to support lighting along the church's rear, but there appears to be no other damage other than aesthetic from this.

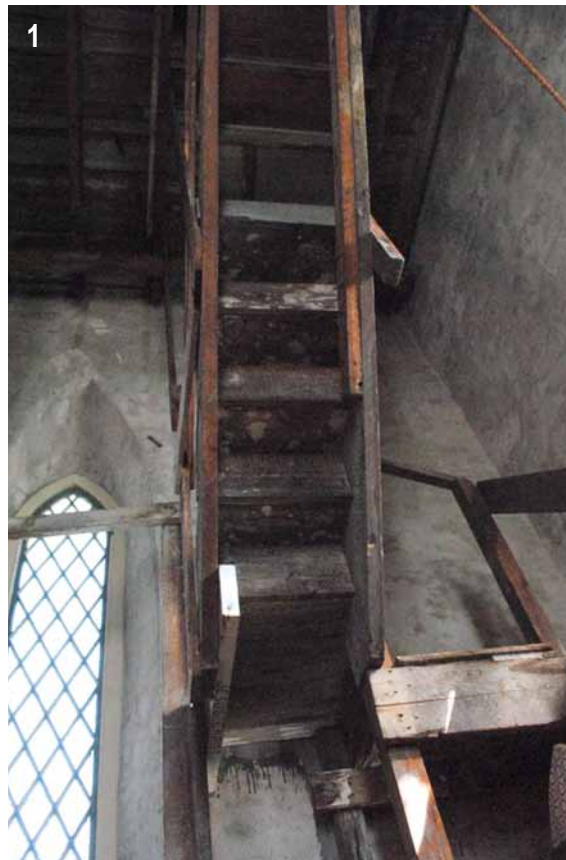
and ladders, although appearing serviceable, are narrow, cramped and unpleasant for the workers at the church. The exposed masonry allows for patching to be done to fix cracks in the mortar. There is a prominent patch under the east window.

Overall the plaster in the sanctuary is in good condition, however there are a few sections throughout that are deteriorating or cracking, especially in the northwest and northeast corner of the building. The chancel also has plaster issues due to the roof leak. Overall, there are no sections where the plaster is completely detaching from the substrate.

Faux wood graining can be found throughout the sanctuary on doors, door casings, pews and wood paneling. On the mezzanine, overlooking the sanctuary, the wood graining is applied on plaster to mimic wainscoting. Sections of the wood graining show failure, especially in areas applied to the plaster.

1. Narrow stairway to the bell tower, accessed through a door in the sanctuary's balcony.
2. Cracked plaster walls in the sanctuary.
3. Faux wood graining shows failure throughout the church.

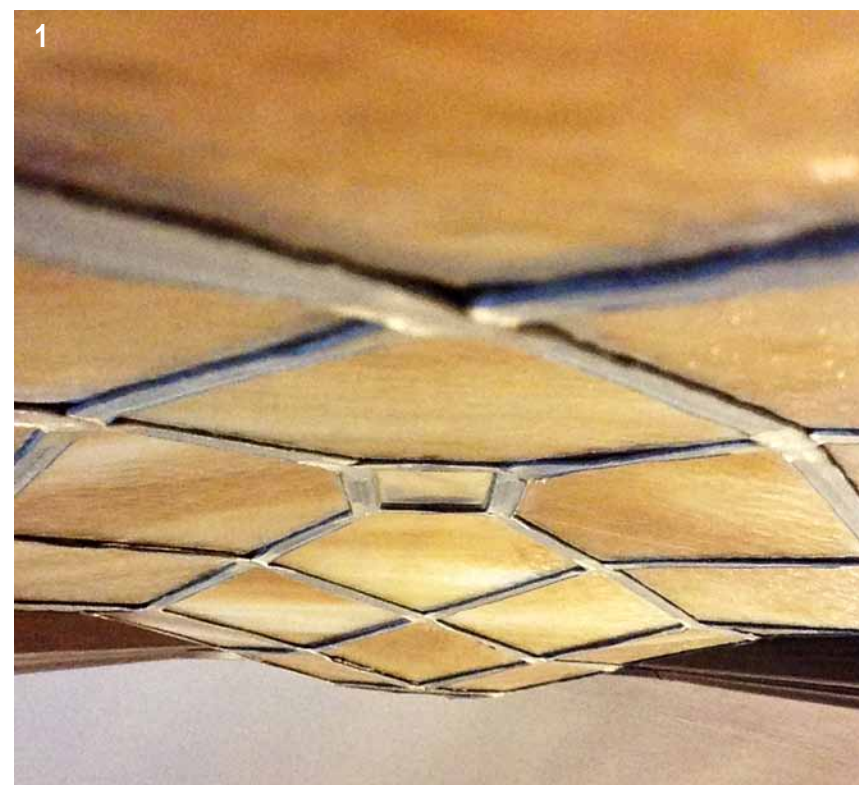
There is leaded glass throughout the sanctuary. It is found on the doors leading into the sanctuary from the front entrance. It is also found in a wooden partition separating the front entry into the sanctuary. The sagging of the lead and glass is an indication that the structural integrity of the lead support is beginning to fail, but the lead came has not failed to the point of breakage or dislodging the glass. On the western and eastern elevation, the stained glass windows are in need of re-caming.

The carpeting in the main sanctuary is heavily stained by water damage with sections worn through to the backing. The finishes throughout the rest of the building are all stable and do not require any necessary replacement at this time.

1. A pronounced view of the stained glass bowing of the doors leading into the sanctuary.
2. The carpet shows signs of water damage.

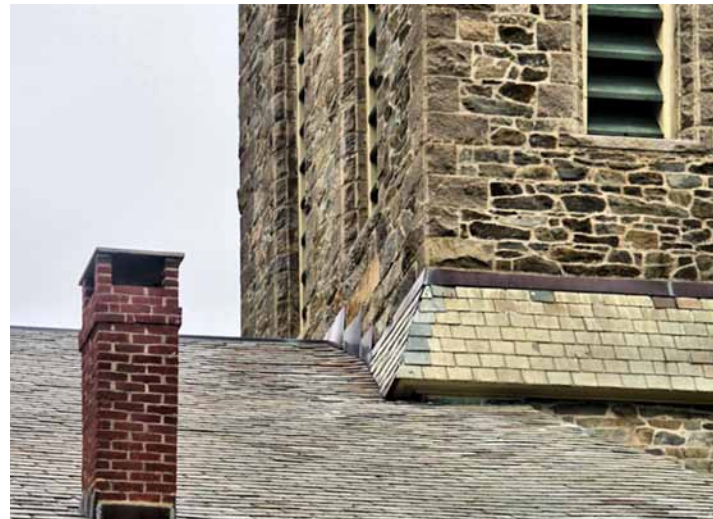
The gable roof of the main structure is covered in “sea green” slate. The main roof is in poor condition; the existing slate roof was installed over a wooden shingled roof. The condition of the wooden shingles is unknown and could be the cause of the roof’s poor condition. Slates are sliding out of position, which could be caused by failing ferrous fasteners. Certain slates exhibit breakage and could be the result of impurities in the slate. Currently the roof is being repaired. Around 1400 slate tiles have been replaced. The tower roof is in fair condition and is covered with alternating courses of scalloped “sea green” and rectangular “unfading red” slate. Some slates are sliding out of position.

- **1.2.1** Replace broken, cracked and missing slates with new slate material. New slate should match the size, shape, texture and weathered color of old slate. Assess the condition of slates sliding out of position; salvage sound undamaged slate and re-hang with copper fasteners.
- **1.2.2** Slide new slate into place and hold in position with one nail inserted through the vertical joint between the slates in the course above and approximately one inch below the tail of the slate two courses above. To prevent water penetration through the newly created nail hole, a piece of copper with a friction

- **1.2.3** Alternate methods for securing the replacement slate include the use of metal hooks, clips and straps that are bent over the tail end of the slate.

- **1.2.4** The application of roofing mastic or sealants to damaged slates should not be considered a viable repair alternative because these materials, though effective at first, will eventually harden and crack, thereby allowing water to enter.

- **1.2.5** Sheathing should be checked for rotted areas. Plywood is generally not a good replacement material for deteriorated wood sheathing due to the relative difficulty of driving a nail through it (the bounce produced can loosen adjacent slates). Instead, new wood boards of similar width and thickness to those being replaced should be used.

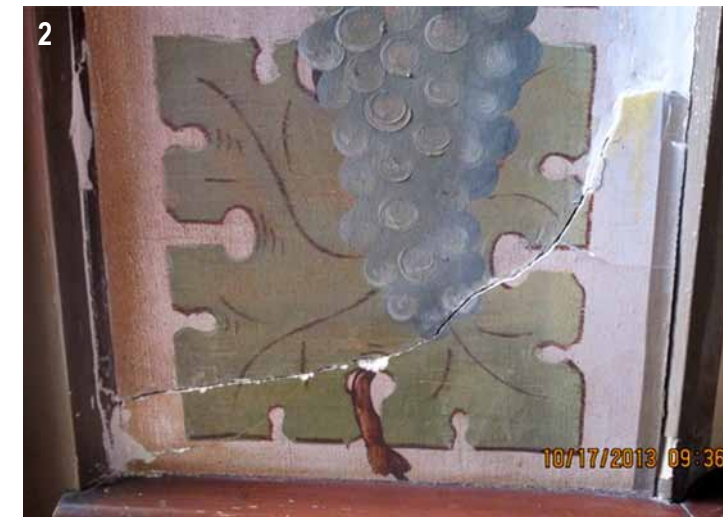
The decorative paint which accents the lancet arches throughout is in good condition. However, the paint on the lower portion of the lancet arch of the windows is deteriorating. The decorative paint in the chancel is in fair condition. The paint in the chancel has suffered moisture damage from a roof leak that has since been repaired. The damaged paint and plaster areas have not been repaired.

1. Areas of paint failure need to be scraped, sanded, cracks filled and surface painted to match existing paint.

2. Cracking and peeling of decorative paint, which needs to be filled and painted to match existing paint.

- 1.2.1 Onsite collection of paint samples and laboratory analysis of surface colors and treatments must be undertaken to assess appropriate paint material and colors. Historic paint formulation is not practical for this project.
- 1.2.2 Cleaning may be all that is needed for most of the paint surface. This can be done with warm water to clean off accumulated dirt.
- 1.2.3 Gentle hand scraping and sanding is advised to remove any loose paint or plaster.
- 1.2.4 Plaster surfaces should be made as smooth as they were historically so that the paint film will cover a relatively uniform surface.

- **1.2.5** Once the substrate and its surface are clean, free from crumbling, loose material or dust, the next step is to undercut and fill any cracks in plaster surfaces.
- **1.2.6** Apply matching paint with a natural or synthetic brush.
- **1.2.7** All materials and shop drawings required for work in this section shall be subject to approval by preservation consultant and the architect based on submittal of product information, samples and supporting material.⁸

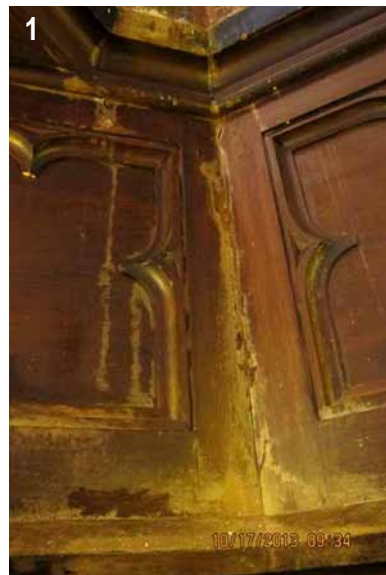
The finish to the wood paneling in the chancel has suffered damage due to the water leak; however, there is no noticeable damage to the structure of the wood. Overall, the wood in the chancel is in good condition.

1. Water damage to chancel woodwork requires repair.
2. Faux finished wood graining has worn away in some areas.

- **1.2.1** Onsite collection of finish samples and laboratory analysis of surface treatments must be undertaken to assess appropriate finish, glazing material and stain color.
- **1.2.2** Sand areas where water damage has occurred to remove finish and expose bare wood. When the finish has been removed, bleach the entire stained surface with a solution of oxalic acid if wood is stained dark.⁹
- **1.2.3** Stain bare wood to match existing stain.
- **1.2.4** Prepare existing finish surrounding treated area with sandpaper grit-220.
- **1.2.5** Re-finish the wood paneling to match existing finish throughout.
- **1.2.6** All materials and shop drawings required for work in this section shall be subject to approval by preservation consultant and the architect based on submittal of product information, samples and supporting material.

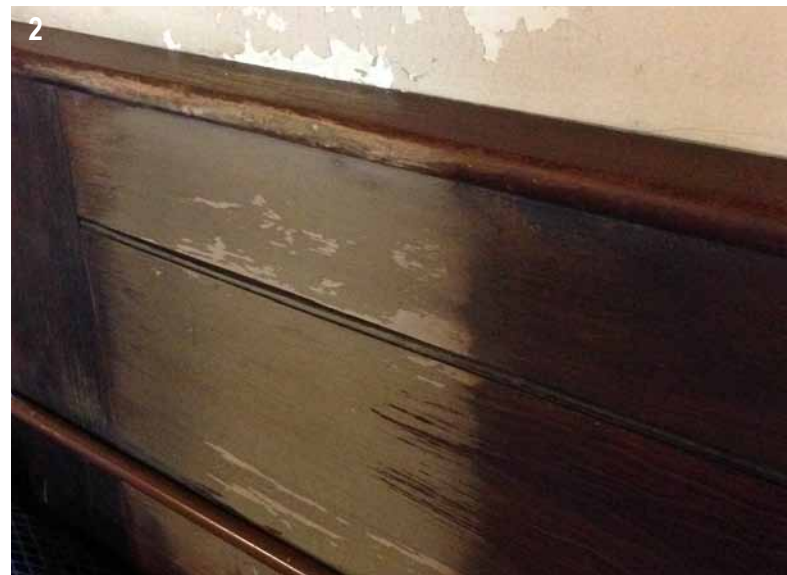
The faux wood graining throughout the sanctuary can be found on doors, door casings, pews and wood paneling. On the mezzanine overlooking the sanctuary, the wood graining is applied on plaster to mimic wainscoting. There are sections of wood graining that are failing, especially in areas applied on the plaster.

- **1.2.1** Onsite collection of finish samples and laboratory analysis of surface treatments must be undertaken to assess appropriate finish, glazing material and stain color.
- **1.2.2** Gentle hand scraping and sanding is advised to remove any loose finish or plaster substrate.
- **1.2.3** Plaster surfaces should be made as smooth as they were historically so that the faux wood graining will cover a relatively uniform surface.

- **1.2.4** Once the substrate and its surface are clean, free from crumbling, loose material or dust, the next step is to undercut and fill any cracks in plaster surfaces
- **1.2.5** Apply wood graining to match existing grain patterns with appropriate brushes.
- **1.2.6** Apply protective finish.
- **1.2.7** All materials and shop drawings required for work in this section shall be subject to approval by preservation consultant and the architect based on submittal of product information, samples and supporting material.¹⁰
