IR THERMOGRAPHY IN MOISTURE AND EARTHQUAKE DAMAGE DETECTION PERFORMED IN THE ŽIČA MONASTERY, SERBIA

Slavica RISTIĆ^{1*}, Suzana POLIĆ-RADOVANOVIĆ²

This paper presents the results of the IR thermographic diagnostics of the seismic damage inflicted upon the Žiča Monastery after the earthquake on 3rd November 2010. The Žiča Monastery founded in 13th century is located in central Serbia. The moisture content in the structure was detected too. The obtained results document the current state of the buildings and, at the same time, confirm the advantages of IR thermography as a method in the diagnosis of earthquake cracks, useful for the seismic retrofit study. The obtained results enable the identification of the structure parts where more in-depth investigations need to be concentrated. The procedures and activities for curative conservation and protection of the Žiča Monastery should include the thermographic test results. The results and the conclusions obtained in this case study could be used as example for further extensive studies of historical and cultural heritage buildings.

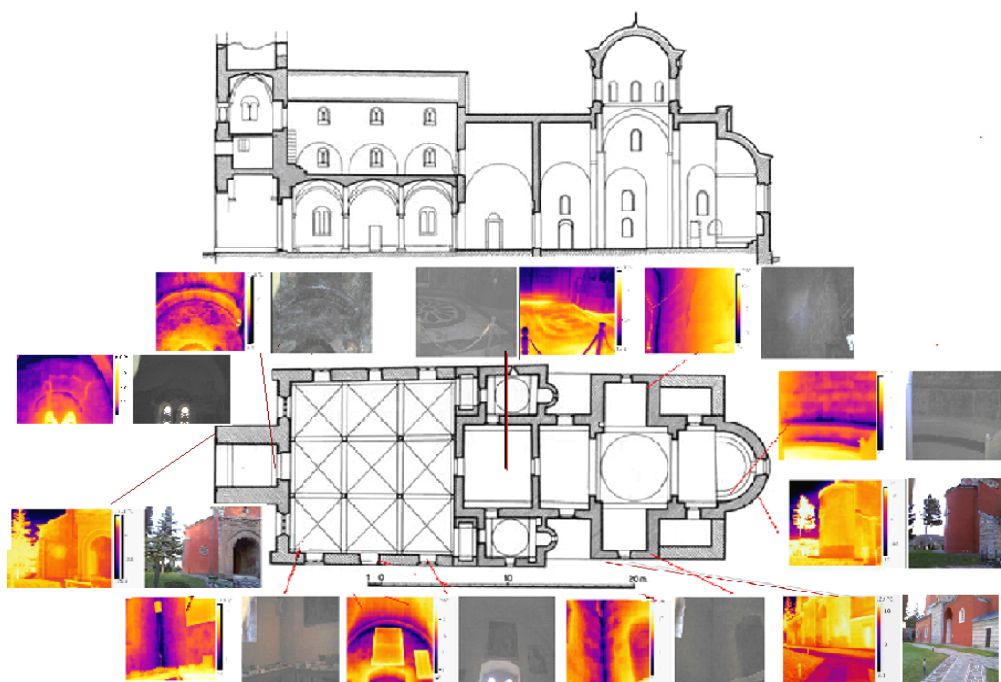
Fig. 1. Architectural drawing of the Žiča Monastery, the Church of St. Savior, illustrated by photos and thermograms

The thermograms and digital photos of some parts of the monastic buildings are presented together. Figure 1 shows an architectural drawing of the Žiča Monastery, Church of the Saint Savior, illustrated by photos and thermograms.
