# The Reveal: A Technical Study and Conservation Treatment of an Overpaint Portrait

**The Reveal: A Technical Study and Conservation Treatment of an  
Overpainted Portrait**

*CNS 695 Master's Project*

Camille Ferrer

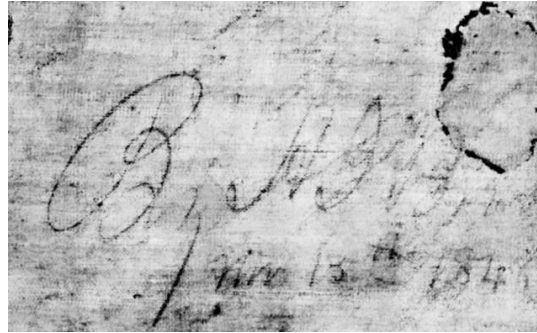
Figure 2: Detail of reflected infrared image of reverse of the painting. Possible Artist signature and date present.

belongs to the artist, the sitter or someone else. The cursive of the signature makes it slightly illegible and hard to identify the name. Two numbers on the date are also hard to distinguish. What can be confirmed is that the name begins with a “B” and the painting was completed around mid-1840s.

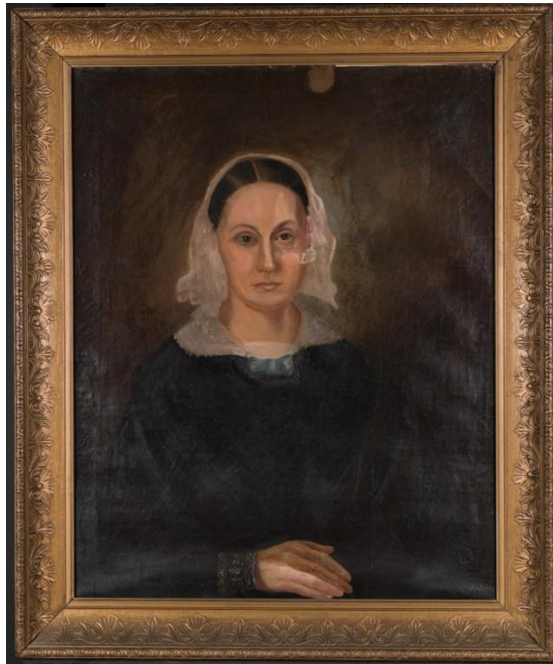
Figure 3: “Portrait of a Woman” with frame. Before Treatment

The painting arrived to the department in generally poor condition. Overpaint was visible on the face, and after further exploration and analysis, was confirmed to be overpainted throughout. The letter provided by the owner, indicates that the artwork was previously restored, but returned with unsatisfactory results. The painting afterward was taken to Westlake Conservators where they, with permission, conducted some cleaning/removal testing on 4 spots: the top, right side of the face, blue bow on the collar, and half of her hands. The full state of condition of the painting was unknown due to a sum of the surface being overpainted. The little areas that have been previously cleaned, showed a glimpse of the damage underneath. There was paint loss and abrasions.

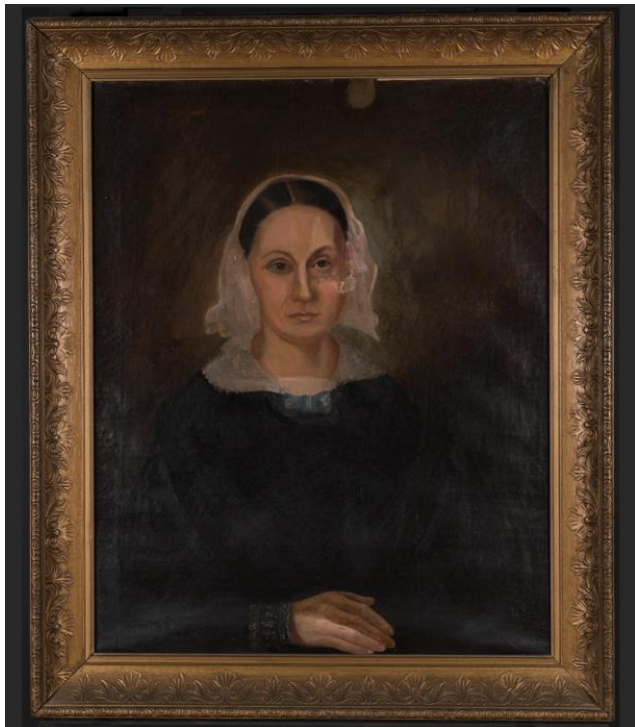
Figure 9: Before Treatment. Front. Artwork with frame.

In normal illumination, the painting condition was captured as we see it (Figure 9-12). The four tested areas done by previous conservators were identified. Without the frame, the masking tape on the right and partial top tacking edges could be seen slightly extending into the paint layer. Also, the tacks on the surface were visible. On the reverse, evidence of previous tear-repair treatment was found. An oval composed of an unknown substance was also seen on the bottom right (Figure 12).

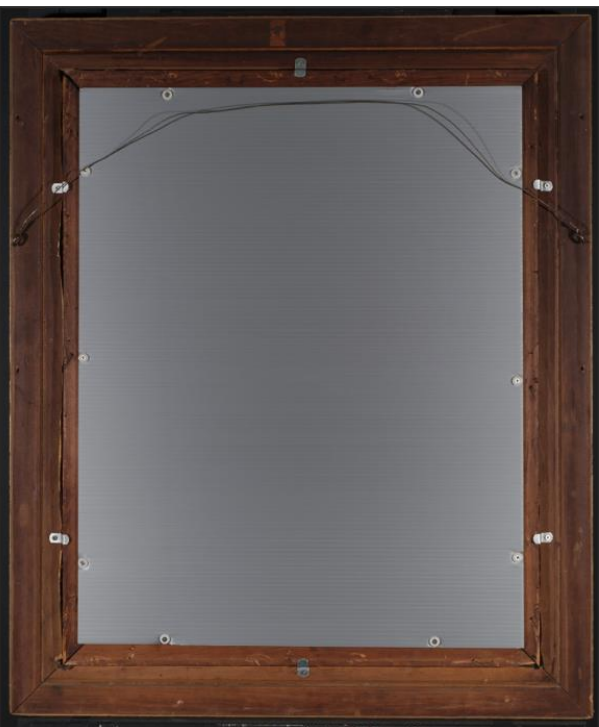
Figure 10: Before Treatment. Reverse. Backing board attached to stretcher.

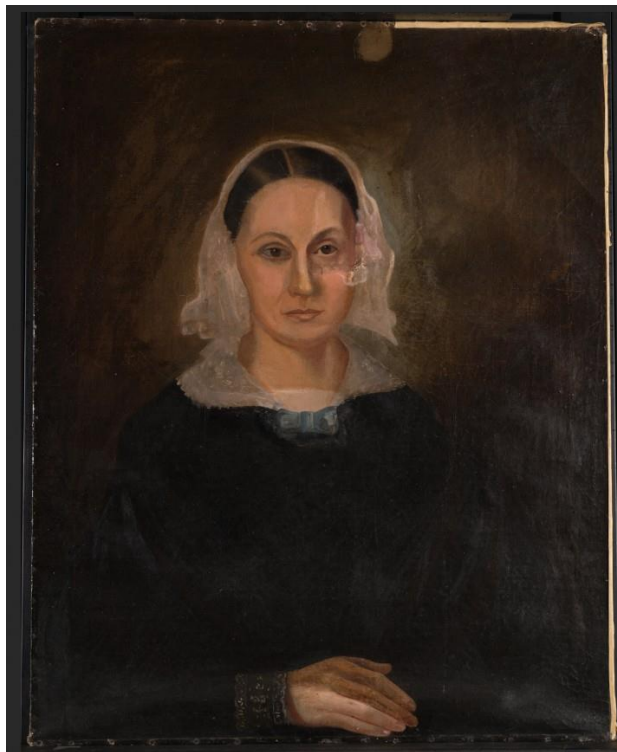
Figure 11: Before Treatment. Front.

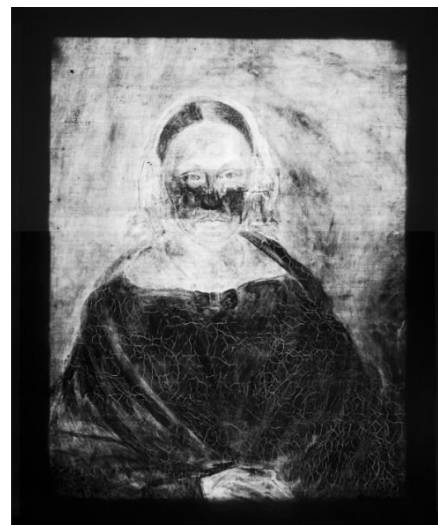
The transmitted infrared radiation image reveals cracking throughout, emphasized by the contrast with the dark garment (Figure 19). The outline of the tear-repair patches on the reverse can be seen in the middle of her face (Figure 20) and slightly on her thumb. The thicker areas will appear darker in the image. The thick layer of overpaint on her nose and cheeks were dramatically emphasized by the dark area on her face. In Figure 20, an underdrawing can possibly be seen.

Figure 18: Before Treatment. Front. Transmitted reflected infrared radiation.

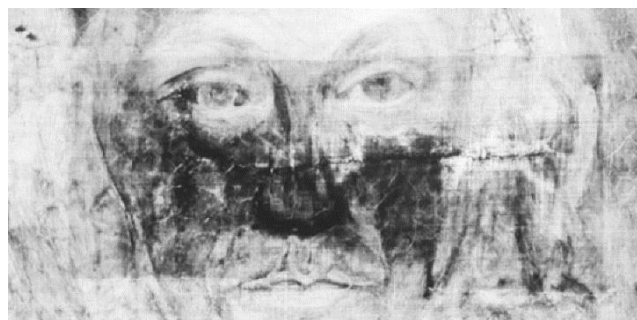
Figure 20: Before Treatment. Close-up. Transmitted reflected infrared radiation.

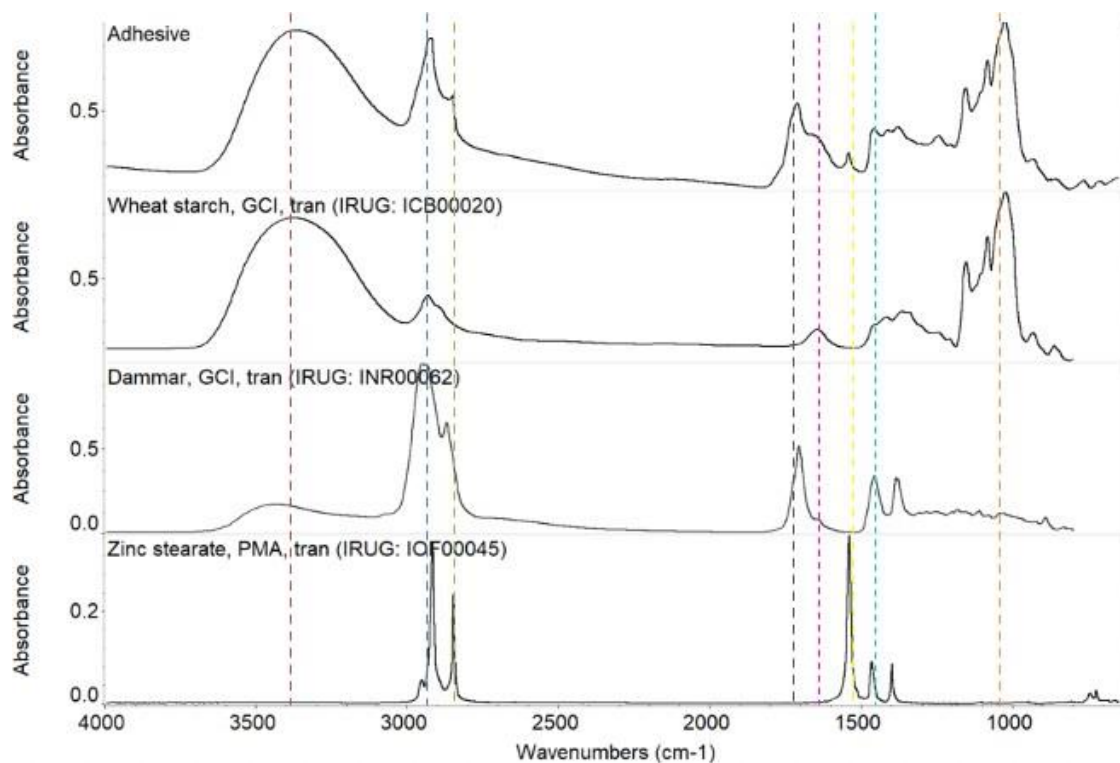
M-Transmission FTIR Microscopy and the infrared spectra revealed the adhesive to be a wheat-starch paste. However, there were other components mixed in besides wheat-starch paste. As seen on Figure 27, the majority of the peaks of the sample matches the peaks of wheat-starch paste. Nevertheless, there are a few differences in the sample spectra. With the aid of the database provided by Omnic software, we were able to find potential matches for the missing peaks in the sample. A natural resin, such as dammar and zinc stearate, may also be present, and are shown as potential spectral matches in Figure 27. Natural resins, such as dammar, are common varnish that could have been used as a coating on the painting and soaked through the reverse where the adhesive was found. Zinc stearate is also a common component, especially in the usage of white pigment, such as zinc white and soap formation. XRF also revealed the presence of zinc, particularly on the overpaint seen on the face (Figure 33d).

Figure 27: Infrared Spectra of adhesive sample, wheat starch, dammar, and zinc stearate.

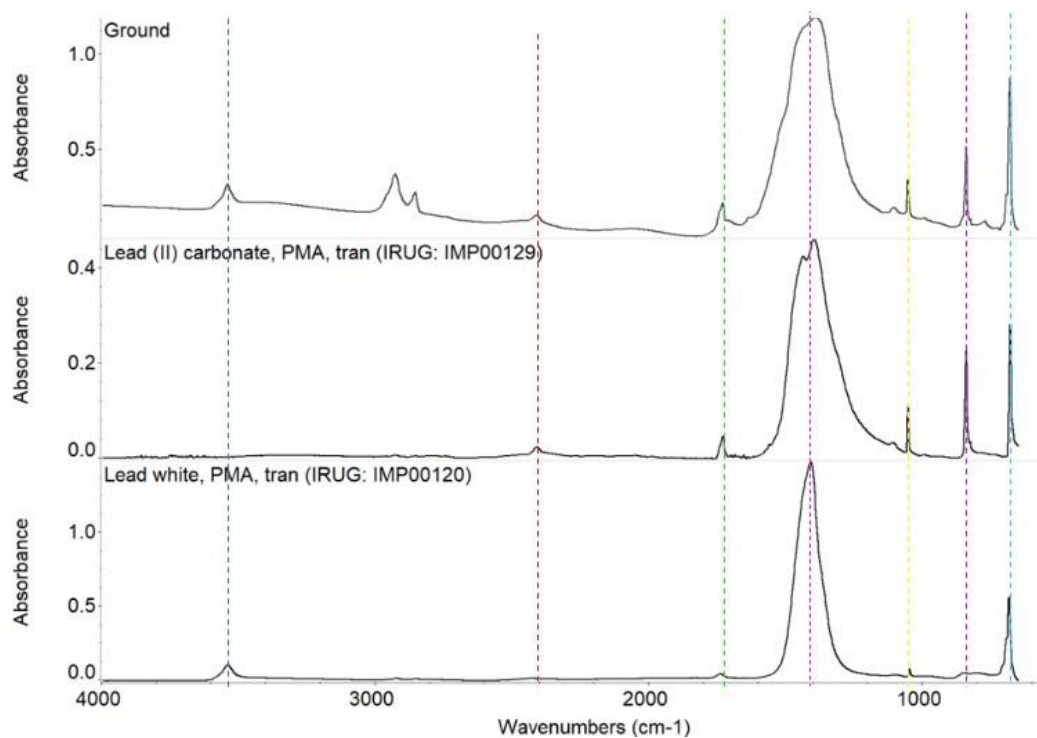
Figure 28: Infrared Spectra of ground sample, lead (ii) carbonate, and lead white.

Similar to the previous test, the sample was taken from the reverse. The ground appeared to have been pressed through the open canvas weave during application, letting us take a sample without disturbing the paint layer. The question was raised if the ground contained lead. Lead white was also known to be potentially used a prime layer instead of gesso. For health and safety reasons, the ground was tested and the infrared spectra did reveal that it was lead based (lead white) with some organic component mixed in.

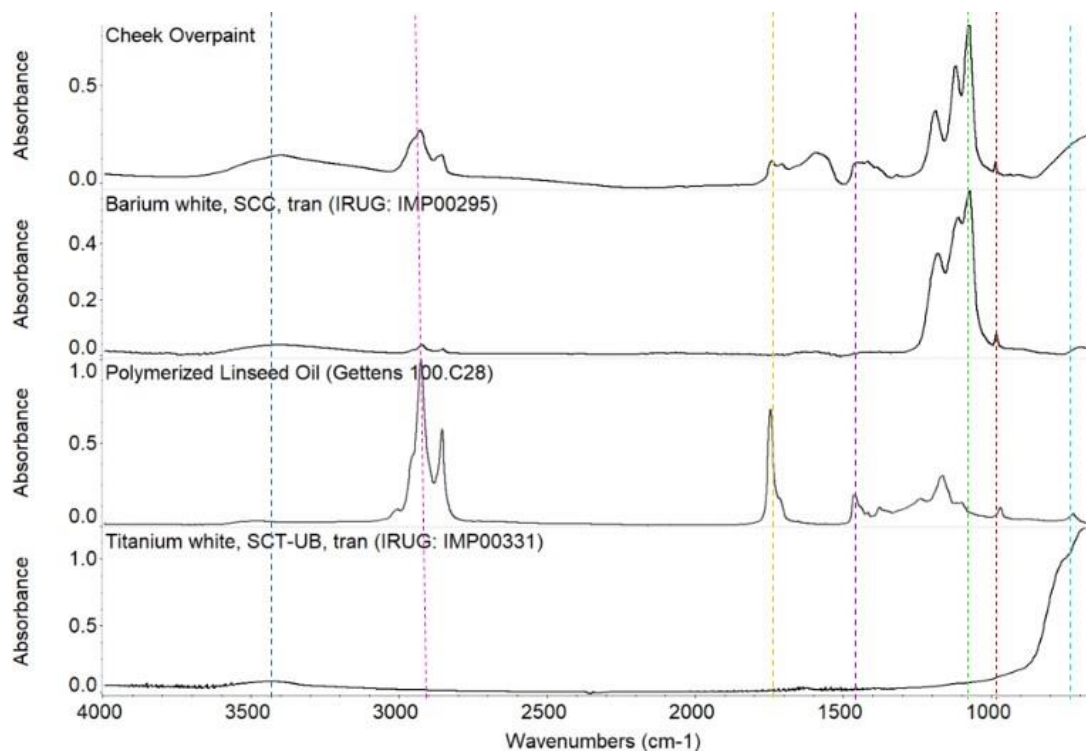
Figure 29: Infrared Spectra of overpaint sample, barium white, linseed oil, and titanium white.

The overpaint infrared spectra showed multiple components. The base component of the sample appears to be barium white. However, there seems to be presence of titanium white and probably linseed oil. There are still a few unidentified elements in the spectra, which is understandable due to complex mixture of the overpaints. The type of oil present can't be fully confirmed using only this method.

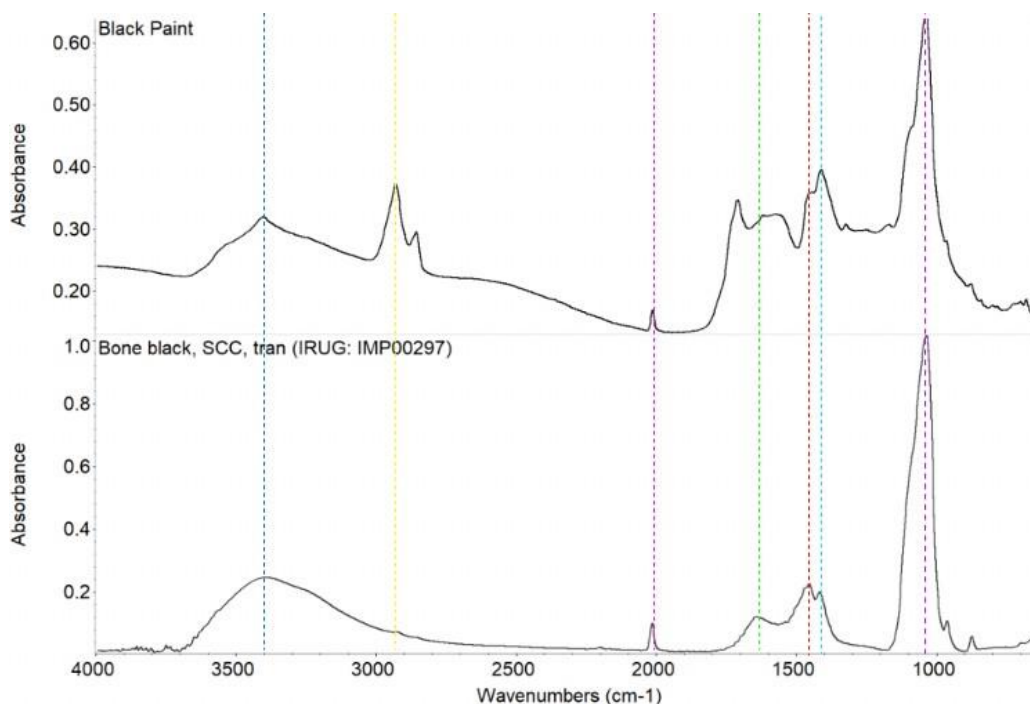
Figure 30: Infrared Spectra of black paint sample and bone black.

The infrared spectra of the black paint sample were more straightforward. The spectra peaks of the sample matches with those found in bone black. Similar as with the other samples, there are other components mixed in with the bone black, most likely oil. Due to the location the sample was extracted from, the bone black could be from the black overpaint, the original paint layer, or perhaps both.

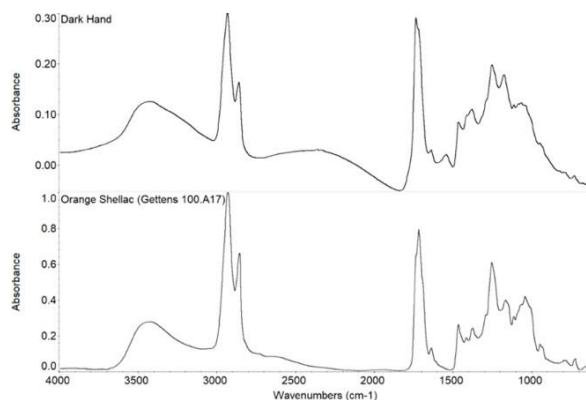
Contrary to the previous test, the sample taken from the darker side of the hand is more difficult to fully identify with this current technique. The database provided two different high potential matches (orange shellac and tung oil). However, further testing is needed to identify the material.

Figure 31: Infrared Spectra of hand sample and shellac.

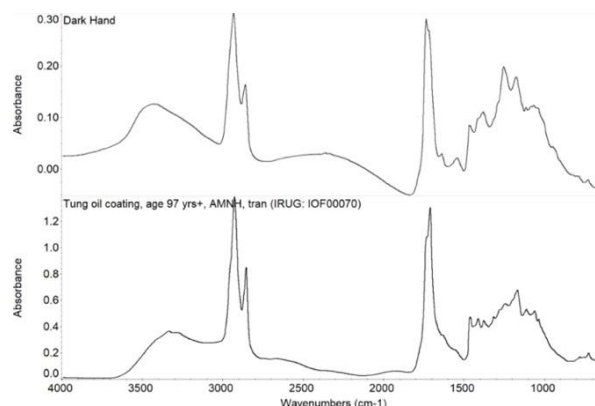
Figure 32: Infrared Spectra of hand sample and tung oil coating.

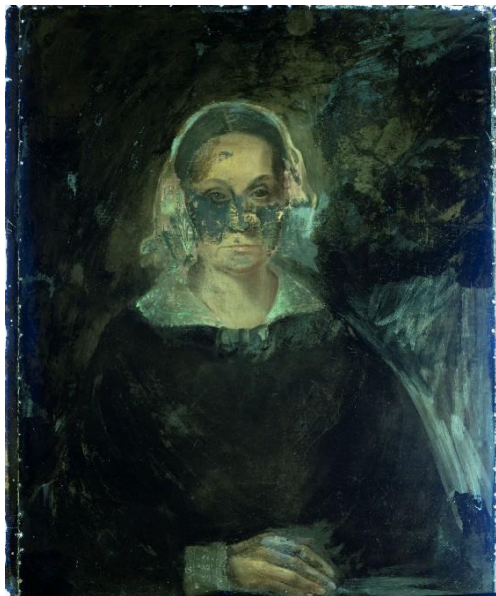
Figure 38: UVA induced visible fluorescence image.

During overpaint removal indicating the large amount of overpaint still present (dark purplish tones) and greenish fluorescence from varnish still present.

After the varnish was removed, the artwork was photographed under UVA induced visible fluorescence. Without the bright fluorescing varnish, the overpaint could be clearly identified on the painting (Figure 38). Together with the scientific material analysis, it was confirmed the artwork was overall overpainted. Further solvent testing was performed to remove the remaining overpaint.

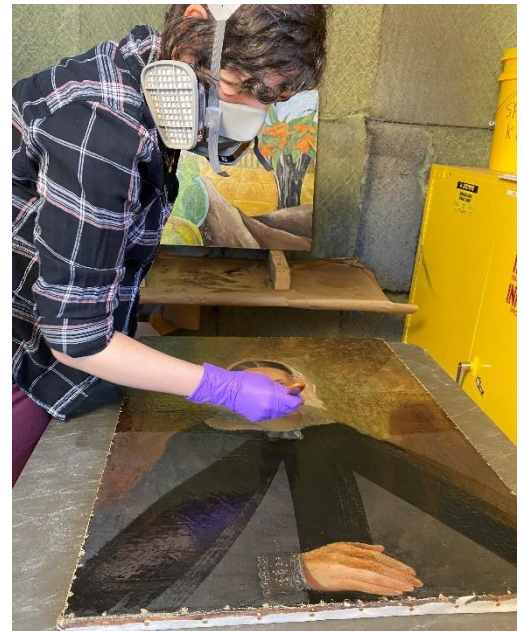
Figure 41: During varnishing.

The painting was brushed varnished with 15% Laropal A81 in 3:3:4 shellsol A100: Shellsol 340: Xylene with 2% Tinuvin 292 (Figure 41). Dry powder pigments, Galdehyde (Laropal A81) inpainting resin and 1-methoxy-2-propanol solution were then used to inpaint. During inpainting, it was important to exert restraint and stay within the ethical boundaries of inpainting while also considering the balance of the composition. There were some areas where it was necessary to inpaint over the old overpaint to better balance the composition and improve aesthetically. A final layer of varnish was then sprayed after compensation.

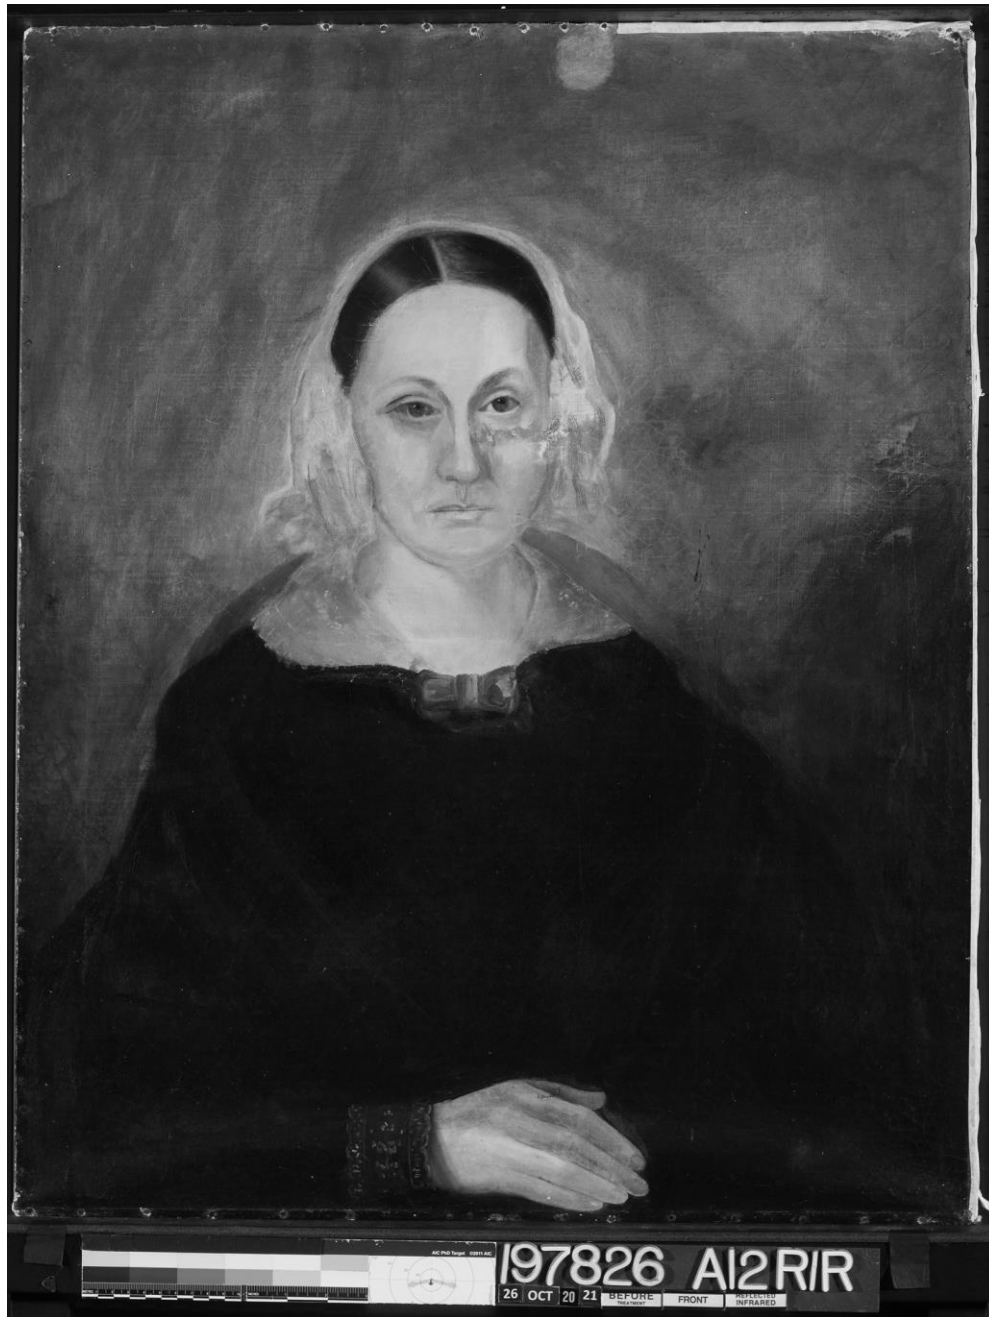
197826\_A12RIR

A12RIR	Front, reflected near infrared photograph, before treatment.	<p>The subject was illuminated with incandescent lamps. A special camera, sensitive to the invisible near infrared radiation emitted by the bulb was used to record how the radiation penetrated the subject, or was absorbed or reflected by the materials in the subject. Infrared radiation may penetrate overlying layers to reveal underlying information or may help to characterize materials or to distinguish different materials that are similar in appearance.</p> <p><i>Camera filtration:</i> UV-Vis-IR modified Nikon 810 with X-Nite 1000 filter.</p>	Note the darker areas around her shoulders. Also, note the slight lighter tone of the clean-tested area on the right-side of her face.
A13RIR	Back, reflected near infrared photograph, before treatment.	<p>The subject was illuminated with incandescent lamps. A special camera, sensitive to the invisible near infrared radiation emitted by the bulb was used to record how the radiation penetrated the subject, or was absorbed or reflected by the materials in the subject. Infrared radiation may penetrate overlying layers to reveal underlying information or may help to characterize materials or to distinguish different materials that are similar in appearance.</p> <p><i>Camera filtration:</i> UV-Vis-IR modified Nikon 810 with X-Nite 1000 filter.</p>	A signature and date were revealed on the bottom right corner.

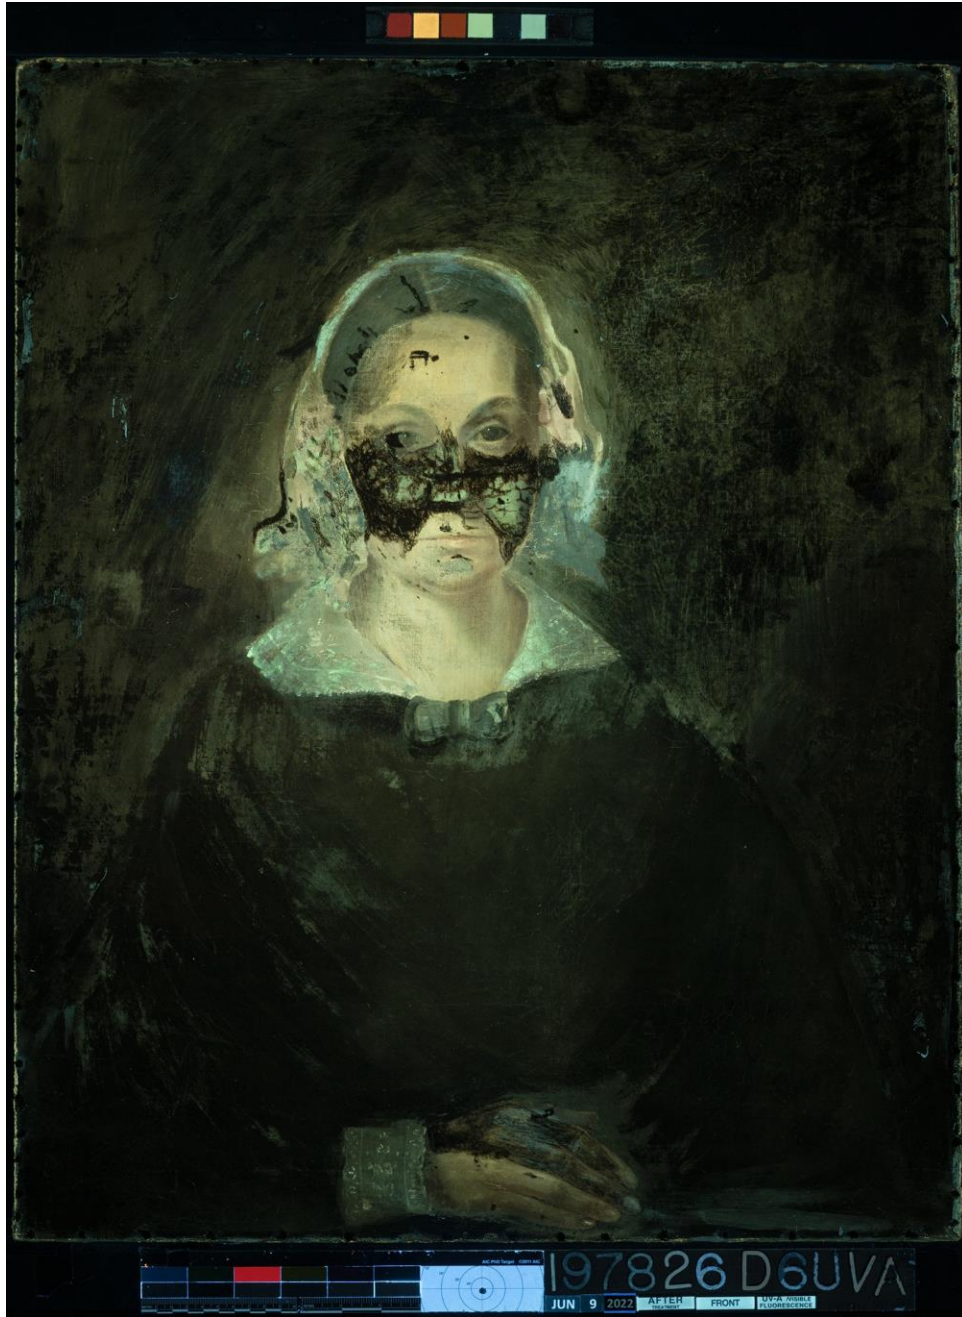
197826\_D5SP\_focus-blended

characteristics (e.g., matte v glossy) as well as information about surface topography (dents, bulges, cracks, etc.)	
D6UVA	Front, longwave ultraviolet (UVA) induced visible fluorescence, after treatment.	<p>The subject was photographed in a darkened room while irradiated by a long wave ultraviolet lamp (blacklight). The ultraviolet radiation causes some materials in the subject to fluoresce (emit light).</p> <p><i>Camera filtration: UV-Vis-IR modified Nikon 810 with X-Nite CCI, PECA 918, and Kodak 2E filters</i></p>	Note the original natural varnish fluorescing green underneath the dark areas of overpaint. Also, note the inpaint materials applied doesn't fluoresce and appear darker than the present overpaint.
D7N	Front, framed, normal illumination, after treatment	See D1N.	Note artwork attached to frame.
D8N	Back, framed, normal illumination, after treatment	See D1N.	Note artwork attached to frame with new hardware.
