# A Lifetime of Stress: Analysis and Treatment of an Inlaid Chinese Box

**A Lifetime of Stress: Analysis and Treatment of an Inlaid Chinese Box**

*CNS 695 Master's Project*

Katherine McFarlin

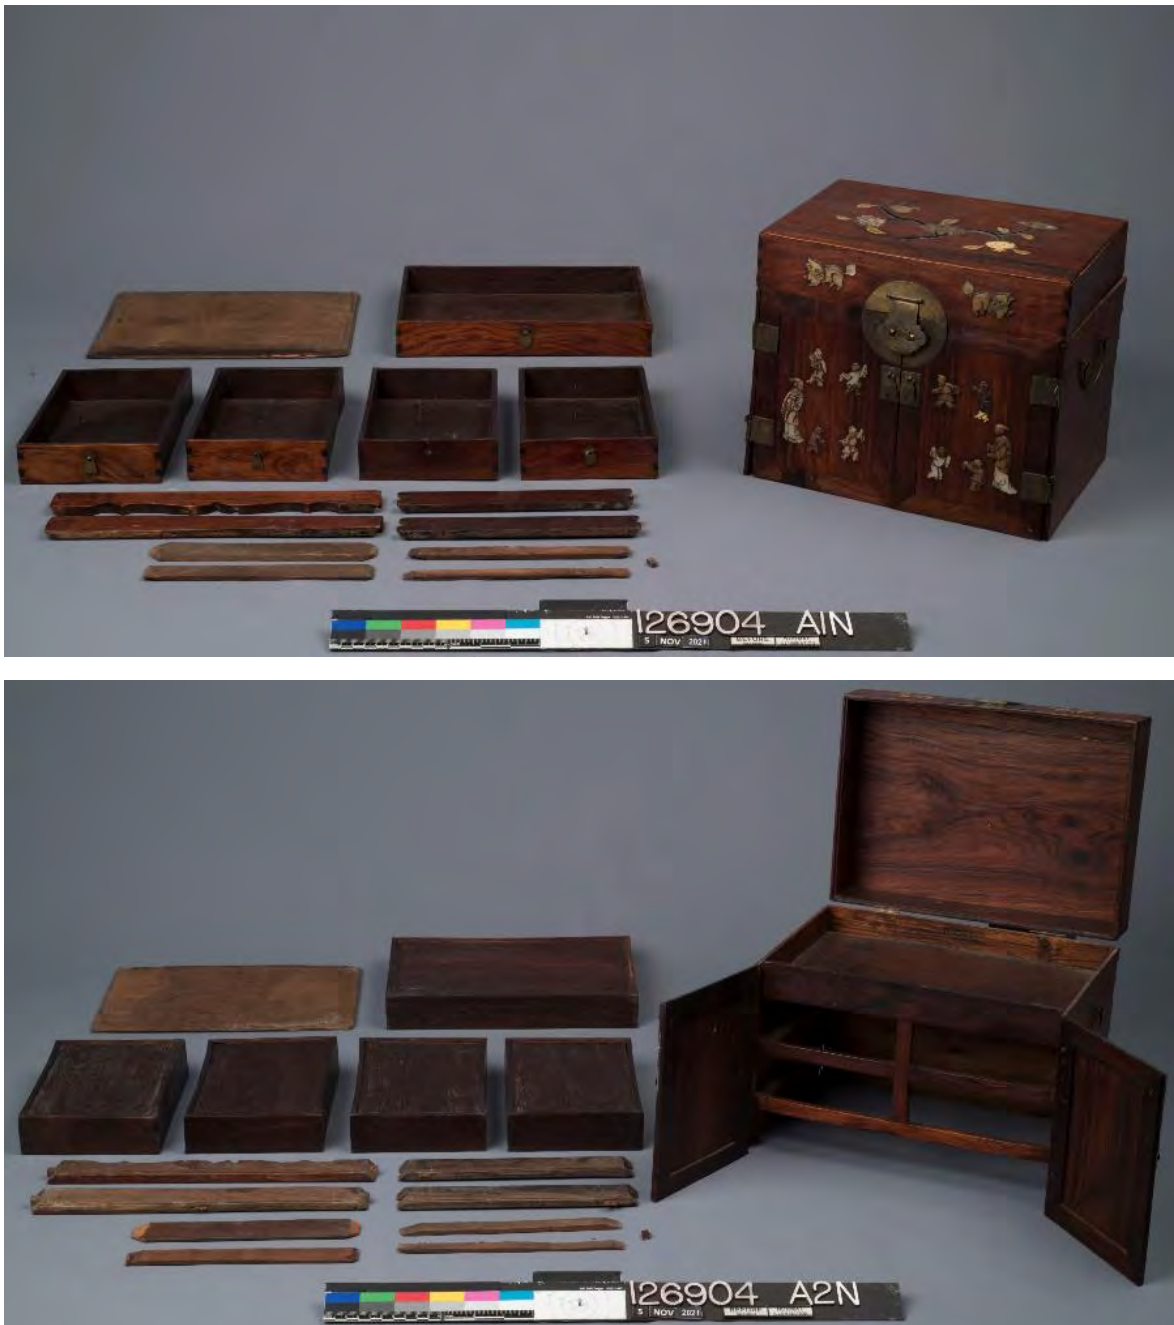
**Fig. 1** Overall inventory shots before treatment, showing the rectos of the accessories with the cabinet and lid closed (top), and the versos of the accessories with the cabinet and lid open (bottom)

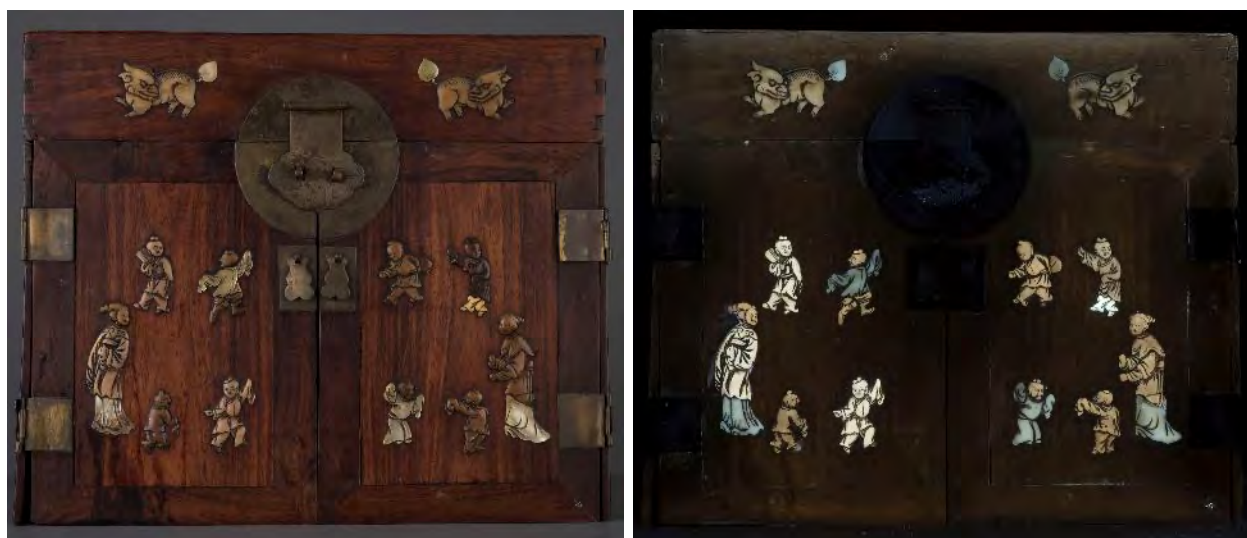
UV fluorescence response can be particularly useful for identifying materials such as ivory and shell, which fluoresce bright white and blue respectively (fig. 3). In some cases, differences in fluorescence were the only way to distinguish inlays that appeared nearly identical in normal illumination. This differential fluorescence can suggest different ratios of components within two iterations of heterogeneous compounds, the presence of impurities, or chemical differences such as hydrate and anhydrate forms of certain inorganic materials (Gleason 1960; Warren et al, 1999). For example, both agate and chalcedony belong to the siliceous quartz family of minerals, and at certain scales can appear identical to the naked eye. However when exposed to longwave UV radiation, the two stones can fluoresce yellow and white respectively (Robbins 1983). These visual indicators are not conclusive on their own as fluorescence is still not entirely understood in some minerals; however, initial visual examination and documentation with UV greatly aids in guiding later analysis, and provides quick visual reference to help differentiate visually similar materials.

**Fig. 3.** Left: Front, before treatment, normal illumination. Right: Front, before treatment, UVA-induced visible fluorescence. Note the vibrant whites, blues, and creams in UVA, particularly the brightness of the boy's pants in the upper right of the right door. While many of the child figures appeared to be carved from different tonal areas of the same material when viewed with the naked eye, they exhibited distinctly separate fluorescent responses in UVA.

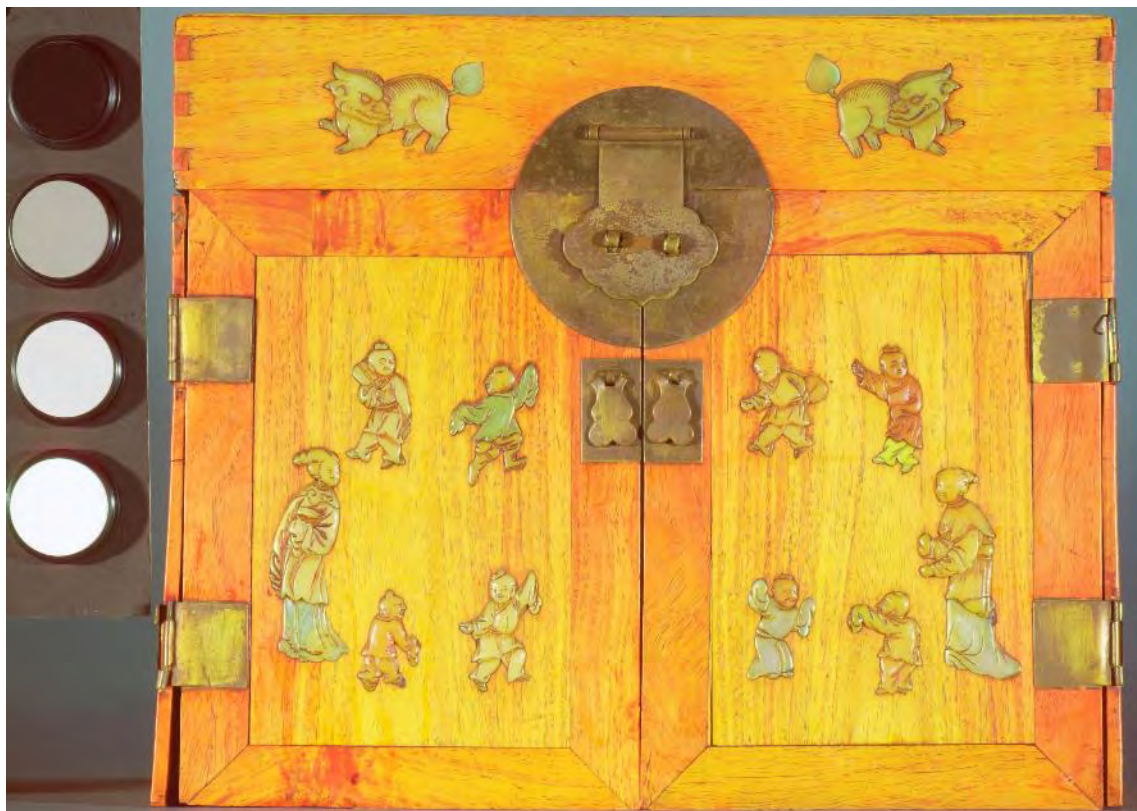
In order to further highlight the material diversity of the piece and map related materials, the front face of the box was documented with multi-spectral imaging. Using a monochrome Canon T3i camera and wavelength-specific filters, the front of the object was photographed nine times at pre-determined wavelengths of light to collect spectral images. Three representative images from along the spectrum were selected at 400, 700, and 1000nm, where distinct differences between the images were visible. These three monochrome images were opened in Photoshop and assigned to the blue, green, and red channels respectively in a new image, to produce a final false-color image (fig. 4). This false-color image correlates materials with similar spectral responses through shared color. For example, the lower skirts of the two women appear as blue to blue-green in the generated image, and by looking for similar colors we can see that the tails of the guardian lions, the robe of the boy in the lower left of the right door and the tunic of the boy in the upper right of the left door appear to have a similar spectral response. These color-coded areas are thus highly likely to be made of the same material, potentially reducing the number of necessary sampling sites if further analytical testing is pursued. This technique is also helpful for identifying materials that may have looked similar at one or two wavelengths, but varied at another, such as the tunic of the boy in the upper right of the right door, which fluoresced similarly to the other pink and brown inlays in UV, but here clearly stands out as a vibrant red false color.

**Fig. 4.** False-color composite image from multispectral imaging photographs, highlighting the material diversity on the front face of the box. By overlaying the spectral data into a false-color image, materials that have similar spectral responses will display as similar colors and can be quickly identified.

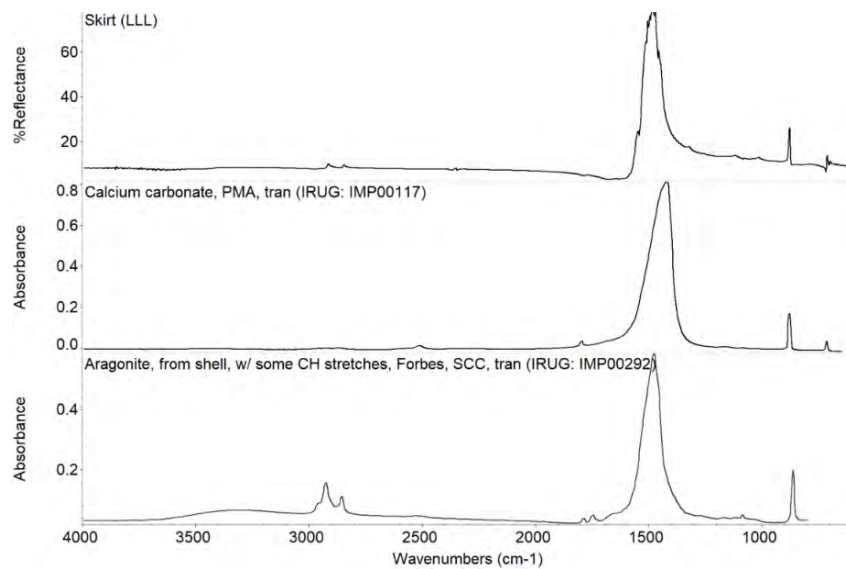
door panel, and the pomegranate in the upper left of the lid all are matches for nacre, commonly known as mother-of-pearl (fig. 8). Nacre is a compound of calcium carbonate and aragonite made by many mollusks as an iridescent inner layer, and it has been harvested as a beloved artist's material for thousands of years. The presence of this material was expected, as the colorful iridescence of these inlays are readily recognizable to the naked eye. The other inlay that stood out during initial visual examination was the trouser section of the boy in the upper right of the right door, as it appeared much more opaque and yellow than the surrounding inlays. The generated spectra is a good match for ivory and was compared to African elephant ivory, but exact species identification was not pursued (fig. 9).

**Fig. 8.** Reflectance FTIR spectra of the lower left (LLL) woman's skirt, compared to transmission spectra of calcium carbonate, and aragonite from shell

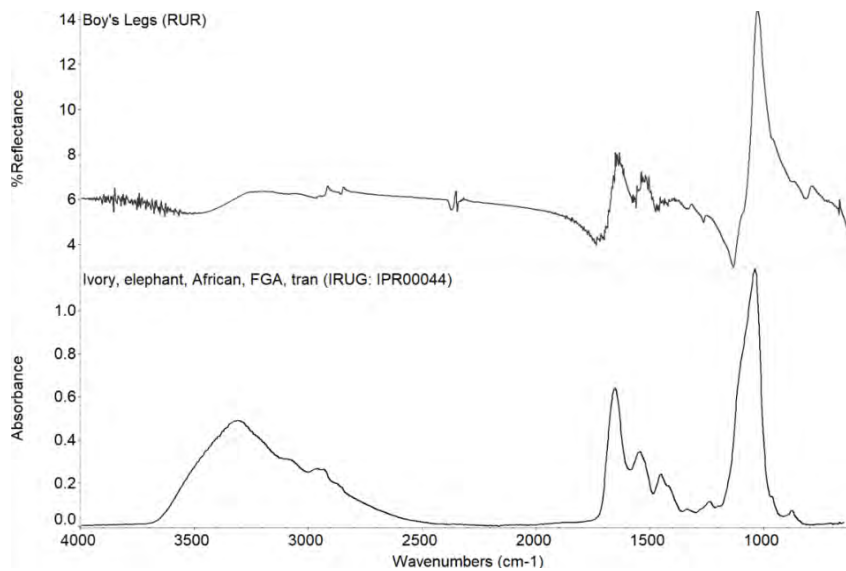
**Fig. 9.** Reflectance FTIR spectra of the boy's pants in the upper right of the right door (RUR) compared to transmission spectra of African elephant ivory

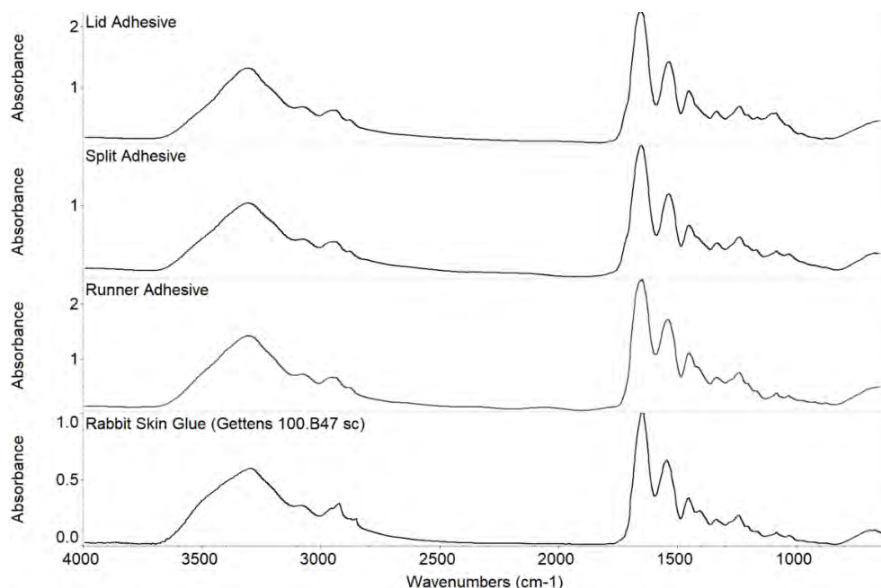
The vast majority of adhesives found on the box are proteinaceous glues, such as historic rabbit skin glues and hide glues (fig. 10). On the interior pins of the right door's upper hinge, an epoxy resin type adhesive was also found, and while no spectrum matched closely enough for a specific identification, based on the good comparative matches in the database it is likely an epoxy-based super glue. This spectrum also showed some minor irregularities consistent with cellulose contamination, indicating that some of the wood may have been pulled up with the adhesive sample.

**Fig. 10.** Micro-transmission FTIR spectra of adhesive samples from the lid, split, and runner, compared to a known spectra for rabbit skin glue

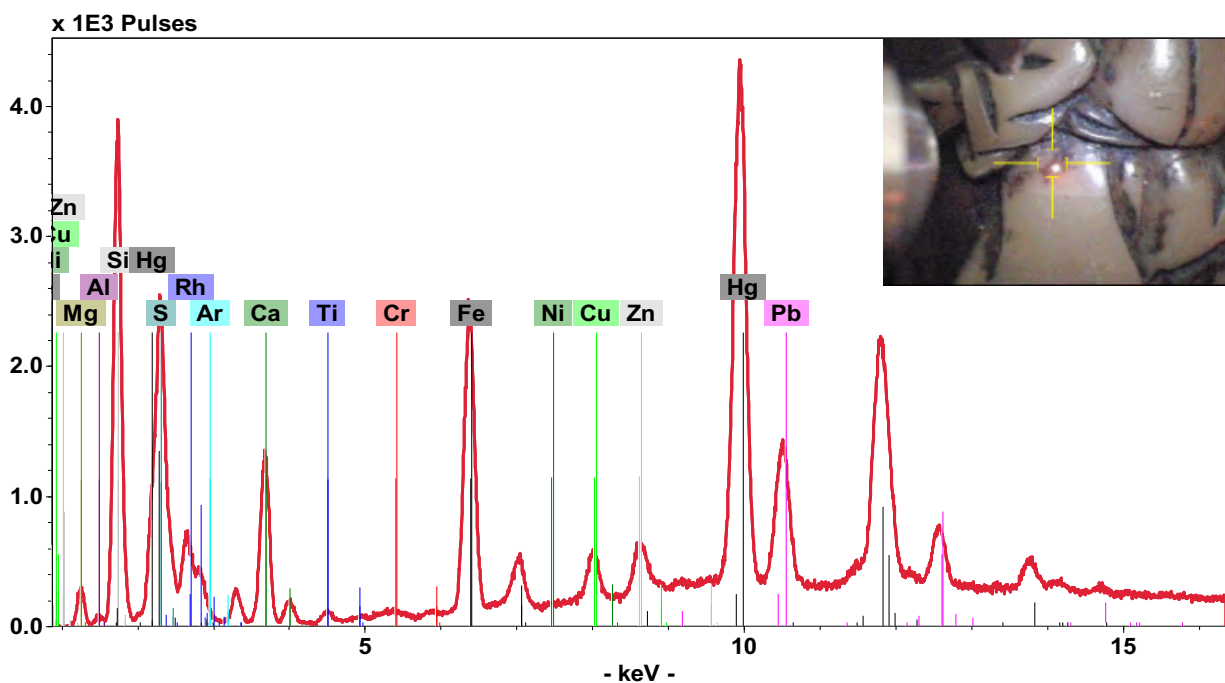
XRF confirmed the presence of high levels of silica in the pink and brown inlay material, alongside an array of minerals that could indicate an agate or similar stone from the quartz family. No significant differences could be found between the different tones of the hardstone, but this is not surprising as only minute differences in elemental compositions are needed to produce visual differences. In the crevices of the inlays however, traces of a red pigment showed high levels of mercury and lead, likely indicated a vermilion or cinnabar pigment (fig. 11). XRF also identified the hardware as a leaded brass, likely a 60:40 composition. This brass is and historically has been one of the most common forms of brass.

Fig. 11. XRF Spectra for the red pigment found in recessed areas of the inlays, with notable Mercury (Hg) and Lead (Pb) peaks that could indicate vermilion or cinnabar

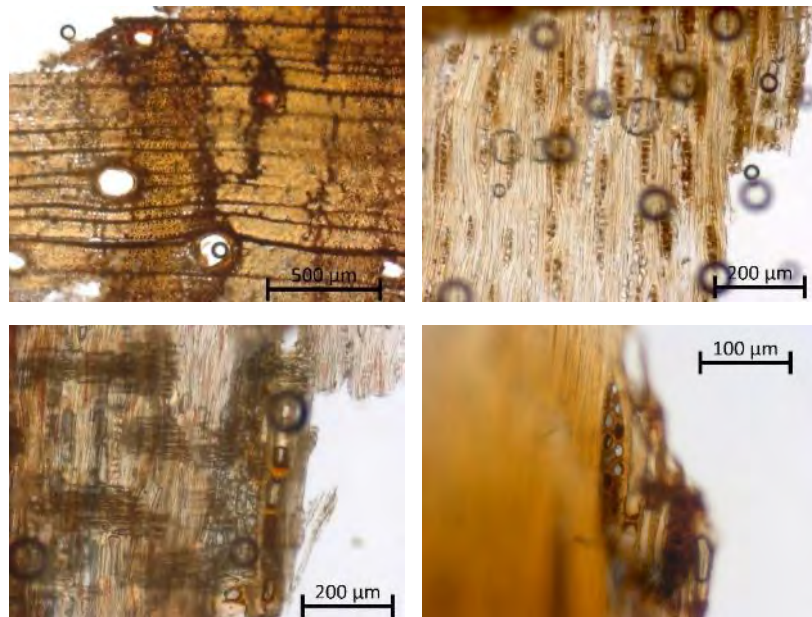
**Fig. 13.** Clockwise from top left: transverse view, tangential view, and radial view of the wood samples, and a close-up of a biseriate parenchyma in tangential view in the lower right

The transverse view revealed that the wood was a diffuse porous hardwood with banded aliform-confluent parenchyma. The tangential view displayed biseriate transverse rays of 5-8 units arranged in uniform rows. The radial view was poorer quality due to the smaller surface area on this face of the sample, but both ray and axial parenchyma were still visible. Vestured pits and crystals were visible in association with the vessel elements, and some vessel elements also contained resin. Based on these features, the wood used for the visible surfaces of the box is definitively a tropical hardwood, and the results seem consistent with the *Dalbergia* or rosewood genus over other groups of tropical hardwoods (Hoadley 1990). On visual comparison, the sample appeared closer to known samples of *huanghuali* *D.odorifera* than Indian rosewood *D.oliveri* or Brazilian rosewood *D.nigra*; however, species identification is not possible without further testing (Gasson et al. 2011). It is sufficient to say that the wood used for the main cabinet is likely a rosewood, and is consistent with the expected time period and location of the piece. Once analysis was complete, the sample piece was glued back into its original position with dilute fish glue.

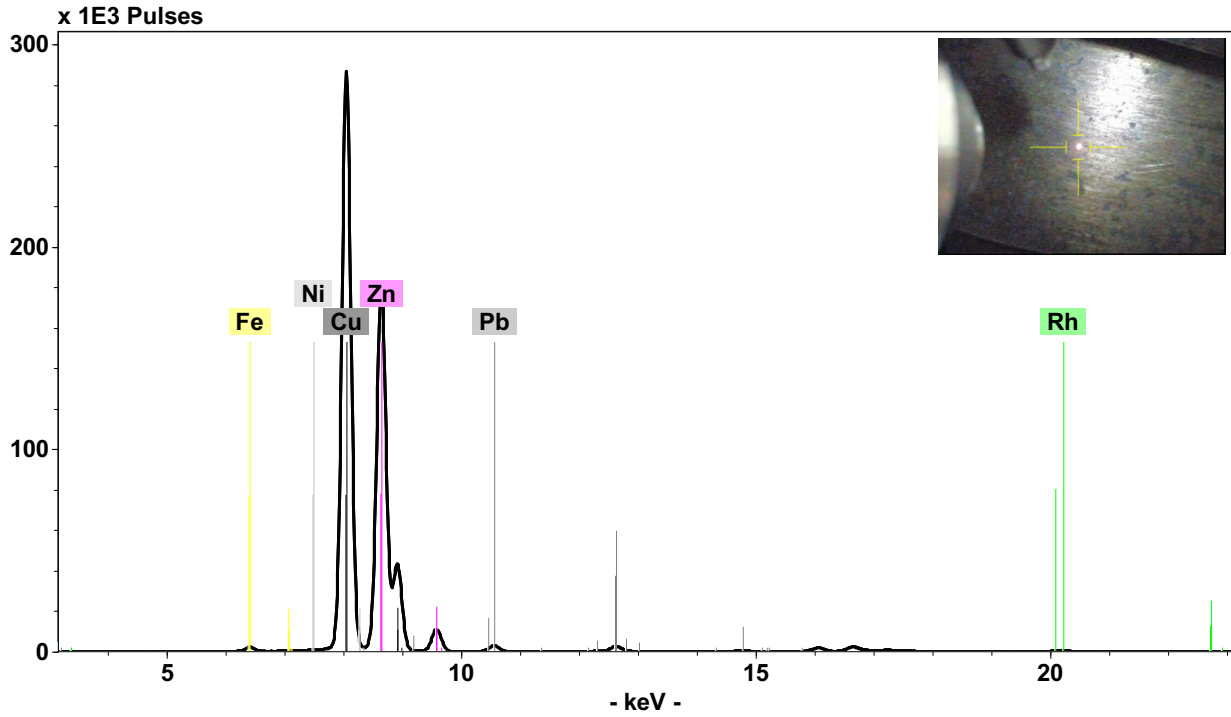
Metal Hinge (60:40 Brass)

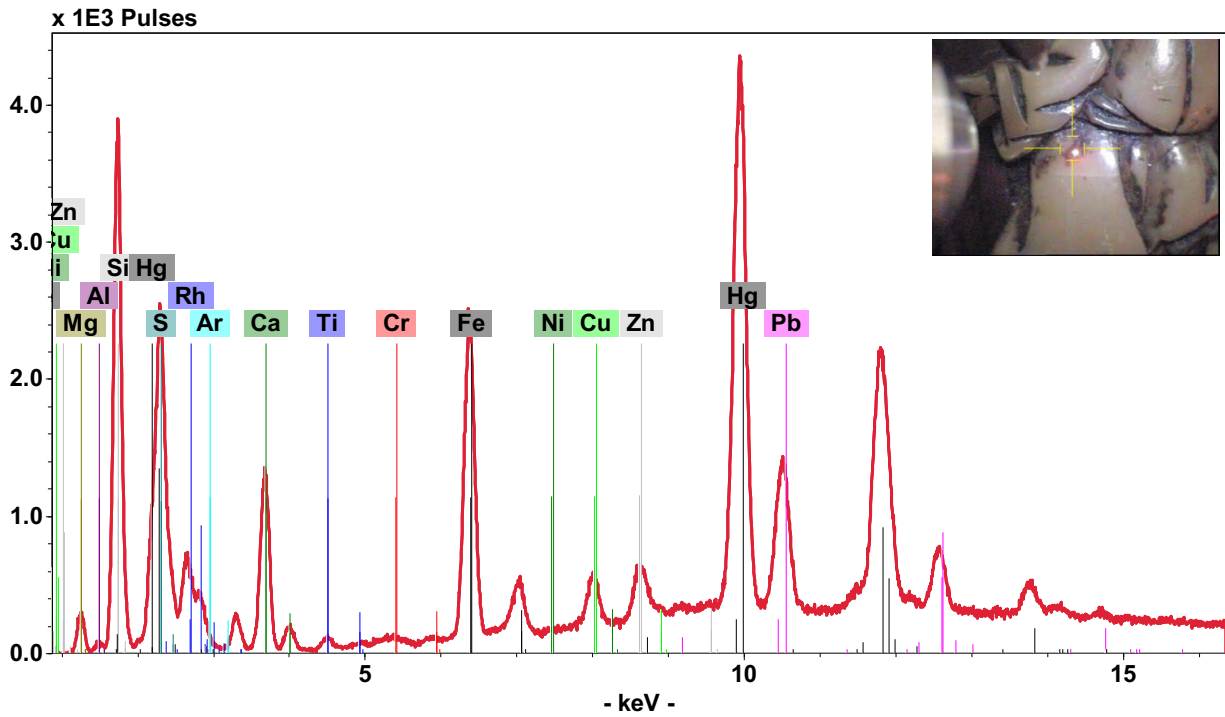
LLR Boy Tunic, Red Pigment (Vermillion)

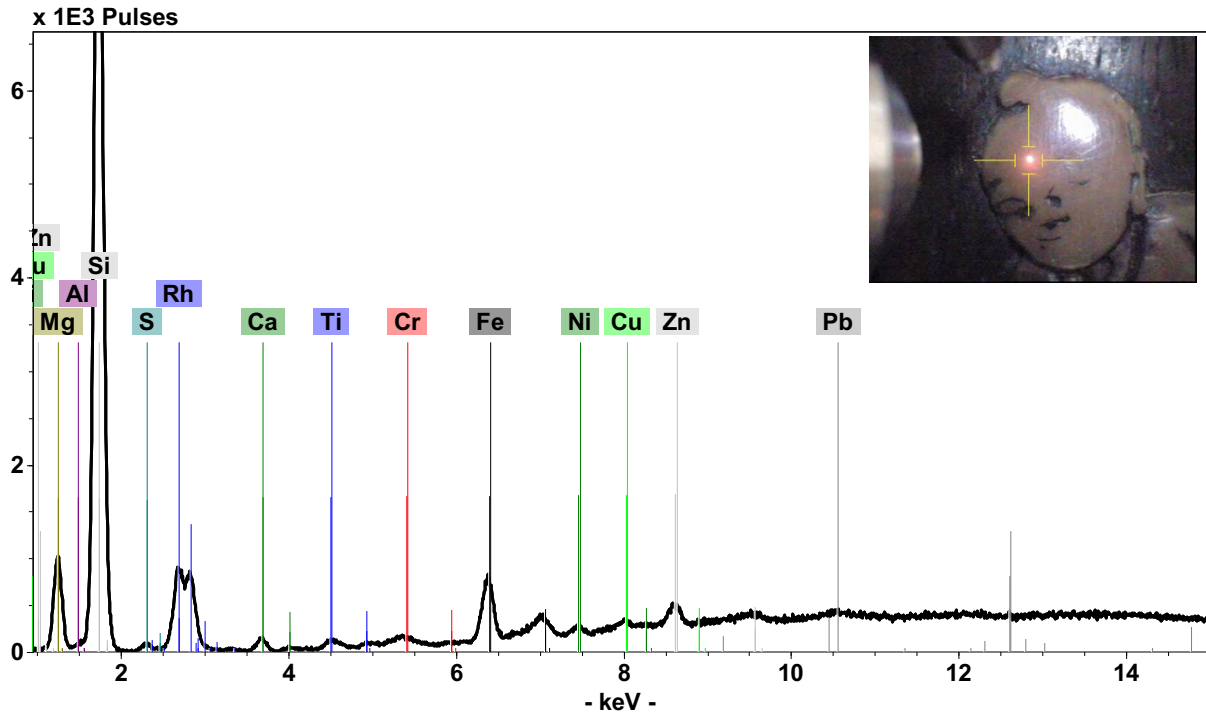
RUL Boy Head (Silicate)

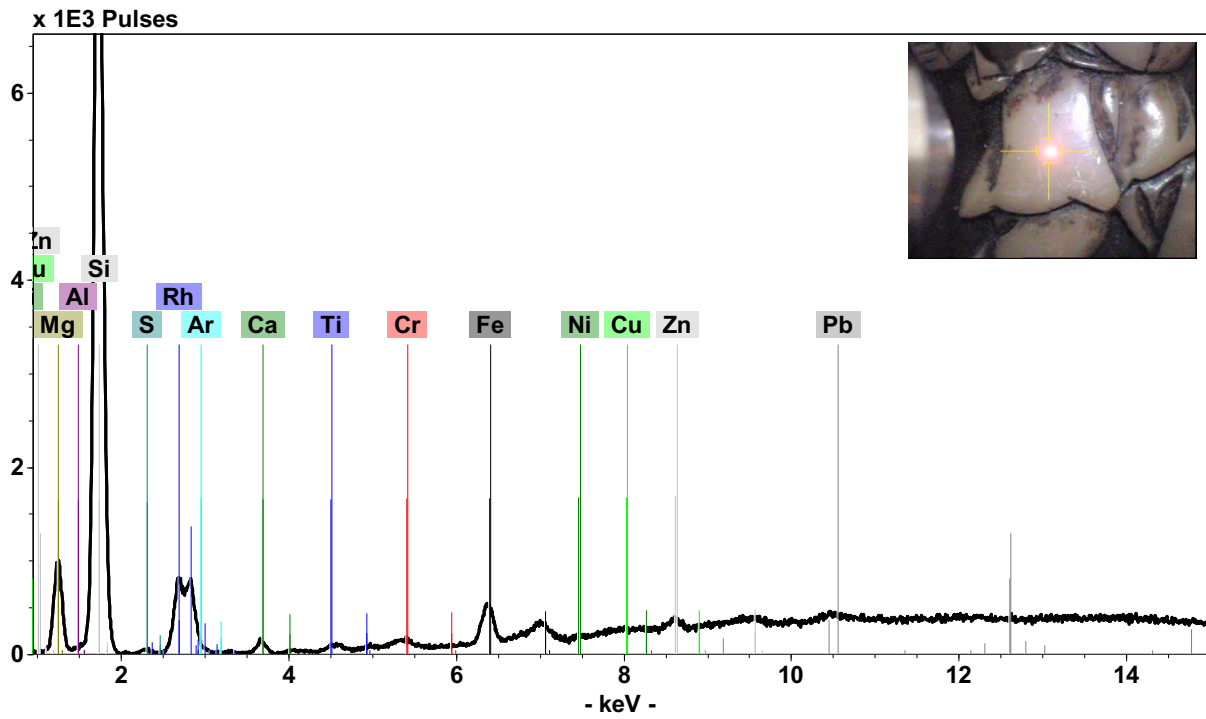
LLR Boy Tunic (Silicate)

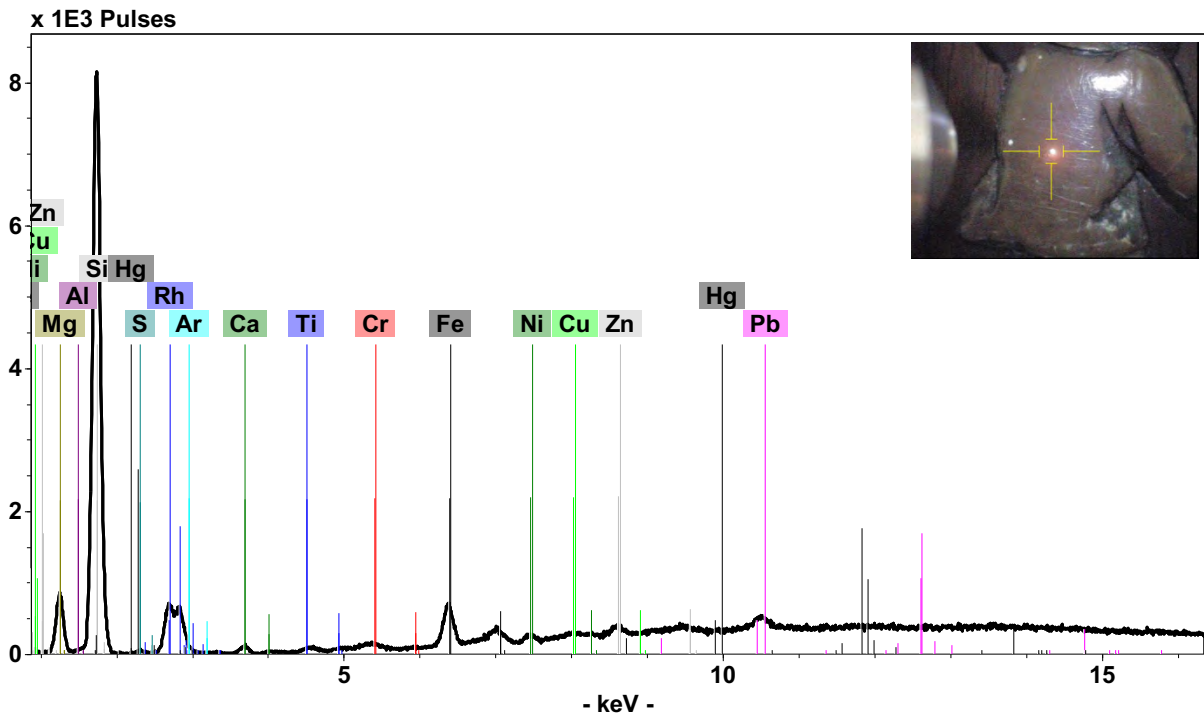
LLL Boy Tunic (Silicate)

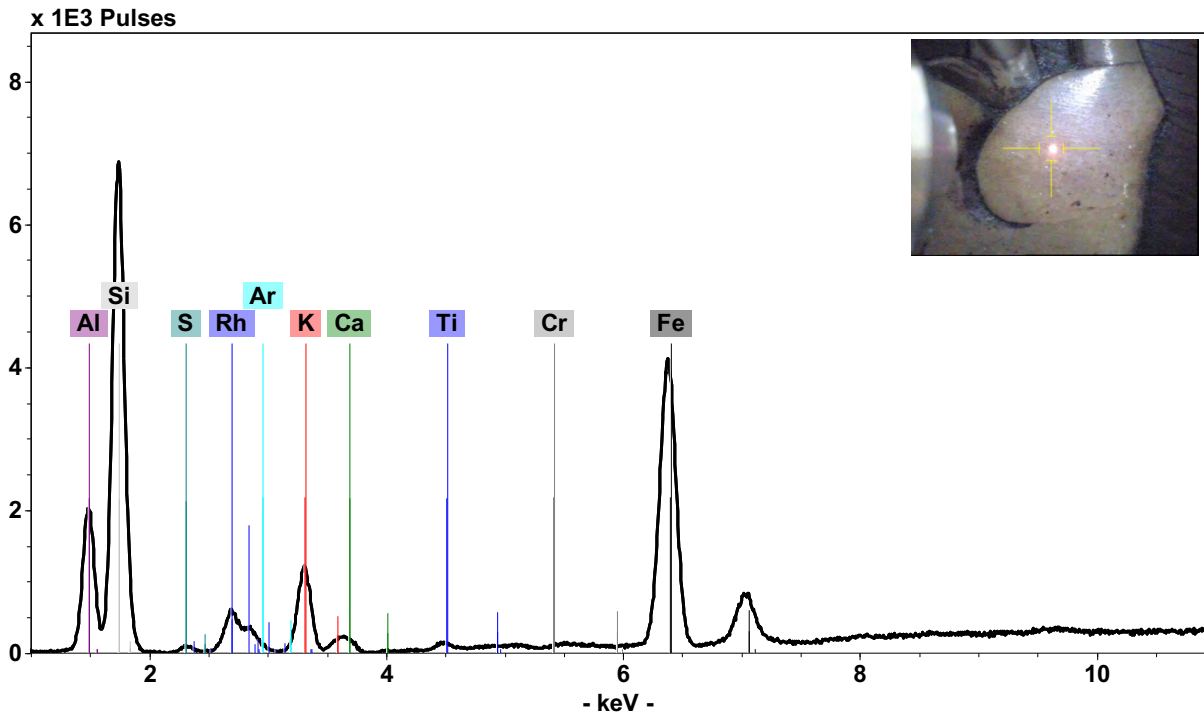
Left Lion, Flank (Silicate, iron-rich)
