LEVEL OF COASTAL PROTECTION DAMAGE AND PRIORITY OF HANDLING: (CASE STUDY OF ALUE NAGA - NEUHEUN, ACEH BESAR, INDONESIA)

Syahrul Mauluddin¹, Ella Meilianda^{1,2}, Syamsidik^{1,2}

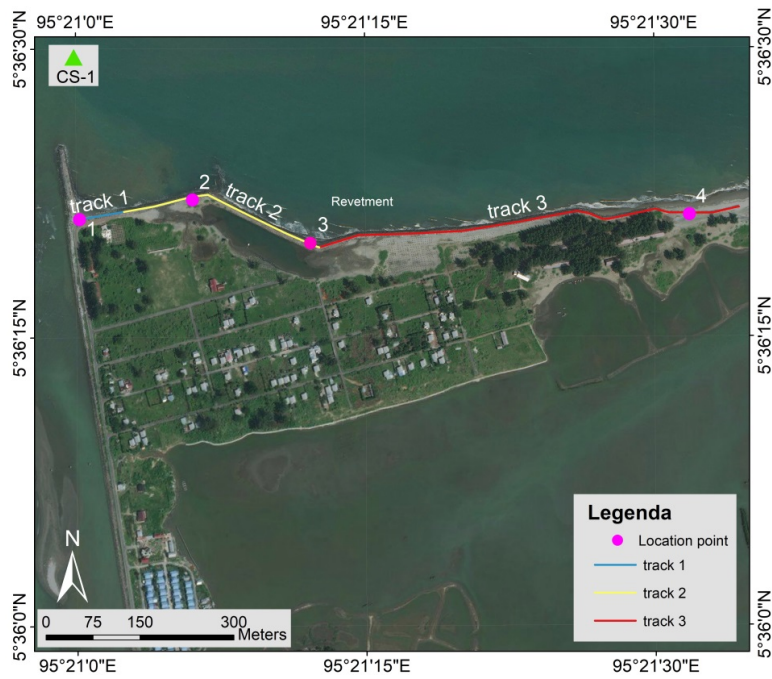
Figure 2. coastal structure location CS-1

The CS-1 beach building is at the coordinate point of $95^{\circ} 21'25.129''$ E and $5^{\circ} 36'21.569''$ N (Figure 2), located in Alue Naga Village. The type of building is a revetment with a length of 1087.34 m along the coast. The building was built in 2009 using rock armor type building with a typical trapezoidal building.

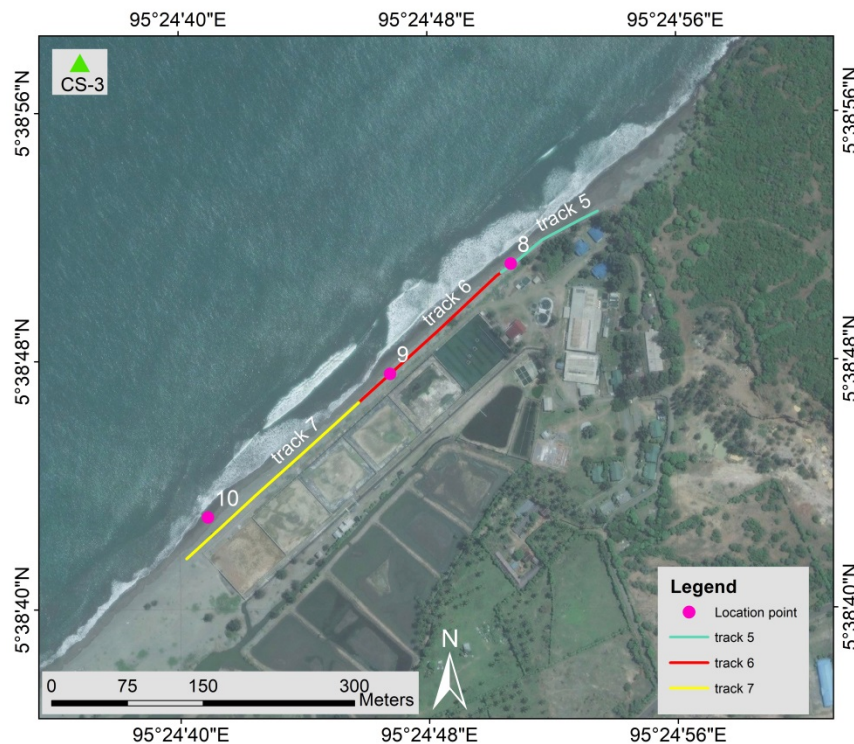
Figure 9. Location of revetment CS3

The building at CS-3 location is a building with a type of revetment, located at $95^{\circ}24'40''$ E - $95^{\circ}24'56''$ E and $5^{\circ}38'40''$ N - $5^{\circ}38'46''$ N with sandy beach types. This building is located next to the cape which is on the east side with a length of 535.39 m. Building construction was carried out in 2009, functioned as a protection for brackish water infrastructure under the Ministry of Maritime Affairs. The assessment of buildings found that the entire building suffered severe damage to function $20 > 25\%$. Along the track-5 situations seen building material has been detached (Figure 9). However, in some locations the building has been covered with sand until the building is overgrown with vegetation (Figure 10). Buildings suffer very heavy damage but do not interfere with environmental damage.

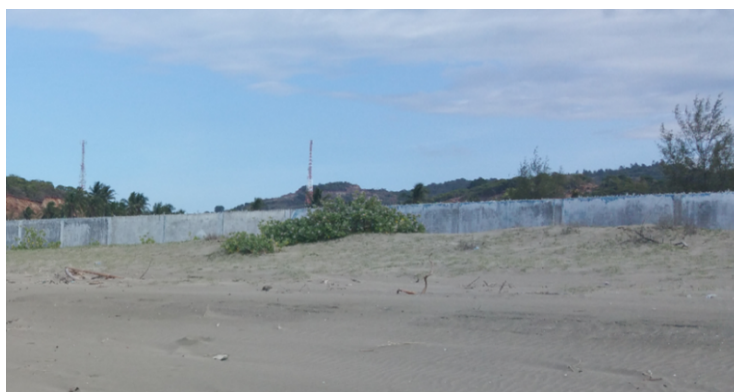
Calculation of changes in shoreline location CS-3 has a baseline length of 637.89 m with a type of sandy beach. The beach has a very heavy accretion tendency > 2 m/year (Figure 16). During the period 2009-2017 there was accretion between 2.14 to 4.78 m/year which caused almost all coastal buildings to be covered by sand (Figure 10). The high accretion rate caused the beach's natural protective feature to form sandbanks along the coast. The construction of the wall appears (Figure 17) as a barrier to protect cultivation ponds from siltation due to high accretion.
