Climamed 2017 – Mediterranean Conference of HVAC; Historical buildings retrofit in the Mediterranean area, 12-13 May 2017, Matera, Italy

## The energy efficiency challenge for a historical building undergone to seismic and energy refurbishment

A case study in L'Aquila city center is proposed in this work. The building, belonging to listed buildings for its historical value, being built in the 1930s, underwent to seismic and energy refurbishment, since it was damaged by the earthquake of 2009. The solution proposed aimed at improving the energy efficiency of the structure, by using an additional insulating layer, made of natural material (i.e. hemp), on the inside of the wall. The ceilings of the unheated spaces have been insulated, too, by using pure cellulose flocks.

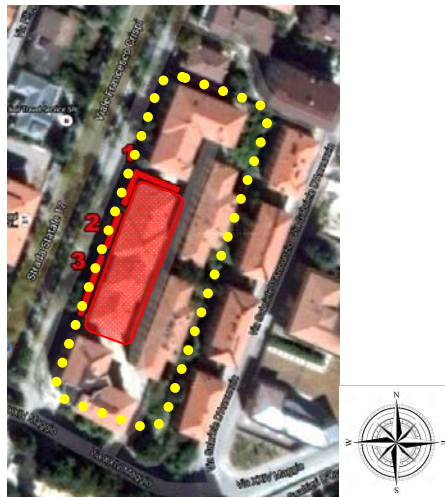
Fig. 1. Aerial view of the investigated building in its urban context. Numbers refer to the viewing point for thermographic inspections.

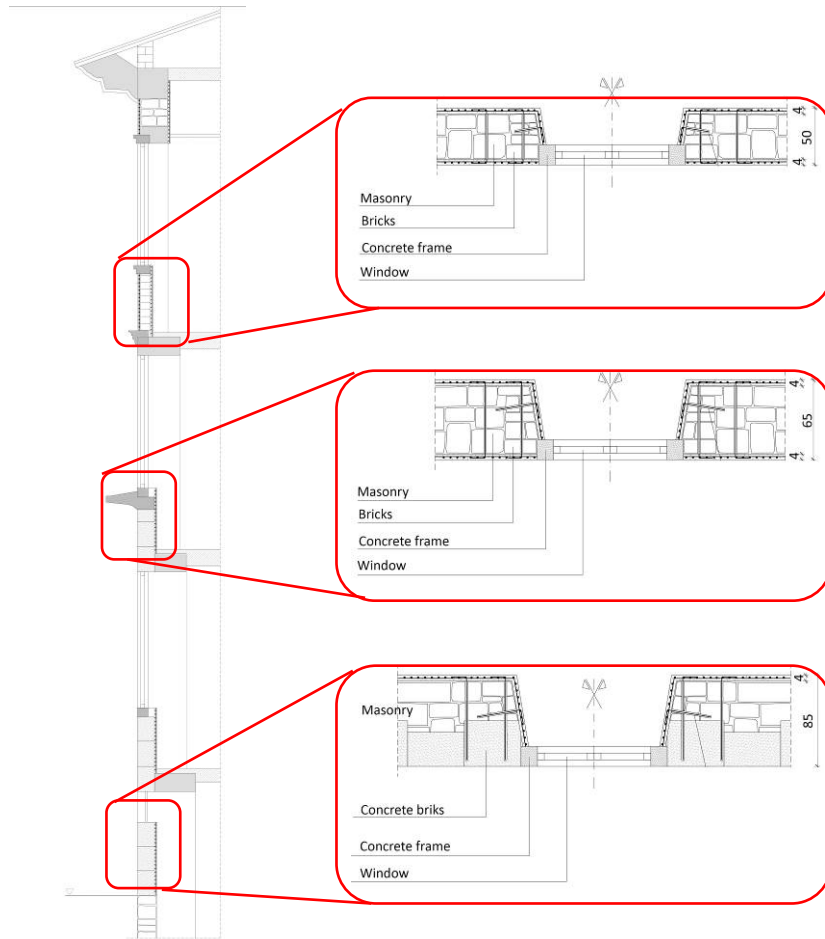
A particular feature of the walls relies in their thicknesses, which decrease along with the height. Therefore, the external walls of the first floor are thicker than the ones on the third. This peculiarity is shown in Figure 2, where a section of the entire west external wall is drawn. Figure 3 shows the perspective drawing of the west wall, that is the one that faces the main street.

The wall assembly of the first floor is made of cement blocks and masonry; the second and third floor walls are realized with the typical construction technique at that time: masonry walls, made of bricks and stones, that constitute the bearing structure of the building. Sections are detailed in Figure 2, where sizes are expressed in cm.

Fig. 2. Section of the west-viewing building wall.

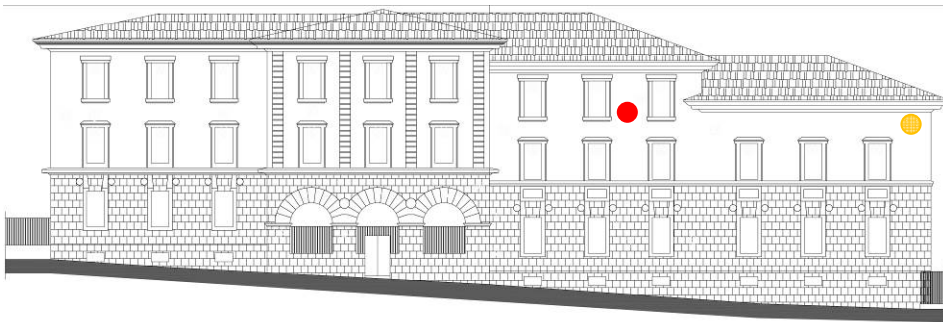
Fig. 3. West view of the inspected building. Dots locate the measurement points.
