Integration of ground-penetrating radar, ultrasonic tests and infrared thermography for the analysis of a precious medieval rose window

L. Nuzzo¹, A. Calia², D. Liberatore³, N. Masini⁴, and E. Rizzo⁵

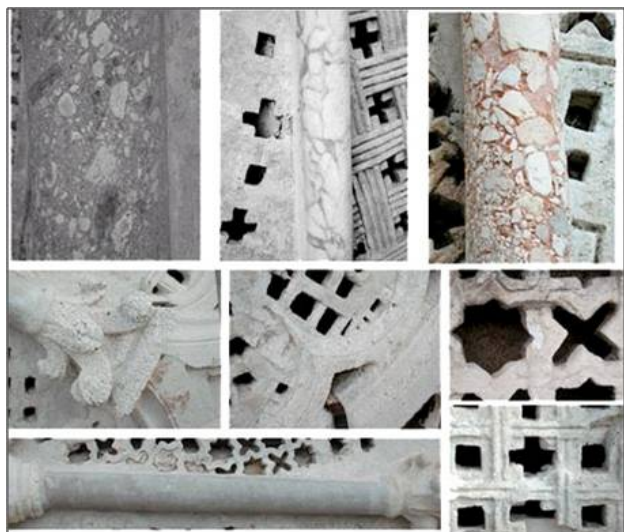
Fig. 2. Examples of building materials used for columns (grey breccia, Pavonazzetto marble, Breccia Corallina and green-grey sandstone), capitals (medium-fine grained calcarenites), arched ribworks and triangular carved panels (medium to coarse grained calcarenites).

Because of the different nature and composition of the constituent stone materials, different responses to the electromagnetic and ultrasonic investigation were therefore expected. The various elements are supposedly joined together by iron bolts and melted lead, as exposed at the base of a damaged column.

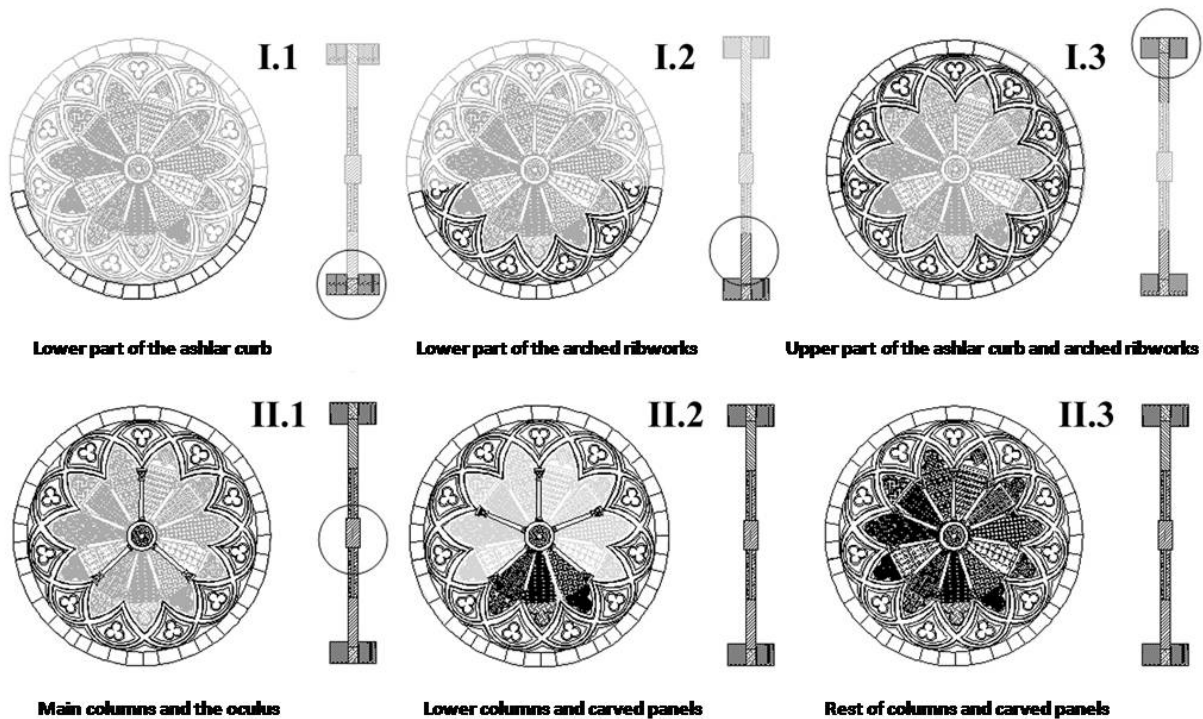
rotations of the capitals, as well as compression failures of the columns, may be observed. Relative displacements, up to 1 cm, may also be observed at the joints between the arched ribworks. An out-of-plane restraint was set up, presumably in the 19th century, consisting of two horizontal tubes, anchored to the ashlar curb and connected to some columns and arched ribworks through metal elements.

It is not clear whether this past intervention might have produced further strains to the anchoring architectural elements (such as in the middle of columns 8 and 4 and toward the oculus in columns 2 and 10) as suggested by the local decrease of ultrasonic velocity. This justifies their removal in future interventions, in favour of less invasive strengthening techniques. From a preliminary study, two different

Fig. 6. Interpreted construction phases of the rose window of Troia Cathedral.

restoration techniques have been proposed: one consisting of dismantling the whole rose window followed by reassembly, the other involving an in situ structural reinforcement with partial dismantling of the architectural elements. To evaluate which method is preferable, besides a detailed knowledge of the materials and the present state of the internal structure, a comprehension is required of the original construction techniques. To this aim, the GPR results were invaluable to gain insights into the original construction techniques, and consequently select the restoration strategy more respectful of the original layout. In particular, the distribution of the iron bolts within the columns allowed us to discover the construction phases of the rose window. Based on the GPR findings, a hypothetical sequence of the construction stages is sketched in Fig. 6. After building the external ring (ashlar curb and arched ribworks), the columns, the central oculus and the carved panels were inserted. In the first phase the lower columns with iron bolts at both ends were positioned and the oculus was centred. Subsequently, the upper columns were inserted for some centimetres in the cups of the oculus and joined with the capitals by means of metal bolts. This solution permitted to optimize the tolerances during the positioning of the columns. The rose window was then completed with the insertion of the carved panels. The GPR investigation provided crucial evidences in favour of one of the various conflicting hypotheses about the original construction techniques, leading to the selection of partial dismantling as the most suitable restoration strategy.
