TERRESTRIAL LASER SCANNER FOR MONITORING THE DEFORMATIONS AND THE DAMAGES OF BUILDINGS

Three case studies are presented relating to damaged and/or unsafe buildings: Sivillier Castle (Villasor - Sardinia-Italy), the Bell Tower of Mores (Sardinia-Italy) and industrial building (Cagliari - Italy).

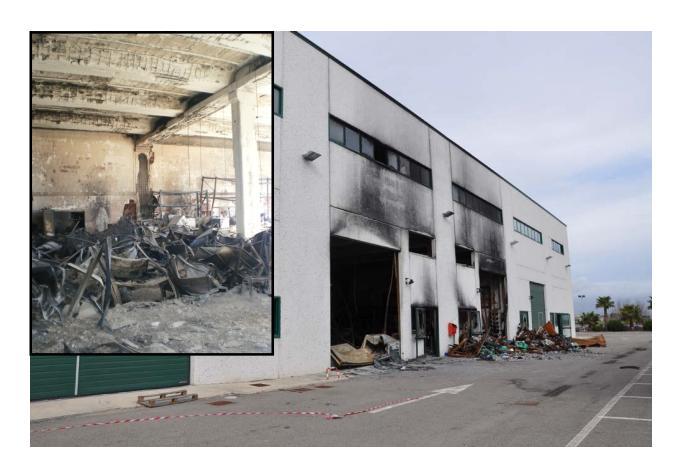
Figure 14: Industrial building

The last case is that of an industrial building (Fig. 14) whose structure was partly damaged by a fire. The effects of extreme actions like blast load or fire is the subject of a current research trend (see for example [4] [5] [6] [8]), and the information obtained from a geomatic survey can be of paramount relevance in the structural analysis [2] [3].

A fire spread over the central part of the ground floor, as shown in Fig. 15, the lateral fire resistant partition walls prevented the fire from spreading to other areas of the building. Indeed, the main damage concerns the central area of the ground floor and the corresponding ceiling. For this reason the laser scanner survey was focused on these parts.

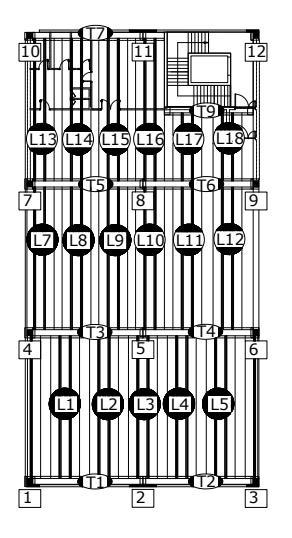
Figure 16: Structural elements scheme

For the sake of clarity, the structural elements subjected to fire were labeled as shown in figure 16. In order to find the position of the centre of gravity, after the fire, of the six central columns (labelled 4 to 9, see Figure 15), their geometry was recorded by the laser scanner after the fire. Obviously damage is also present on these four sections at different heights (see fig. 17 and fig. 18). The bottom and top ends of each column were not exposed to fire, and so their deformation is negligible.

The fire also damaged the ceiling of the ground floor which consists of transversal T-shaped beams (labeled with T code in Fig. 16) simply supported directly by the columns and by the longitudinal omega-shaped beams (labeled with L code in Figure 15), supported by the above mentioned T-shaped beams. The maximum deflection recorded (Fig. 18) for each beam is reported in Table 1. The negative sign indicates upward

deflection, while the positive one refers to downward deflection. The higher negative deflections for T-shaped beams (corresponding to code T, see Figure 15) are located in the right side of the plant (beams T2-T4-T6) while the other beams (T1-T3-T5-T7-T9) present a positive one (see Figure 16). In order to explain these results it must be highlighted that each beam is designed with a negative deflection due to the prestressing tendons. So, in some cases the local damages due to fire were so high to invert the sign of the deflection, in the other cases the negative deflection has survived to fire. The longitudinal omega-shaped beams (corresponding to label L, see Figure 16) present high deflections in the bottom part of the plant (see Figure 16). In particular beam labeled L4 has a maximum deflection of 74.23 mm corresponding to 6/1000 of the span. This results proves that the fire effect in addition to the dead load of the structure has neglected the initial negative deflection (equal to 25-30 mm, see the undamaged beams labeled La and Lb, present in all L-beams), only in several damaged elements.
