Use of FBG sensors for monitoring cracks of the equestrian statue of Bartolomeo Colleoni in Venice

F. Felli, A. Brotzu, D. Pilone, C. Vendittozzi

KEYWORDS. FBG sensors; Health monitoring; Crack monitoring; Restoration; Colleoni equestrian statue.

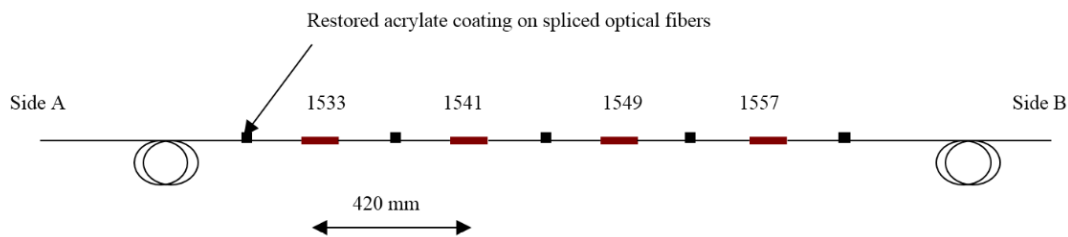
Figure 3: FBG sensor system.

The sensor system has been tested and calibrated via measurement campaigns carried out by applying controlled thermal and mechanical stresses. In a second stage four FBG sensors arranged in series were glued in correspondence to the crack on the right foreleg by means of M-BOND AE10. The array of sensors has been realised and positioned as shown in Fig. 3.

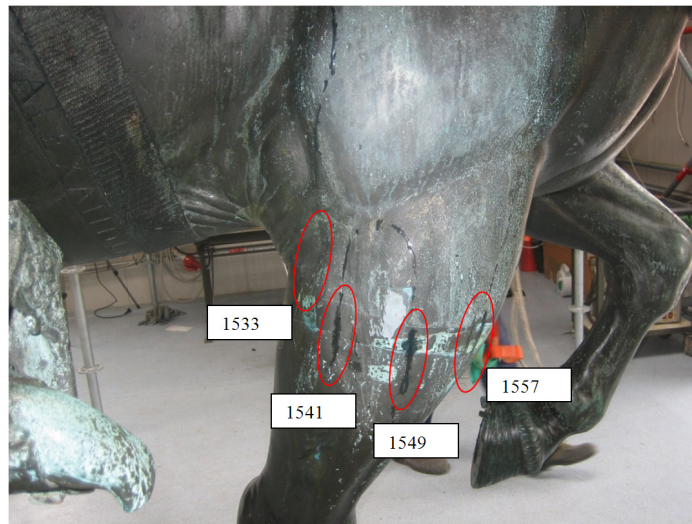
Figure 4: FBG sensor positions.

Fig. 4 shows the sensor array and highlights that the sensor with a wavelength centered at 1533 nm is about 20 cm away from the crack. Two sensors were glued in correspondence of the same areas selected for the previous ones.

The sensors' system has been realized as shown in Fig. 3 and glued on the horse right side as highlighted in Fig. 4.

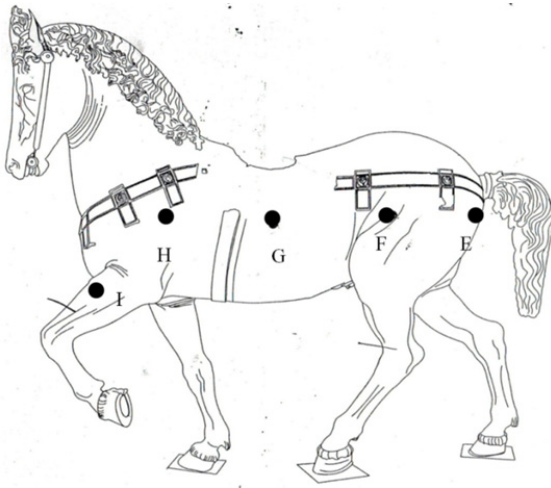
Figure 5: Points of load application.

In order to carry out tests, load was applied by a dynamometer. Fig. 5 shows the points where the load was applied and measured by a dynamometer. On the right side of the horse, the load was applied in correspondence of points A, B, C, D and L while on the left side it was applied in correspondence of points H, G, F, E and I that are arranged symmetrically with respect to the previous ones.

Tests highlighted the good response of the sensors showing that when load is applied on the points A and B the crack closes (compression) while the application of a load on the point D produces an area subjected to compression and an area subjected to tension. Fig. 8 shows the graphs of the second array of sensors, always in arbitrary units. They highlight again the deformations detected by the sensors but in this case, as indicated in the figures, the load trend is represented by the blue curve.

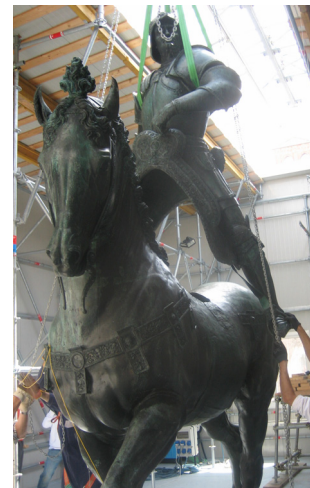
Figure 6: Repositioning of the rider on the horse.

The last measurements were made while repositioning the rider on the horse (Fig. 6).

The plot in Fig. 9 shows the trend of the crack deformation during the repositioning of the rider. It highlights an important opening of the crack always in the front area where the sensor 1557 is located. The crack does not deform in his central area (sensor 1549), while it closes in the posterior part of the foreleg (sensor 1541).
