**TESTING OF NEW BRIDGE RAIL AND TRANSITION
DESIGNS. VOLUME 3. APPENDIX B. BR27D BRIDGE
RAILING**

Testing of New Bridge Rail and Transition Designs

Volume III: Appendix B

BR27D Bridge Railing

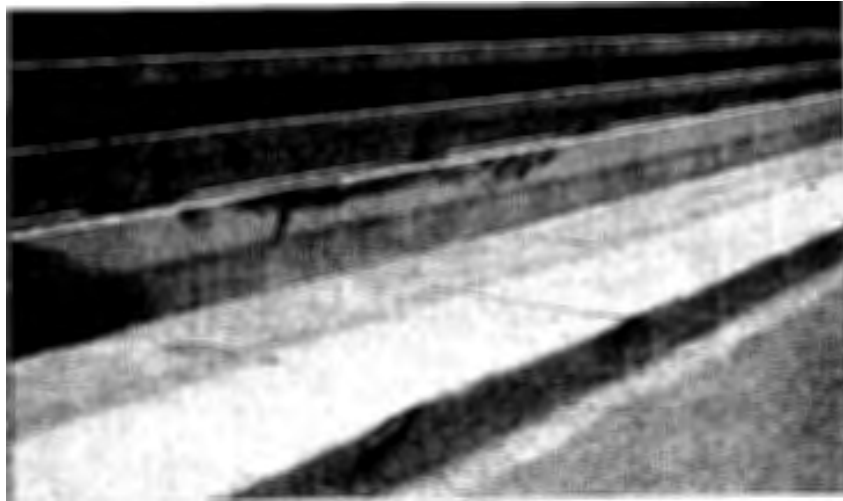
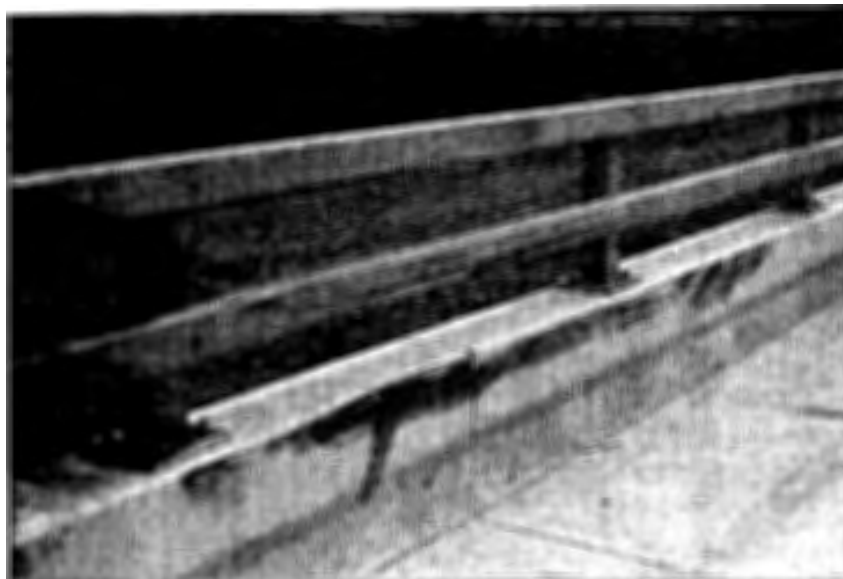
Figure 7. BR27D bridge railing on sidewalk after test 7069-22.

As can be seen in figure 7, the bridge railing system received minimal damage. There was no measurable permanent deformation to the railing elements and only cosmetic damage to the concrete parapet. There were tire marks on the concrete parapet, on the face of the lower metal railing element in the area of impact, and also on the lower part of post 6. The vehicle was in contact with the bridge railing for 11.5 ft (3.5 m). Length of contact with the concrete parapet was 7.0 ft (2.1 m).

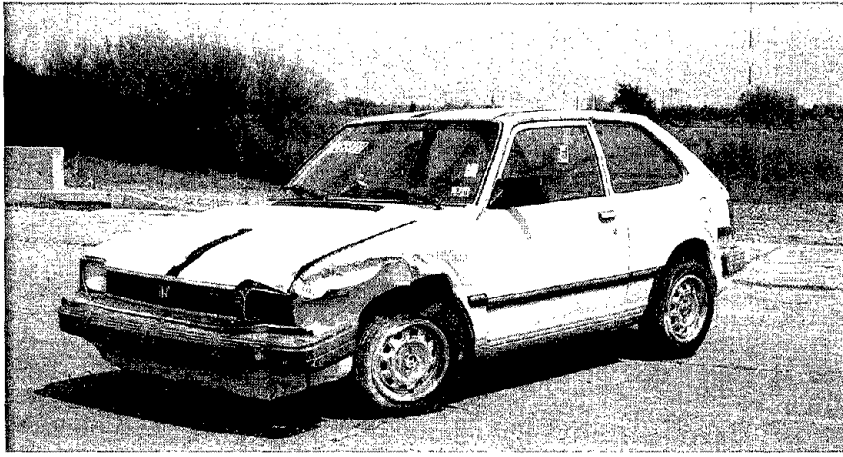
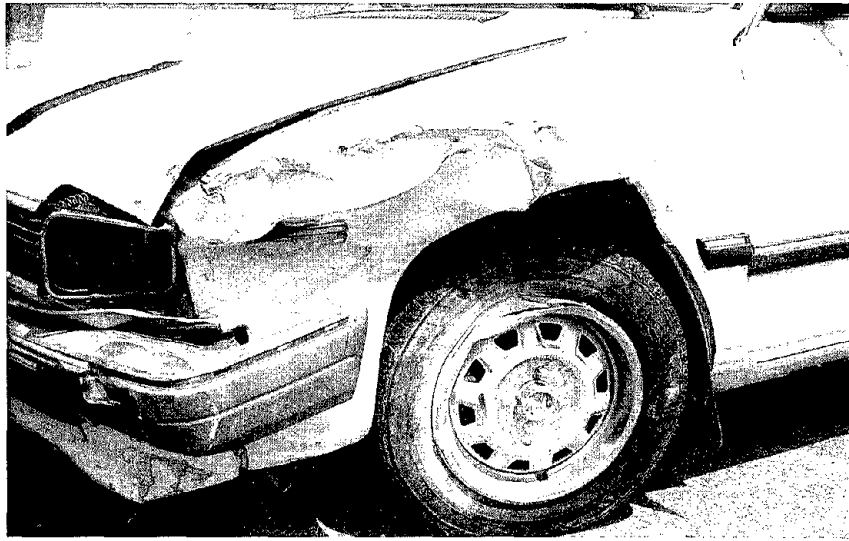
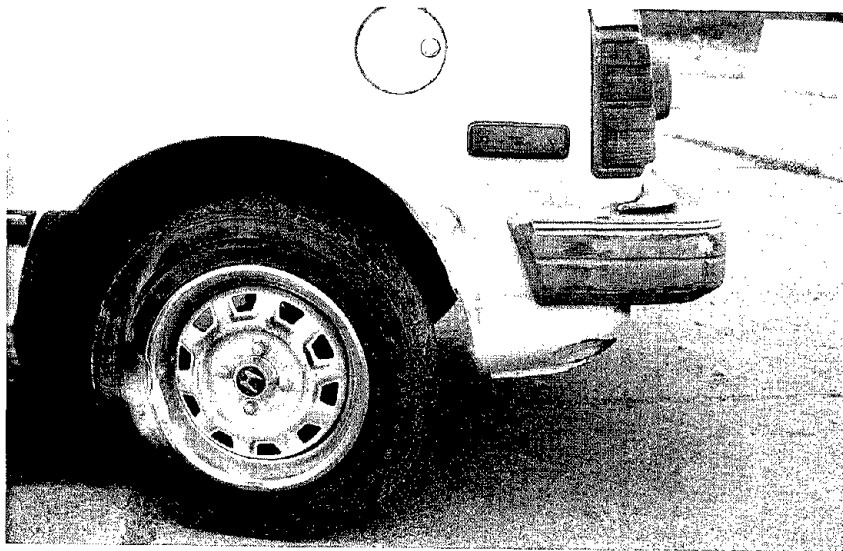
Figure 8. Vehicle after test 7069-22.

The vehicle sustained damage to the left side as shown in figure 8. Maximum crush at the left front corner at bumper height was 6.0 in (152 mm). The left front strut was damaged, and the left front wheel was canted inward at the bottom and pushed back reducing the wheelbase on the driver side by 2 in (51 mm). Also, damage was done to the front bumper,

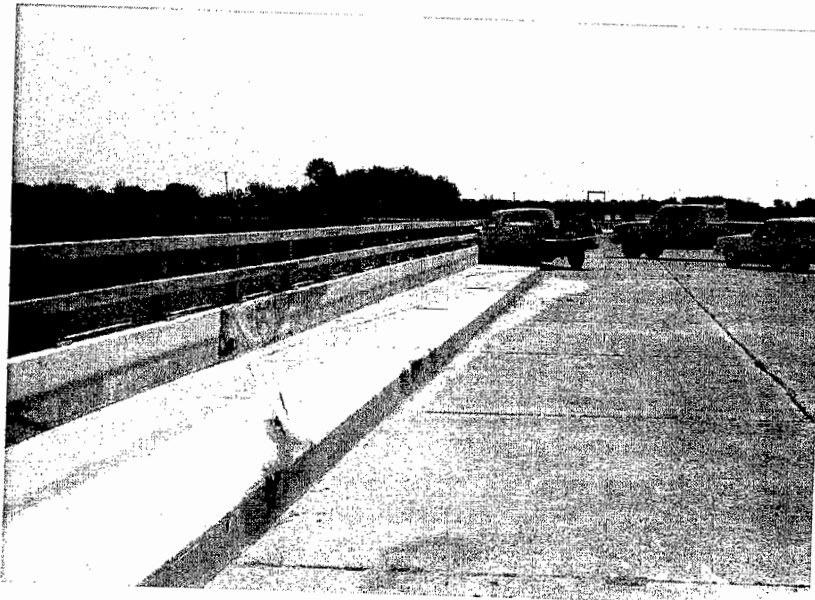
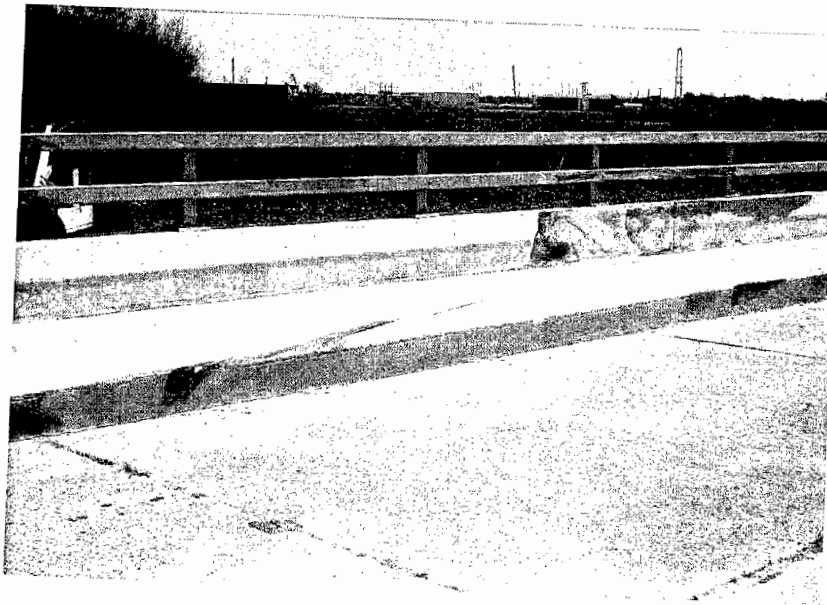
Figure 20. BR27D bridge railing on sidewalk after test 7069-23.

As can be seen in figures 20 and 21, the bridge railing received minimal damage. The maximum permanent deformation to the railing element was 0.5 in (13 mm) between posts 5 and 6. Posts 5 and 6 were also pushed rearward approximately 3/16 in (4.8 mm) as shown in figure 22. There was only cosmetic damage to the concrete parapet. There were tire marks on the concrete parapet, on the face of the lower metal railing element in the area of impact, and also on the lower part of post 5 and 6. The vehicle was in contact with the bridge railing system for 12.8 ft (3.9 m).

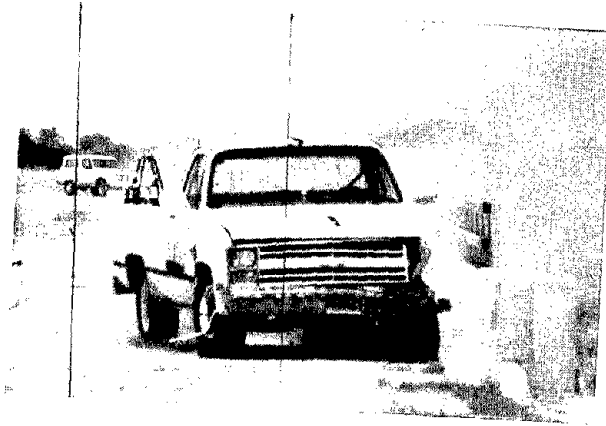
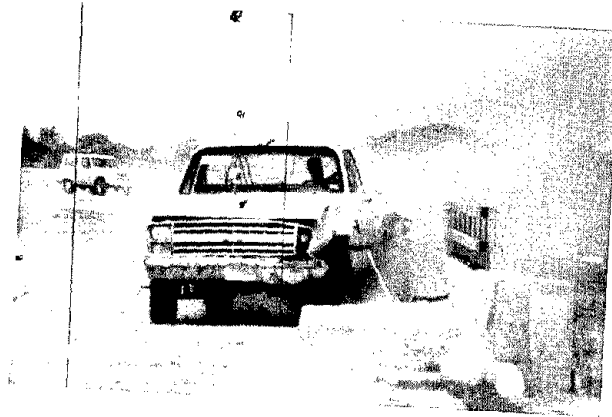
Figure 23. Vehicle after test 7069-23.

The vehicle sustained damage to the left side as shown in figures 23 and 24. Maximum crush at the left front corner at bumper height was 12.5 in (318 mm) and the right side was deformed outward 5.0 in (127 mm). Also, damage was done to the front bumper, hood, grill, radiator and fan, left front quarter panel, left door, left rear quarter panel, left front and rear tires and rims, rear bumper, and right front quarter panel and right door.

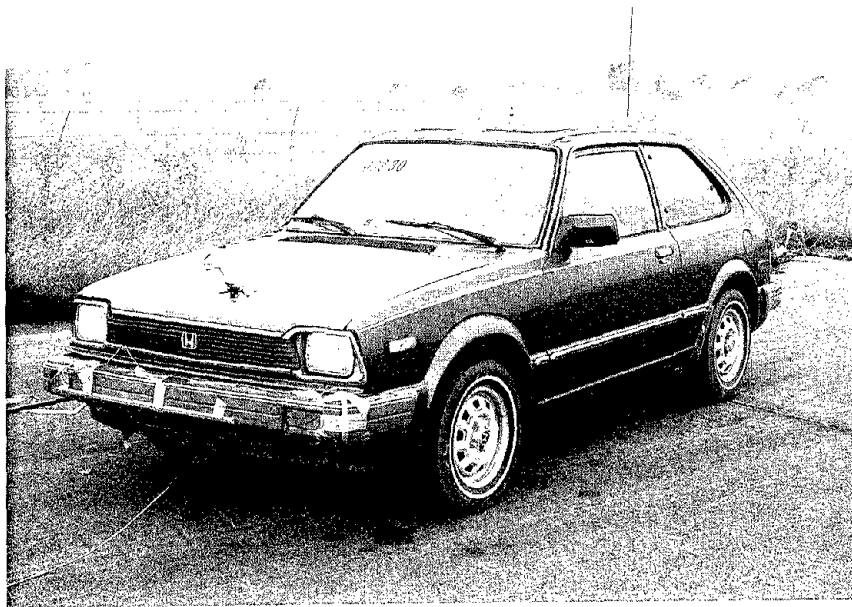
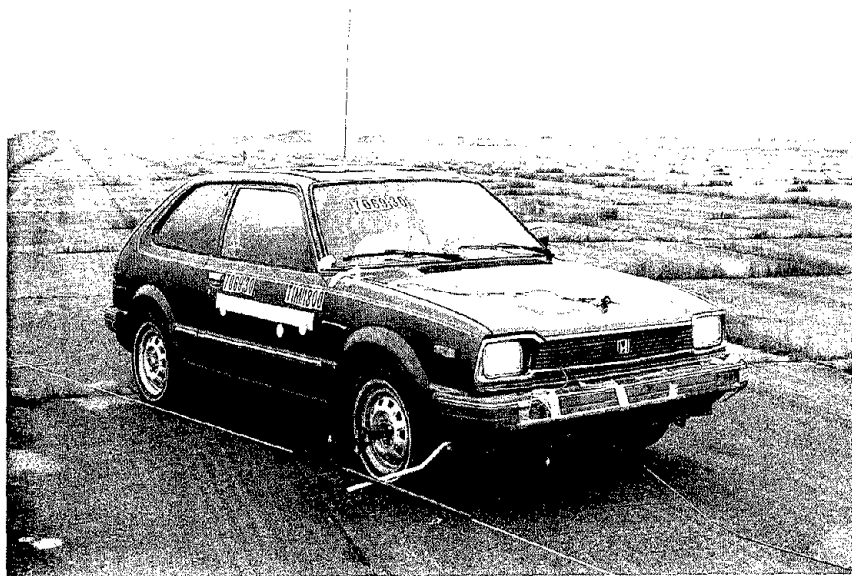
Figure 36. Vehicle before test 7069-30.

A 1983 Honda Civic (figures 36 and 37) was used for the crash test. Test inertia mass of the vehicle was 1,800 lb (817 kg) and its gross static mass was 1,970 lb (894 kg). The height to the lower edge of the vehicle bumper was 14.5 in (368 mm) and it was 19.5 in (495 mm) to the top of the bumper. Additional dimensions and information on the test vehicle are given in figure 38. The vehicle was directed into the BR27D bridge railing on deck (figure 39) using the cable reverse tow and guidance system and was released to be free-wheeling and unrestrained just prior to impact. The vehicle impacted the concrete parapet approximately 25.5 ft (7.8 m) from the end of the bridge railing at a speed of 51.2 mi/h (82.4 km/h) and the angle of impact was 20.5 degrees.

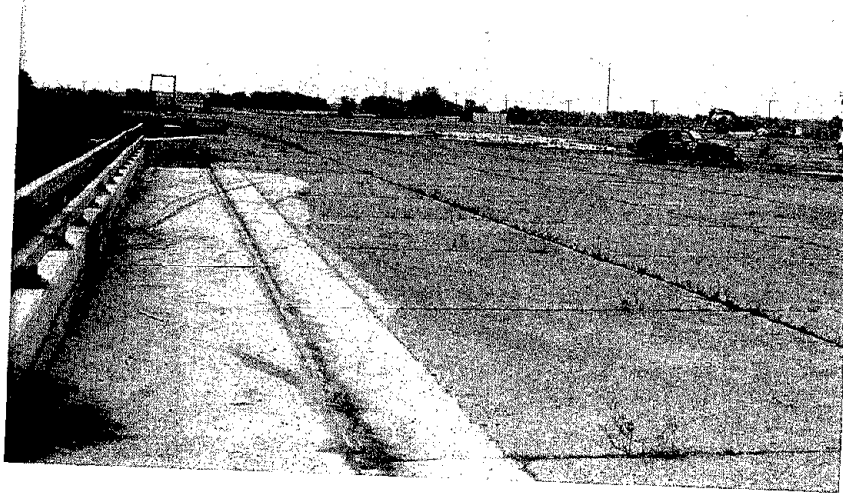
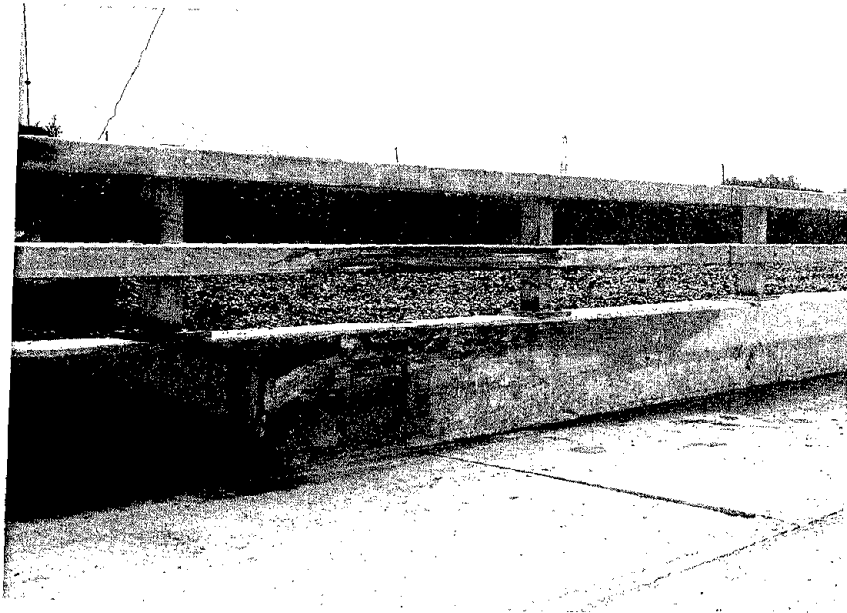
Figure 40. BR27D bridge railing on deck after test 7069-30.

As can be seen in figure 40, the bridge railing received minimal damage. There was no measurable permanent deformation to the railing elements and only cosmetic damage to the concrete parapet. There were tire marks on the concrete parapet and on the face of the lower metal railing element in the area of impact. The vehicle was in contact with the bridge railing for 8.0 ft (2.4 m).

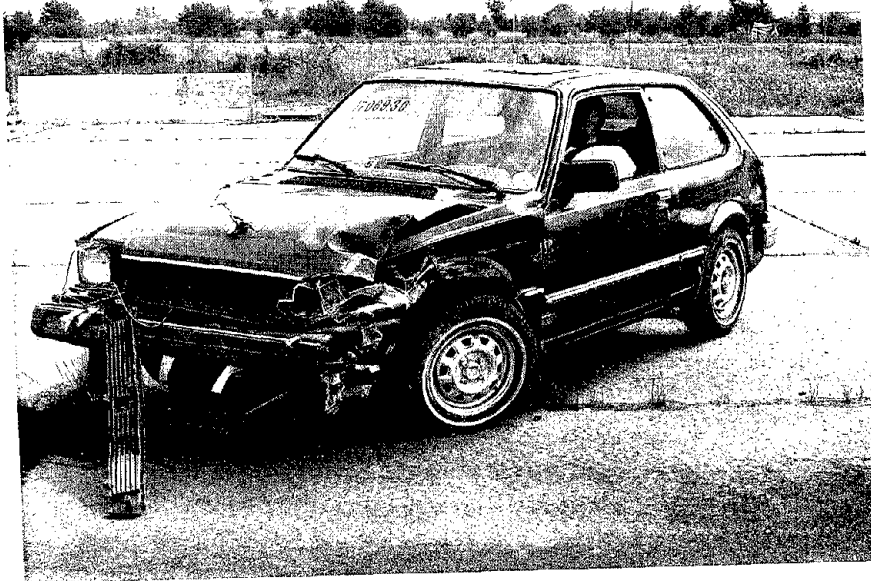
Figure 41. Vehicle after test 7069-30.

The vehicle sustained damage to the left side as shown in figure 41. Maximum crush at the left front corner at bumper height was 7.0 in (178 mm). The left front strut was damaged and the left front wheel was canted inward at the bottom and pushed back reducing the wheelbase on the driver side by 2.25 in (57 mm). Also, damage was done to the right front quarter panel, front bumper, hood, left headlight, left front quarter panel, left door and glass, left rear quarter panel, rear bumper, and left front and rear tires and rims.

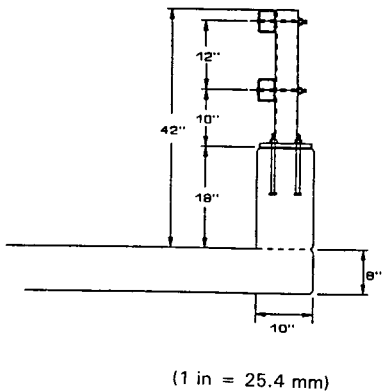
Test No. 7069-30
 Date 05/19/92
 Test Installation . . . BR27D Bridge Railing
 on deck
 Installation Length . . 100 ft (30 m)
 Test Vehicle 1983 Honda Civic
 Vehicle Weight
 Test Inertia 1,800 lb (817 kg)
 Gross Static 1,970 lb (894 kg)
 Vehicle Damage Classification
 TAD 11LFQ3
 CDC 11FLEK2 & 11LFES2
 Maximum Vehicle Crush . 7.0 in (178 mm)

Impact Speed. 51.2 mi/h (82.4 km/h)
 Impact Angle. 20.5 deg
 Speed at Parallel 43.6 mi/h (70.2 km/h)
 Exit Speed 43.0 mi/h (69.2 km/h)
 Exit Trajectory 6.8 deg
 Vehicle Accelerations
 (Max. 0.050-sec Avg) at true c.g.
 Longitudinal. -7.5 g
 Lateral -12.8 g
 Occupant Impact Velocity at true c.g.
 Longitudinal. 16.0 ft/s (4.9 m/s)
 Lateral 21.5 ft/s (6.6 m/s)
 Occupant Ridedown Accelerations
 Longitudinal. -3.6 g
 Lateral -6.1 g

CRITERIA		TEST RESULTS		PASS/FAIL*
A.	Must contain vehicle	Vehicle was contained		Pass
B.	Debris shall not penetrate passenger compartment	No debris penetrated passenger compartment		Pass

H.	Exit angle shall be less than 12 degrees	Exit angle was 6.8 degrees		Pass

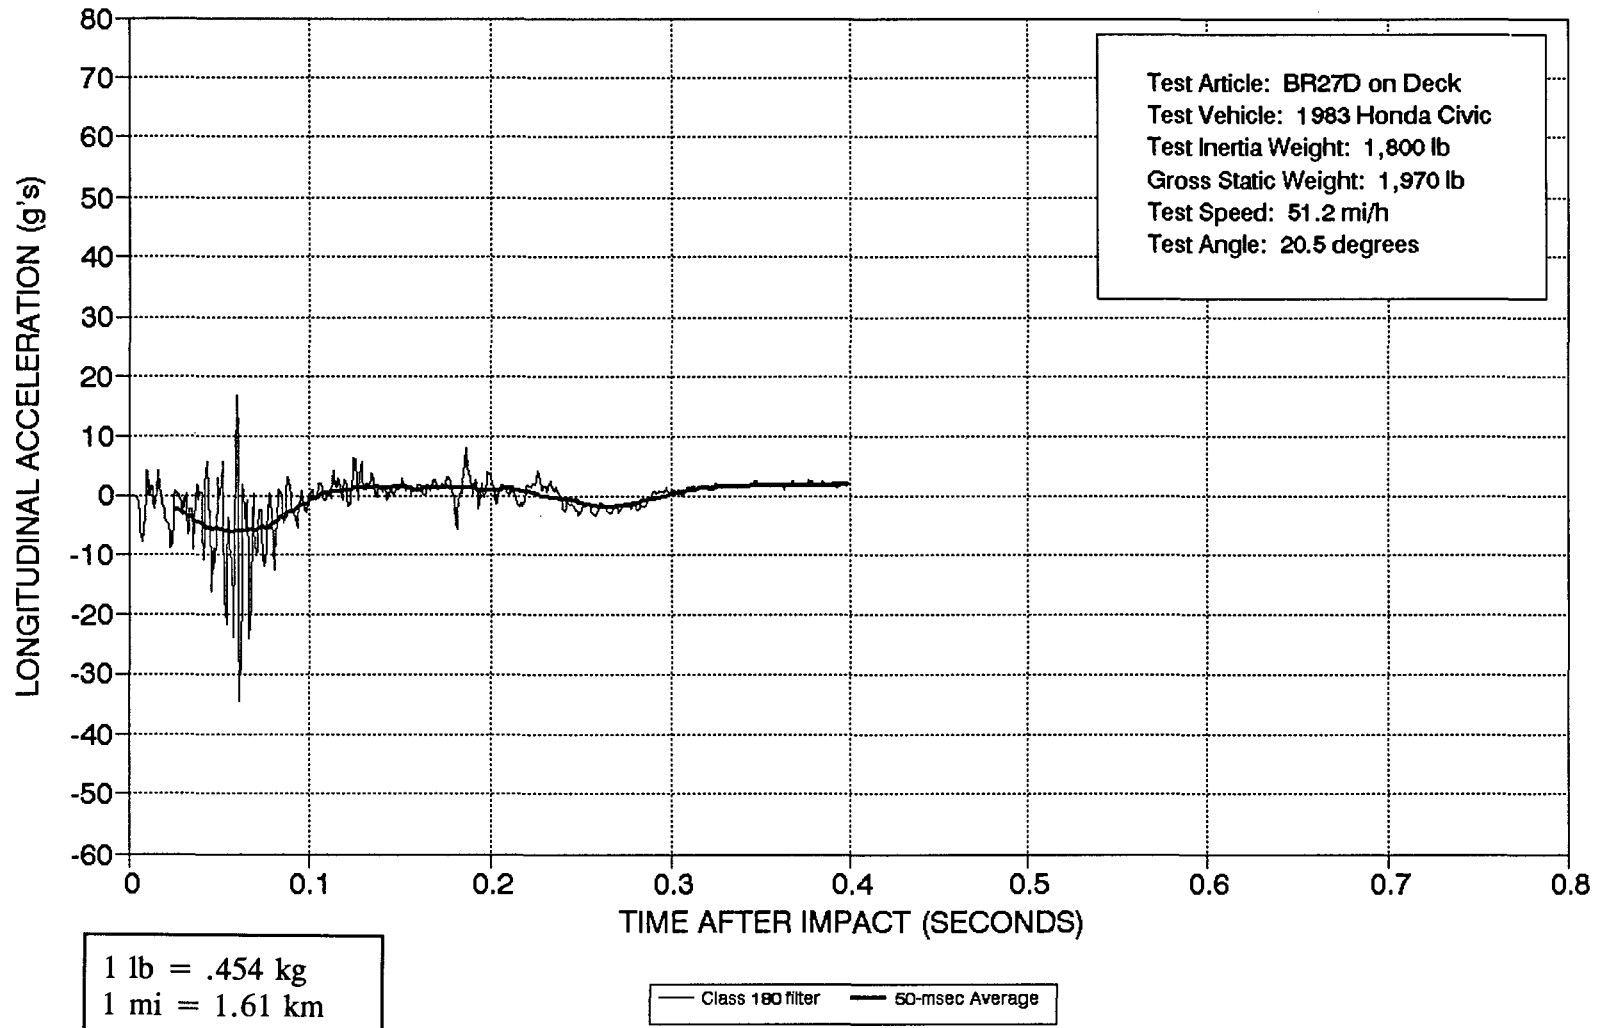
Figure 46. Vehicle longitudinal accelerometer trace for test 7069-30 (accelerometer located at center-of-gravity).

with the bridge railing traveling at 43.0 mi/h (69.2 km/h), and the exit angle between the vehicle path and the bridge railing was 6.8 degrees. Data from the accelerometer located at the center-of-gravity were digitized for evaluation, and occupant risk factors were computed as follows. In the longitudinal direction, occupant impact velocity was 16.0 ft/s (4.9 m/s) at 0.179 s, the highest 0.010-s average ridedown acceleration was -3.6 g between 0.248 and 0.258 s, and the maximum 0.050-s average acceleration was -7.5 g between 0.032 and 0.082 s. Lateral occupant impact velocity was 21.5 ft/s (6.6 m/s) at 0.098 s, the highest 0.010-s occupant ridedown acceleration was -6.1 g between 0.175 and 0.185 s, and the maximum 0.050-s average acceleration was -12.8 g between 0.031 and 0.081 s. The change in vehicle velocity at loss of contact was 8.2 mi/h (13.2 km/h) and the change in momentum was 672 lb-s (2,990 N-s). These data and other pertinent information from the test are summarized in figure 42 and table 4. Sequential photographs are shown in figures 43 and 44. Vehicular angular displacements are displayed in figure 45. Vehicular accelerations versus time traces filtered with SAE J211 filters are presented in figures 46 through 48.

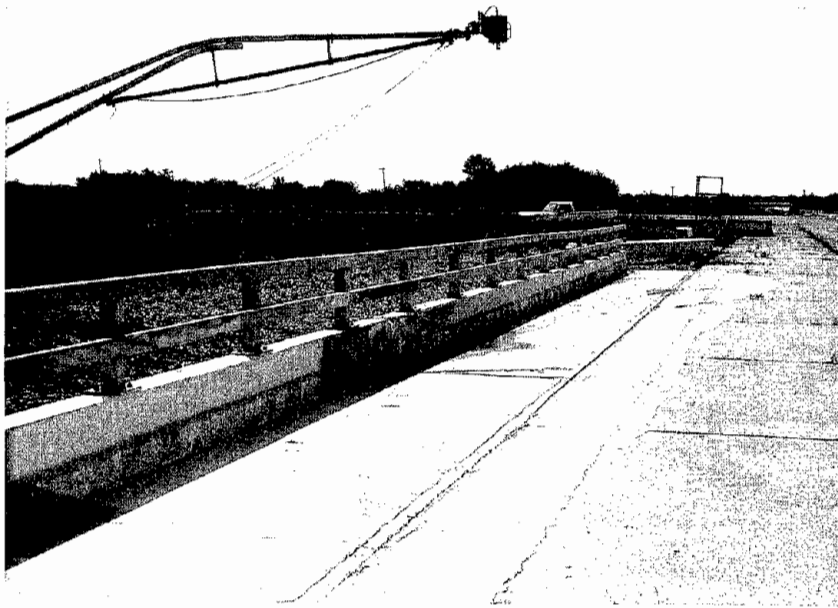
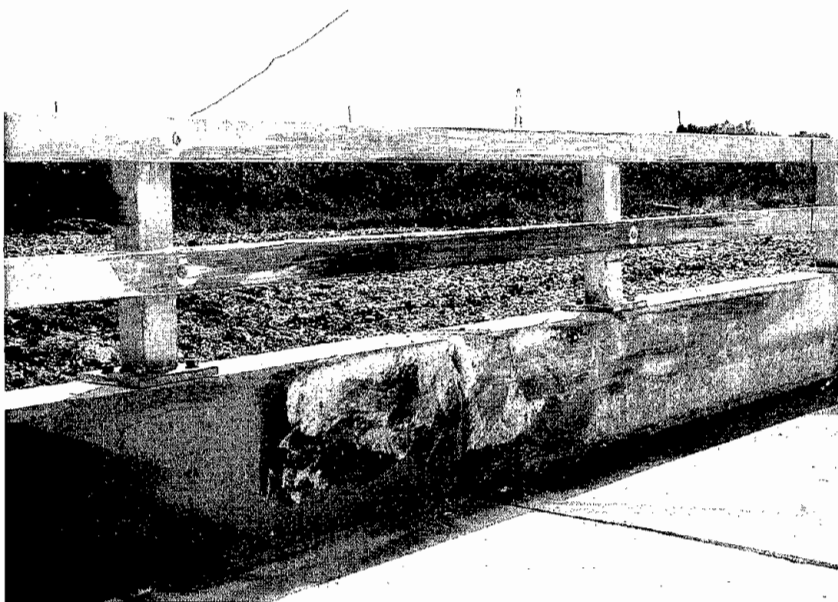
Figure 53. BR27D bridge railing on deck after test 7069-31.

As can be seen in figure 53, the bridge railing received minimal damage. The maximum permanent deformation to the railing element was 0.5 in (13 mm) between posts 5 and 6. There was only cosmetic damage to the concrete parapet. There were tire marks on the concrete parapet, on the face of the lower metal railing element in the area of impact, and also on the lower part of post 6. The vehicle was in contact with the bridge railing for 11.7 ft (3.6 m).
