TURBOMACHINERY & PUMP SYMPOSIA

Investigation of a Compressor Coupling Failure by Torsional Excitation

A Problem of a Complex Interaction
where a Structural Natural Frequency
Excited a Torsional Natural Frequency

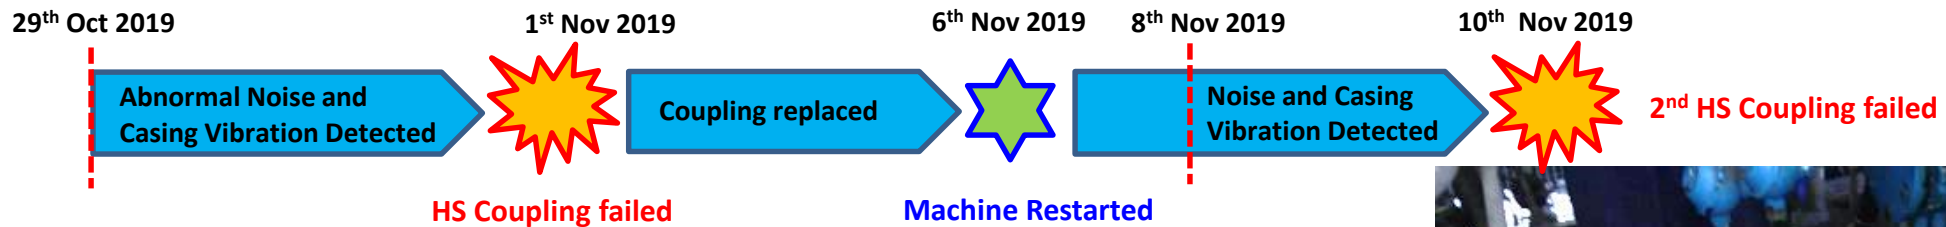
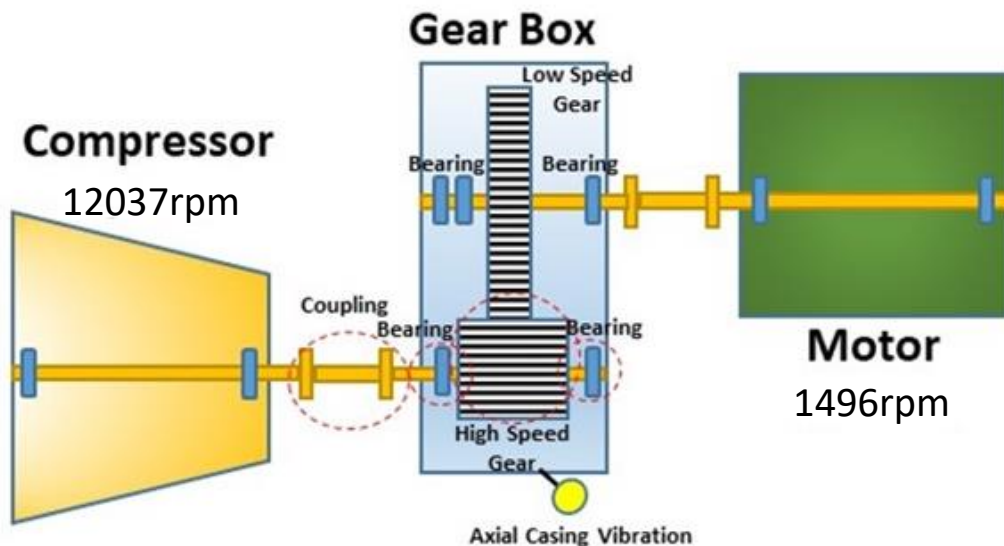
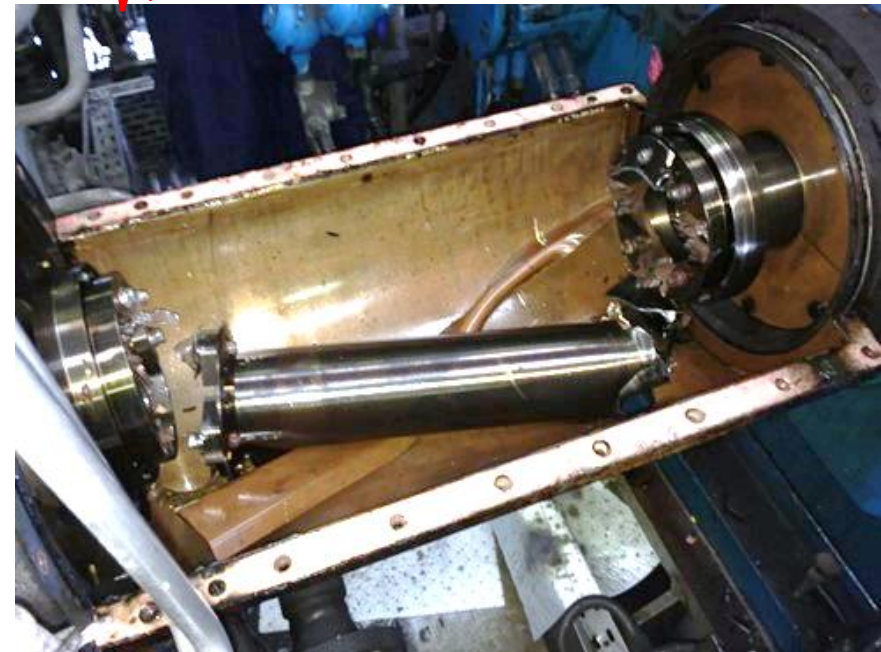
The motor driven centrifugal compressor had a catastrophic failure on the high-speed coupling. The coupling spacer was sheared while several smaller pieces were ejected through the coupling guard. An emergency repair was carried out on the compressor and the train was restarted. A repeat failure happened 4 days after the restart.

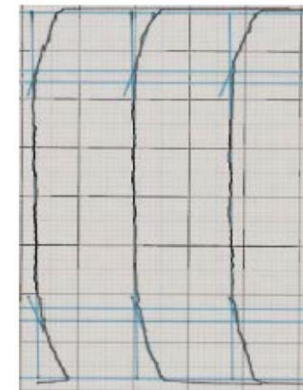
B: Pinion Flank Line Profile

- Pinion shaft gear tooth profile showed severe wear compared to original
- Gear tooth wear pattern on both loaded and unloaded flanks

Original delivery 1995 - according to specification

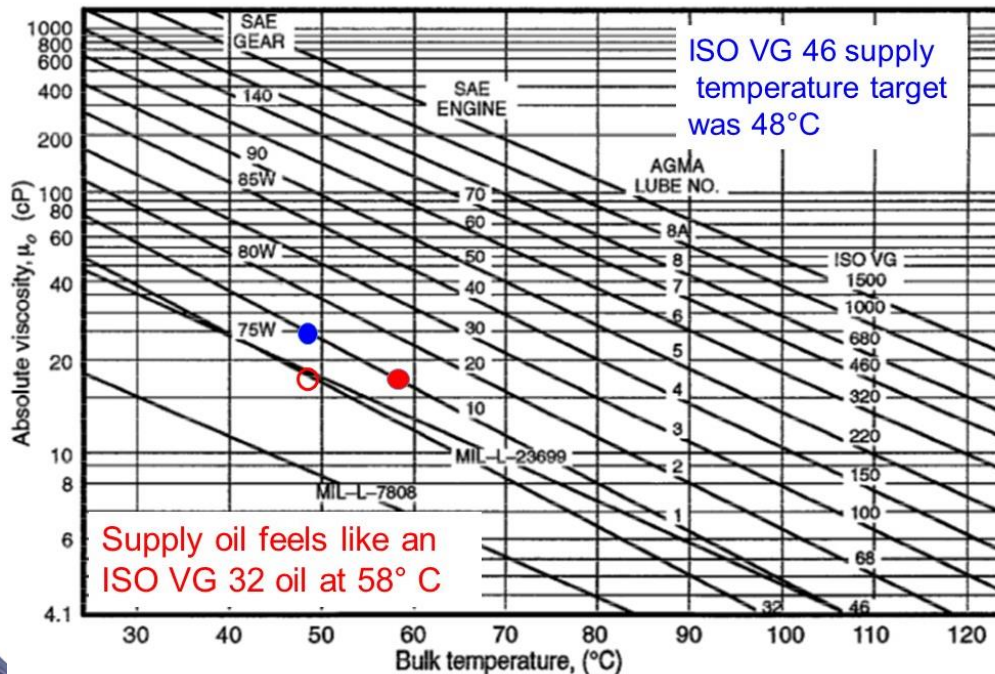
- AGMA Gear Lubrication Analysis
 - Analysis indicated marginally adequate design. Analysis indicating high probability of wear post contamination (changes surface roughness) and high oil temperature events.

Reference: AGMA 2101-C95 Appendix Pg. 52
Figure A.12 – Absolute viscosity versus temperature

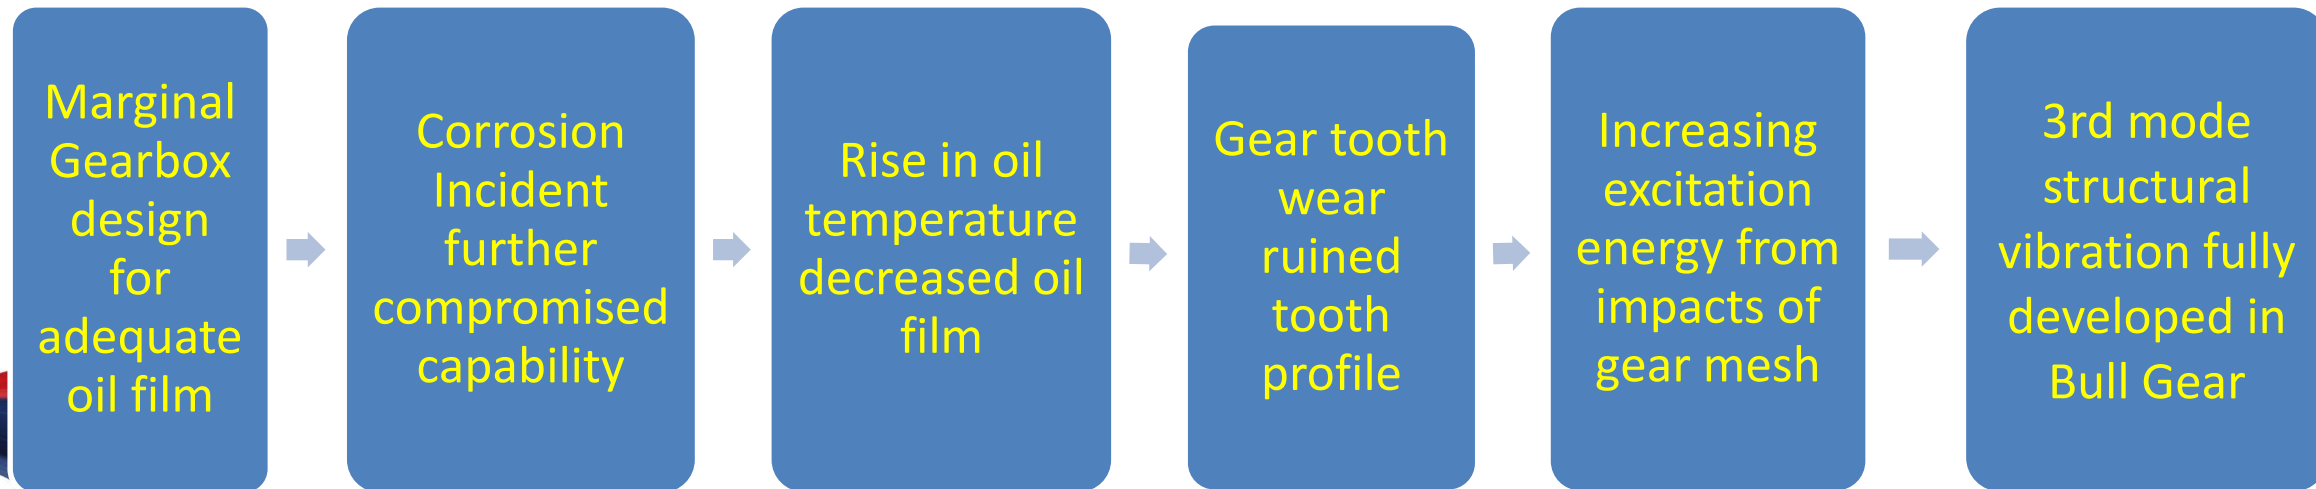
Gear wear resulted in torsional excitation

- Significant gear wear resulted in high levels of tooth contact at the gear mesh.
- The tooth impacts generated an energy that excited the gear structural natural frequency
- The bull gear 'rang' notably at 1688 Hz on its 3rd modal deflection shape of 3 lobes with 6 nodes.

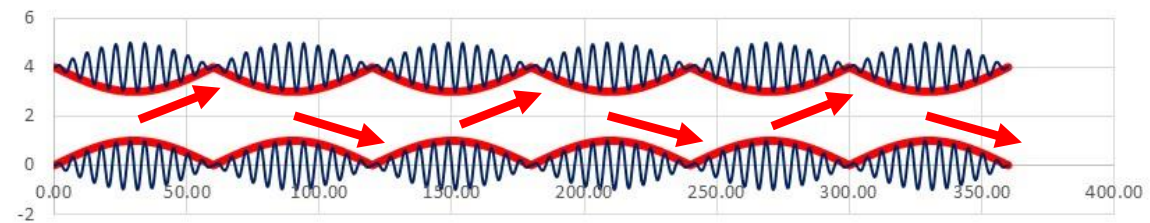
Pinion Position Within the Backlash

- The displacement of the single helical gear teeth due to modal oscillation resulted in a relative tooth advancement at the lobes.
- With the relative tooth advancement of the bull gear and axial inertia of the pinion gear, there were intermittent contacts of the gear teeth to create an effective torsional excitation at 3x of the low-speed shaft (74 Hz), which was close enough to intermittently excite the 2nd TNF of 69 Hz.
- Once the 2nd torsional natural frequency was excited, the train experienced torque reversal as evidenced by unloaded flank tooth wear, gear vibration increase and audible noise..
