49TH TURBOMACHINERY & 36TH PUMP SYMPOSIA SEPTEMBER 14-17, 2020 | HOUSTON, TX | GEORGE R. BROWN CONVENTION CENTER

Successful 2 planes balancing confirm by rotordynamics calculation

This historical case is focus on the vibration behavior of a generator. After a short circuit issue on the grid, the machine train trip. At this time the level of vibration of the generator was acceptable and well below the level of alarm. However, 10 days after the restart of the unit the level of vibration started to increase. The analysis of the data pointed out an increase of the 1X component. There were no signs of rub or other malfunctions. The analysis of the data concluded on an increase of unbalance or a decrease of the dynamic stiffness. Even if, It is unusual to observe such increase of vibration on a generator, the full inspection of the generator was rejected. In order to operate, even if the root cause was not identified, it was decided to balance the generator. The balancing activity was a success using a modal method. Since the root cause was not determined and in order to be sure that the dynamic behavior of the generator was as expected compare to its design, a lateral analysis was don

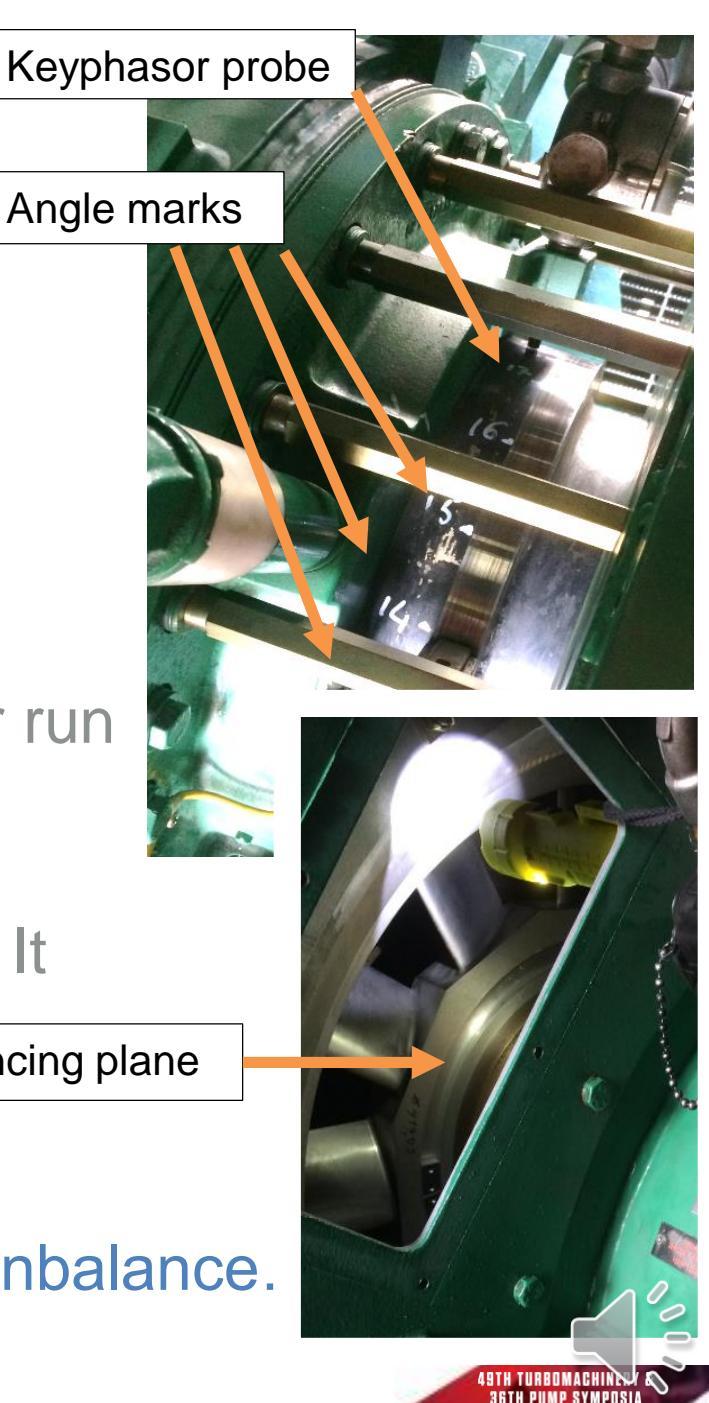
- The Vibration are mainly 1X with forward precession
- The orbits are elliptical
- The 1X amplitude increases with the "square" of the speed
- The Dynamic behavior is repeatable from one run to another run
- There is no hysteresis between startup and shutdown
- The 1X vectors of DE and NDE sides are opposite in phase. It most probably due to the influence of a second mode. Balancing plane

The level of vibration is most probably due to an unexpected unbalance.

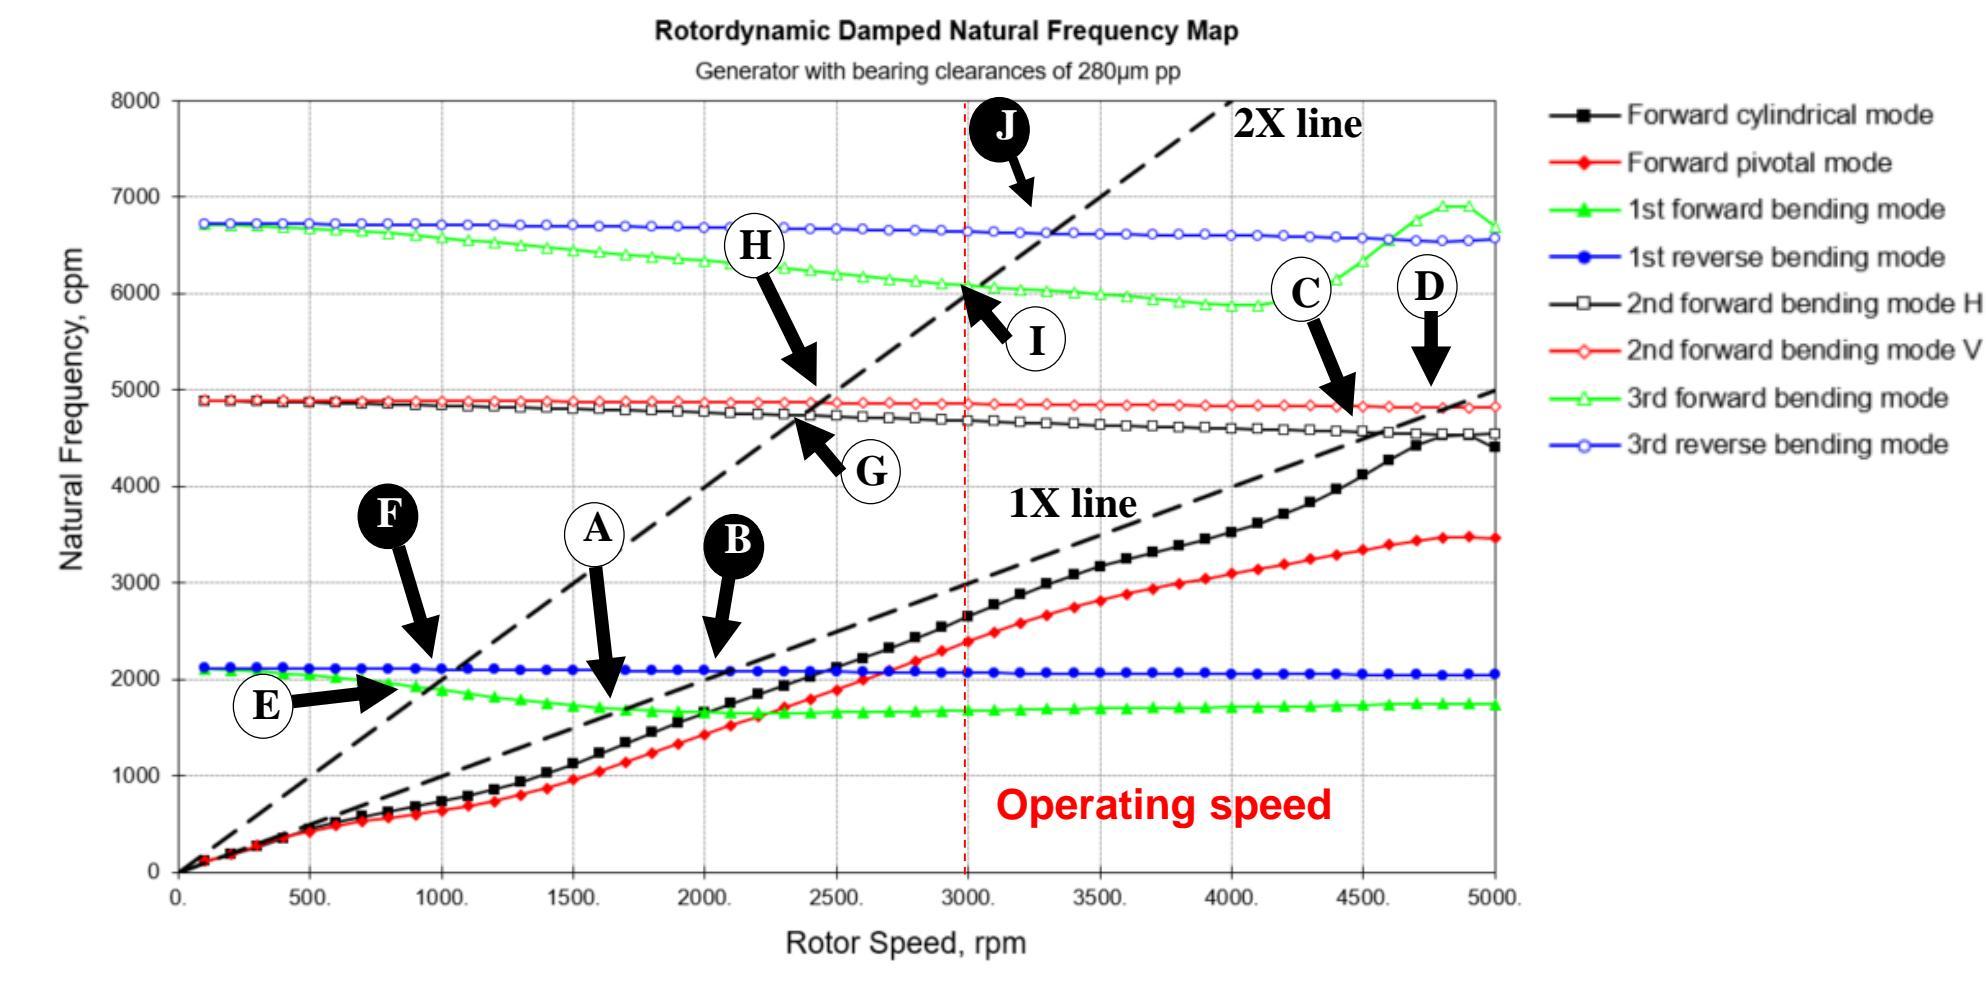
Damped Critical Speed Map

Pivotal mode identified around 4700cpm Relatively far from 3000cpm

Do those intersection points match with the measurements ?

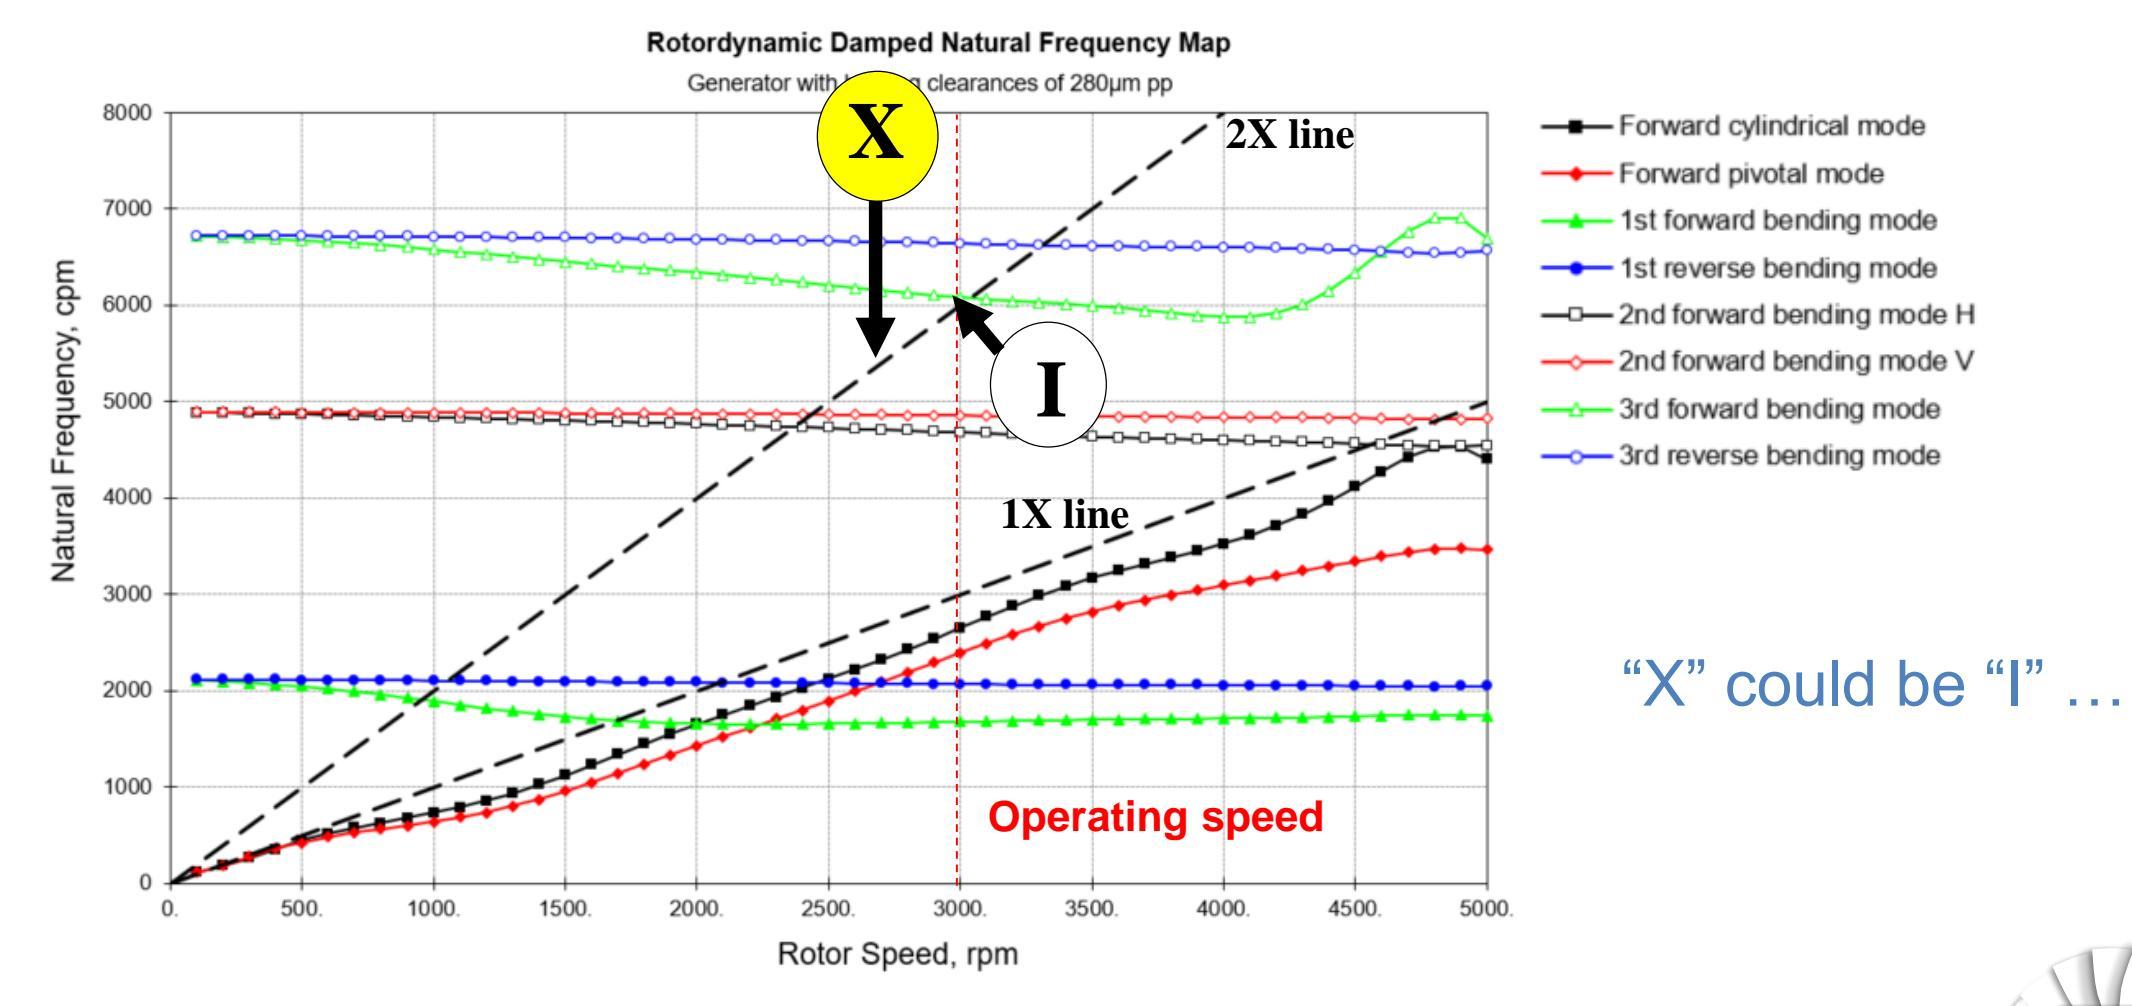
Damped Critical Speed Map

- Let's increase bearing clearances from 280µm to 325 µm ?
- X and I points merge
- Given clearances were not correct ? Bearings worn ?
- In any case, the model and measurement match for several points.
- It seems that the increase of vibration after the grid short circuit incident didn't induced major mechanical issue on the generator
