using proximity probes on rotating machines

Guillaume Christin Nicolas Peton

In this session, a brief introduction about electrostatic discharge phenomena will be done. Then three historical cases with Electrostatic Discharge (ESD) issue will be analyzed in order to explain how to detect Electrostatic Discharge using proximity probes. It will point out that the vibration behavior in case of ESD is not always the same.

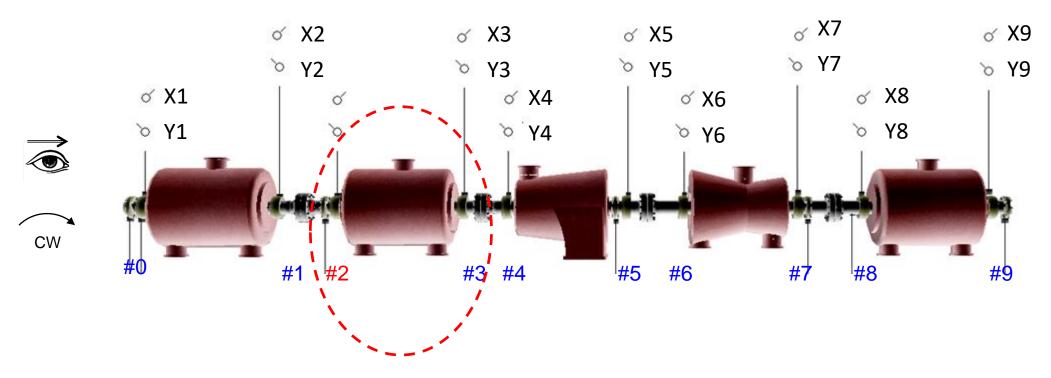
Historical CASE 1: Machine train diagram

Syngas compressor

All bearings are equipped with XY proximity probes. All these data are connected to a condition monitoring platform that saves static and dynamic data.

- Only steady state data are available.
- During 2 days the level of vibration increases from 0.5mils pp to 2.5mils pp (from 13µm pp to 64µm pp)
- Vibration are mainly 1X / Forward precession / Elliptical orbits

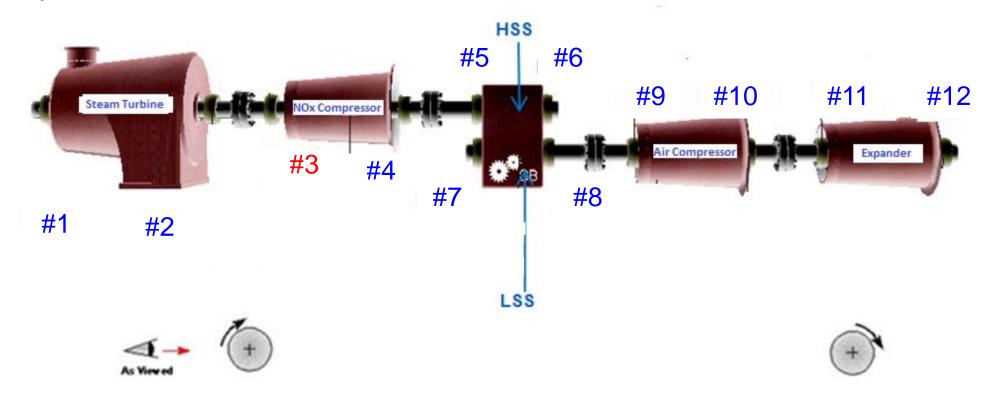
Historical CASE 2: Machine train diagram

Nox compressor

All bearings are equipped with XY proximity probes. All these data are connected to a condition monitoring platform that save static and dynamic data.
