51ST TURBOMACHINERY & 38TH PUMP SYMPOSIA

Integrally Geared Compressor Failure due to excessive pipe strain

Marcela Lopez – Rotating Systems Engineer
Robert C. Eisenmann Jr. - Rotating Systems Advisor

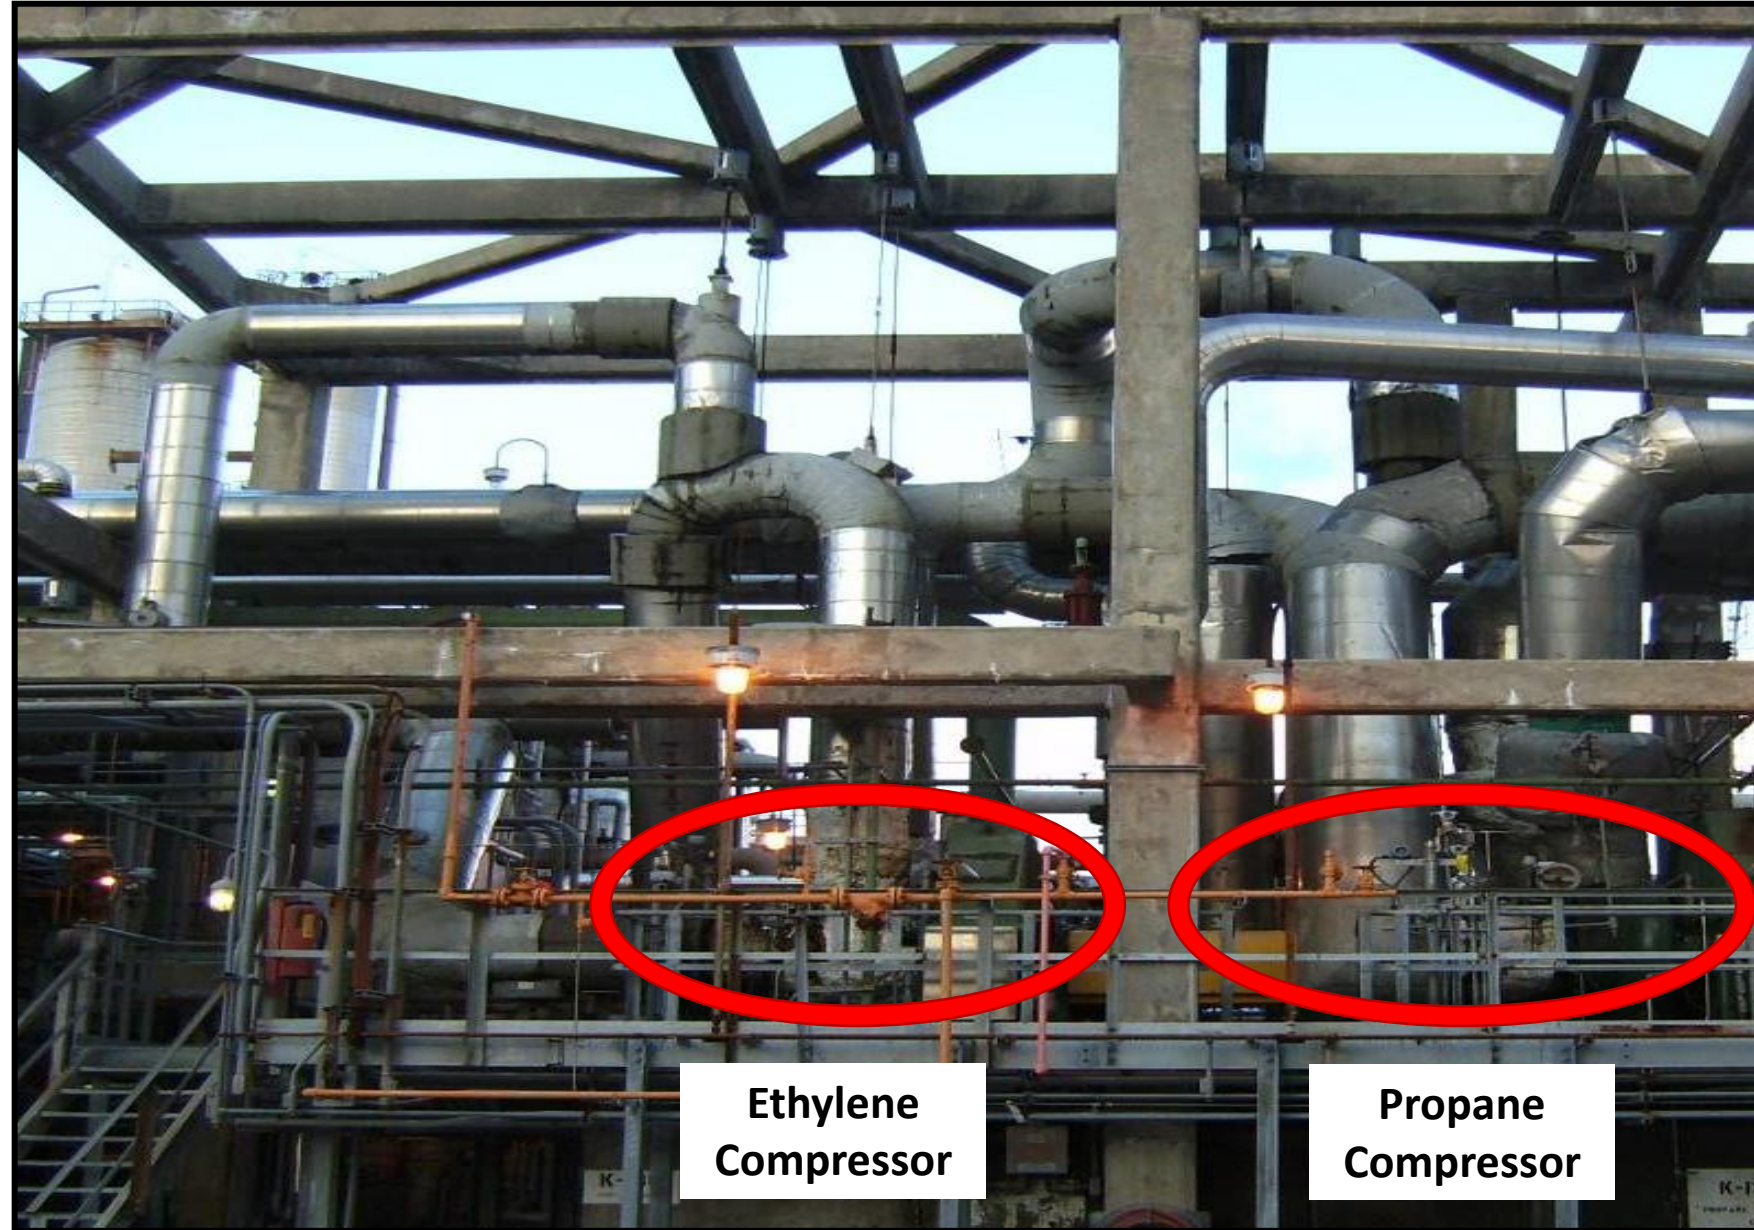
Piping System

- **Pipe Strain – Primary Cause**
 - **Piping Alignment**
 - Step by step piping alignment not followed in sequential order
 - **Spring Cans**
 - Piping installed with spring cans locked and unlocked only after installation of all piping to compressor case was completed
 - Spring cans final position unknown + not documented
 - Only verbal communication that deflections on the machine were monitored

- Complex piping arrangement
- Piping supported by spring cans
- Vertically supported

- Defined sequential order of piping connection/installation
- Defined communication plan onsite to ensure coordination of different discipline crews to achieve defined sequence
- Unchoked spring cans before installation and adjusted during installation to ensure adequate load setting
- Implemented QA/QC and check sheets
- Engineering witness points at all piping reassembly monitoring volute deflection
- Updated site procedures

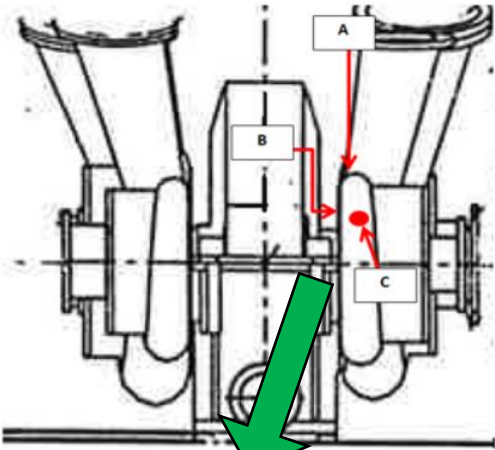
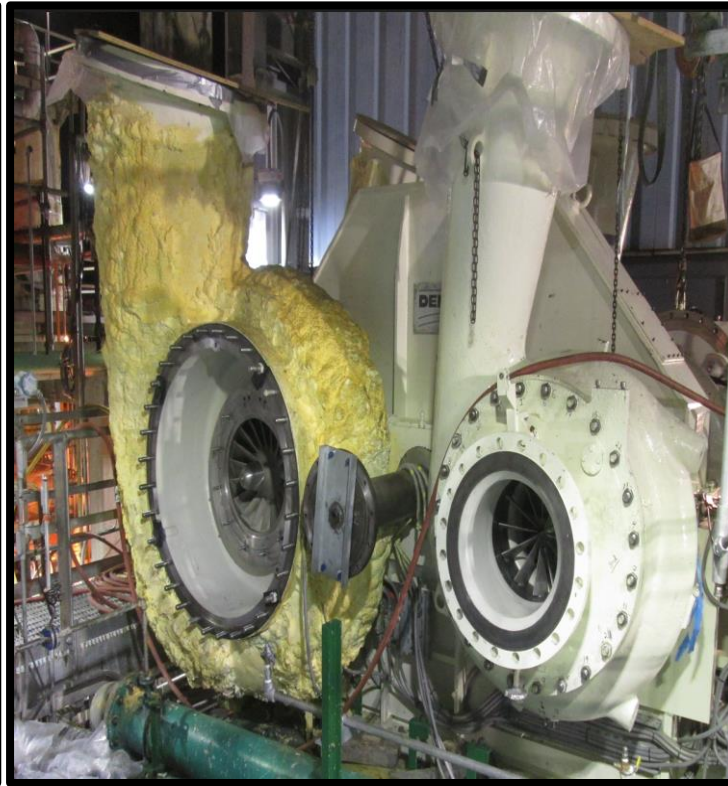
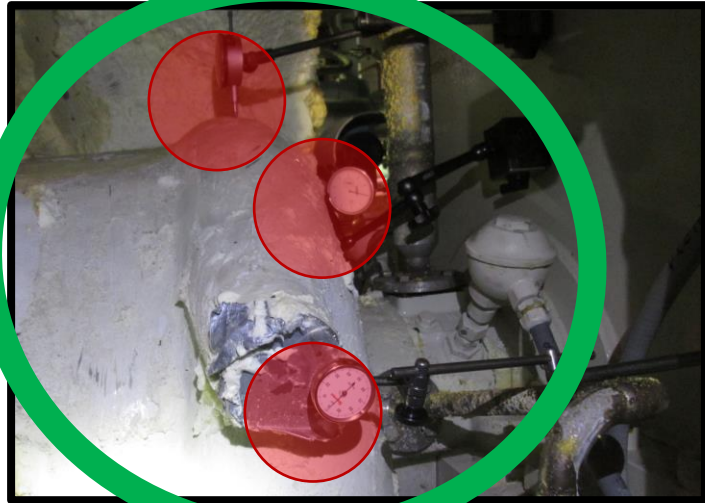
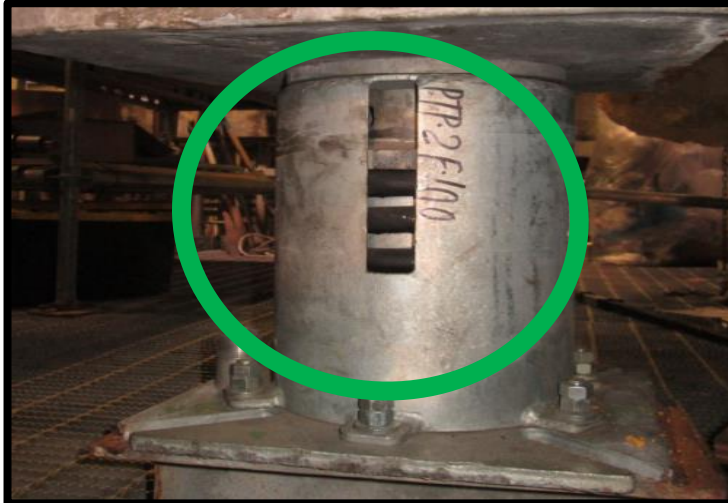
PIPE FLANGE ALIGNMENT & PIPE STRAIN DATA SHEET ON VOLUTE

Acceptance Criteria	Piping	A Position (Y Axis)	B Position (X Axis)	C Position (Z Axis)	Sign Off Date/Time:
	Suction Bolt up Stage:				
0.002"	Discharge Pipe Bolt up Stage:
