Moto-Compressor coupling failure:

API 10% separation margin to
calculated or to real critical
torsional speeds?

TURBOMACHINERY & PUMP SYMPOSIA

This case study will present the failure of the LS coupling of a variable speed moto compressor, due to a resonance of the first critical torsional speed while running at Minimum Operating Speed. The path followed for the investigation and to define design modifications will be presented, followed by a discussion and lessons learned about separation margins to torsional critical speeds on variable speed trains with disc type couplings.

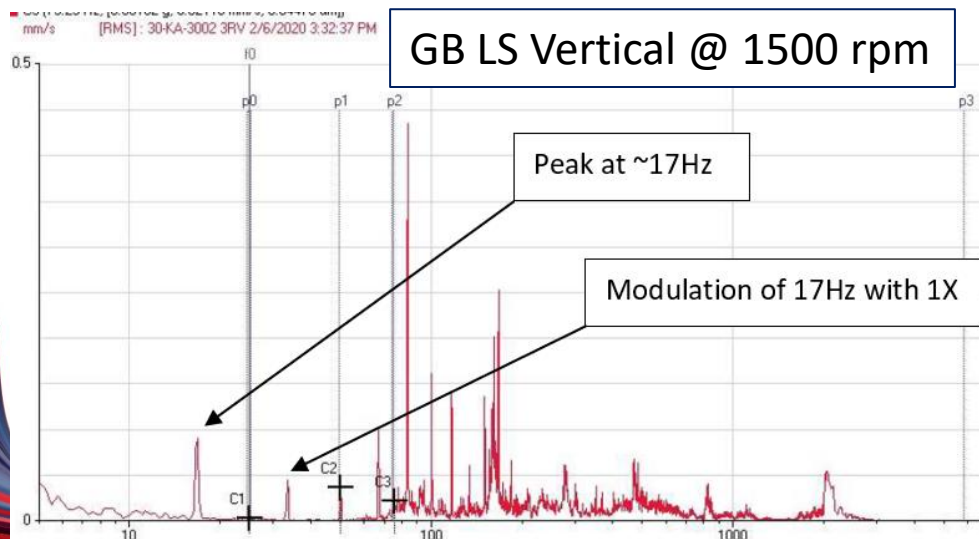
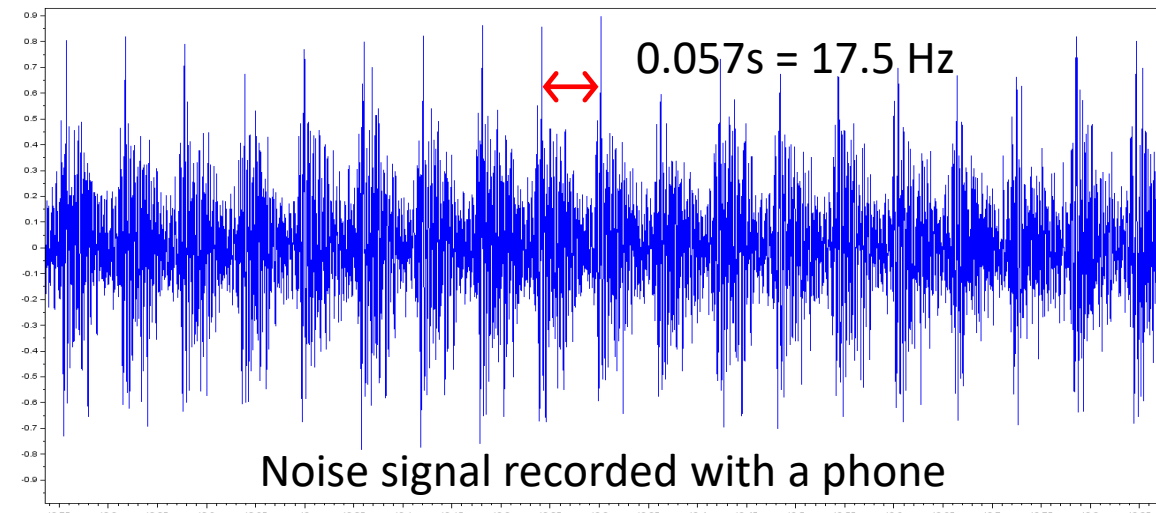
6th Feb: 6 min run with accelerometers on GB bearings (~17Hz peak observed on LS side)

Torsional critical speed suspected (even if predicted at 15.75 Hz)

4th March: ADRE arrived to site and runs were recorded 4th, 5th and 7th March from Min to max speed.
