Vibration issue on Compressor in a Nitric Acid Plant (Part 2)

ASIA TURBOMACHINERY & PUMP SYMPOSIUM

SYMPOSIA: 24 – 26 MAY 2022
SHORT COURSES: 23 MAY 2022

Problem Statement

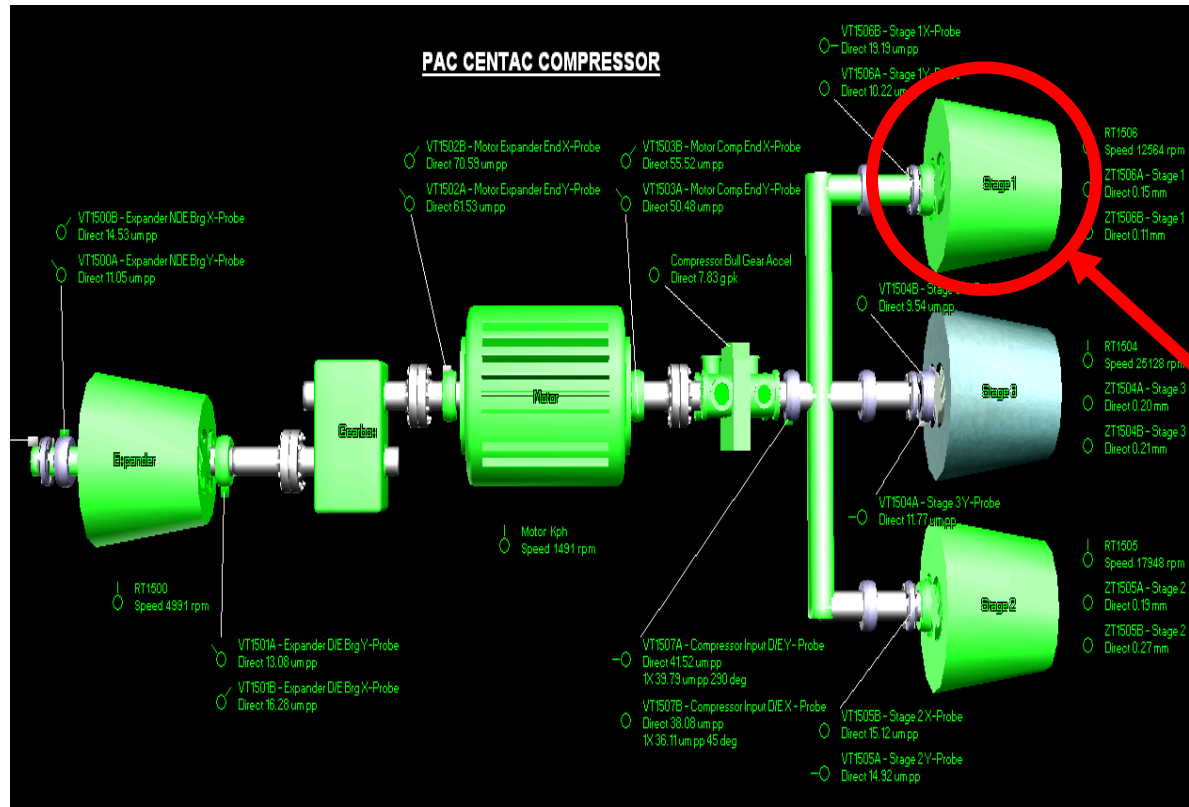
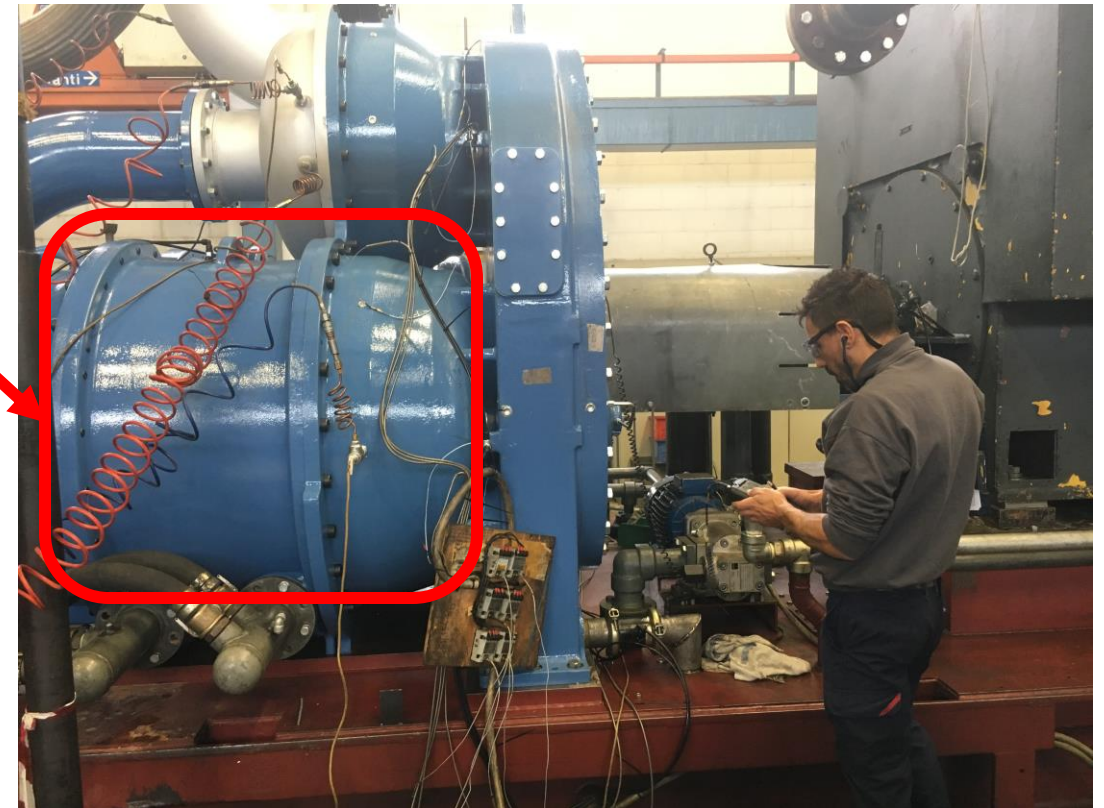
NAP2 PAC at OEM Facility/S1 View

- The NAP2 PAC drive train was completely overhauled during a once-every-five-years turn-around period inclusive of the installation of a completely new air end compressor.

- Shortly after the turn-around re-start and due to a process related issue, the compressor was shutdown which resulted in a significant 1st stage surge event.

- During the subsequent (within 3 hours) re-start the compressor tripped off-line (within 2 minutes of reaching steady state operation) due to high compressor 1st stage direct & 1x synchronous vibration associated with a rub condition.

- During the next twelve-month operating period, the NAP2 PAC experienced numerous additional 1st stage rubs during steady state operation, as well as occasional 1st stage stall and/or surge events during shutdowns.

- Additionally, a prominent 1st stage -3x reverse vibration component manifested post the turn-around with increasing amplitudes up until the OEM attended site to perform a repair in (February 2020).
