**Corrosion Under Insulation In-Situ Testing in Marine Environment**

**Doctor of Philosophy**

**May 2023**

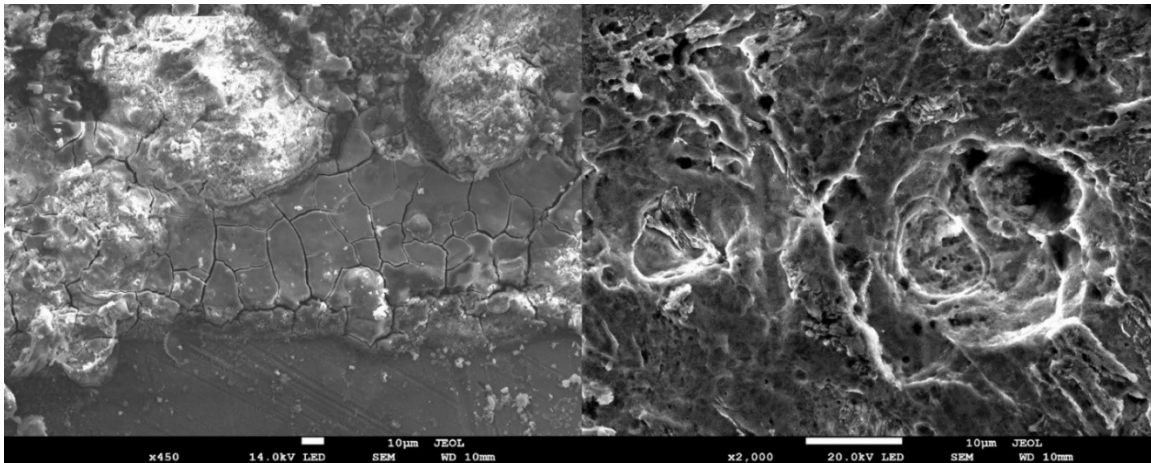
Figure 5.47: Experiment 8, heated seawater, uncleaned electrolyte interface zone, left, cleaned, right.

The surfaces for seawater seem rougher, and the cleaned surfaces seem to have more pits than NaCl in previous section. Cracking on surface also very apparent as seen in experiment 8 interface with electrolyte.

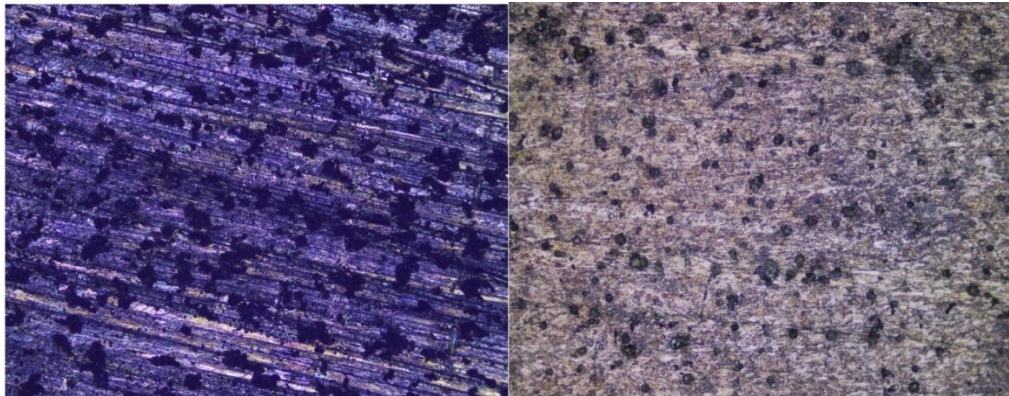
NaCl exposed electrodes are presented here. Black surface oxide was present (Figure 5.49), and reddish-brown (Figure 5.50) though it was not as coloured as seawater. After cleaning pitting was seen clearly.

Figure 5.49: Experiment 5, NaCl, room temperature, left uncleaned, right, cleaned

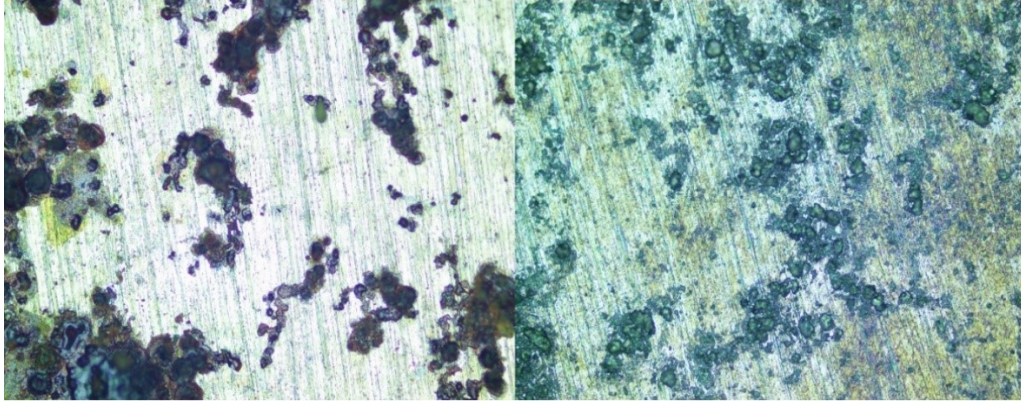
Figure 5.50: Experiment 5, 3.5% Room Temperature NaCl, left uncleaned, right, cleaned.

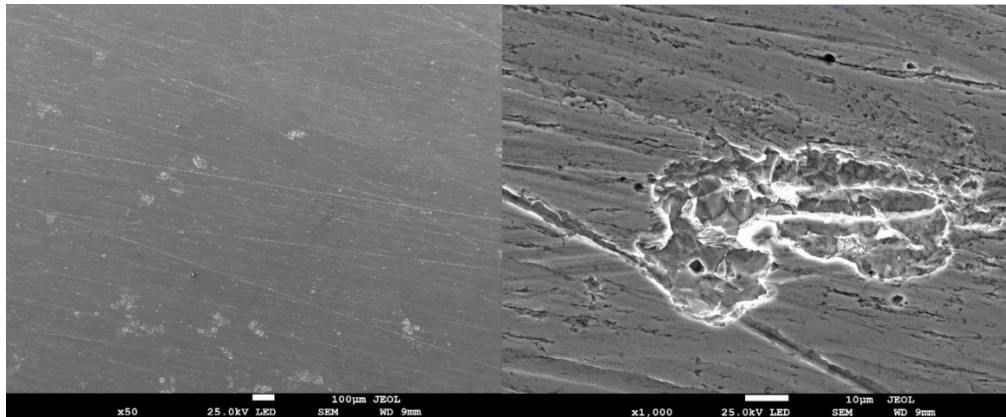
Room temperature Experiment 5 (shown in Figure 5.14, Figure 5.15, Figure 5.16, and Figure 5.17) has peak energy in D3/D4 and D7/D8 in Figure 5.14. D7-D12 show multiple times in wavelet plotted as original time below. Localized corrosion with pitted surface images confirmed in Figure 5.52 and Figure 5.51.

Figure 5.51: Experiment 5 NaCl, cleaned.

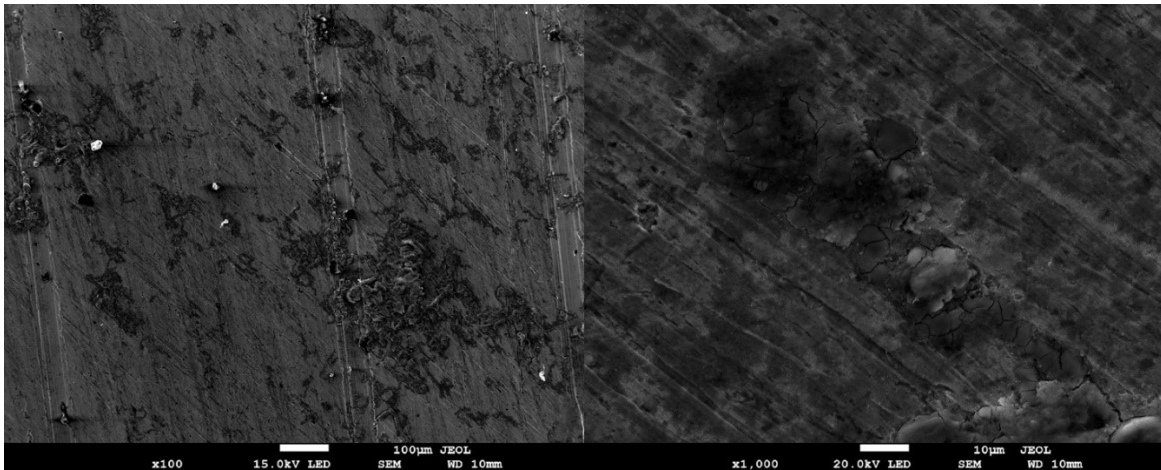
In higher temperatures of 40°C on zoom there is more attack on the surface microstructure in Figure 5.52. Figure 5.53 shows the cleaned surface of experiment 18, heated NaCl, showing more pitting than when unheated in Experiment 5.

Figure 5.52: Experiment 18 heated NaCl, uncleaned.

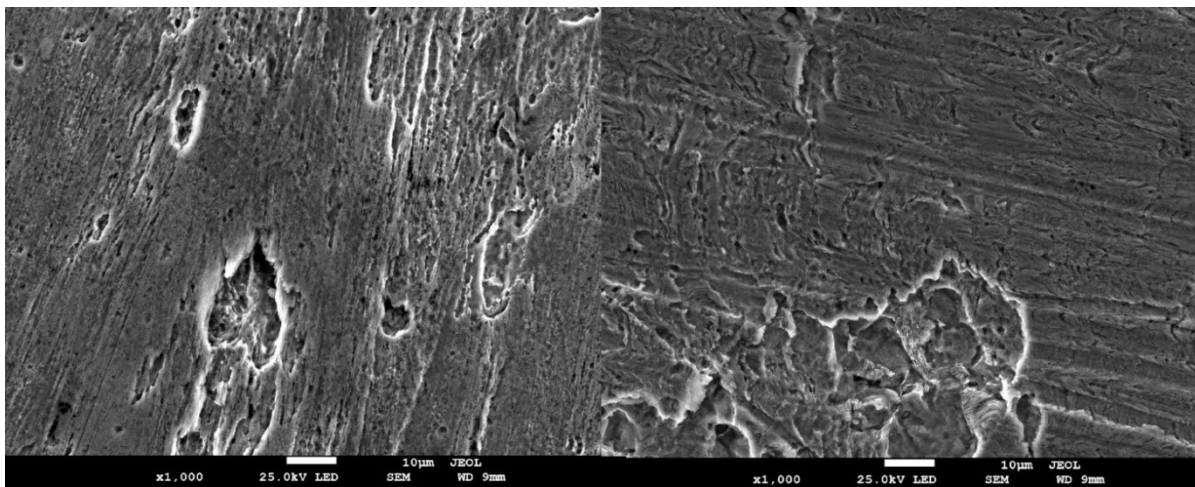
Figure 5.53: Experiment 18, heated NaCl, cleaned.
