Young Cities Research Paper Series, Volume 06

Construction Competencies and Building Quality Case Study Results

Bernd Mahrin, Johannes Meyser (Eds.)

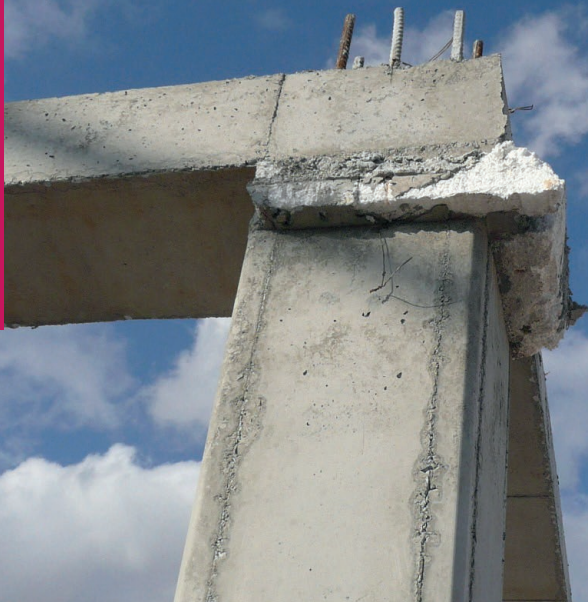
**Exposed access bars of the supporting reinforcement (very common in Iran, building will be continued as needed)
Steel is left exposed to the elements**

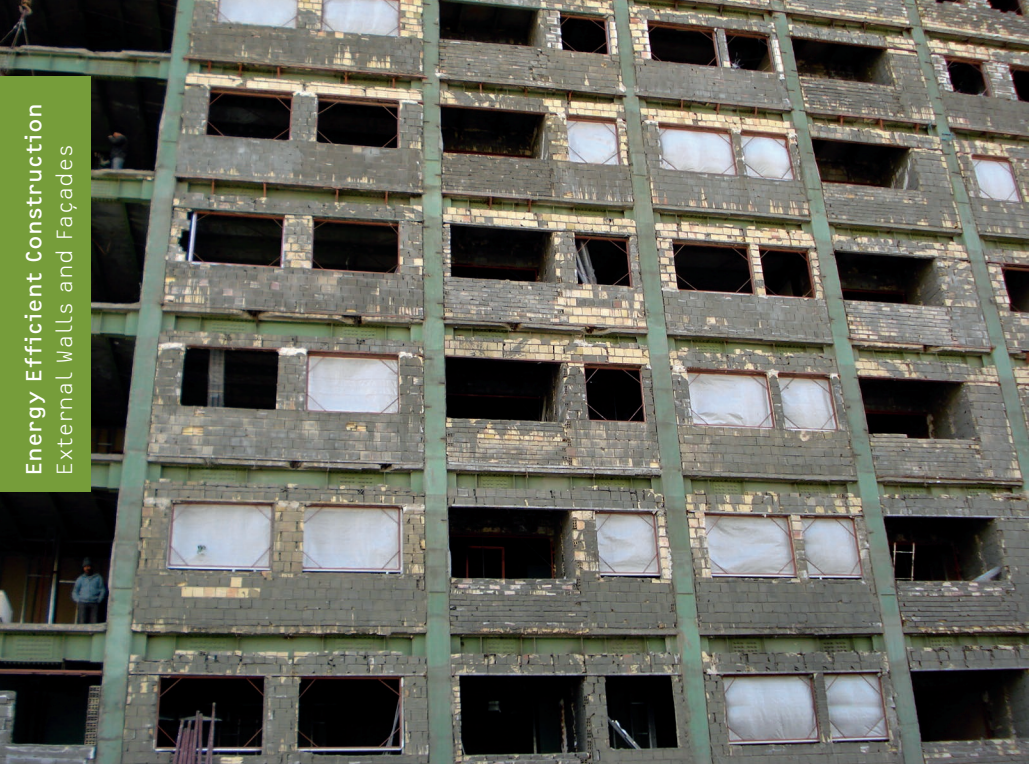
Poor brickwork in terms of quality, heat insulation and construction physics, irregular brickwork bond, grooves are partly too large (straight- and course joints)

Thermal bridges due to steel frames used as lintels

- consistent joint structure and bond in the brickwork
- ensure mortar creates a friction-locked connection between bricks
- leveling out dimensional variations of the bricks

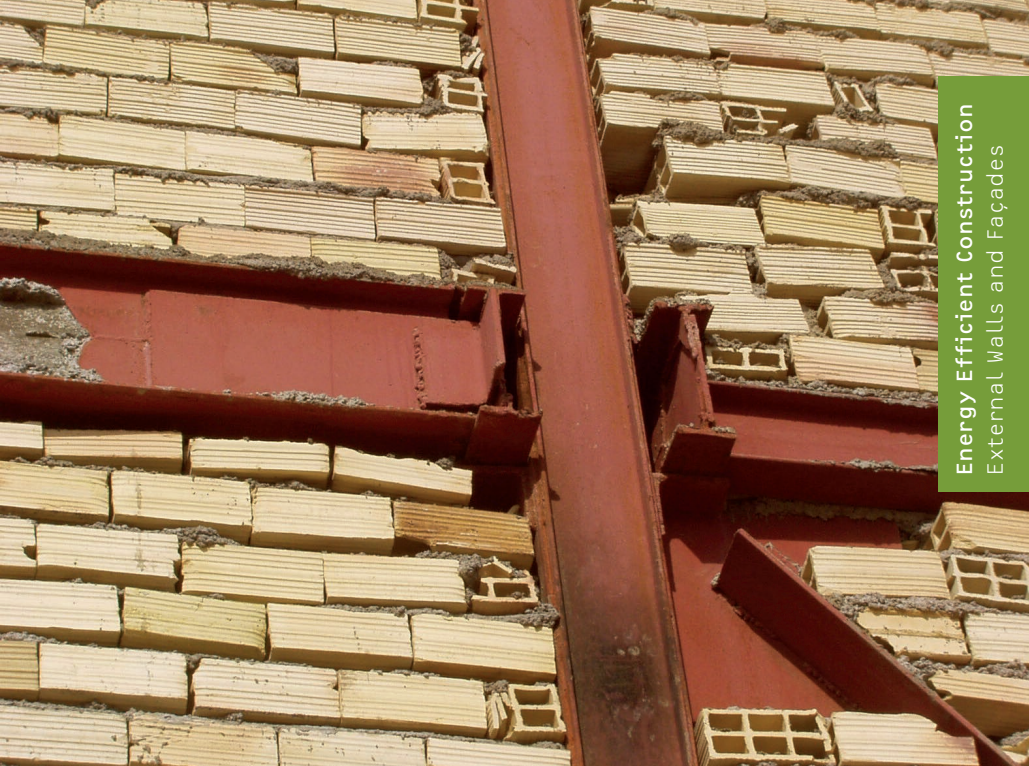
Poor quality brickwork

Alignment of the outer wall edge is not uniform

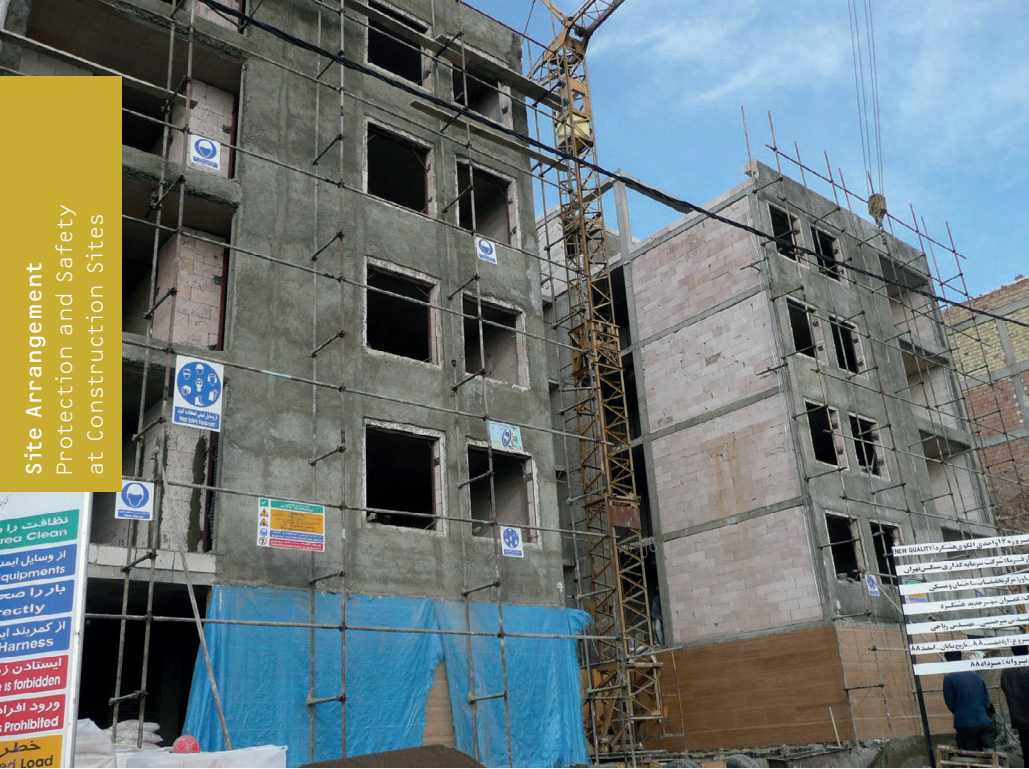
Site Arrangement
Protection and Safety
at Construction Sites

Missing barriers, protective structures, or other safety measures for passersby

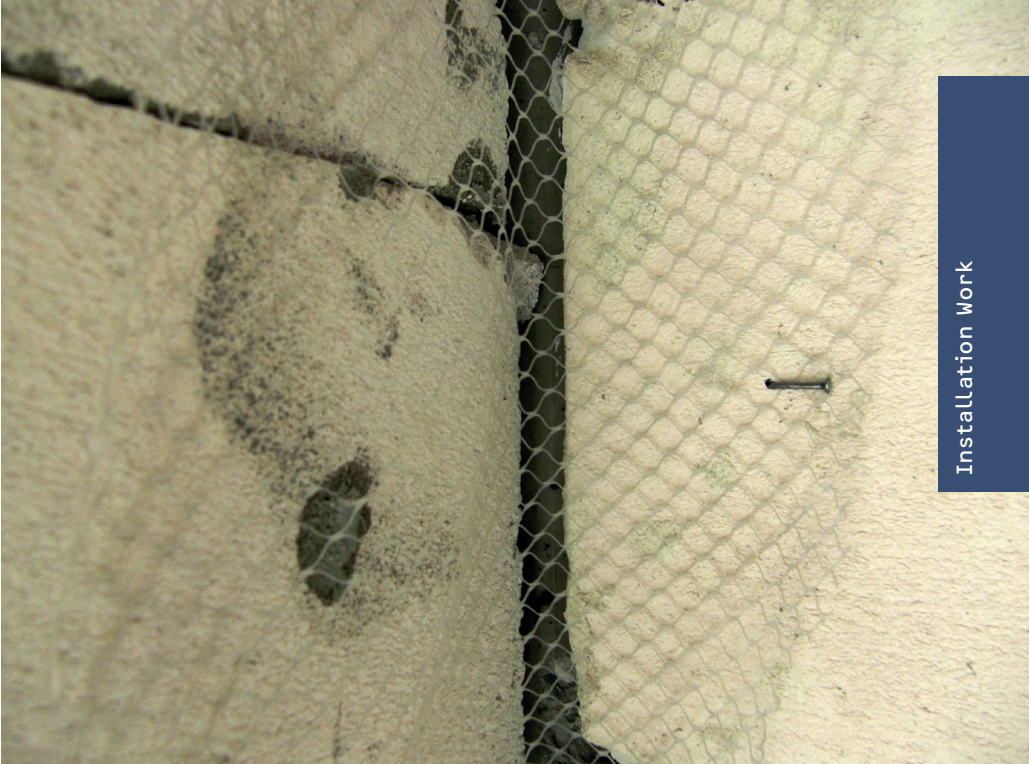
Connection of masonry to concrete column

Installed reinforcement fabric for bridging the cracks located in the plaster because the masonry and reinforced concrete have different thermal expansion coefficients

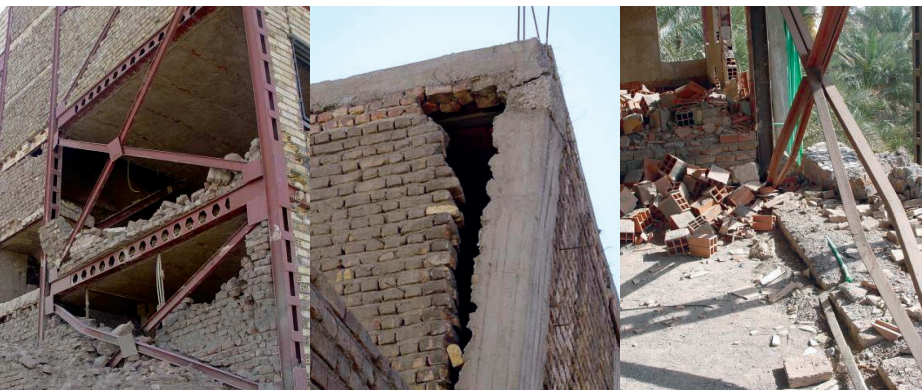
Outdoor Walls

Outdoor walls did not comply with building codes and regulations regarding thickness to height ratios, and they were built with neither bracing, to bear side forces, nor reinforcement (Code 2800).

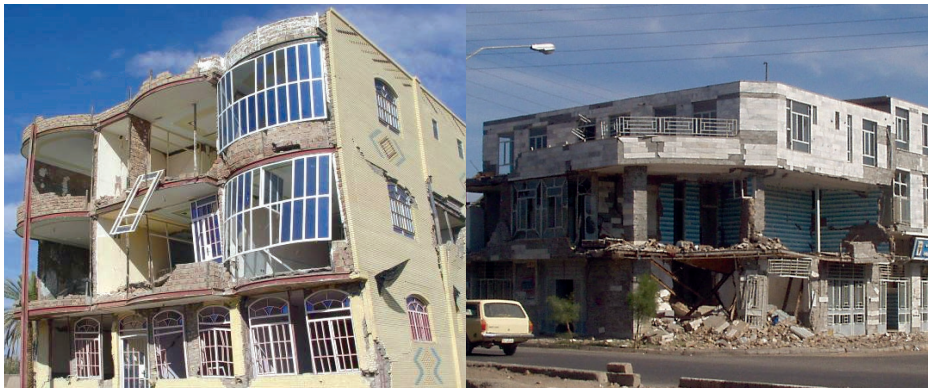
Façade Walls

Detachment from load-bearing walls caused the majority of brick façades to be destroyed. Different levels of harm were evident, from partial damage to complete demolition of the brick façade.

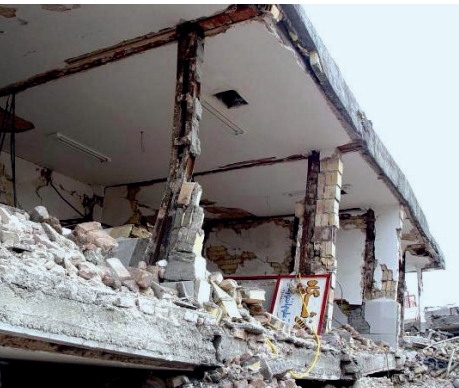
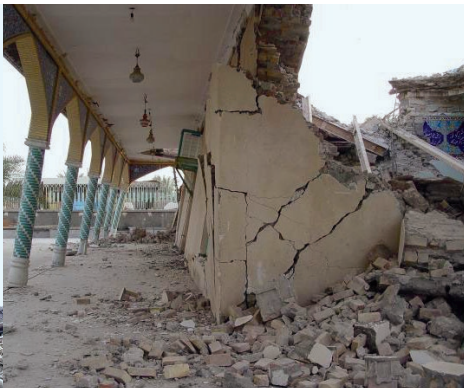
There were many buildings with boveda ceilings and no compliance with Seismic Building Codes in Bam; buildings with no cross bracing in

the ceiling, no convenient support for beams and end spans and no tie beams underneath the ceiling. Thus, the damage seen in these ceilings was actually entirely predictable.

Boveda arches with no or weak footing and no bracing in end spans did not bear horizontal forces and collapsed in the quake.
