# LONGYEARBYEN, SVALBARD - VULNERABILITY AND RISK MANAGEMENT OF AN ARCTIC SETTLEMENT UNDER CHANGING CLIMATE - A CHALLENGE TO AUTHORITIES AND EXPERTS

Erik Hestnes\*, Steinar Bakkehøi and Christian Jaedicke

Norwegian Geotechnical Institute (NGI), Oslo, Norway

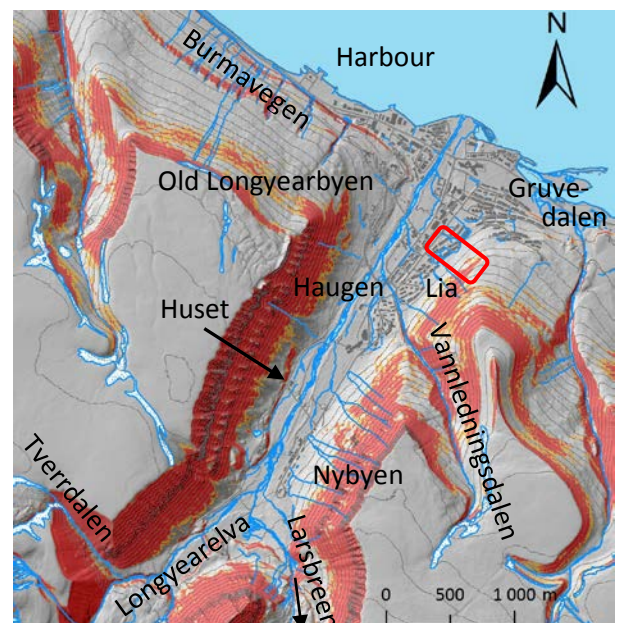
Fig.1: Longyearbyen. The town is located below steep mountainsides. Names in the paper is shown.

The location of the old settlement shifted with the opening and closing of adits in the mountainsides. The main part of the settlement moved to the east side of the river after the Second World War and a marked expansion in more hazard-prone areas started. The town has grown even faster after 1989, now constraining the floodplain and growing along the foot of the NE-facing mountainsides as well, i.e. in the harbour area and in Gruvedalen (Fig.1).

Debris from a far bigger slushflow surging across the floodplain smashed a window in a bakery on the opposite riverbank. Smaller slushflows have reached the location of the new harbour-area, and those from Tverrdalen interfere with the access to Longyearbreen, while potential slushflows from Larsbreen may reach Nybyen (Fig. 1).
