AN ANALYSIS OF CATALOGED DECEMBER 2020 LANDSLIDES NEAR HAINES, ALASKA

Geological Engineering

University of Alaska Fairbanks

May 2023

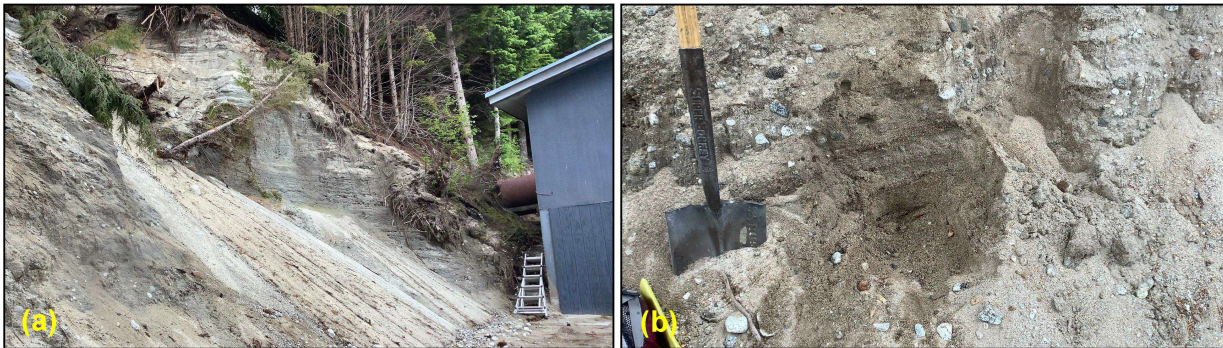
Site Description: A sand flow occurred in a ~40° slope composed mostly of sand with gravel (lithology: tonalite) and forested with hemlock, impacting the back corner of the house (fig. 13). During the December 2020 event, this flow broke through the basement wall of the structure. The deposits reflect pulses of flow with fine layers 20-40-cm thick separated by coarse sand ~2-cm thick. Gullies were observed on the slope on either side of the failure area.

>10 cm Gy PG Sa w/ cobbles, alternating coarse and fine layers; cross-bedding present; magnetic content; iron-cemented sand in upper 1 m

Figure 13. Photographs of the GP sand flow (June 2021 after some clearing efforts) showing: (a) alternating coarse and fine layers exposed in the left flank adjacent to the impacted corner of the house; (b) sampling location (shovel for scale).

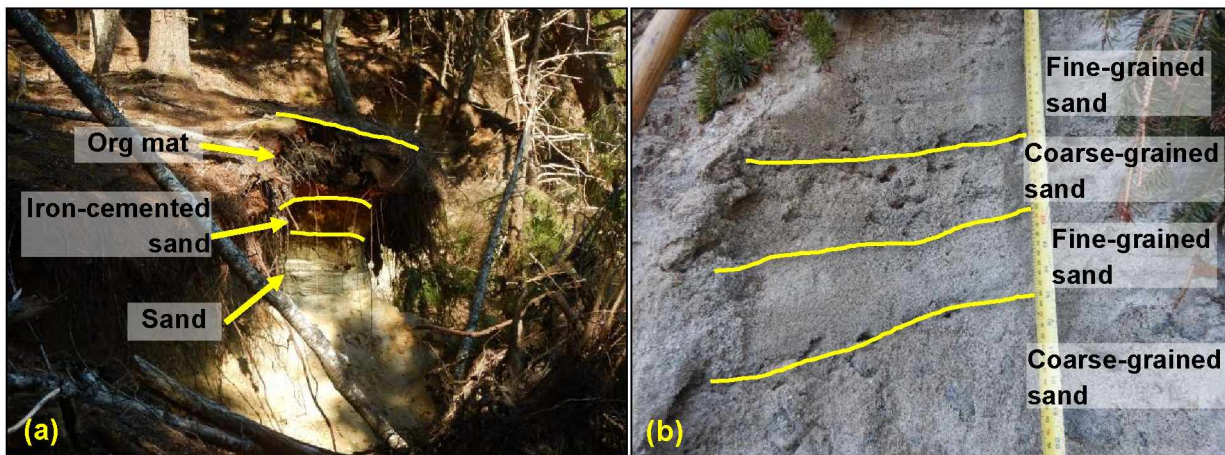
Site Description: Residential structures are at the base of a ~40° slope composed mostly of sand; the above bluff and adjacent slopes are forested with hemlock. The exposed stratigraphy (fig. 22) alternates between fine-grained and coarse-grained sand with gravel clasts (tonalite with 30% amphibole, 40% quartz, 30% plagioclase feldspar). We observed iron-cemented sand in the head scarp, but not in soil pits dug in the bluff above the landslide.

- 0 – 20 cm Org mat with roots
- 20 – 25 cm Gy PG Sa, w/ iron oxidation
- >25 cm Gy PG Sa w/ rounded granitic clasts up to 10 cm, cross-bedding

Figure 22. Photographs of the MP sand flow (June 2021): (a) head scarp area with annotated stratigraphy; (b) annotated view of stratigraphy along right flank.

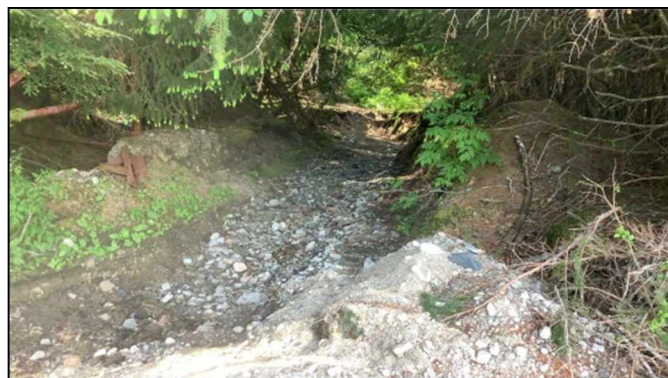
Site Description: Remnant debris from this channel was visible from the road in June 2021 (fig. 24). ADOT&PF (2020) marked this site as having a major impact on Lutak Road, blocking both lanes and requiring permanent repair. The length of highway impacted was between 20 and 100 ft (6 – 30 m). ADOT&PF additionally noted that the channel is now in a different location than before the event.

Figure 24. Photograph of the channel at FEMA DOT#12 taken from Lutak Road, with remnant debris in the foreground (June 2021).

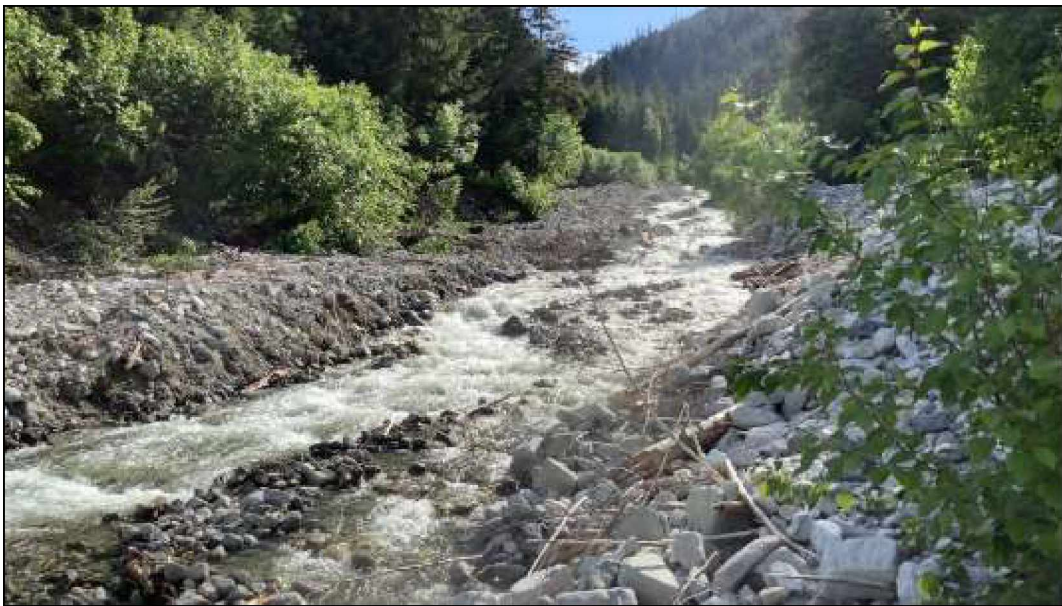
Site Description: This is an established river channel (i.e. Shakuseyi Creek) containing large cobbles (fig. 26). During the December 2020 storm event, debris came up to the top of the culvert on the upstream side, but did not overtop the road. ADOT&PF removed the debris with an excavator (Eckhoff, pers. comm., June 2021).

Additional notes: ADOT&PF routinely removes debris from this area and has built berms to constrain the channel (Eckhoff, pers. comm., June 2021). We observed sediment deposited downstream of the culvert outlet; this is potentially indicative of past debris flows going out of the channel and over the road.

Figure 26. Photograph of FEMA DOT#15 channel upstream from Lutak Road (June 2021).

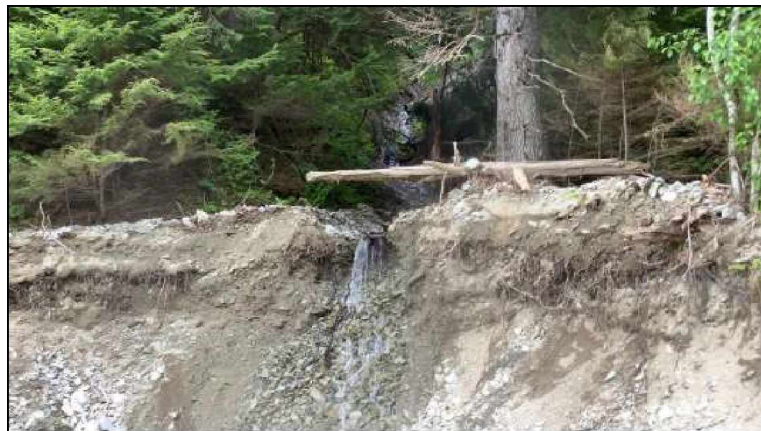
Site Description: At this site, debris coming from a steep channel (fig. 28) blocked both travel lanes and impacted a length of road greater than 100 ft (30 m) (ADOT&PF, 2020). It was flagged as a major source of debris, with several hundred cubic yards/meters requiring removal. An earth berm was constructed to contain potential future deposits.

Figure 28. Photograph of FEMA DOT#18 channel from Lutak Road (June 2021).

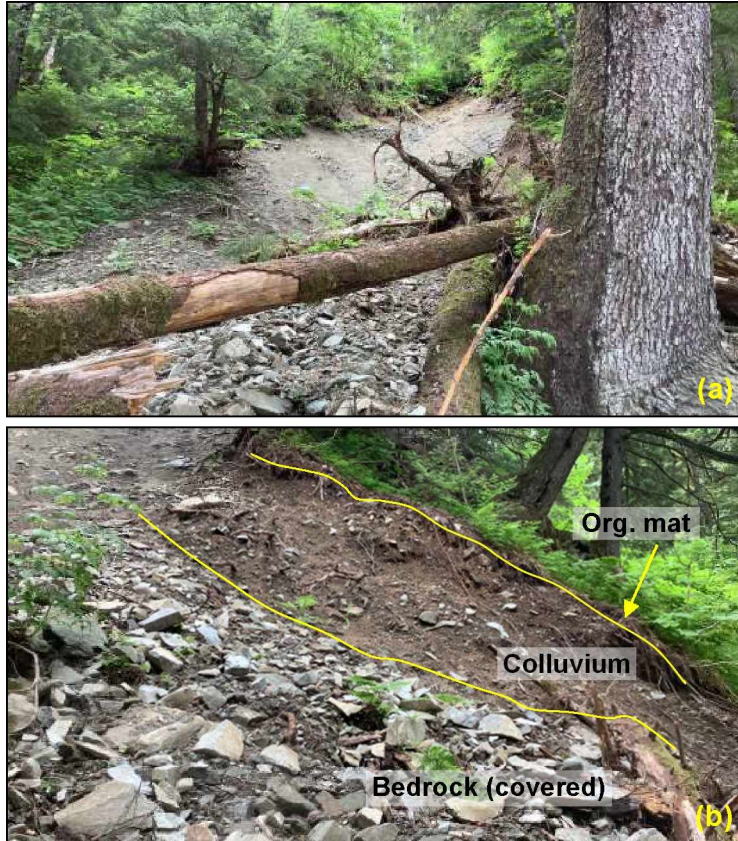
Site Description: This was the site of a landslide occurring in colluvium over diorite bedrock (fig. 30). Several downed trees spanned the slide area. This site was described by ADOT&PF (2020) as a major impact, blocking the full width of the road and depositing several hundred cubic yards/meters of debris.

- 0 – 15 cm Org mat
- 15 – 200 cm Bn Si w/ Sa (colluvium)
- >200 cm Diorite Bx

Figure 30. Photographs of FEMA DOT#19 (June 2021): (a) view of head scarp from road level; (b) left flank showing approximately 2 m of brown colluvial material; the diorite bedrock exposed near the head scarp was mostly covered by debris at this location.

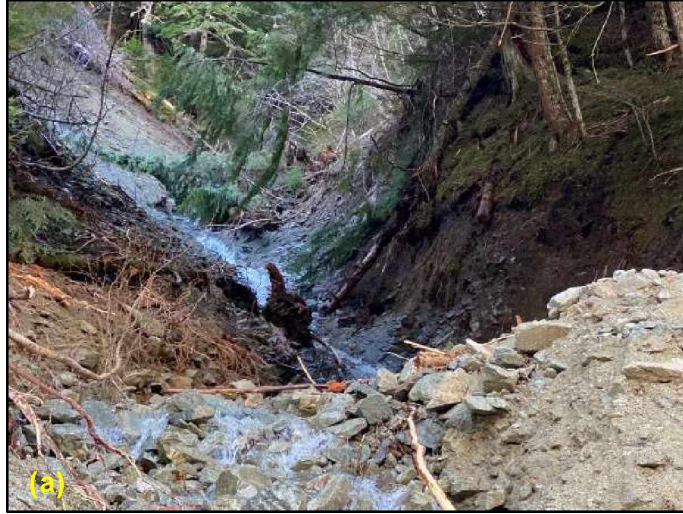
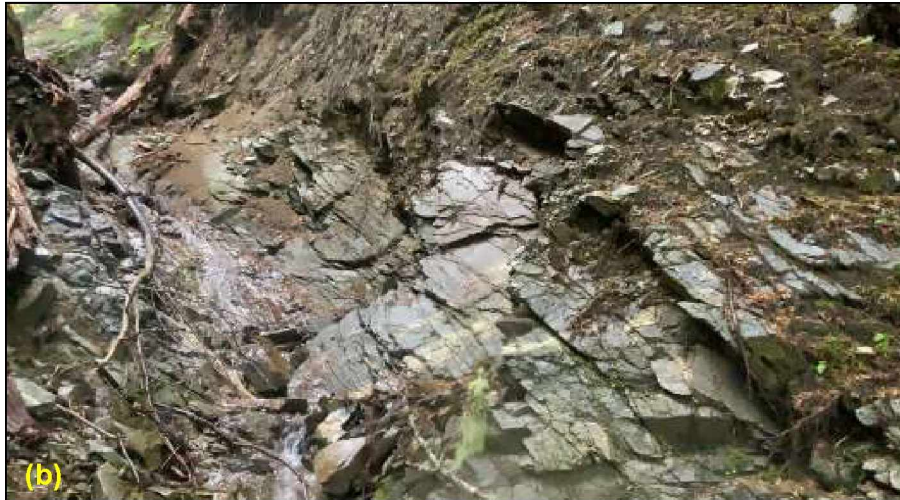
Site Description: At this site, there was a significant buildup of debris that blocked both lanes of Lutak Road for at least 100 ft (30 m). ADOT&PF (2020) estimated that “several hundred cubic yards of material if not thousands” were deposited on the road and within the right-of-way (fig. 32). The channel at this location was scoured to bedrock.

Soil Stratigraphy: Close to the road, diorite bedrock is exposed in the creek channel; to the sides of this exposure, there are 2–3 m of colluvium overlying bedrock. Closer to the head scarp, the colluvium layer is thinner (<1 m), and bedrock is exposed intermittently.

Figure 32. Photographs of the landslide area at FEMA DOT#20: (a) view up the channel in December 2020 (photograph courtesy of ADOT&PF); (b) diorite bedrock exposed in the channel (July 2022).

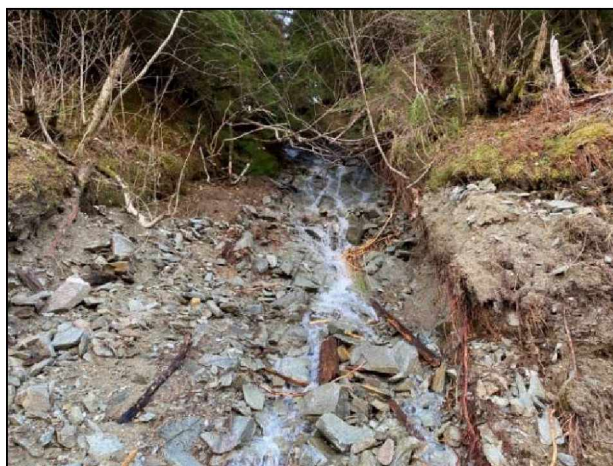
Site Description: The landslide at this site deposited several hundred cubic yards/meters of material onto the roadway (fig. 34), blocking both lanes (ADOT&PF, 2020). The channel was scoured to bedrock.

Figure 34. View up the channel at FEMA DOT#21 from Lutak Road in December 2020 (photograph courtesy of ADOT&PF).

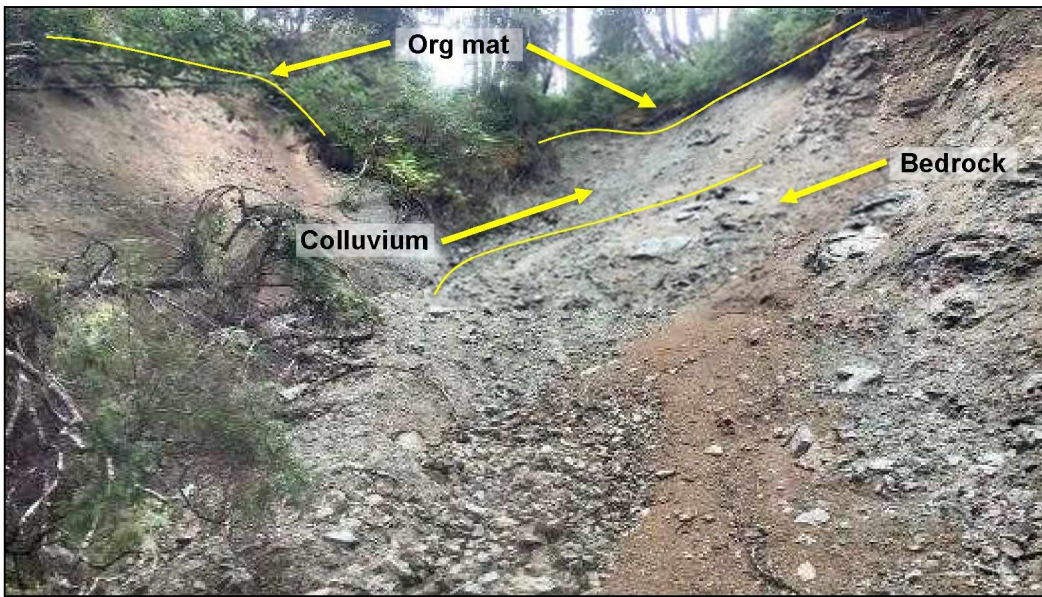
Site Description: This landslide occurred in colluvium and scoured to bedrock (fig. 36), blocking the entire width of the road (ADOT&PF, 2020).

- 0 – 10 cm Org mat
- 10 – 80 cm Gy-Bn Si w/ Sa and cobbles (colluvium)
- > 80 cm Diorite Bx

Figure 36. Annotated view of the head scarp of FEMA DOT#22 (July 2022), illustrating colluvium overlying bedrock (covered by slope wash in places).

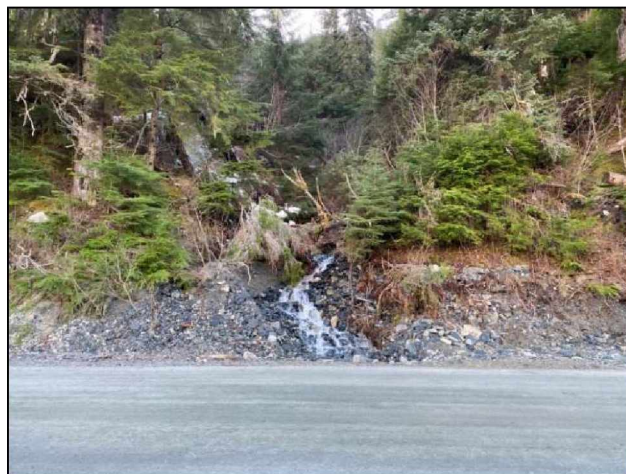
Site Description: ADOT&PF (2020) noted that this debris flow blocked both lanes of Lutak Road for more than 100 ft (30 m), with several hundred cubic yards/meters of material (fig. 38).

Figure 38. The channel of FEMA DOT#23 from Lutak Road in December 2020, after clean-up occurred (photograph courtesy of ADOT&PF).

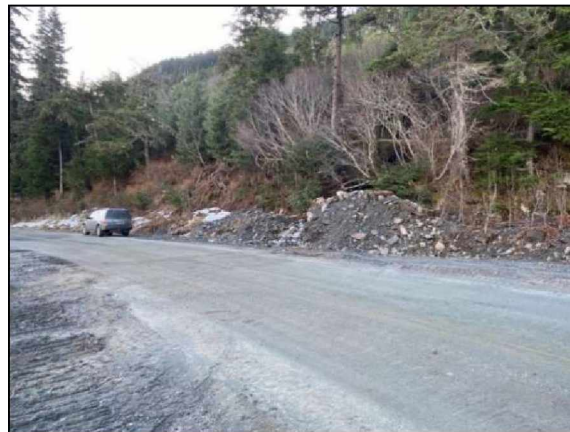
Site Description: ADOT&PF (2020) reported a full blockage of Lutak Road. In the week following the storm events, ADOT&PF conducted further repairs as a result of piping through the embankment (when the culvert was plugged by debris) that caused road settlement. Figure 42 illustrates the site after clean-up.

Figure 42. FEMA DOT#25 area in December 2020, following road clean-up (photograph courtesy of ADOT&PF).

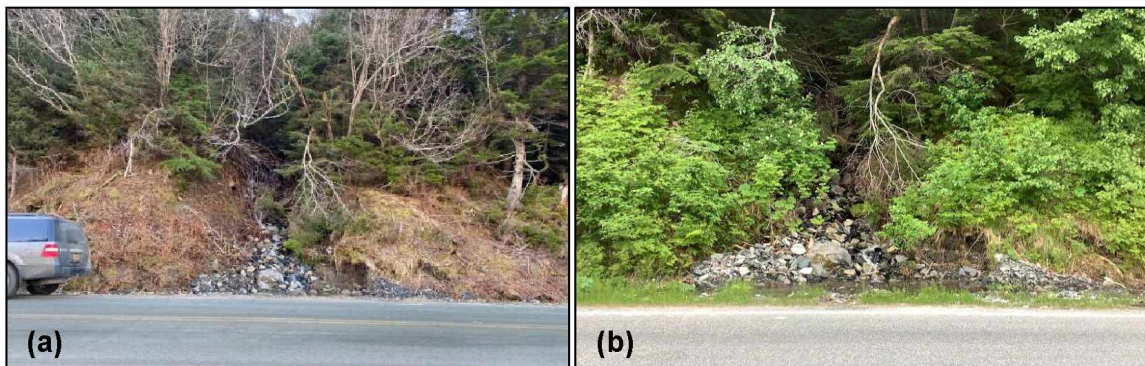
Site Description: ADOT&PF (2020) reported that debris from this site was mostly contained within the ditch (fig. 44).

Figure 44. Photographs of FEMA DOT#26 channel in (a) December 2020 (photograph courtesy of ADOT&PF) and (b) June 2021.

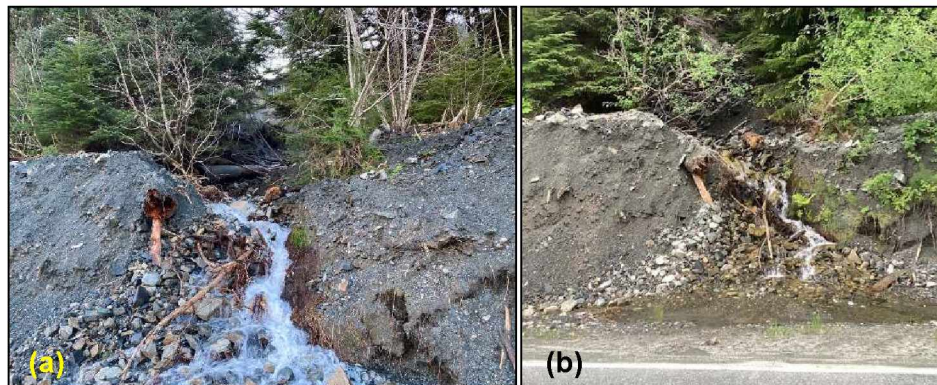
Site Description: ADOT&PF (2020) marked this as a major impact, blocking both lanes of Lutak Road with several hundred cubic yards/meters of material (fig. 52).

Figure 52. Views of the FEMA DOT#29 channel: (a) in December 2020 (photograph courtesy of ADOT&PF) and (b) in June 2021.

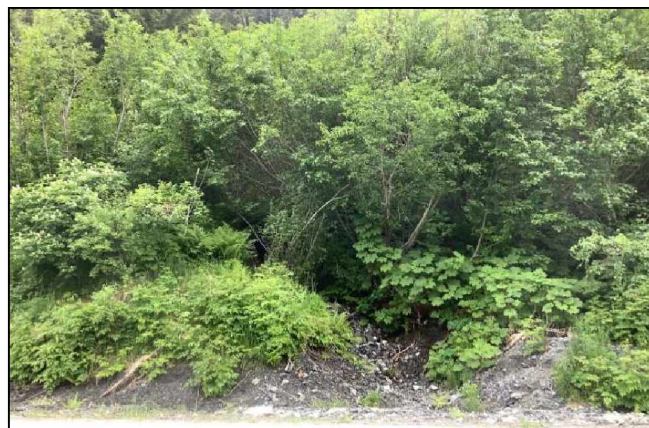
Site Description: ADOT&PF (2020) noted that the source of this debris flow was in the uphill logging area. Several hundred cubic yards/meters of debris had to be removed from both lanes of Lutak Road (fig. 54).

Figure 54. View of the FEMA DOT#30 channel mouth from Lutak Road in June 2021.

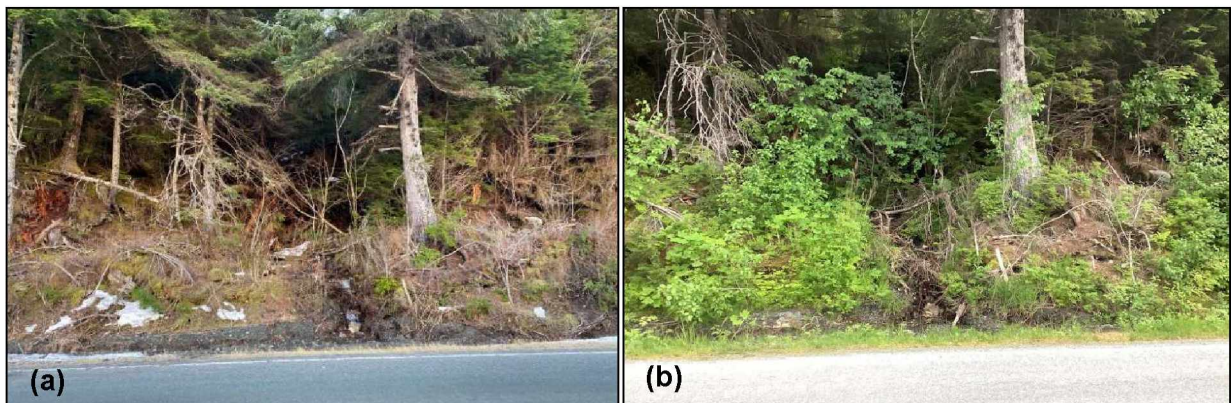
Site Description: ADOT&PF (2020) considered this site to be a minor deposit (less than 50 cubic yards (~30 m³) of material deposited; fig. 56).

Figure 56. The channel at FEMA DOT#31 in (a) December 2020 (photograph courtesy of ADOT&PF) and (b) June 2021.

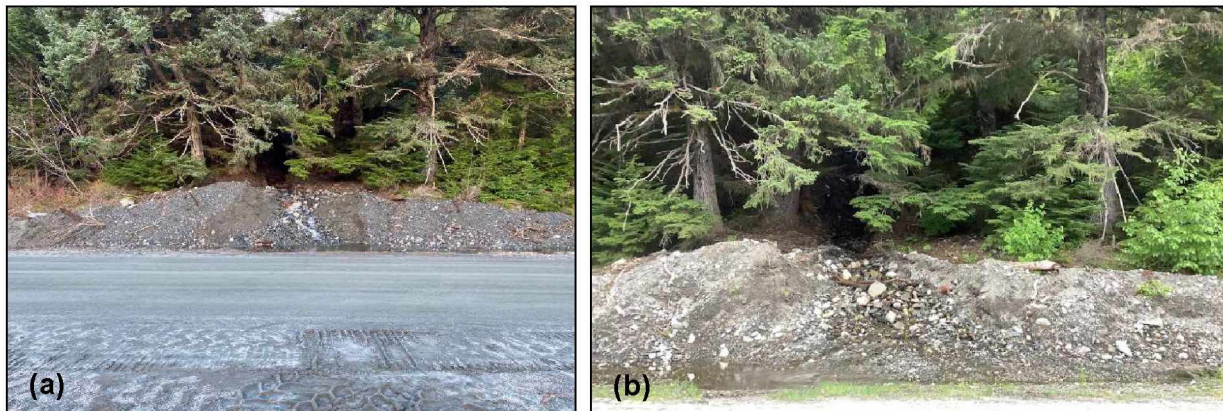
Site Description: From the road, we observed deeply-incised (~1–3 m), near-vertical walls of the drainage channel (fig. 58).

Figure 58. The channel at FEMA DOT#32 in (a) December 2020 (photograph courtesy of ADOT&PF) and (b) June 2021.

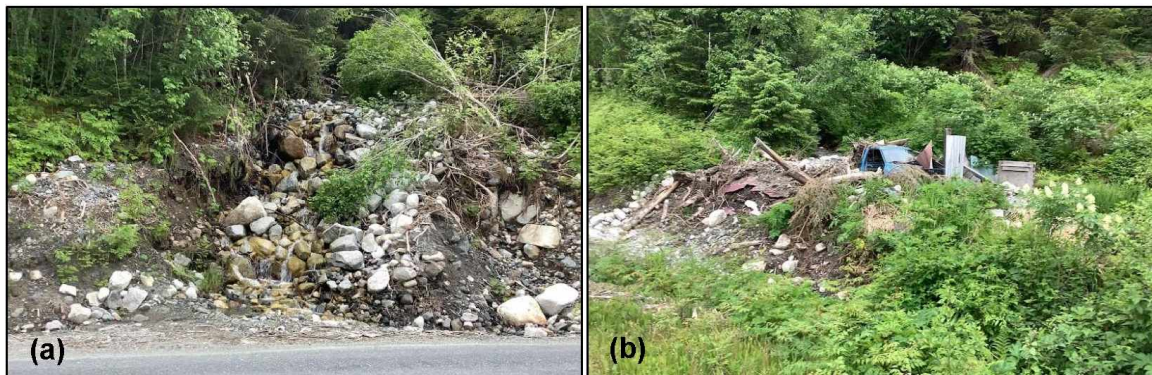
Site Description: This site is associated with a major channel having a significant source area. ADOT&PF (2020) reported between 750 and 1,000 cubic yards (570 – 760 cubic meters) of material removed from the site. Deposits of cobbles and boulders (< 0.6 m) were present along the road in June 2021 (fig. 60), as well as two vehicles buried by the deposits. This debris flow also impacted a cabin.

Figure 60. Photographs of FEMA DOT#33 (June 2021): (a) channel area; (b) a vehicle adjacent to the channel that was buried by debris.

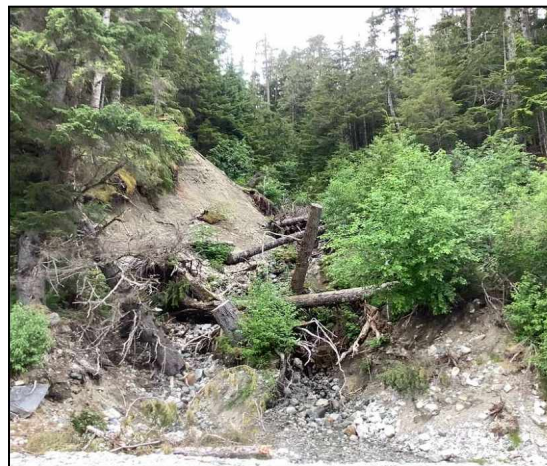
Site Description: ADOT&PF (2020) reported removing between 500 and 750 cubic yards (380 – 570 cubic meters) of material from Lutak Road as a result of this debris flow. Several undercut trees were still in place at the top of the bank edges in June 2021 (fig. 62). We observed sub-horizontal stratigraphy in the right bank of the channel.

Figure 62. View of the FEMA DOT#34 channel from Lutak Road in June 2021.

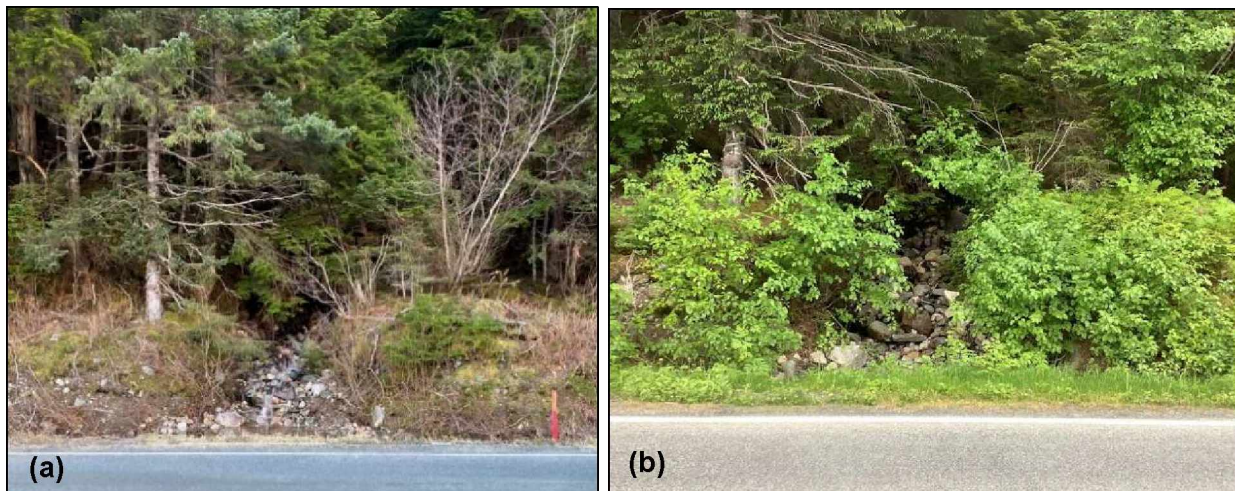
Site Description: Less than 50 cubic yards (38 cubic meters) were deposited by this flow, and the deposit was mostly contained within the uphill ditch (fig. 64; ADOT&PF 2020).

Figure 64. FEMA DOT#35 channel in (a) December 2020 (photograph courtesy of ADOT&PF) and (b) June 2021.

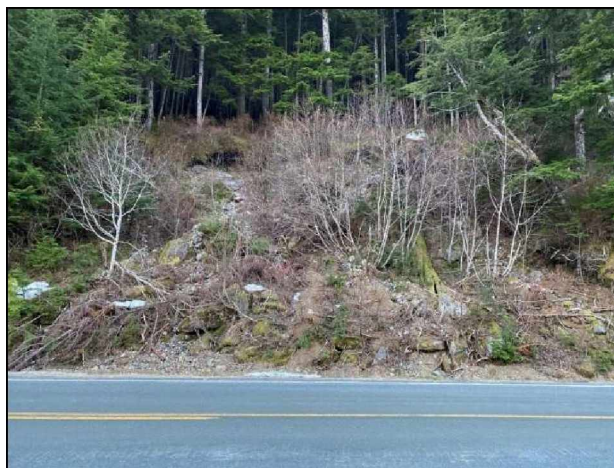
Site Description: ADOT&PF (2020) reported this landslide as minor, depositing less than 100 cubic yards (76 cubic meters), most of which was retained in the ditch (fig. 71).

Figure 71. View of the landslide area at FEMA DOT#38 from Lutak Road in December 2020 (photograph courtesy of ADOT&PF).

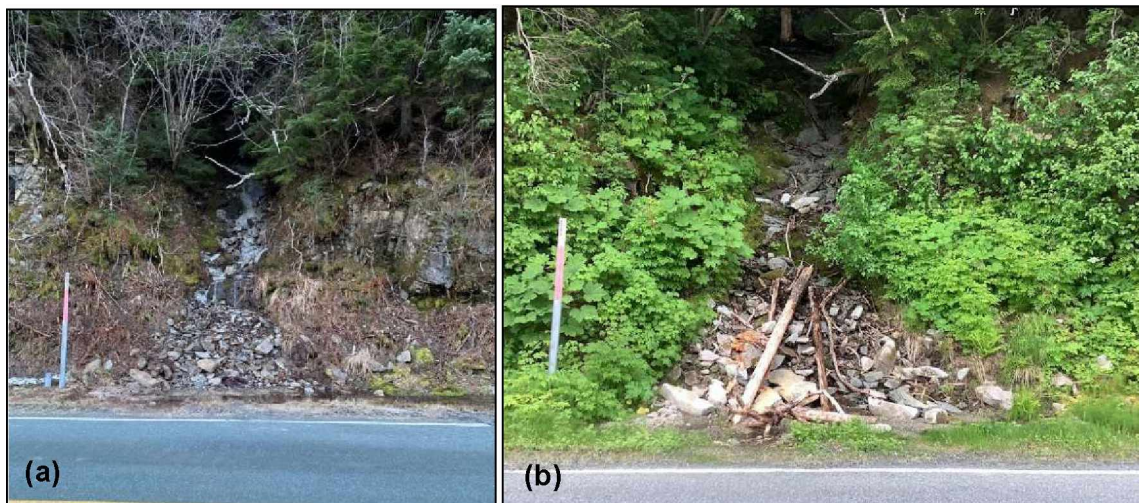
Site Description: ADOT&PF (2020) reported that this was a minor landslide, with less than five cubic yards (four cubic meters) of material requiring removal (fig. 73).

Figure 73. The FEMA DOT#39 channel in: (a) December 2020 (photograph courtesy of ADOT&PF); and (b) June 2021.

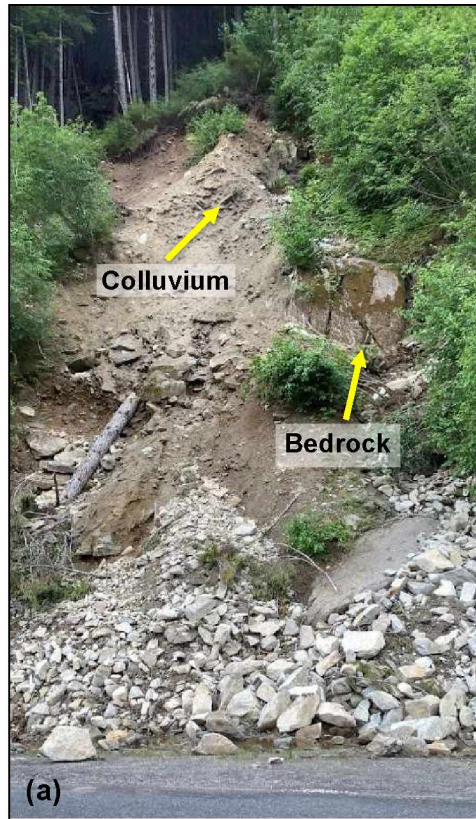
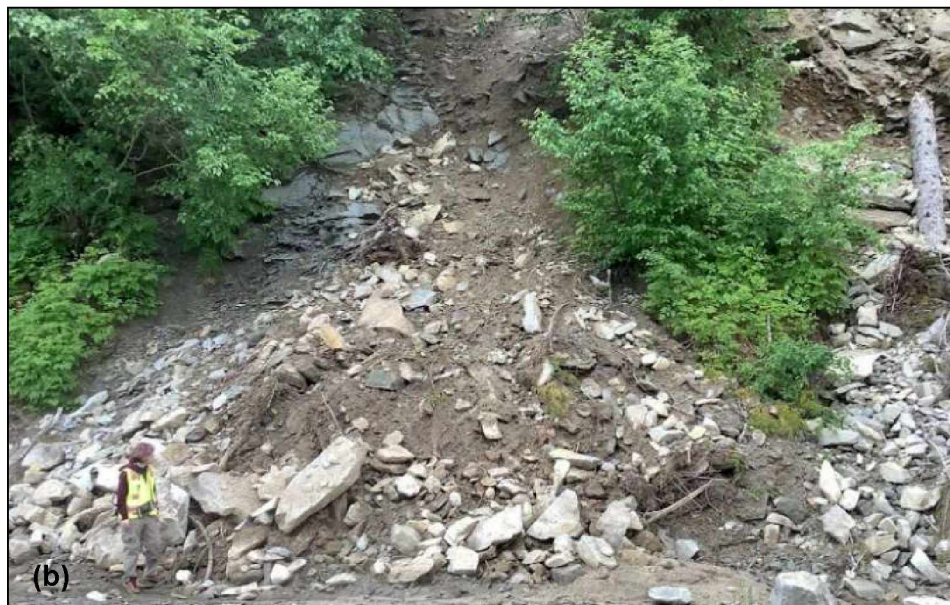
Site Description: ADOT&PF (2020) described this site as a combined slope failure and debris flow (fig. 75); crews removed several hundred cubic yards/meters of material, which blocked both lanes of Lutak Road.

Soil Stratigraphy: We observed ~2-m thick colluvium with cobbles and boulders overlying exposed bedrock along the left flank (fig. 75).

Figure 75. Views of the landslide at FEMA DOT#40 (June 2021): (a) annotated view of the left flank with exposed bedrock location; (b) right flank as visible from Lutak Road.

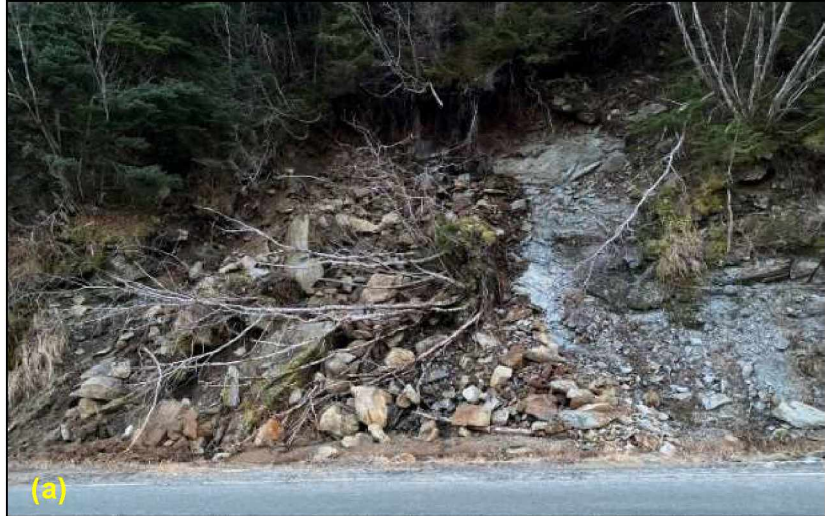
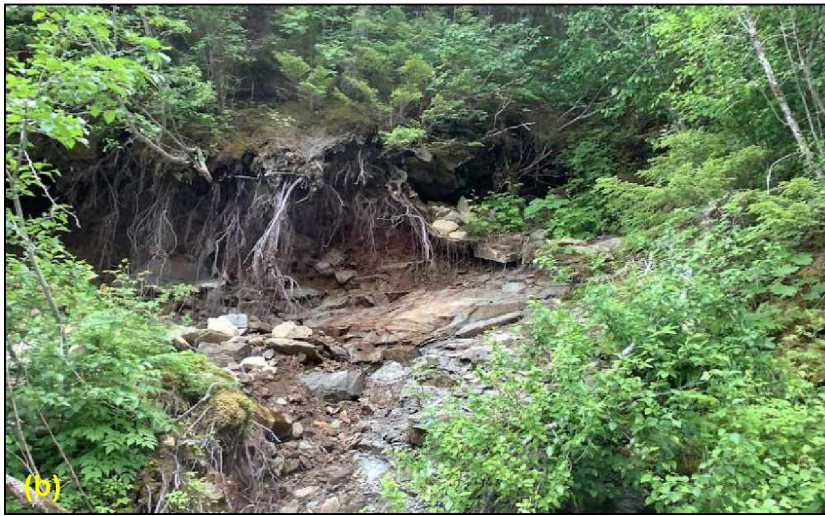
Site Description: ADOT&PF (2020) indicated approximately 50 cubic yards (38 cubic meters) of rock fall at this location, which was mostly contained within the uphill ditch. We observed that soil along the head scarp and flanks was being held in place by tree roots (fig. 77). ADOT&PF (2020) noted there was a “hazard tree” 50 ft (15 m) uphill from the road that was undercut by the failure.

Figure 77. Views of the affected area at FEMA DOT#41: (a) slope in December 2020 (photograph courtesy of ADOT&PF); (b) head scarp area (June 2021).

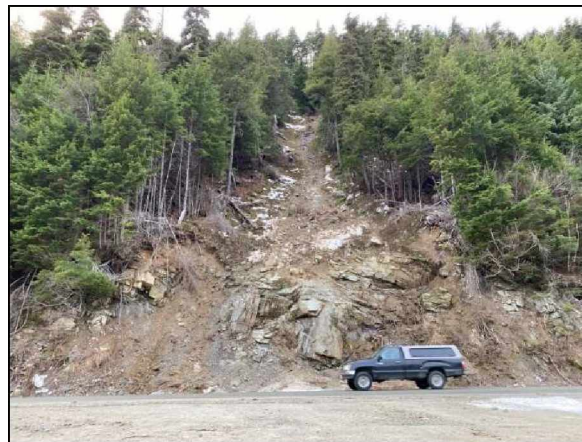
Site Description: ADOT&PF (2020) noted that the slope failure occurred above the rock face. We suspect this landslide originated in an existing drainage upslope (fig. 82). Bedrock in the area is diorite.

Figure 82. View of the landslide area at FEMA DOT#43 from Lutak Road in December 2020 (courtesy ADOT&PF).

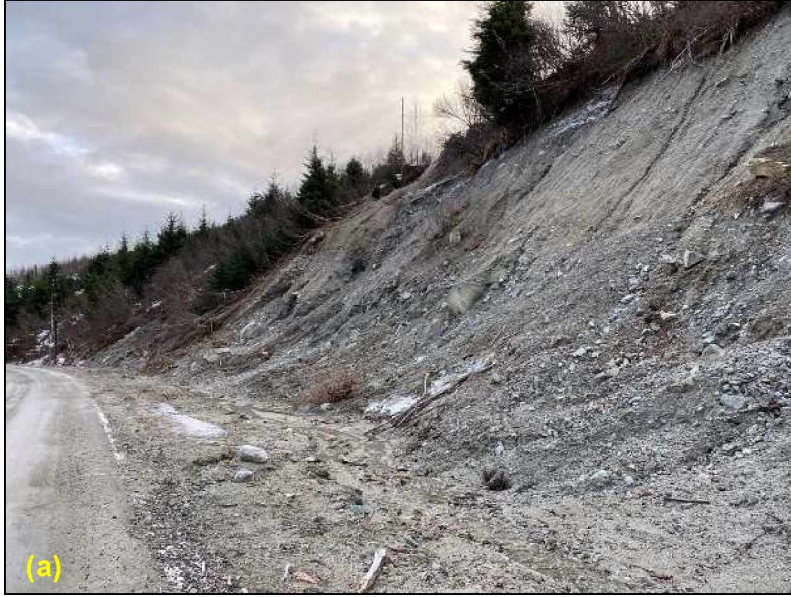
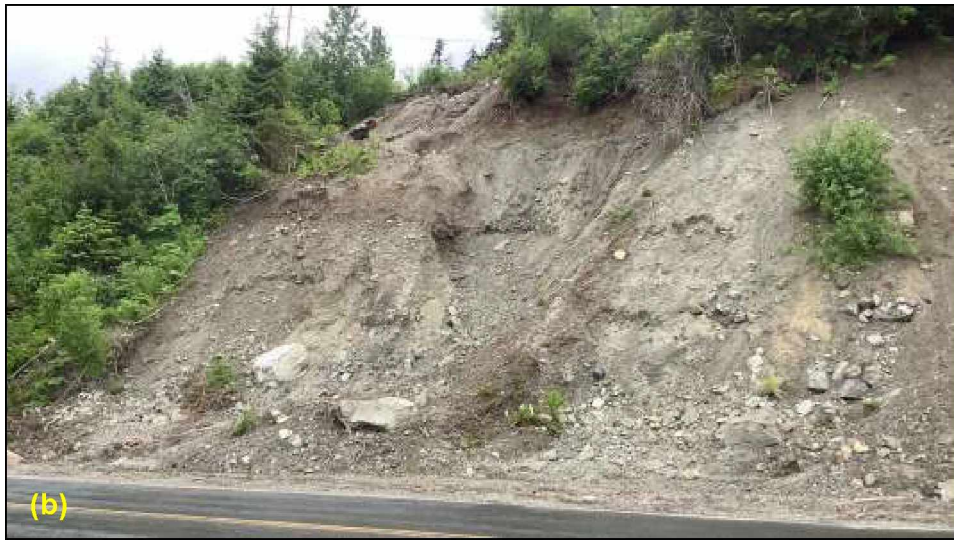
Site Description: ADOT&PF (2020) noted that the affected area for this location was significant, and that material was still raveling from the surface after three days of no precipitation following the storm event. Several hundred cubic yards of material were deposited in the ditch and road (ADOT&PF, 2020). The landslide occurred in coarse-grained soil (fig. 90).

Figure 90. Views of the FEMA DOT#47 slide area in: (a) December 2020, following clean-up efforts (photograph courtesy of ADOT&PF); and (b) June 2021.

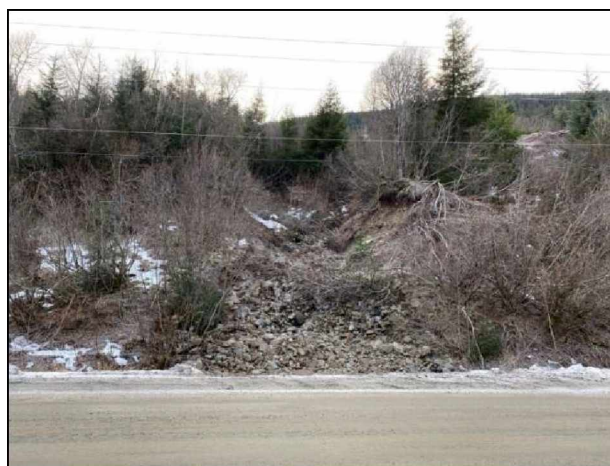
Site Description: At this site, we observed a channel containing granitic cobbles and boulders with minimal fine-grained soil (fig. 92). ADOT&PF (2020) noted that the area had a large debris source, as personnel removed several hundred cubic yards/meters of material.

Figure 92. View of the FEMA DOT#48 channel from Lutak Road (facing south) in December 2020 (photograph courtesy of ADOT&PF).

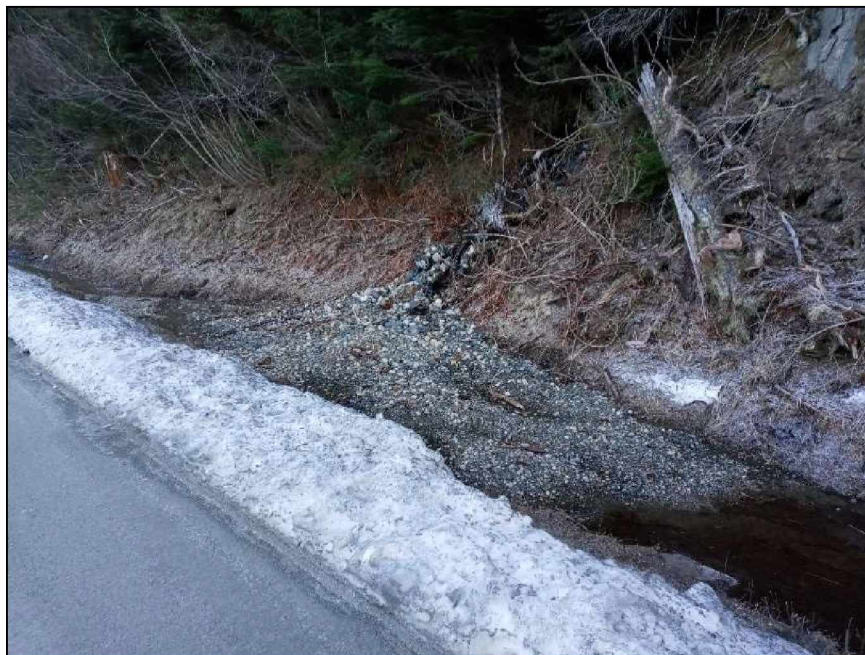
Site Description: A minor debris flow produced a small deposit (about 5 cubic yards/~ 4 cubic meters of material) that was contained within the ditch (fig. 98; ADOT&PF, 2020). The remnants that we observed in the ditch consisted of angular cobbles of diorite and metabasalt.

Figure 98. Debris contained within the ditch at FEMA DOT#67 in December 2020 (photograph courtesy of ADOT&PF).

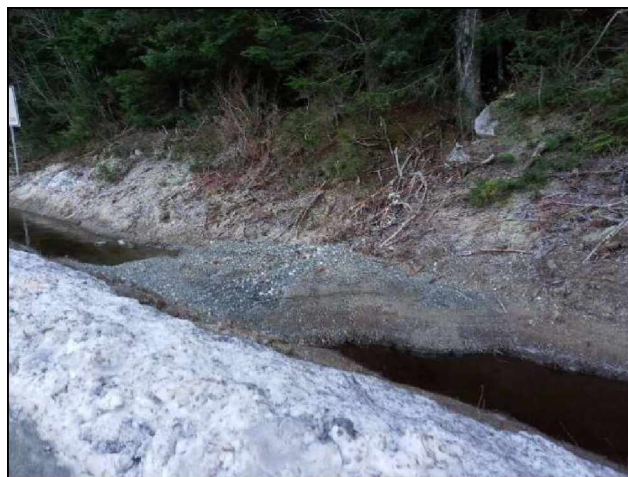
Site Description: ADOT&PF (2020) reported this was a small debris flow area, with approximately 5 cubic yards/~4 cubic meters of material contained within the ditch (fig. 100). We observed both rounded gravel (diorite) and angular metabasalt, as well as woody debris. No water was observed in the channel.

Figure 100. Debris contained within the ditch at FEMA DOT#68 in December 2020 (photograph courtesy of ADOT&PF).

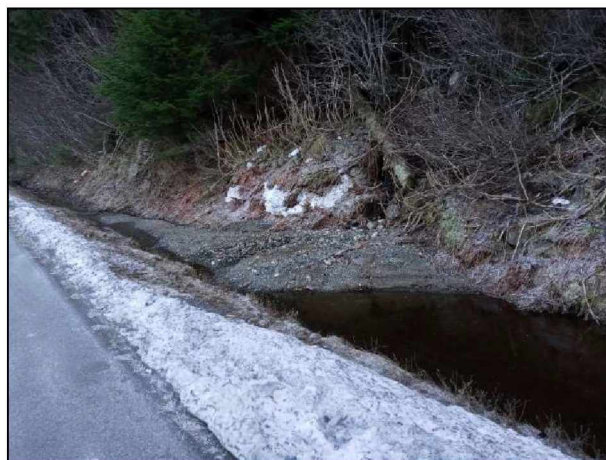
Site Description: ADOT&PF (2020) reported this was a small debris flow area, with approximately 5 cubic yards/~4 cubic meters of material contained within the ditch (fig. 102). This channel appeared to be well-developed with flowing water, and contained boulders and cobbles of diorite.

Figure 102. Debris contained within the ditch at FEMA DOT#69 in December 2020 (photograph courtesy of ADOT&PF).

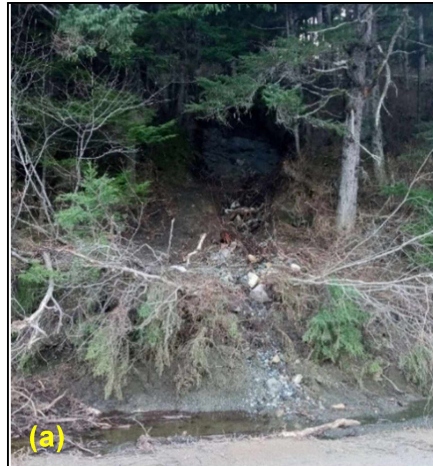
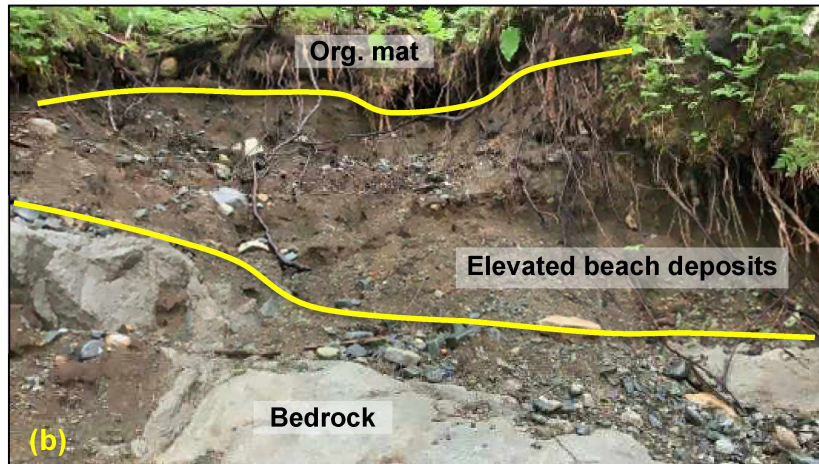
Site Description: ADOT&PF (2020) reported the head scarp for this landslide was approximately 100 ft/~ 30 m uphill from the edge of pavement; we observed the soil stratigraphy at that location (fig. 104). Reports indicate the impact from this landslide was localized (0–20 ft/~6 m of the roadway was impacted), requiring minimal clearing (ADOT&PF, 2020).

0 – 20 cm Org mat
 20 cm – 3 m Bn Si Sa w/ Gr to Sa Gr; stratified with rounded clasts (elevated beach deposit)
 >3 m Bx (diorite)

Figure 104. Photographs from the FEMA DOT#55 area: (a) view of the landslide area from Lutak Road in December 2020 (photograph courtesy of ADOT&PF); and (b) annotated image of stratigraphy at the head scarp (June 2021).

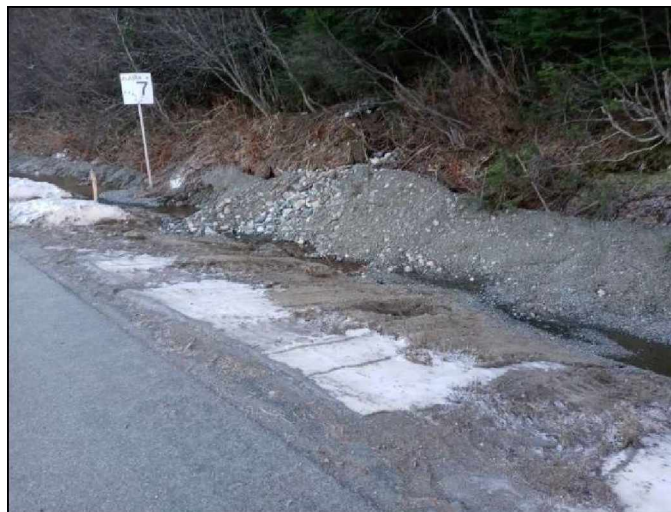
Site Description: ADOT&PF (2020) reported this was a small debris flow area, with about 5 cubic yards/~ 4 cubic meters of material contained within the ditch (fig. 106). We observed a small, pre-existing channel containing rounded cobbles and boulders and minimal flowing water.

Figure 106. View of deposited material remaining in the ditch at FEMA DOT#70 after road clearing in December 2020 (photograph courtesy of ADOT&PF).

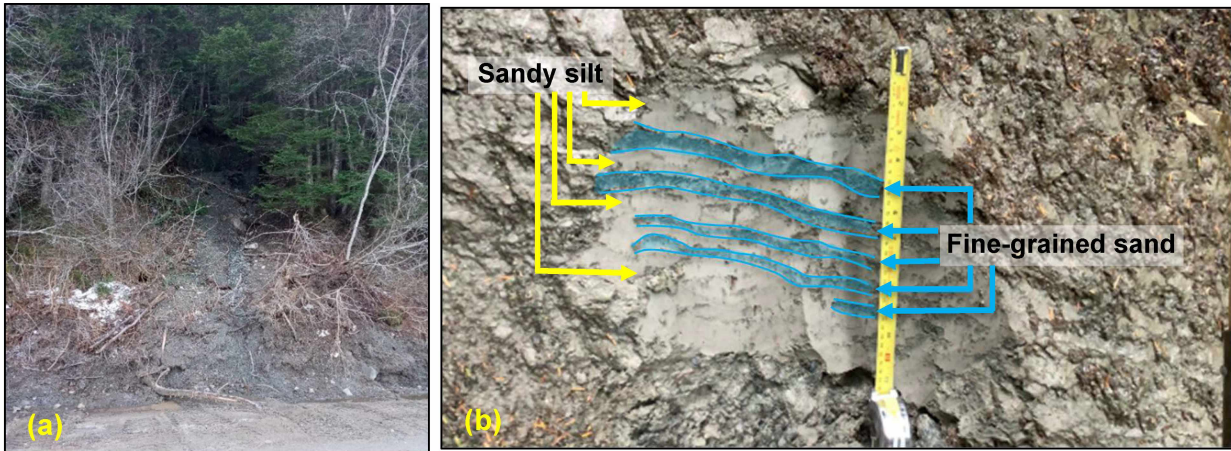
Site Description: ADOT&PF (2020) reported this was a localized slide, with 20–25 cubic yards (15–19 cubic meters) of material removed. We observed varved deposits exposed in the landslide body (fig. 109), consisting of distinct alternating sandy (5-mm–1-cm thick) and silty (~3-cm thick) layers, suggesting they are elevated fine-grained marine deposits (Lemke and Yehle, 1972).

Figure 109. Photographs from FEMA DOT#56: (a) view of the landslide from Lutak Road post-cleaning in December 2020 (photograph courtesy of ADOT&PF); (b) annotated photograph of cleaned exposure of varve deposit (June 2021).

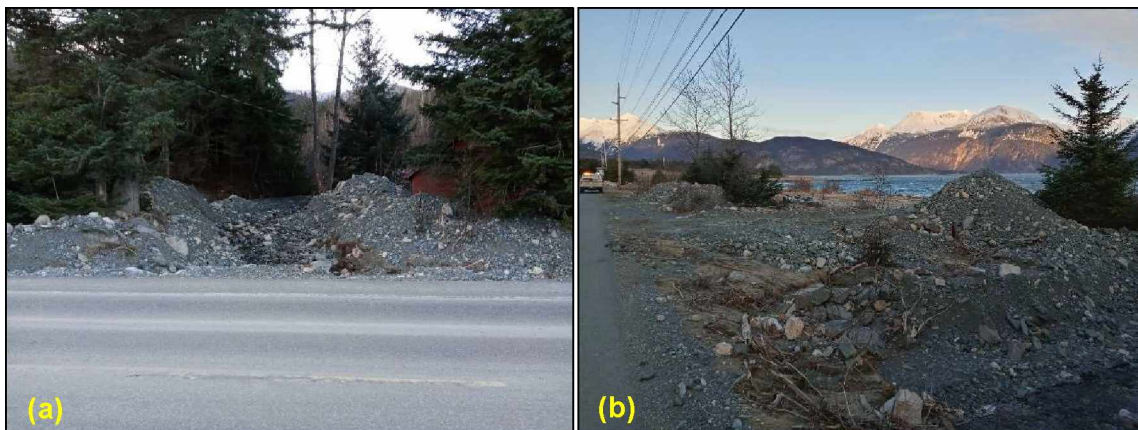
Site Description: ADOT&PF (2020) reported that, after plugging the culvert, debris overtopped the roadway at this location (fig. 111). This is a well-established creek filled with rounded cobbles. Evidence of the 2020 debris flow was still present at the site in June 2021. Our investigation of this site was brief due to time constraints; a more thorough investigation is recommended.

Figure 111. Photographs of FEMA DOT#66 in December 2020: (a) view of the channel from Lutak Road; (b) debris pushed off the road to the east (photographs courtesy of ADOT&PF).

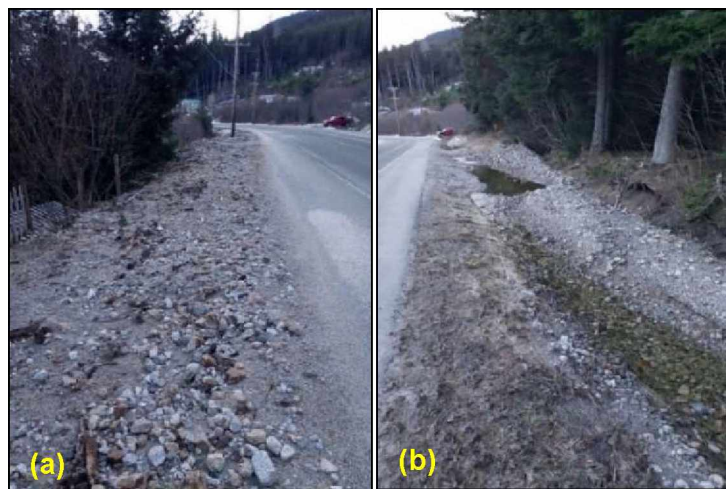
Site Description: The small channel at this site produced ~30 cubic yards (23 cubic meters) of angular debris, which was contained within the ditch (fig. 113; ADOT&PF, 2020). Our investigation of this site was brief due to time constraints; a more thorough investigation is recommended.

Figure 113. Views of FEMA DOT#65 in December 2020, illustrating (a) debris that was pushed off the road and (b) debris that was caught in the ditch (photographs courtesy of ADOT&PF).

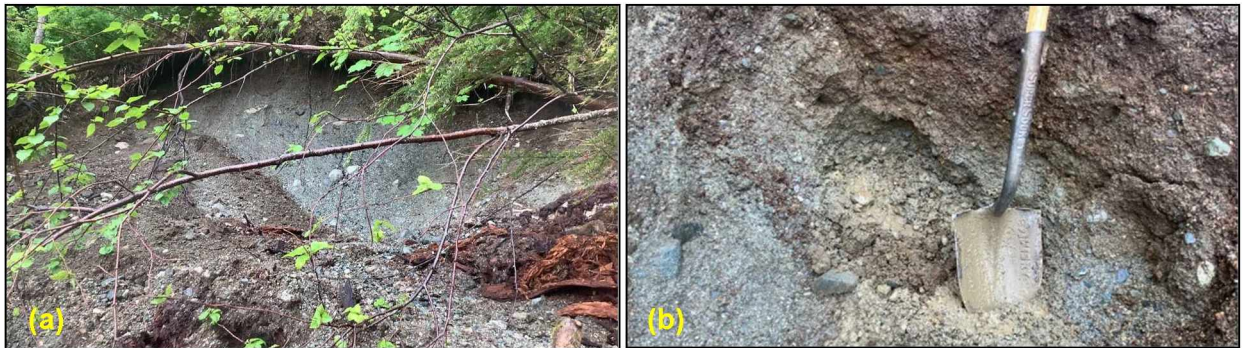
Site Description: This landslide impacted a small structure on the property, moving it several feet toward Lutak Road. At the time of sample collection, the soil contained enough water to liquefy and flow (fig. 116).

Soil Stratigraphy: Bn org mat (~20-cm thick), overlying Gy Sa Gr with sub-rounded cobbles and boulders interpreted as elevated shore and delta deposits (Lemke and Yehle, 1972)

Figure 116. Photographs from the Woodshed site landslide along Lutak Road in June 2021: (a) head scarp area as seen from the property; (b) sample location, which was saturated and flowed when disturbed (shovel for scale).

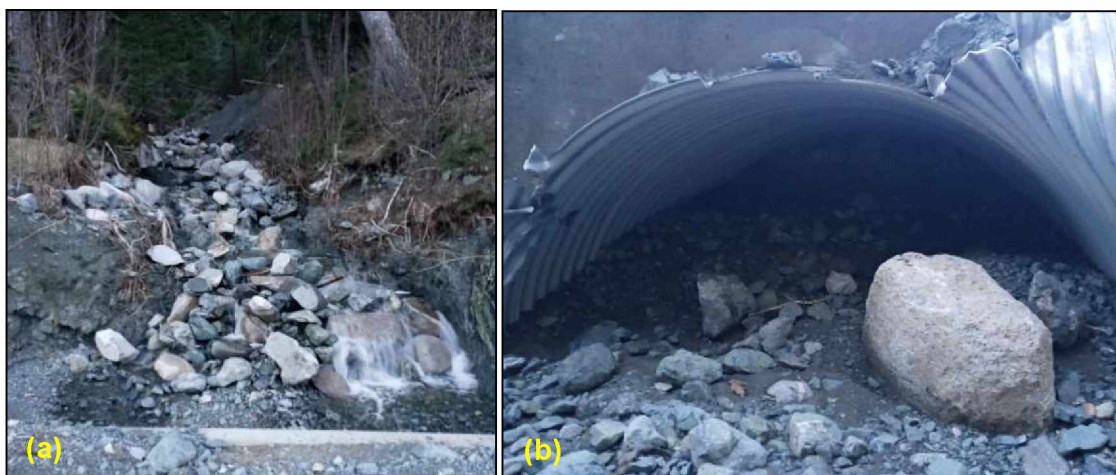
Site Description: Johnson Creek is well-established, containing cobbles and boulders with bedrock exposed in the channel bottom. The culvert sustained heavy damage during debris removal after the December 2020 debris flow; no information on debris volume is available (fig. 118; ADOT&PF, 2020). Our investigation of this site was brief due to time constraints; a more thorough investigation is recommended.

Figure 118. Photographs of the Johnson Creek location in December 2020: (a) the channel from Lutak Road; and (b) culvert filled by debris (photographs courtesy of ADOT&PF).

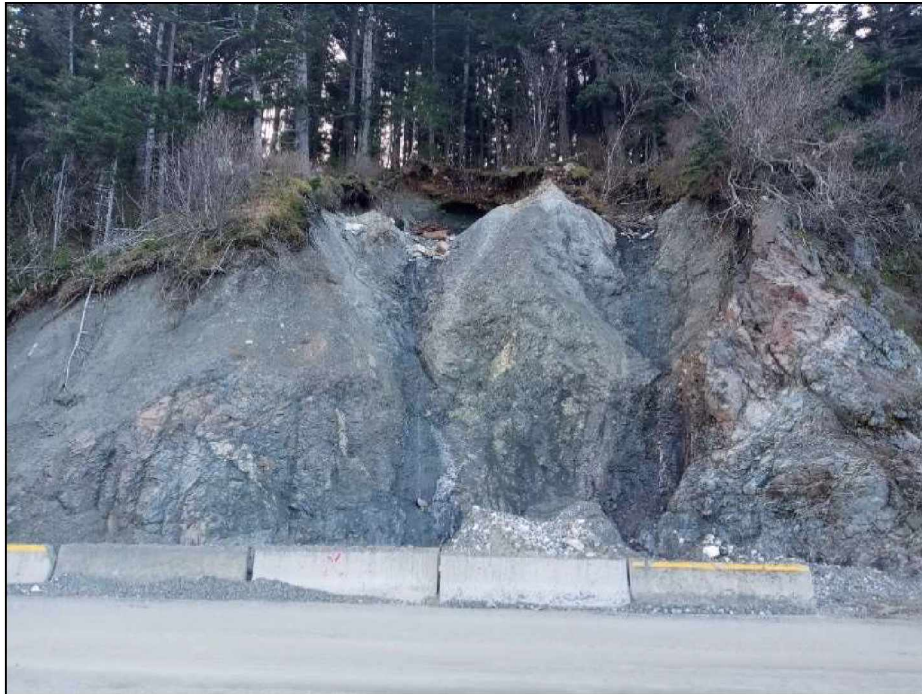
Site Description: According to ADOT&PF (2020), approximately 50 cubic yards (~38 cubic meters) of material failed at this location in December 2020 (fig. 120). Our investigation of this site was brief due to time constraints; a more thorough investigation is recommended.

- 0 – 50 cm Org mat
- 50 cm – 2 m Gy Sa Gr to Gr Sa (colluvium)
- > 2 m Bx

Figure 120. View of slope at DOT#57 from Lutak Road in December 2020 (photograph courtesy of ADOT&PF).

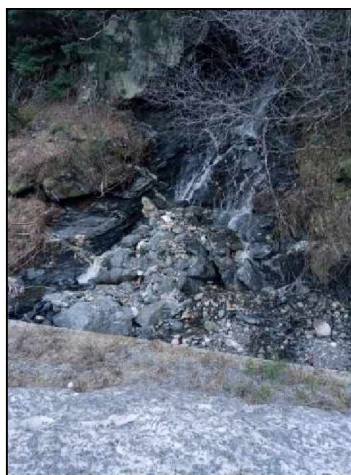
Site Description: This is a well-established channel flowing over exposed bedrock (fig. 122). According to ADOT&PF (2020), this site produced less than 5 cubic yards/~4 cubic meters of material that was contained within the ditch. Our investigation of this site was brief due to time constraints; a more thorough investigation is recommended.

Figure 122. View of debris in the channel at FEMA DOT#63 in December 2020 (photograph courtesy of ADOT&PF).
