AN ANALYSIS OF CATALOGED DECEMBER 2020 LANDSLIDES NEAR HAINES, ALASKA

Geological Engineering

University of Alaska Fairbanks

May 2023

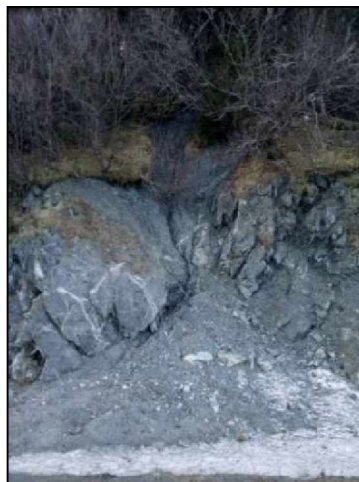
Site Description: According to ADOT&PF (2020), less than 5 cubic yards/~4 cubic meters of rockfall debris fell at this site, and was contained within the ditch (fig. 124). Our investigation of this site was brief due to time constraints; a more thorough investigation is recommended.

Figure 124. View of debris in the ditch at FEMA DOT#58 in December 2020 (photograph courtesy of ADOT&PF).

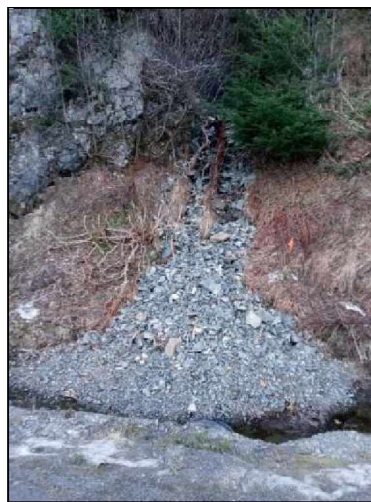
Site Description: According to ADOT&PF (2020), less than 5 cubic yards/~4 cubic meters of debris accumulated in December 2020, which was contained within the ditch (fig. 126). No water was flowing in the channel at the time of our field visit, which was brief due to time constraints; a more thorough investigation is recommended.

Figure 126. View of debris in the channel and ditch at FEMA DOT#61 in December 2020 (photograph courtesy of ADOT&PF).

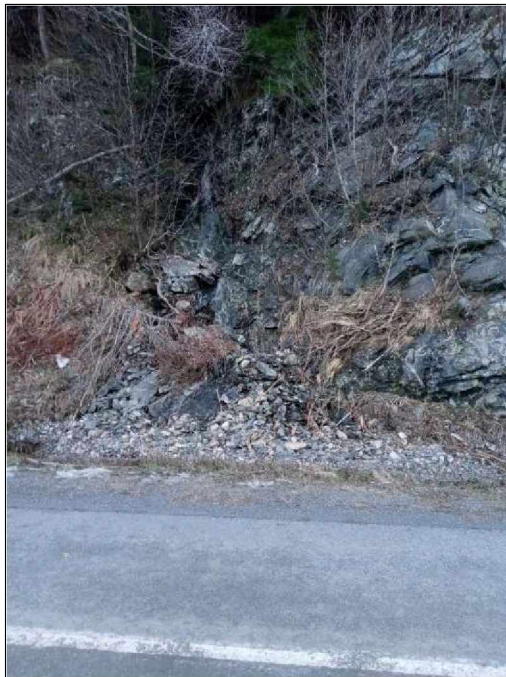
Site Description: ADOT&PF (2020) indicated that approximately 5 cubic yards/~4 cubic meters of debris were deposited within the ditch at this site in December 2020 (fig. 128). At the time of our field visit, a trickle of water was flowing in the channel (which runs over exposed bedrock); some cobbles were present in the ditch. Our investigation of this site was brief due to time constraints; a more thorough investigation is recommended.

Figure 128. View of debris in the ditch at FEMA DOT#62 in December 2020 (photograph courtesy of ADOT&PF).

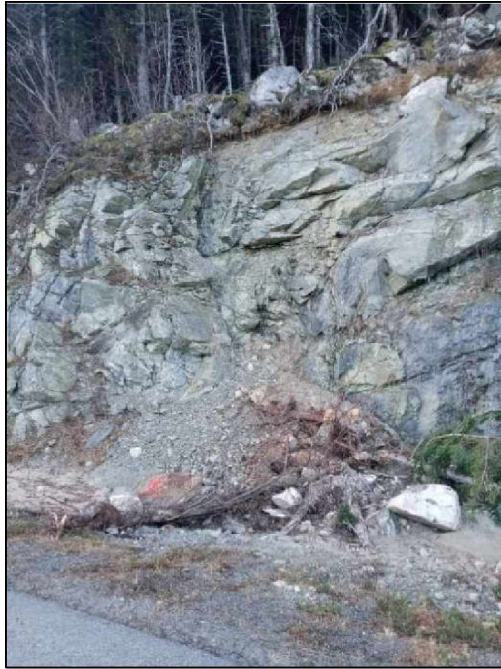
Site Description: This site produced approximately 5 cubic yards/~4 cubic meters of rockfall debris that the ditch contained (fig. 130; ADOT&PF, 2020). Our investigation of this site was brief due to time constraints; a more thorough investigation is recommended.

Soil Stratigraphy: We estimated approximately 1 m of gray to brown silty sand (colluvium) overlying bedrock. Large boulders are present on the slope surface above the roadcut.

Figure 130. View of the FEMA DOT#59 slope with debris at its base in December 2020 (photograph courtesy of ADOT&PF).

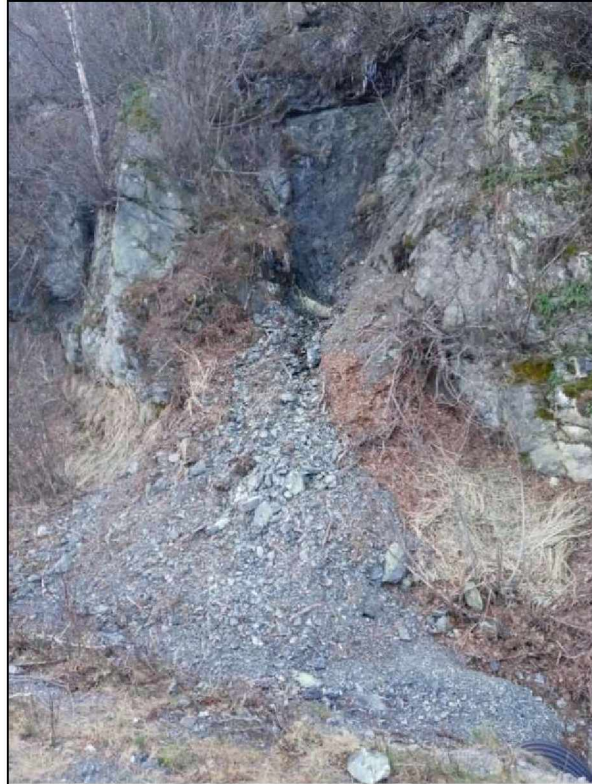
Site Description: This site produced approximately 5 cubic yards/~4 cubic meters of rockfall debris that was contained within the ditch (fig. 132; ADOT&PF, 2020). Our investigation of this site was brief due to time constraints; a more thorough investigation is recommended.

Figure 132. View of debris at the base of the slope at FEMA DOT#60 from Lutak Road in December 2020 (photograph courtesy of ADOT&PF).

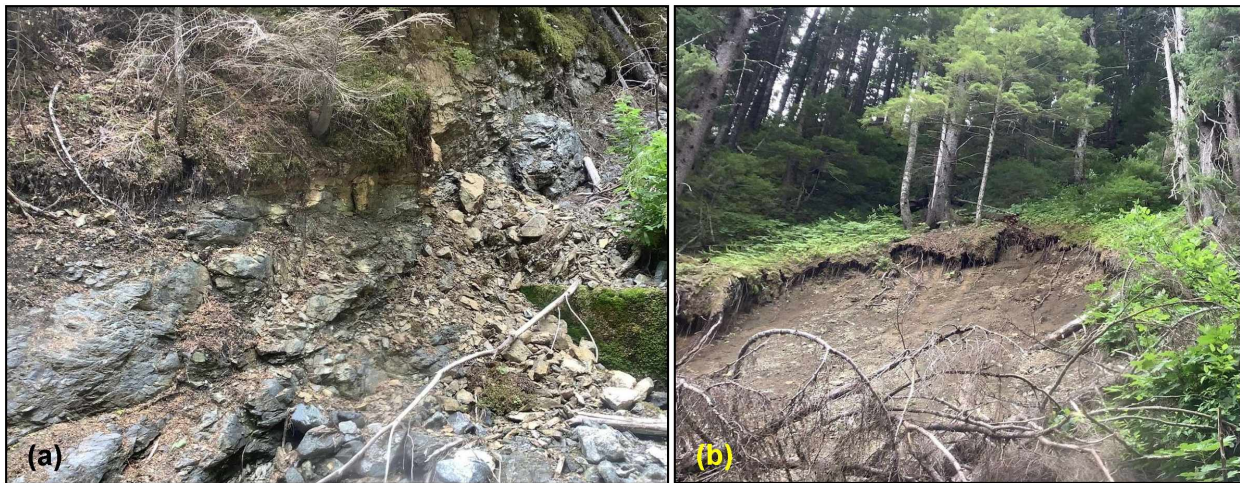
Site Description: This site is a well-established channel containing large boulders (>2-m diameter) and evidence of previous debris flow events visible in the exposed channel bank stratigraphy. The channel has steep banks with a wide (~9 m) relatively flat bottom, which is unlike other V-shaped channels in the area. We investigated the channel up to an elevation of ~ 209 m, noting bedrock exposure along the channel bottom at several locations (fig. 134a), as well as the head scarp of a debris slide that contributed material to the 2020 debris flow and deposited trees into the channel bottom (fig. 134b).

Figure 134. Photographs of upper Cunningham Creek, taken in July 2022: (a) exposed bedrock in the channel at ~126 m elev.; (b) the head scarp of one of the sources of debris for the December 2020 event (~210 m elev.).

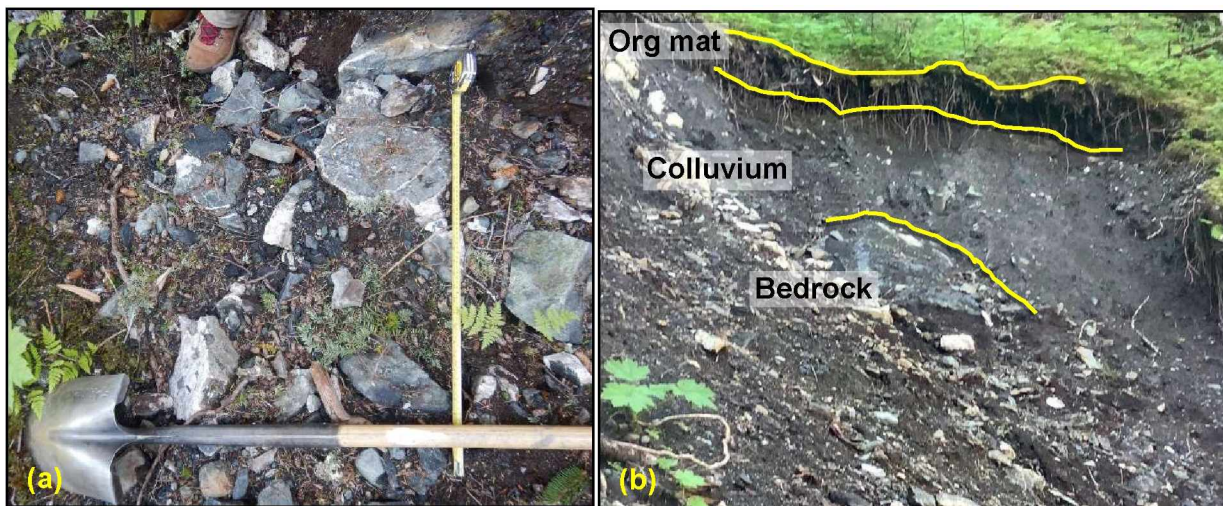
Site Description: This is a small debris slide accessible to the southeast from the end of Mt. Riley Road. We investigated the head scarp area, where the landslide occurred in colluvium and scoured down to the bedrock surface (fig. 138). A fiber optic cable runs up the slope to the east of the slide.

0 – 10 cm Org mat with roots
 20 – 30 cm Bn PG Sa w/ Si and Gr [21-01, 21-02] (colluvium)
 >30 cm Bx (ultramafic); Bk sandy veneer at surface

Figure 138. Photographs of the Beach Road Minor Slide (June 2021): (a) typical soil in the slide body; (b) view of left flank near the head scarp with annotated stratigraphy.

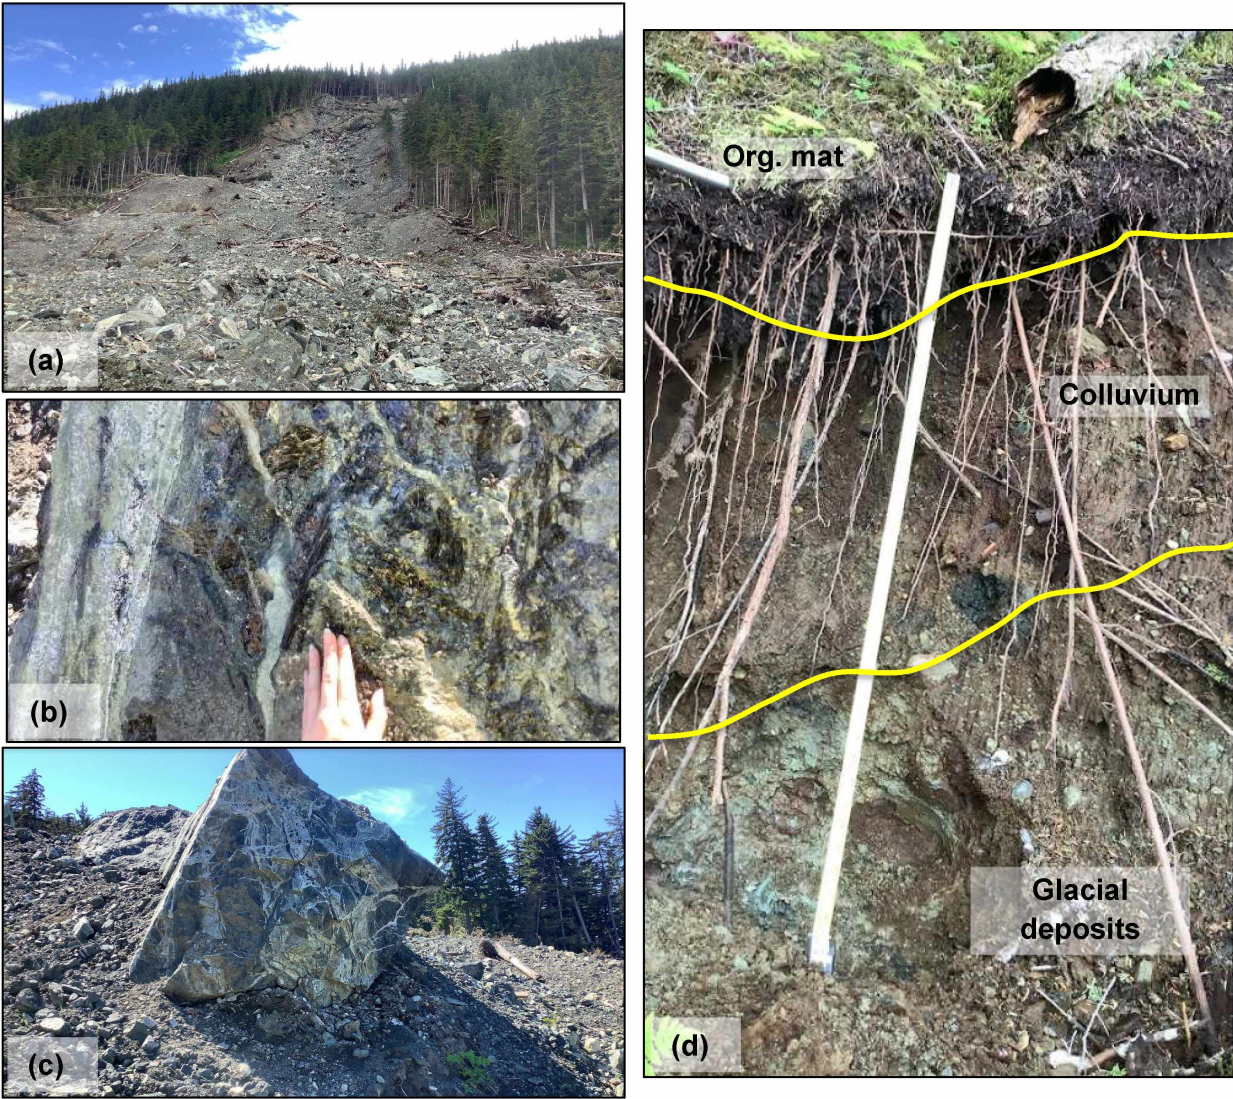
Site Description: The Beach Road Landslide (BRLS) was the largest of the December 2020 mass movements, having an approximate volume of 187,100 m³. It destroyed or severely damaged four residences, and killed two occupants of one of the residences (Darrow and others, 2022). Analysis of lidar data and field investigations revealed evidence (e.g., head scarps, displaced rock masses) of other large paleolandslides along North Riley Ridge, where the BRLS originated (Darrow and others, 2022). The bedrock is biotite magnetite clinopyroxenite with intrusions of diorite (fig. 141).

0 – 10cm Org mat
10 – 64 cm Bn Sa Si w/ Gr [21-19, 21-20] (colluvium), ultramafic clasts up to 10 cm in diameter
64 – 98 cm Gy Si Sa w/ Gr [21-21] (glacial deposits)
> 98 cm Bx (Biotite magnetite clinopyroxenite)

Figure 141. Photographs from the Beach Road Landslide (BRLS): (a) looking up to the head scarp from the road (~ 200 m elevation difference; July 2022); (b) a close-up view of a biotite magnetite clinopyroxenite boulder with diorite veins and large (8 cm) biotite crystals (June 2021); (c) the entire ~5 m dia. boulder seen in (b) (June 2021); (d) annotated photograph of soil stratigraphy above the BRLS head scarp (June 2021).

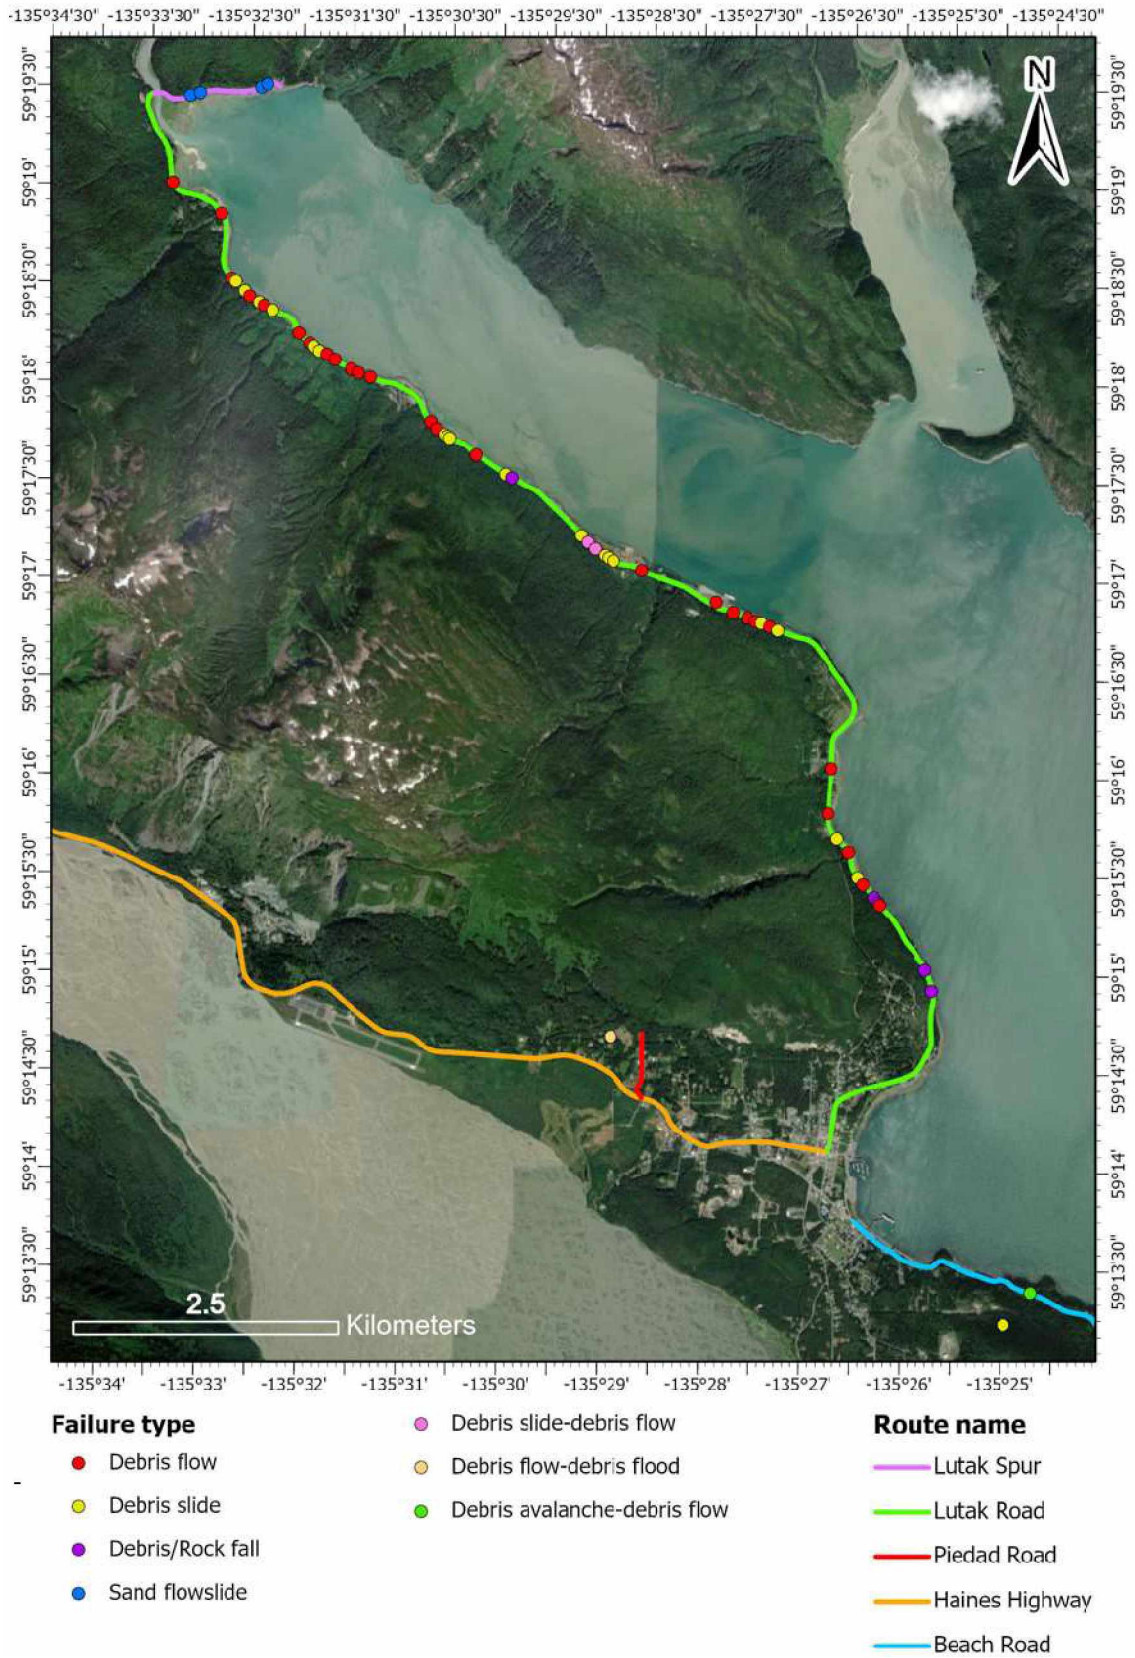
The 58 sites presented in the catalog (Chapter 4) fall into eight landslide types (table 2, fig. 142), following the classification of Hungr and others (2001; 2014). The most common mass wasting events that occurred as a result of the December 2020 storm were debris flows, followed by debris slides; both of these types are widespread in mountainous regions.

Figure 142. Location map of investigated landslides, colored based on classification according to Hungr and others (2001; 2014) (basemap from ADNR, 2020).

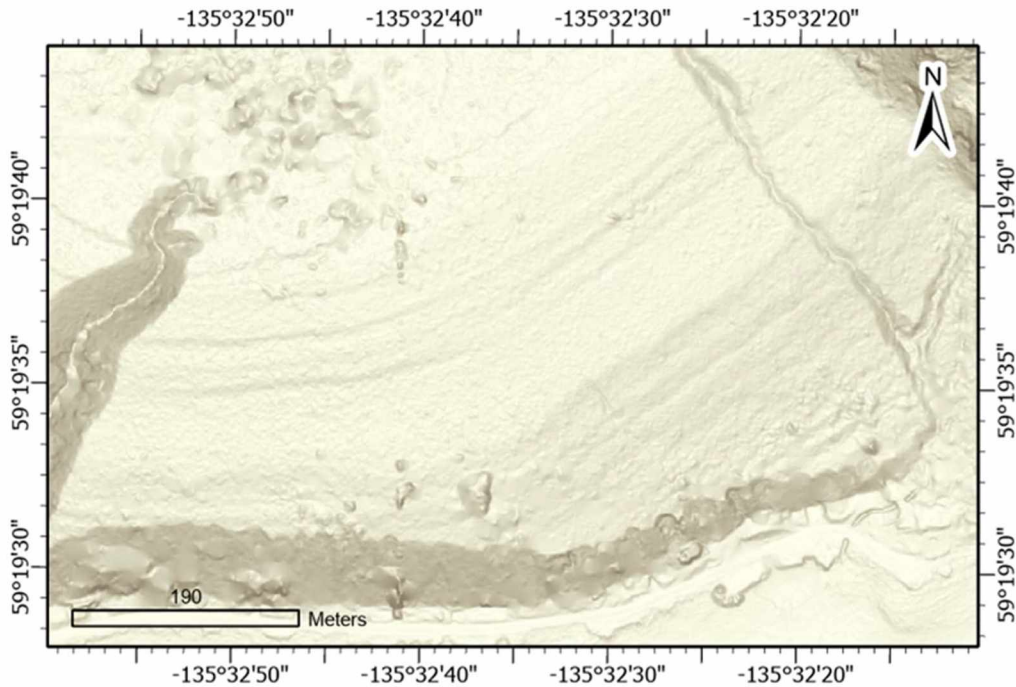
Shore deposits consist mostly of sand and gravel-sized soil, but also may contain pockets of finer-grained soil like silt (Thornbury, 1954). In the lidar-based slope maps, paleo-shorelines are evident in the areas adjacent to the BRLS, around the Haines Ferry Terminal, along Lutak Road, and along Lutak Spur (fig. 143). These uplifted shorelines are most commonly observed below 100 m elevation and near most of the sampled landslides (for example, see figs. 61 and 96). Marine deposits consist of fine-grained silt and clay, but also can contain seams of fine- to medium-coarse sand (Bowles, 1984). These deposits were observed mostly around the Haines Ferry Terminal, and in areas lower in elevation than the paleo-shorelines (often immediately adjacent to Lutak Road), which is stratigraphically consistent for marine-related deposits. These elevated deposits are the result of the significant GIA that has occurred in the Haines area (Larsen and others, 2005; Motyka and others, 2007). One distinct feature of marine deposits is varves, which form as a result of the seasonal deposition of silt in the summer months and clay in the winter months (Terzaghi and Peck, 1948). We observed and sampled a varved deposit,

Figure 143. Paleo-shorelines visible above Lutak Spur, as seen in the slope map derived from 2020 lidar (Daanen and others, 2021)

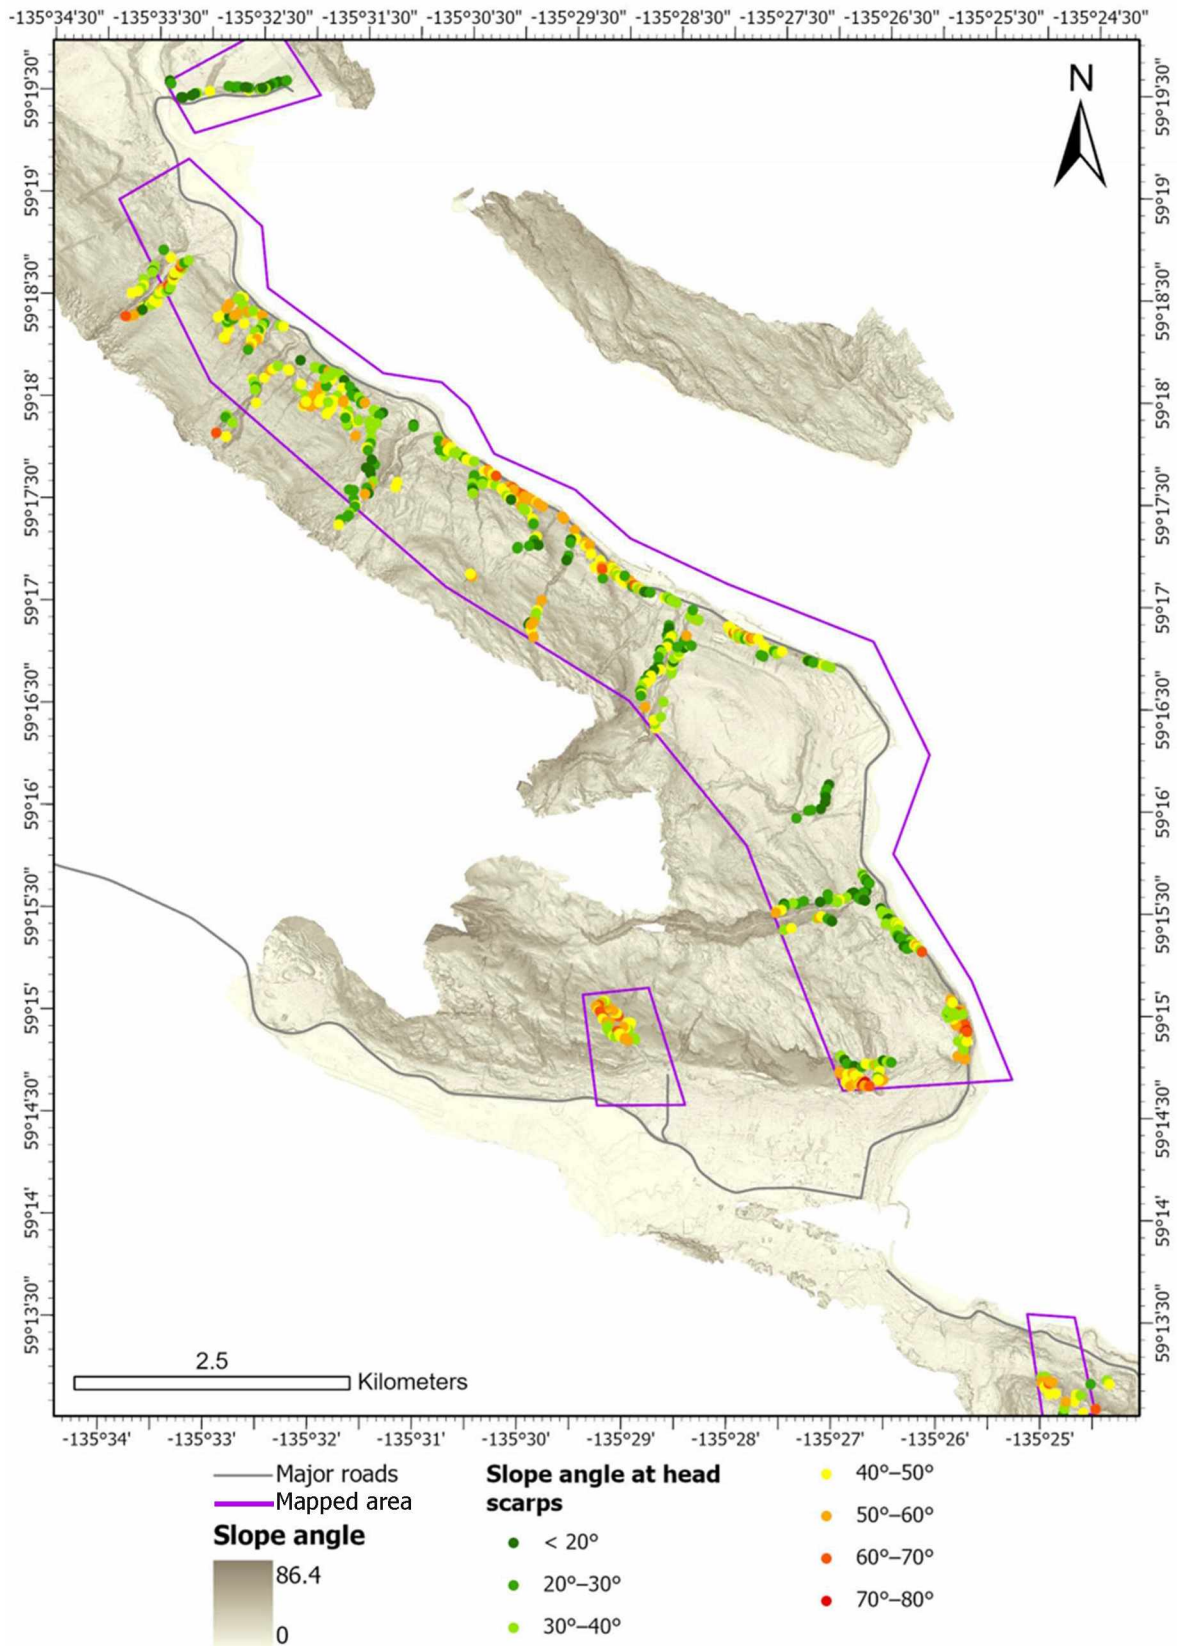
Figure 144. Slope map of the study area including slope angles of points at the head scarps of mapped landslides. Map derived from 2020 lidar (Daanen and others, 2021).

The 768 mapped points are located within an area of interest delineated at the start of this thesis (see pink outline in fig. 144). We mapped scarps in a ~200-m wide buffer along Lutak Road and Lutak Spur, and within drainages that produced debris flows. Given this narrow linear mapping corridor, it is difficult to generalize slope relationships broadly for the area; however, observations can still be made regarding certain localized trends within the data. For example, there is an extended area of yellow and orange dots in the middle of figure 145; this area corresponds to sites 28–36. Seven of these 10 sites were debris slides, and all the landslides occurred in either colluvium or in drift deposits, both of which are a mix of silt, sand, gravel, and cobbles. As summarized in table 3 and mentioned in previous sections, a slope that is steeper than a soil’s angle of internal friction is unstable. The yellow and orange dots along this section represent slopes steeper than 40°, which is greater than the highest average angle of internal friction for a soil containing gravel (Bowles, 1984). On the other hand, along Lutak Spur (i.e., the deltaic landform) the slopes are less steep, as indicated by the green dots. These slopes are either below or just above the angle of internal friction for sand. It is likely that the high-intensity rainfall played a larger role than slope angle in slope failure in this area. The red dots at the end of Lutak Road closest to downtown Haines (around sites 54 and 55) are areas of exposed bedrock (as observed in the field) that produced rock fall during the storm event. Our site investigations indicated the presence of fractured bedrock. The catchment of Cunningham Creek is also steep, with most of the dots representing slope angles greater than 40°. We posit that this is due to previous landslide activity exposing bedrock within the catchment.

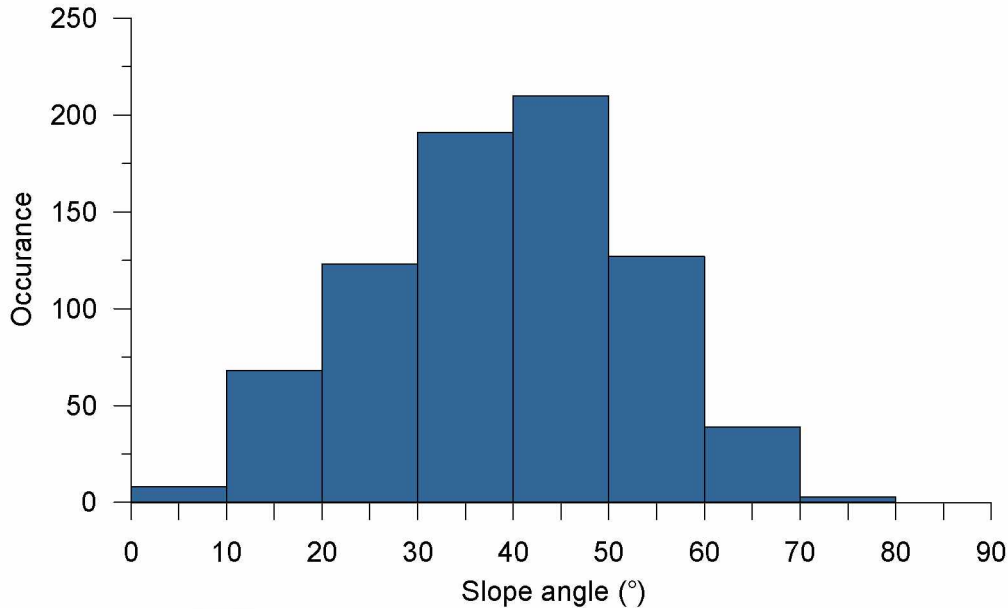
Based on 768 scarp points, the average slope at the head scarps is approximately 39° ±13° (1 standard deviation), and the median slope angle is approximately 40° (fig. 145). The data in figure 145 have a normal distribution; this indicates that many factors (discussed in later sections) contributed to the slope failures (Charan 2020). Within drainage channels, the average slope angle for the scarps is between 40°–50°. Of the points located within 100 m of a roadway, the average slope is 40°, and for the points located within 50 m of a roadway, the average slope angle increases to 46°. Of the 768 points, 329 (43%) have slope angles of 20°–40°, which is the expected range for debris slides (Highland and Bobrowsky, 2008), and 698 of the points (91%) have a slope angle greater than 20°, which Hungr and others (2014) indicate as the necessary steepness for debris flows. This helps to explain why debris flows were the most observed landslide type within the study area.

Figure 145. Histogram of slope angle at head scarp locations in the study area. Slope angle data from Daanen and others (2021)

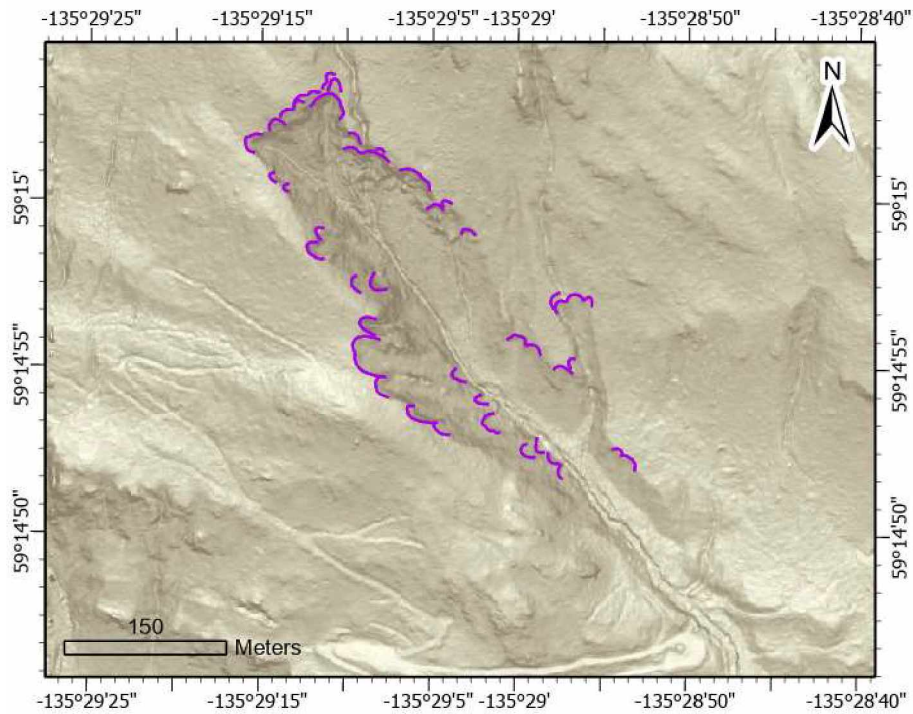
The catchment that feeds Cunningham Creek near Piedad Road is lined by dozens of scarps, suggesting a tumultuous history. We observed geomorphologic evidence, both in the field and in lidar data, of previous landslide events in the form of scarp scars (fig. 146). During our field investigation of this channel we observed what appeared to be two potential debris flow deposits in the channel bank. Each of the 0.5–1-m thick debris flow deposits buried an organic layer containing roots, which we interpreted as buried organic mats of paleosurfaces (fig. 135b).

One of our objectives for investigating Cunningham Creek was to determine if another significant storm event could result in more material coming down the channel and into the residential areas below. Interpretation of the lidar data indicates that the creek bed is wide (~9 m) with a relatively flat bottom. Our field observations indicate that soil and debris has filled in the creek bed to form the flat bottom, which suggests that more debris is available to be released in another 2020-magnitude storm event.

Figure 146. Scarps (purple) visible in the catchment area of Cunningham Creek, site 56. Slope map derived from 2020 lidar (Daanen and others, 2021)

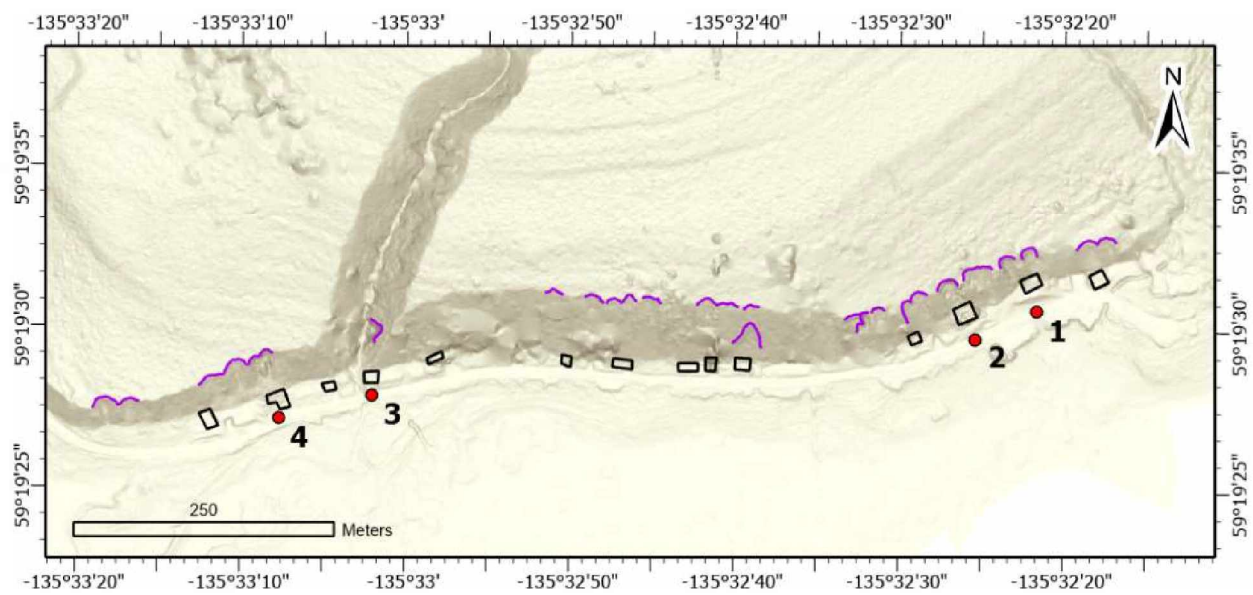
Lutak Spur also demonstrates evidence of previous landslides. Arcuate shapes are visible along most of the bluff edge, at the bottom of which many residents have built structures (fig. 147). Lidar mapping indicates nested scarps, providing evidence for repeated slope failures.

Figure 147. Scarps (purple) visible along the slopes of Lutak Spur. Figure includes locations of sites 1 through 4. Approximate locations of structures are outlined in black. Slope map derived from 2020 lidar (Daanen and others, 2021).
