U.S. Department  
of Transportation  
Federal Railroad  
Administration

## Locomotive Crash Energy Management Vehicle-to-Vehicle Tests 1 & 2: Analyses and Test Results

<b>1. REPORT DATE (DD-MM-YYYY)</b> 9/9/2022	<b>2. REPORT TYPE</b> Technical Report	<b>3. DATES COVERED (From - To)</b> 8/24/2018–5/10/2022
--	---	--

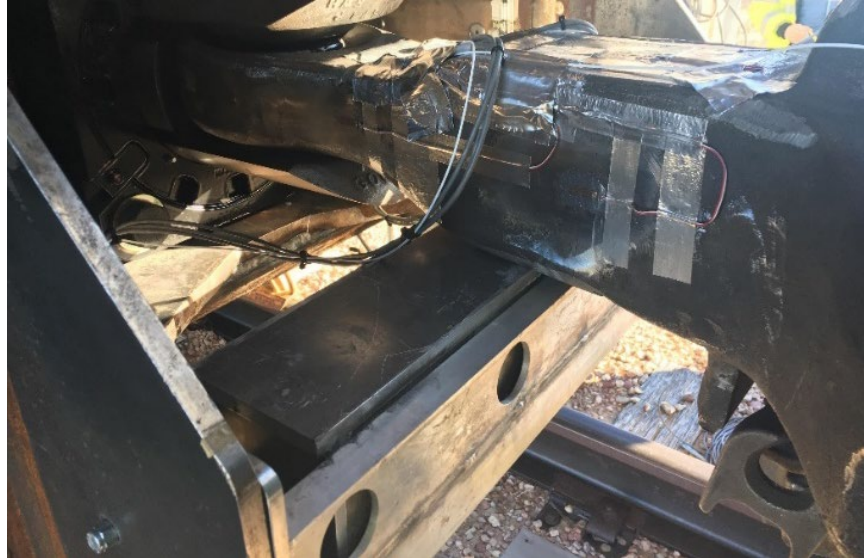
**Figure 15. Pre-test photograph of the coupler carrier**

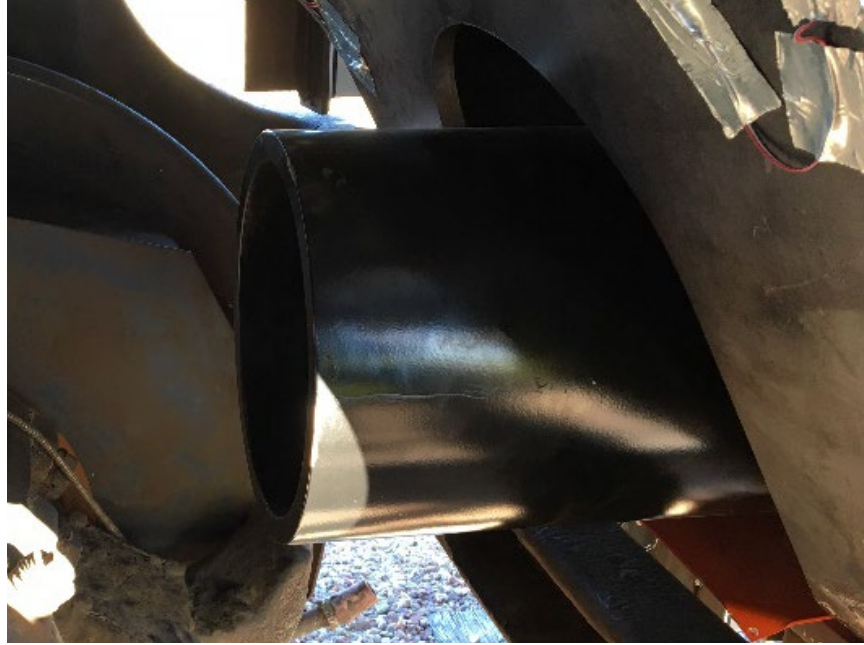
**Figure 17. Pre-test photograph of the back of the PBC deformation tube**

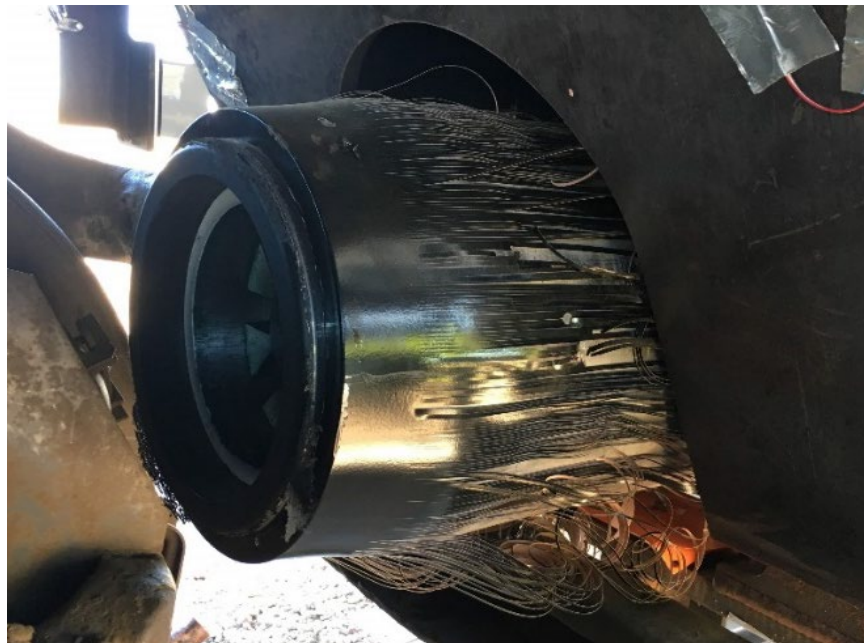
After pushing through the coupler carrier, the PBC continued to move back, deforming the crush tube. [Figure 17](#) and [Figure 18](#) show the back of the deformation tube of the PBC before and after the impact. The deformation tube was covered in paint that was designed to peel off in strips as the exterior tube deformed. [Figure 18](#) indicates that the stroke of the deformation tube was

almost exhausted. [Figure 19](#) shows the deformation tube after it was removed from the draft pocket. Measurements taken confirmed that the full design stroke of the deformation tube was nearly exhausted. This was confirmed by evidence of contact between the limit stop mounted on the sliding lug and the rear of the PBC head, as shown in [Figure 20](#) and [Figure 21](#). This contact was designed to occur at the full stroke of the PBC.

**Figure 18. Post-test photograph showing the back of the PBC deformation tube**

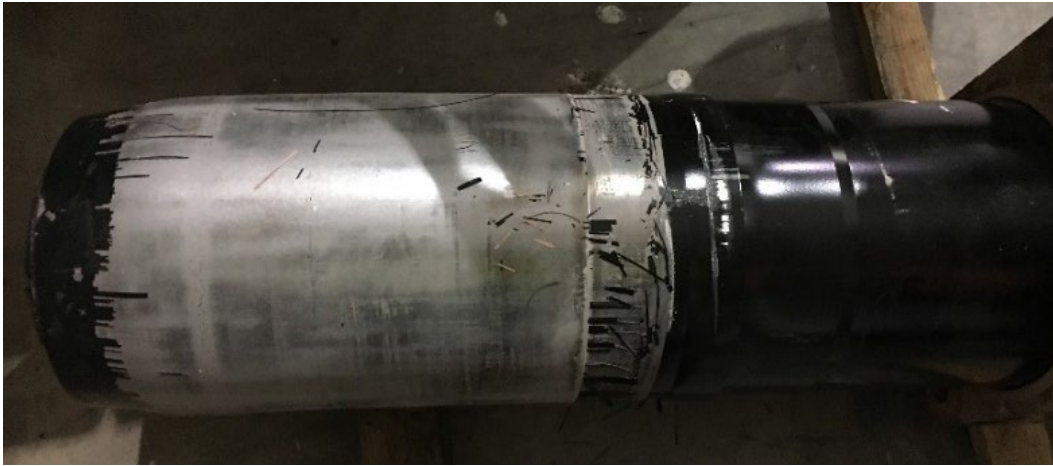
**Figure 19. Deformed PBC deformation tube removed from the draft pocket; peeled paint has been removed**

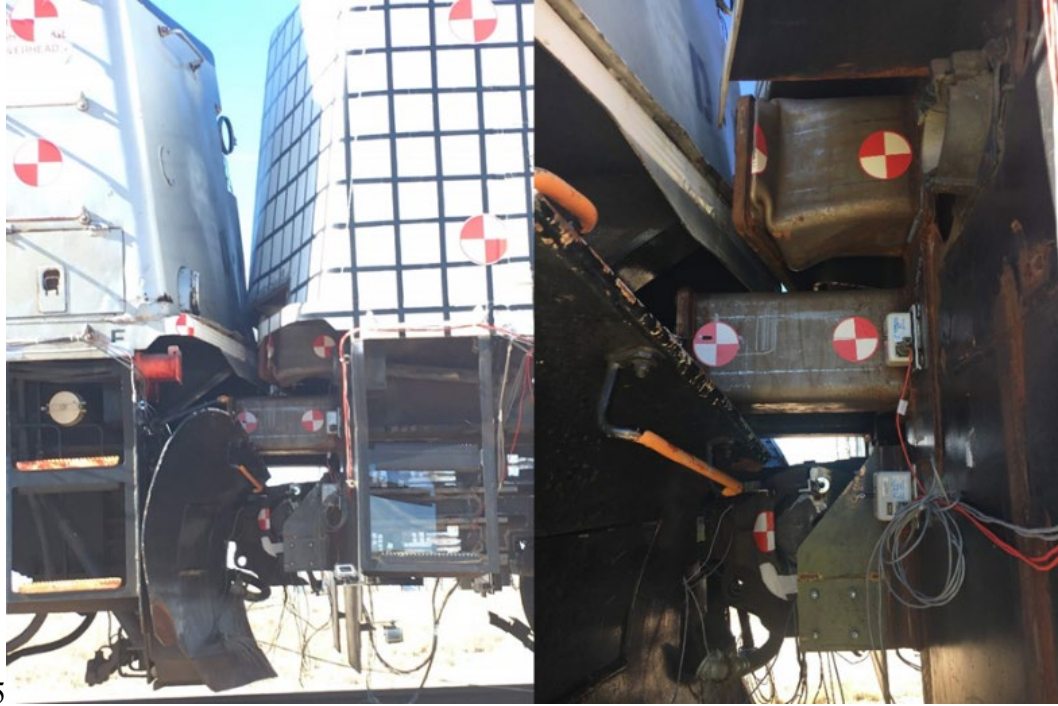
As the PBC was pushed back, the top DAC tubes impacted the front of the conventional locomotive and began to crush. [Figure 22](#) shows the two locomotives engaged after the impact. The photo on the right shows that only the upper DAC tubes crushed; the lower DAC tubes did not deform, as expected.

**Figure 22. Post-test photo of CEM system; close-up on the right**

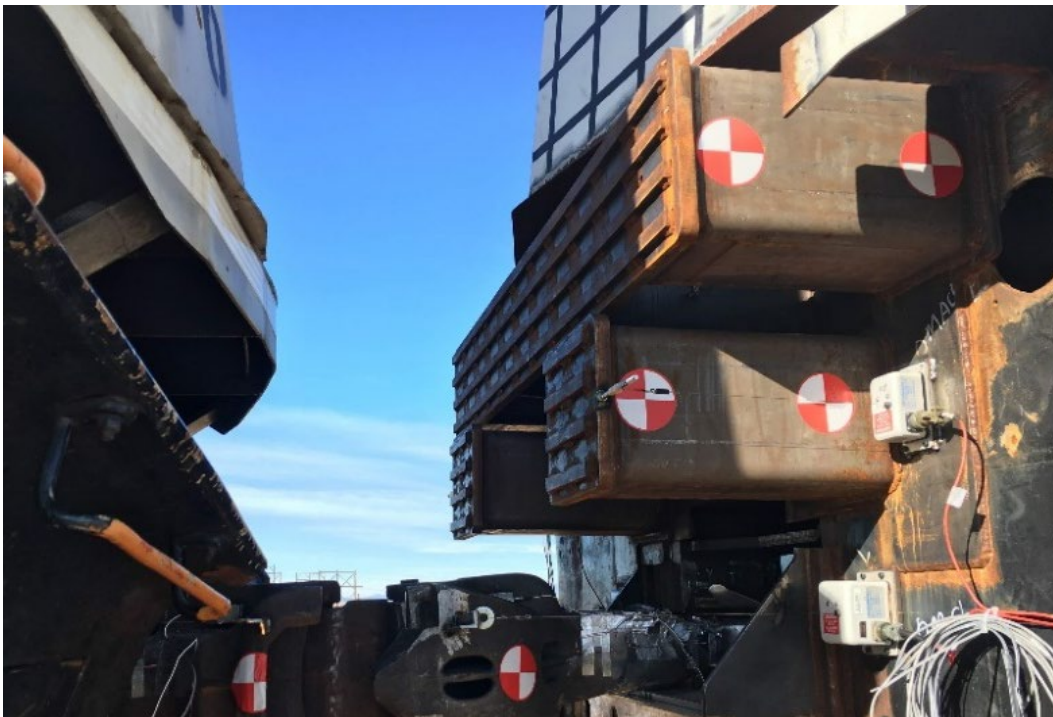
**Figure 23. Pre-test photograph of DAC**

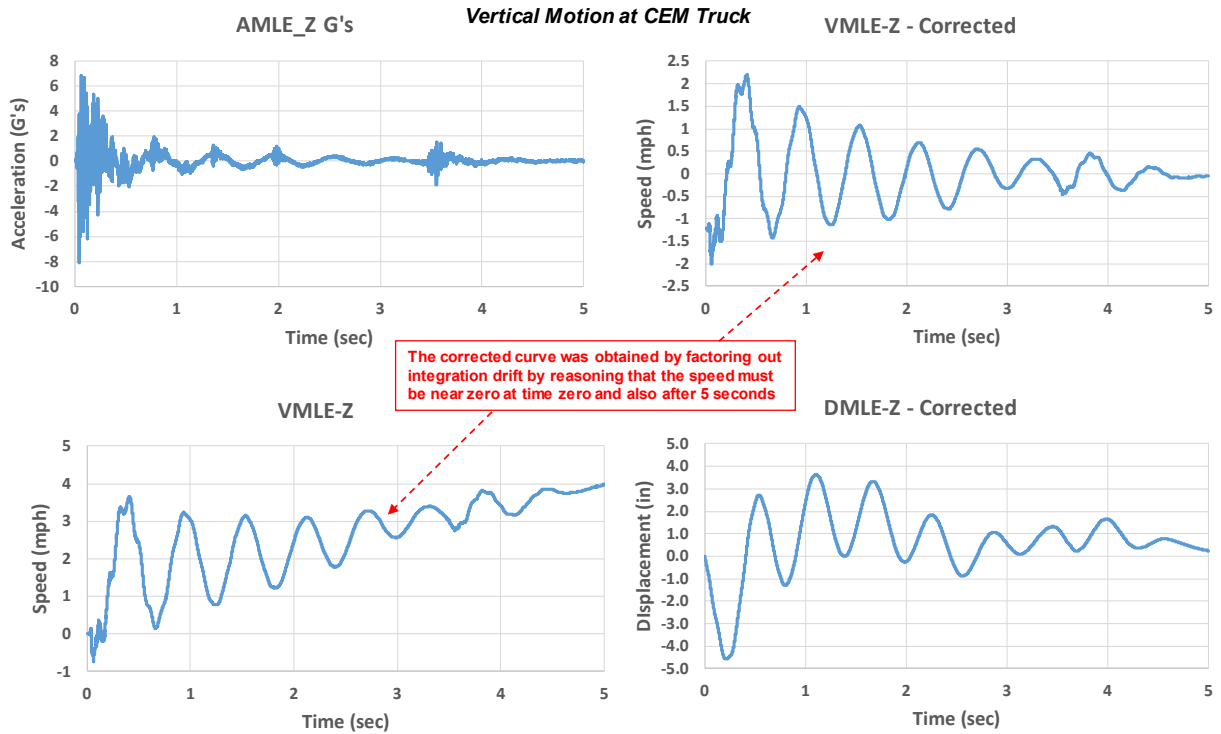
Test videos indicated a noticeable cyclic pitch (bouncing) of the CEM locomotive carbody on the suspension system of the forward truck during the collision. The vertical travel was much larger than anticipated, as the truck suspension is meant to have a limit stop of  $\pm 2''$ , which was included in the FE model. The vertical acceleration pulse for the CEM carbody at the forward truck (see [Figure 37](#), upper left) was integrated to estimate the speed time-history at this location (see [Figure 37](#), lower left). This curve was then corrected (see [Figure 37](#), upper right) to remove drift (a common issue with these types of data) by reasoning that this curve must be near zero both at impact and after 5 seconds, when the oscillations had damped out. Finally, the corrected speed curve was integrated again to estimate the vertical displacement time-history at this location (see [Figure 37](#), lower right). The displacement curve indicates an initial downward displacement of about 4.5'' followed by continued oscillation, with an approximate magnitude of about 3'' that slowly decreases over the next several seconds.

**Figure 37. Upper left — vertical acceleration of carbody at CEM forward truck; lower left — integration of acceleration pulse to yield vertical speed (in mph); upper right — correction of speed curve to remove drift; lower right — integration of corrected speed curve to yield vertical displacement time-history**

Recall that VTVT1 test videos indicated a noticeable cyclic pitch (bouncing) of the CEM locomotive carbody on the suspension system of the forward truck during the collision (nearly  $\pm 4$ ”; see [Figure 37](#)). This was attributed to missing limit stops on the CEM truck-to-body connections. For VTVT2, the limit stops were in place, and the CEM pitch motions were much less pronounced, as indicated in [Figure 93](#).

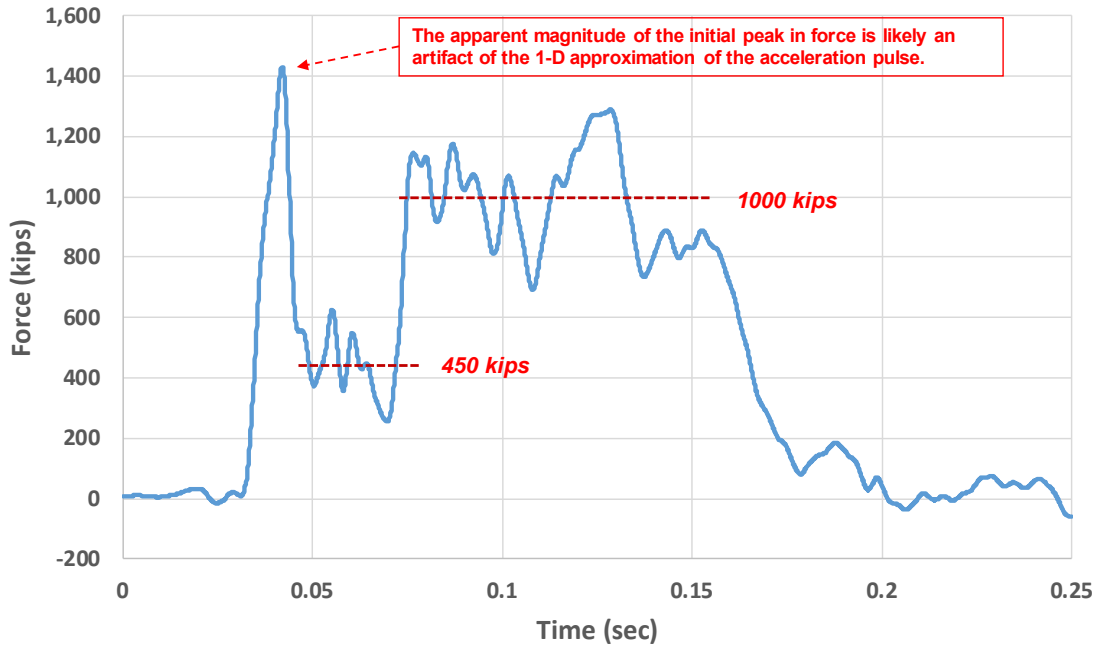
The longitudinal acceleration can be multiplied by the mass of the CEM locomotive (232,600 lbs) to get an estimate of the longitudinal force, as shown in Figure 38. The resulting curve indicates that the force increased considerably — from an average of about 450 kips to an average of about 1,000 kips — when the DAC assembly was impacted. The huge peak in force after initial impact (almost 1,400 kips) and the oscillation during push-back suggest that this measure of forces must be considered approximate, at best, as it depends on the vehicle acting as a single-degree-of-freedom system.

**Figure 38. Force time-history based on single-degree-of-freedom approximation ( $F = ma$ ) where ‘m’ is the mass of the CEM locomotive and ‘a’ is the longitudinal acceleration at the center of the vehicle**

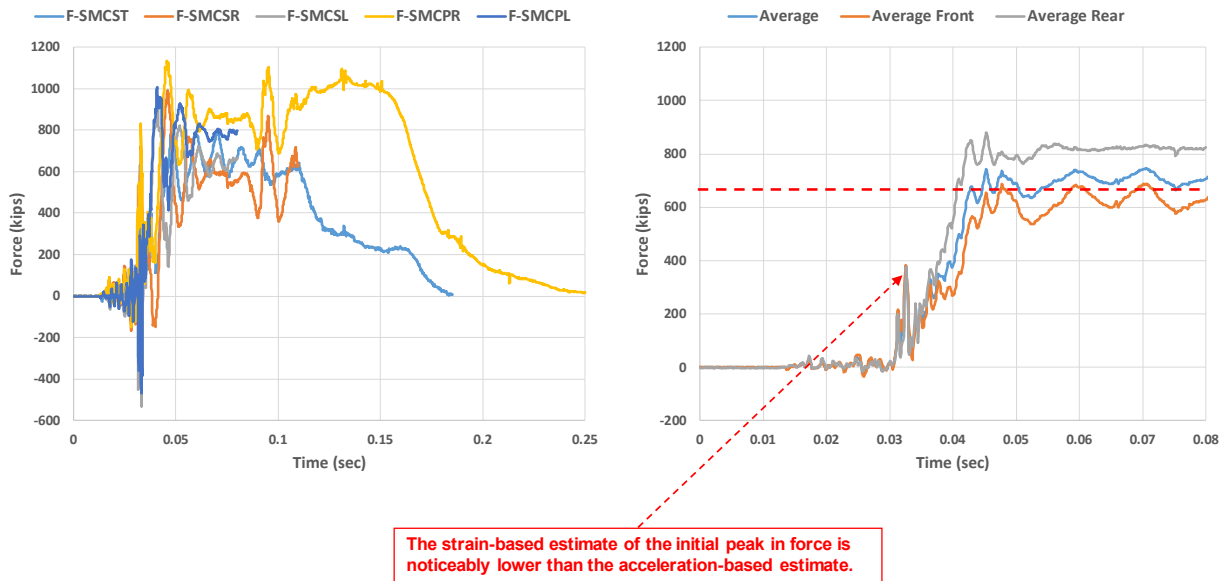
Based on results from coupler impact studies [12], a better estimate of the force through the push-back coupler is derived from the longitudinal strains in the coupler shank. Figure 39 (left) shows estimated time-histories of the force through the coupler based on data from the five strain gages positioned on the shank (top, left, and right) and a few inches forward of the pin (left and right). The data from the five gages were somewhat noisy, so averages of the forces for the three front gages (shank) and two rear (pin) gages, as well as the overall average, were calculated. Figure 39 (right) shows the calculated averages over the first 0.08 seconds after impact. Compared to the acceleration-based estimates of force, these strain gages provided a more reasonable estimate of force when all of the force was going through the coupler (i.e., prior to DAC impact). The jump in force at impact was much smaller, and the plateau force was much more consistent with the rated push-back load of 674 kips for the PBC.

**Figure 39. Left — estimated time-histories of the force through the coupler based on data from strain gages positioned on the shank and near the pin; right — calculated averages forces for the three front (shank) and two rear (pin) gages over the first 0.08 seconds after impact**

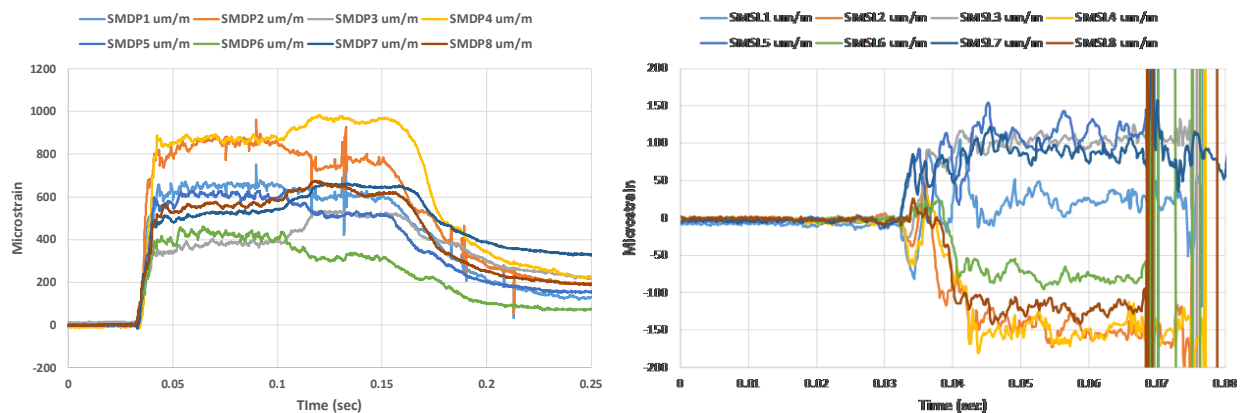
Sliding lug side plate strains were generally much smaller than draft pocket side plate strains, making it difficult to infer trends from the data. It did appear, however, that the strain levels were very different front-to-back, with the front gages indicating compression and the back gages indicating tension. It was not immediately evident why these strain magnitudes changed sign, but it should be noted that previous testing and analysis on stiff bolted rail components have indicated that the transmission of force through the bolted connections can be quite complex [3].

**Figure 40. Left — time-histories of strain behind the eight top and bottom shear bolts on the draft pocket side plates; right — time-histories of strain ahead of the eight top and bottom shear bolts on the sliding lug side plates**

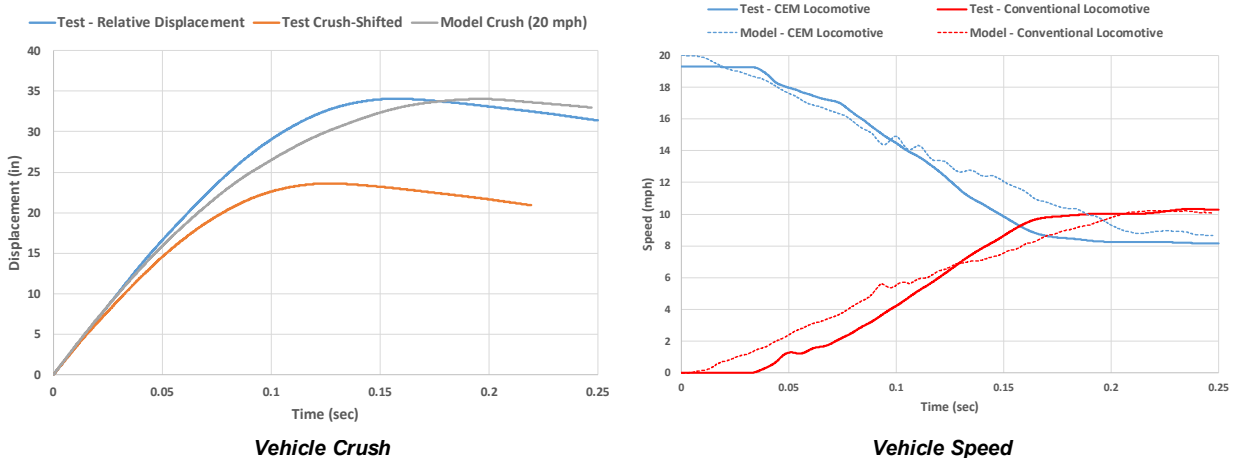
Comparing the relative displacement (or crush) and speed time-histories derived from test results with model predictions (Figure 41) indicated that the CEM locomotive slowed down more quickly than pre-test model results would indicate, especially when the first 0.031 seconds after impact are neglected (allowing the open couplers to fully engage). This difference in behavior was indicative of higher collision forces and became more pronounced at about 0.075 seconds when the DAC tubes began to crush. These differences were likely attributable to the much earlier impact of the DAC (relative to the extent of PBC crush) during the test than was modeled, as noted above. Accounting for the 10.5” travel of the couplers prior to impact in the model, as well as the 1.375” additional protrusion of the DAC, as noted, will likely improve agreement.

**Figure 41. Left — comparison of measured displacement time-histories with model predictions; right — comparison of measured speed time-histories with model prediction**

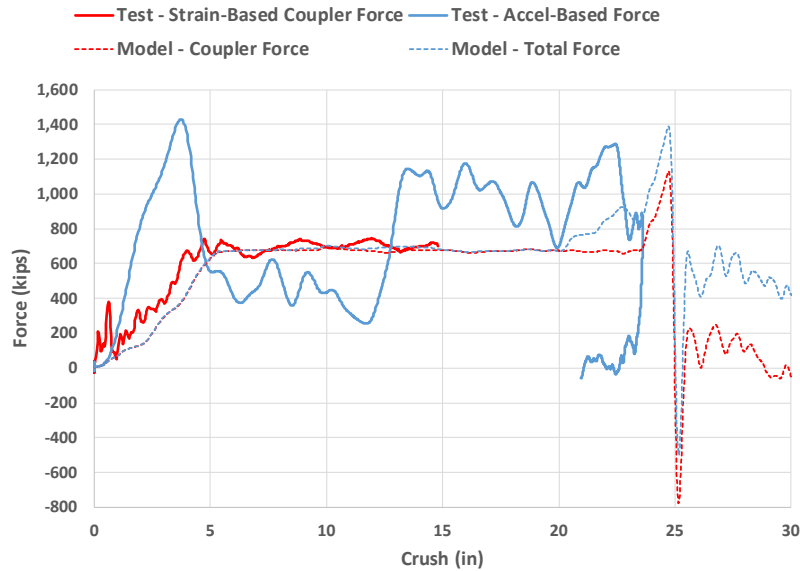
Figure 42 shows the force versus crush through the carbody and through the coupler, from both the pre-test prediction and the test data. The solid blue line is the accelerometer-based force from the longitudinal center of the underframe. The solid red line is the strain-based force from the coupler shank, which gives a better estimate of the force through the push-back coupler. As seen in the figure, the average force through the CEM locomotive carbody (solid blue line) increases considerably — from an average of about 450 kips (when the PBC deformation tube alone was absorbing energy) to an average of about 1,000 kips (when the DAC assembly was impacted). While the estimated carbody force was about 450 kips during the PBC deformation, the coupler force (solid red line) was approximately 670 kips — the designed force level for PBC pushback. A comparison of test/model force-crush behavior (Figure 42) indicates that, in the test, the DAC tubes began to absorb collision energy much earlier than in the model. As noted, this was

primarily due to the 10.5” or so of travel prior to loading the push-back coupler system, which caused the DAC assembly to engage earlier relative to PBC crush.

Note that while the early engagement of the DAC likely prevented shear bolt failure at this test speed, it nonetheless contributed significantly to energy absorption.

**Figure 42. Left — comparison of calculated test/model force crush curves (coupler only and total)**

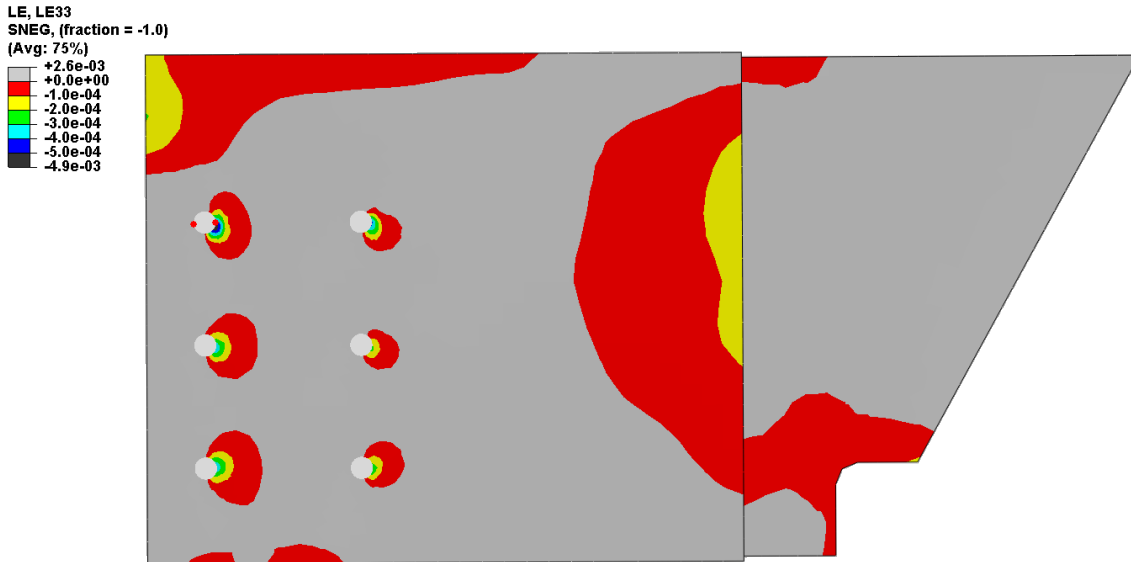
A contour plot of longitudinal strain in the draft pocket side plate (see [Figure 43](#)) during PBC pushback indicates that the model predicted smaller strain levels than were measured in the test (see [Table 1](#)). The strain levels were greater near the forward bolt holes — also contrary to test results which indicate that they were about the same. Note that the use of connector elements to define the shear bolts likely detracted from the accuracy of predicted strain levels in the region of the bolts, as it was difficult to determine their influence on the stiffness of the structures surrounding the bolts.

**Figure 43. Left — contours of strain on the side of the draft pocket during deformation tube stroke**

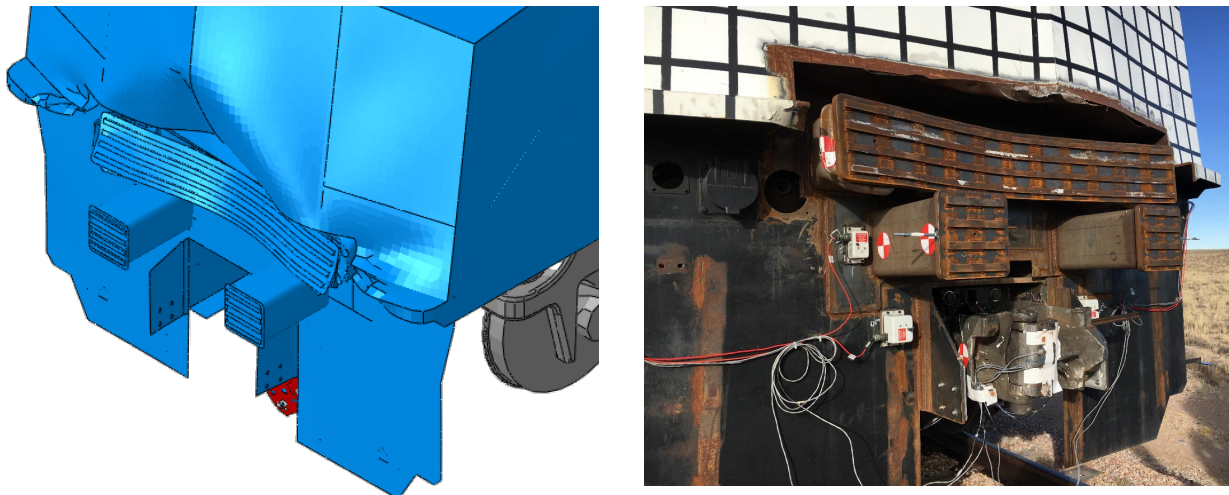
The predicted mode of deformation of the top DAC assembly appeared to be very consistent with test results, as shown in [Figure 44](#). The model did not, of course, pick up the side-side variation in crush due to the ~2” lateral motion following impact. The much greater predicted extent of crush of the nose of the short hood was consistent with the much more extensive predicted crush of the DAC (13.5” in the FE model vs. 10” in the test) due to the higher target speed versus actual test speed.

**Figure 44. Comparison of FE model prediction of CEM end frame mode of deformation with post-test photograph of the end frame (right)**

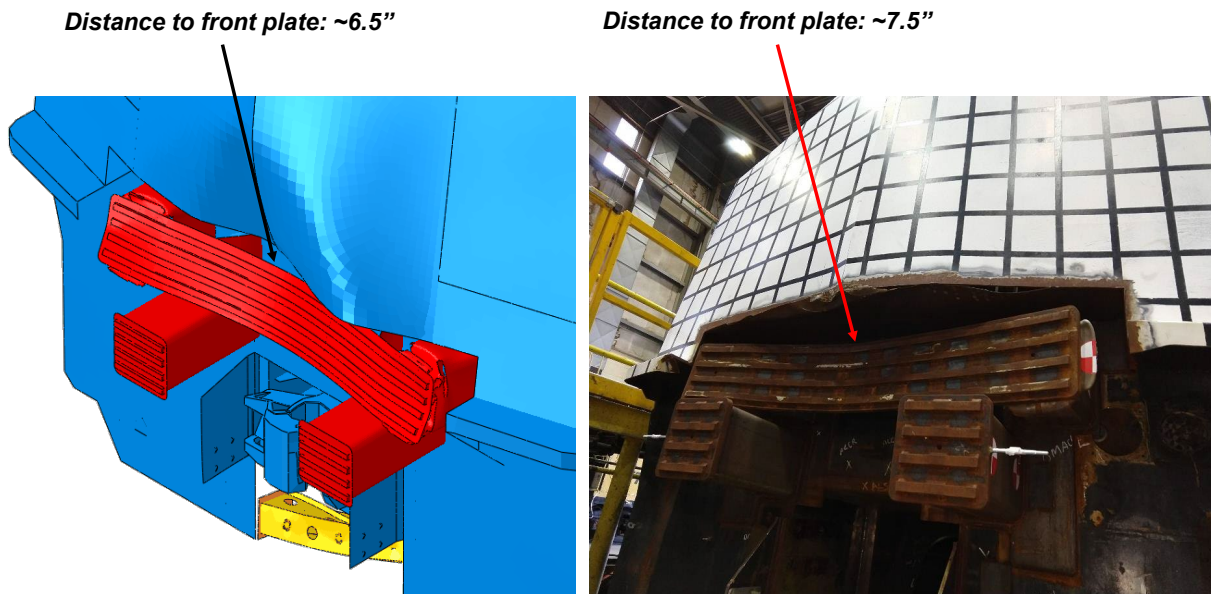
Aside from the PBC deformation tube, most of the deformation that occurred was, by design, concentrated in the DAC. Predictions of DAC deformation are compared with test results in [Figure 48](#). As is evident, the model appeared to capture quite well the deformation of the upper DAC tubes, which crushed and rotated upwards during the collision. The deformation at the center of the DAC was predicted to decrease the distance from the DAC plate to the end plate of the locomotive from 18.875" to about 6.5", i.e., about 12.4" of crush. The post-test measured distance was determined to be about 7.5" at this location, indicating a total crush of about 11.4". Part of this 1" difference may be attributable to the lateral offset of the impact.

**Figure 48. Comparison of predicted DAC deformation with test results**

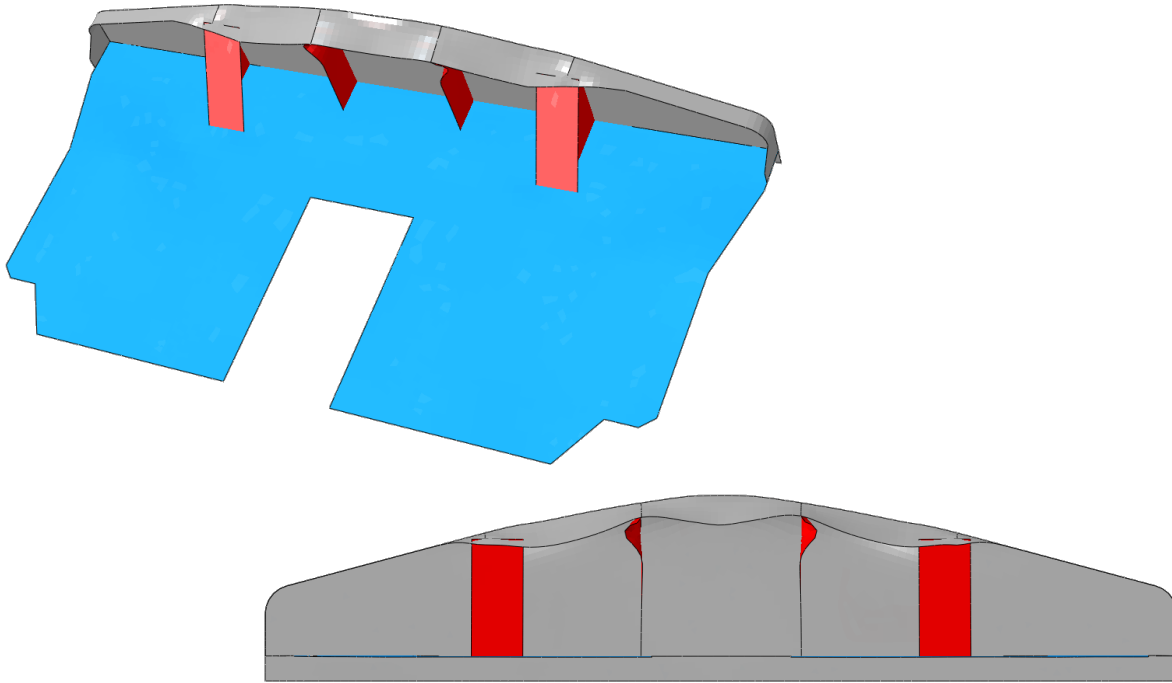
The FE model also predicted some deformation of the conventional locomotive anti-climber gusset plates, as illustrated in [Figure 49](#). This did not appear to have occurred during the test.

**Figure 49. Predicted deformation of conventional locomotive anti-climber apron and inner gusset plates**

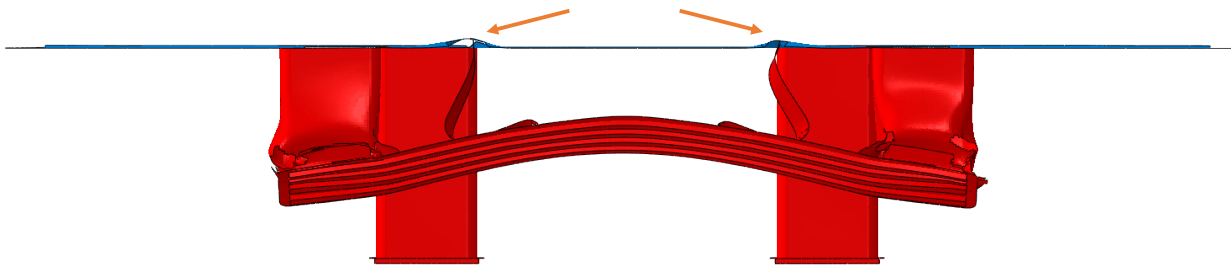
The damage in this area was consistent with pre-test model predictions which indicated high levels of plastic strain in this region prior to folding of the angle support plates, as shown in [Figure 51](#).

**Figure 51. Detail of deformed CEM locomotive at the end of the simulation of V2VT1 showing plastic deformation at the top of the welded connection of the angled support plate to the end plate, as indicated**

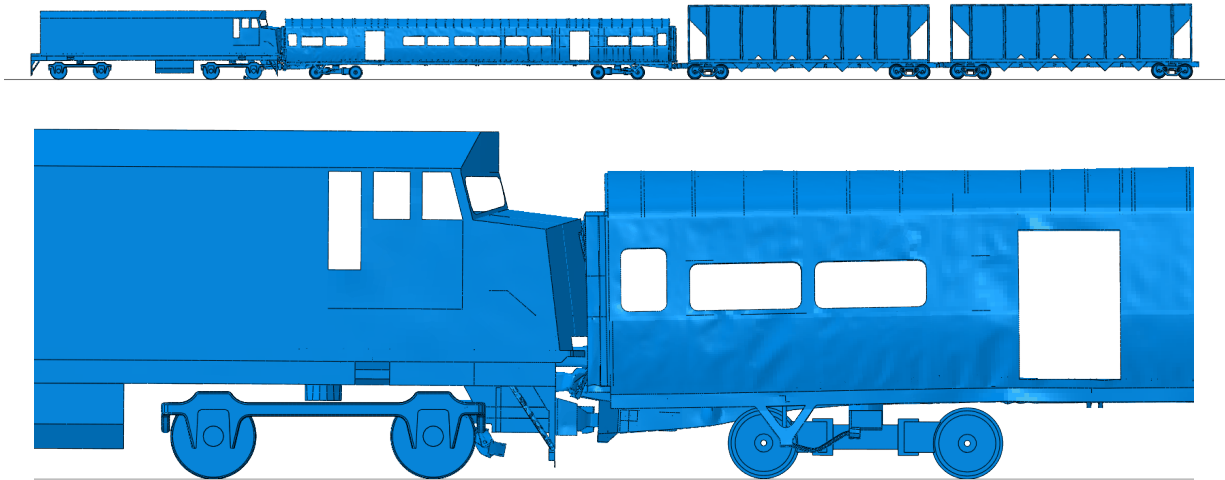
The FE model was modified accordingly. In addition, the model was revised to allow for yaw rotation of the impacting couplers to ensure that such motion did not hinder the activation and complete push back of the PBC. FE results with the modified model indicated the minimum speed at which the shear bolts are predicted to fail is 29 mph. At this speed, a desirable outcome was achieved, in the sense that all the key objectives of the test were predicted to be met. A side view showing the predicted deformation at the end of the analysis (0.25 seconds) is shown in [Figure 58](#), and indicates that localized deformation at the forward side door is minimal, and the cab car truck wheels do not lift off the rail.

**Figure 58. Predicted results for FE model with retrofit plywood flooring and coupler yaw rotation during impact at 29 mph collision speed: top — a side view showing all vehicles; bottom — a detailed side view showing the impacting CEM locomotive and cab car**

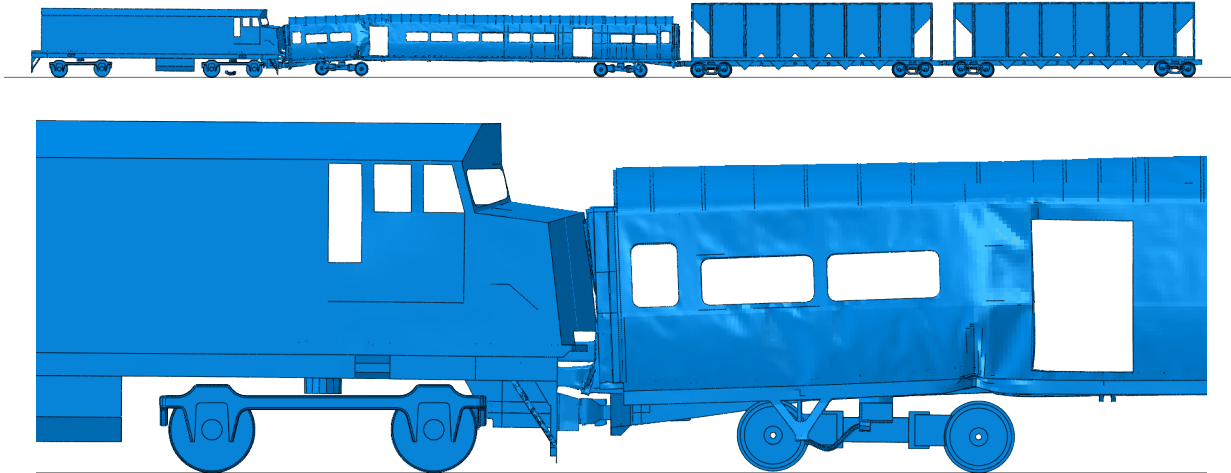
Interestingly, at 28 mph, the outcome of the test was less desirable. The deformation tube of the PBC was fully exhausted, but the impact of the PBC against the sliding lug was not sufficient to fail the shear bolts. Instead, the load through the coupler gradually began to drop. Simultaneous with the drop in load was the formation of a buckle in the underframe of the cab car, near the front side door openings (see [Figure 59](#)). This seems to have occurred because a sizable load was still being transmitted through the coupler as another large load built up in the DAC. These two loads acting in parallel became greater than the cab carbody could withstand, particularly at the door opening, where the strength of the carbody cross-section was weakened. At this speed, the forward wheel was predicted to rise, but only by a few tenths of an inch, far less than predicted when the flooring had been removed.

**Figure 59. Predicted deformation at 28 mph collision speed: top — a side view showing all vehicles; bottom — a detailed side view showing the impacting CEM locomotive and cab car**

[Figure 89](#) shows still images from the overhead standing drone video taken: (1) near the point of maximum crush and (2) after elastic rebound (i.e., close to a state where the post-test photographs were taken). These images are consistent with the model results shown in [Figure 59](#), and further indicate an extent of rebound that appears to be 12" to 15" (note that the grid on the locomotive hood is 6" x 6").

Because the FE model predicts an abrupt change in behavior between 28 and 29 mph, and because it seems prudent to provide a “cushion” that accounts for potential inaccuracies in FE model predictions, researchers decided to increase the minimum acceptable test speed to 31 mph and, accordingly, increase the target speed to 33 mph. The predicted deformation at the target speed is shown in [Figure 60](#). At this speed, there was substantial deformation in both the CEM and the cab car end structures, and the predicted extent of energy absorption in the DAC (710 ft-kips) was well above the 300 ft-kip target.

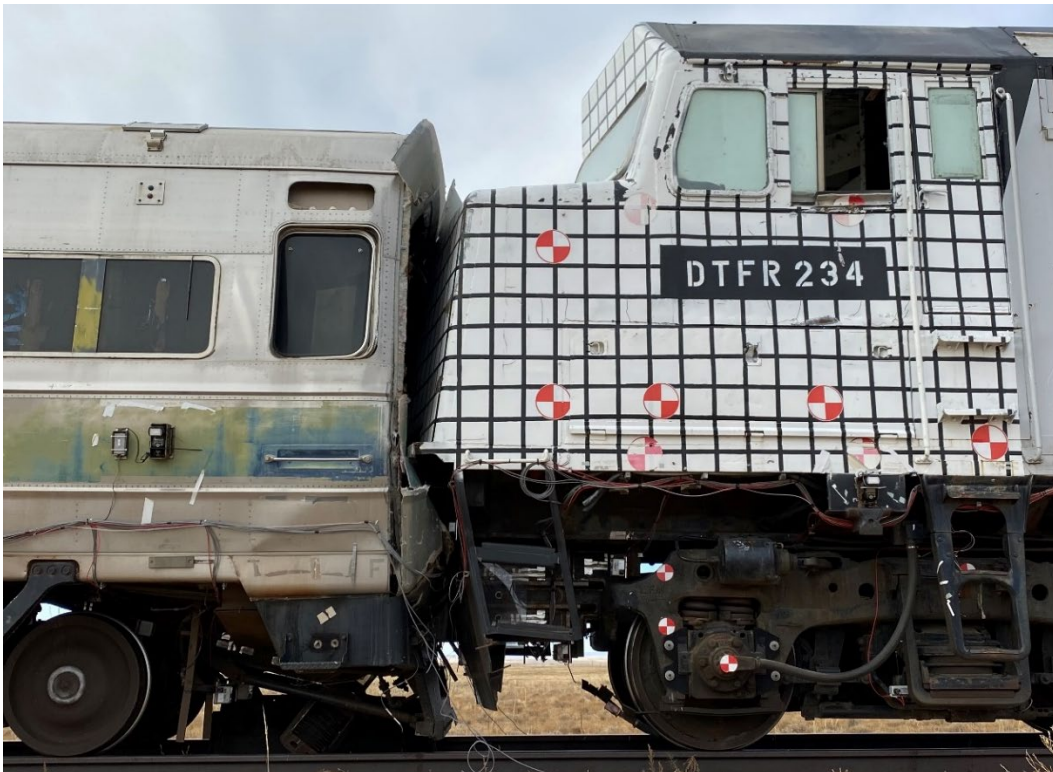
On the day of the test, the weather conditions were clear with low winds. Both couplers were left closed, and the couplers were aligned within 1” vertically. [Figure 63](#) is a pre-test photo of the impact interface. The target impact speed was 33 mph, and the actual impact speed was 32.8 mph. [Figure 64](#) shows the impact interface after the test. The vehicles were kept in-line. There was no derailment of the vehicles and no override.

**Figure 64. Post-test photo of the impact interface**

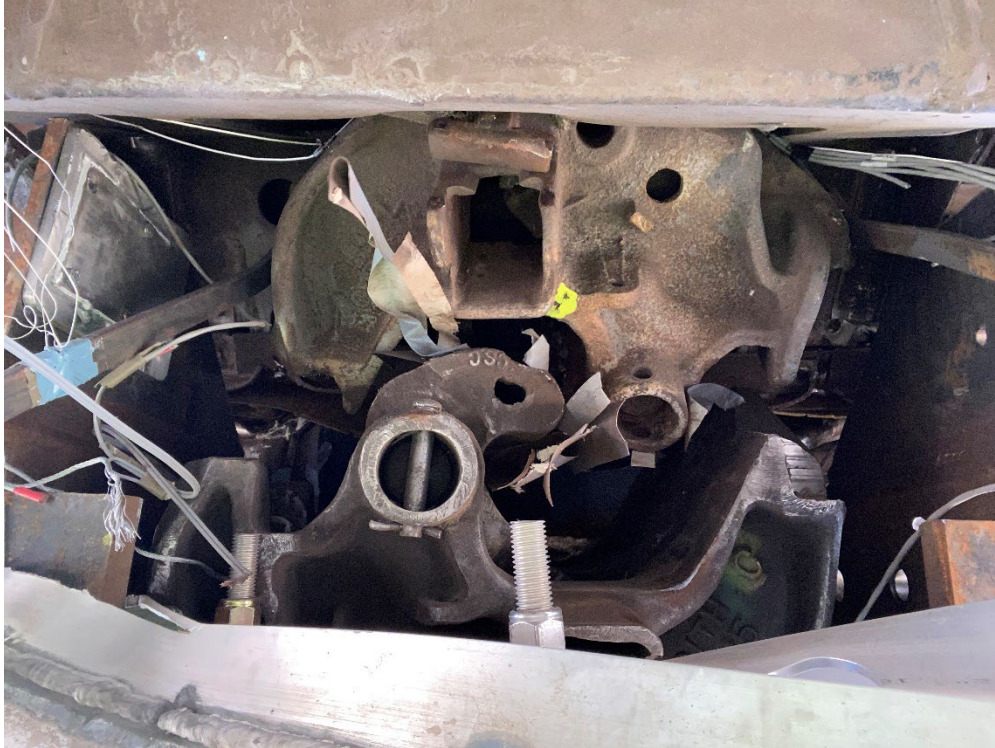
Prior to the impact, the two impacting couplers were set to their “closed” position, which was expected to maximize the extent of PBC stroke prior to DAC engagement, thereby reducing the time during which collision loads acted in parallel through both components. During the test, the closed couplers engaged at impact and the knuckle of the cab car coupler fractured. It appeared that the knuckle of the CEM locomotive pushed past the vertically oriented split in the cab car coupler knuckle and seated against the back of the coupler head, as if the couplers had been open prior to impact, as can be seen in [Figure 65](#).

**Figure 65. View of impacting couplers from below: M1 coupler on top, CEM loco coupler on bottom**

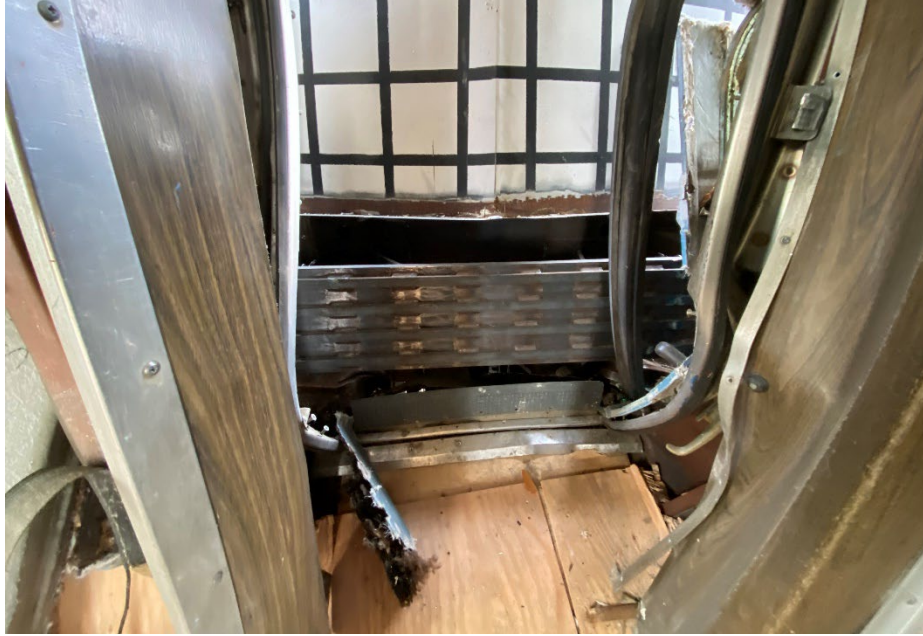
At this point in the collision, the top DAC tubes impacted the end frame of the M1, causing the M1 collision posts to deform inward, as seen in [Figure 66](#) and from inside the M1 in [Figure 68](#). The PBC head continued to move back and the deformation tube was expanded along its entire stroke of 21", as shown in [Figure 69](#). This was confirmed by evidence of contact between the limit stop mounted on the sliding lug and the rear of the PBC head, as shown in [Figure 70](#). This contact was designed to occur at the full stroke of the PBC.

**Figure 68. The view from inside the M1, looking at the CEM locomotive, before the vehicles were separated**

The collision posts of the cab car folded back due to impact by the upper DAC plate, as seen in [Figure 68](#). Measurements indicated that the posts intruded into the vestibule of the cab car by about 29". [Figure 80](#) shows the damage to the end frame of the M1. Both the coupler and the bellmouth ended up tilted upward, as seen in the photo. This was due to the M1 draft sill buckling. The draft sill deformed downward by about 15", as shown in [Figure 81](#).

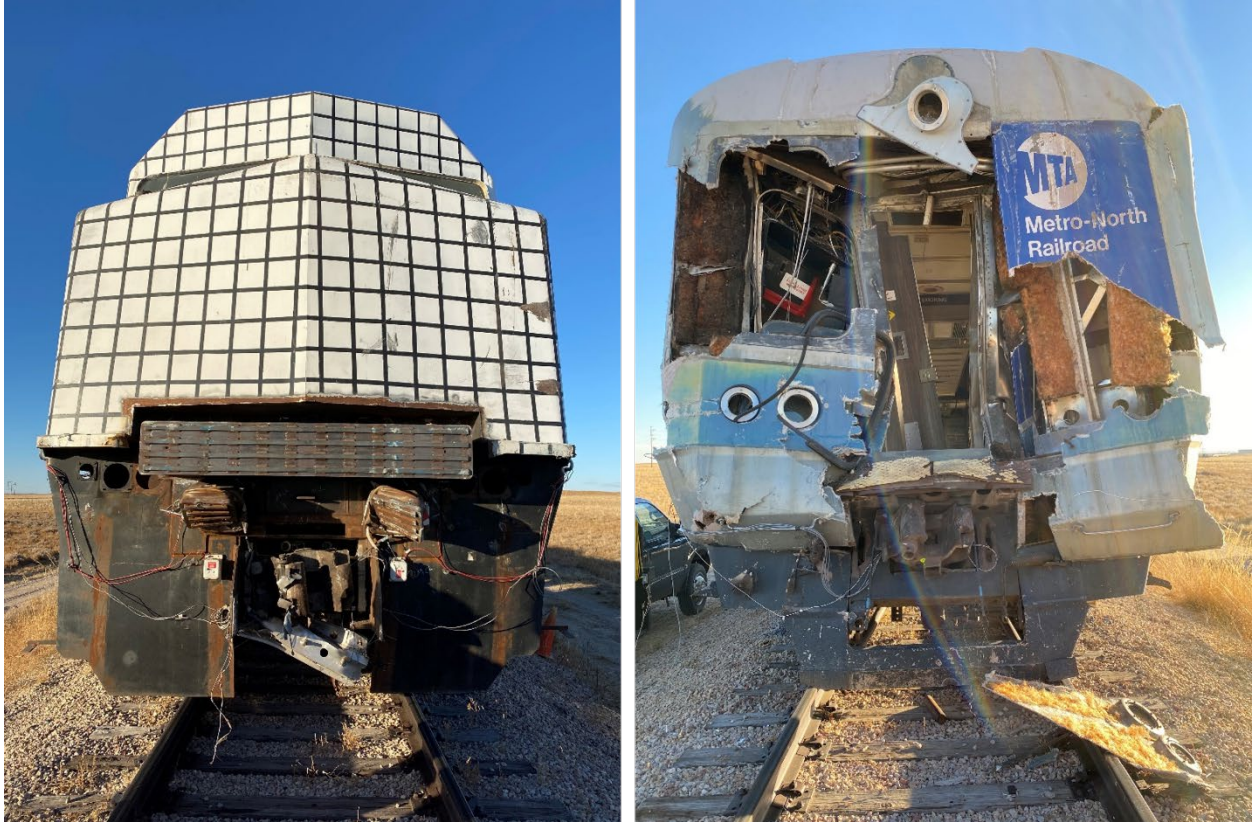
After the test, the vehicles were pulled apart. [Figure 72](#) shows the post-test impact interface of both vehicles.

**Figure 72. Post-test impact vehicles: CEM locomotive (left), M1 cab car (right)**

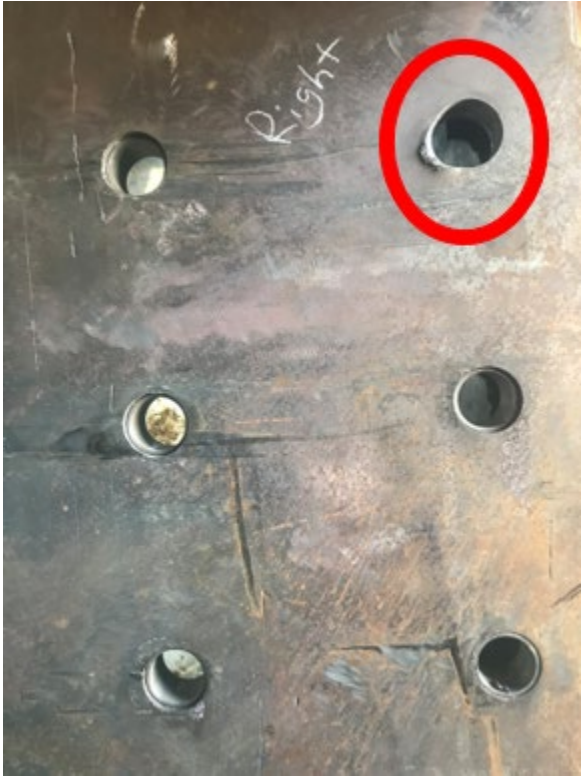
All shear bolts broke, but one (#5) did not break as cleanly as the others, as shown in [Figure 75](#). This caused some damage to its draft pocket bolt hole, as shown in [Figure 76](#). No damage was imparted to the corresponding bolt hole in the sliding lug.

**Figure 76. Draft pocket deformed bolt hole**

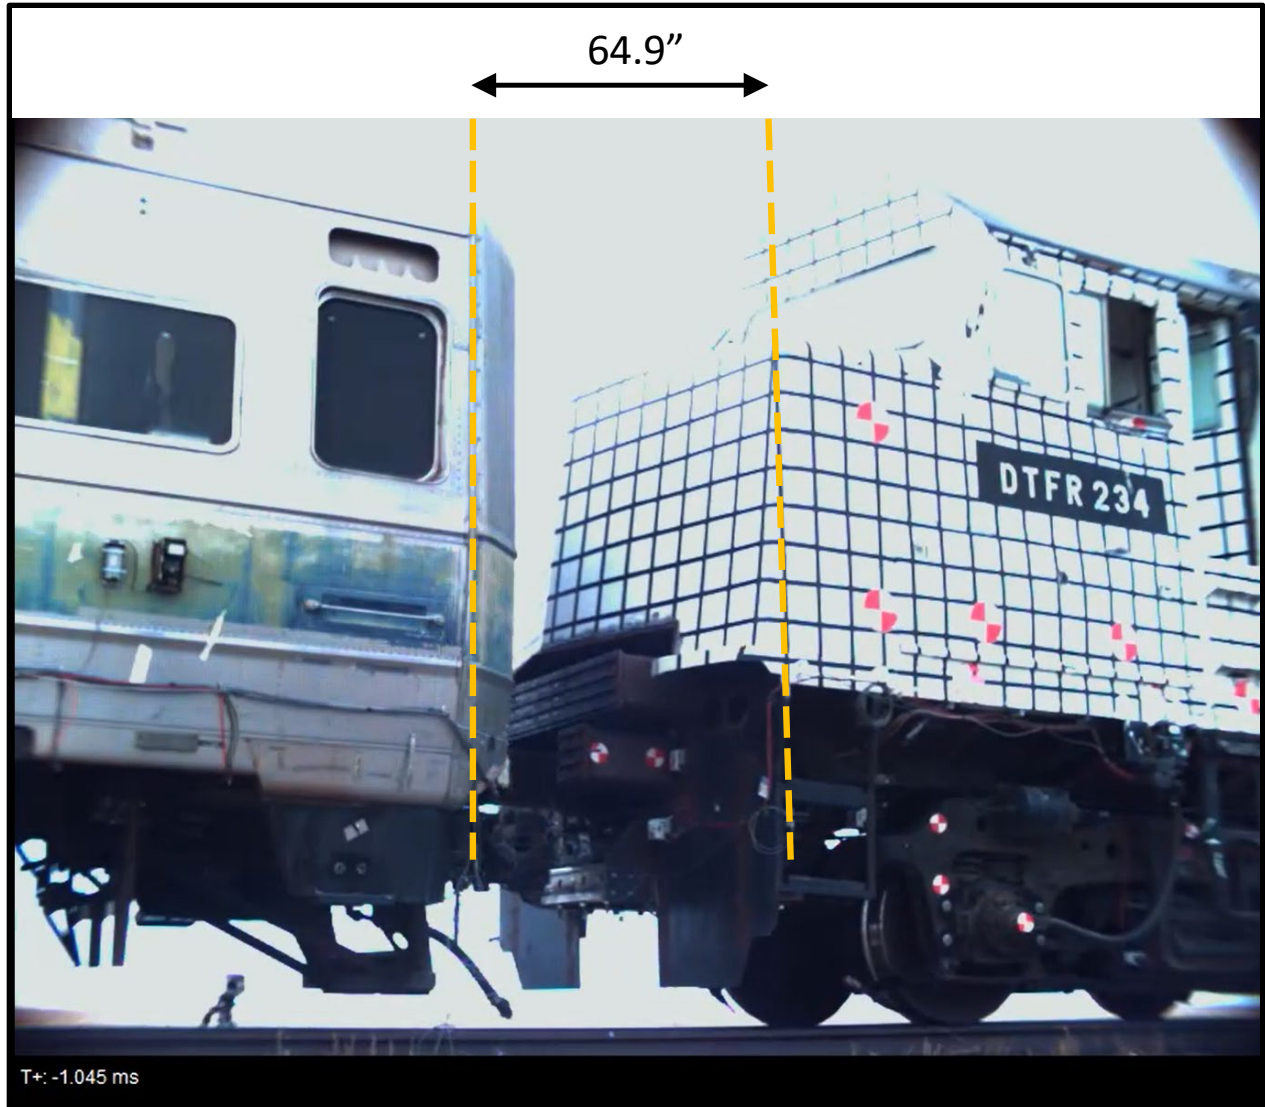
[Figure 87](#) shows an image made just before impact. The image is annotated with dashed yellow lines, indicating distinct longitudinal reference points on each of the respective vehicles: the top-front left corner of the locomotive hood and the end of the cab car side wall/side sill, where the cladding becomes rounded. Dimensions taken from the FE model indicate that this distance is approximately 64" at impact. (The indicated distance of 64.9" takes into account about 0.6" of pre-impact travel at 32.8 mph over 1.045 msec). The image in [Figure 88](#), from a high-speed test video taken about 280 msec after impact, clearly shows these two longitudinal reference points to be effectively coincident, indicating that the maximum crush was about 64". In the figure, the top-front corner of the locomotive hood has been pushed all the way to the end of the side wall of the cab car, where the cladding begins to curve inward at the forward end of the vehicle.

**Figure 87. Image from high-speed video annotated to indicate the distance just prior to impact between reference points on each vehicle.**

Post-test measurements indicated that the extent of crush between the CEM locomotive and the cab car was between 45.6” and 51”. Video evidence (see [Figure 87](#) through [Figure 89](#)) indicated that the maximum penetration of the end frames was about 64”, with an extent of rebound in the range of 12” to 15”, yielding a crush of 49” to 52”.
