U.S. Department  
of Transportation  
Federal Railroad  
Administration

## Locomotive Crash Energy Management Vehicle-to-Vehicle Tests 1 & 2: Analyses and Test Results

<b>1. REPORT DATE (DD-MM-YYYY)</b> 9/9/2022	<b>2. REPORT TYPE</b> Technical Report	<b>3. DATES COVERED (From - To)</b> 8/24/2018–5/10/2022
--	---	--

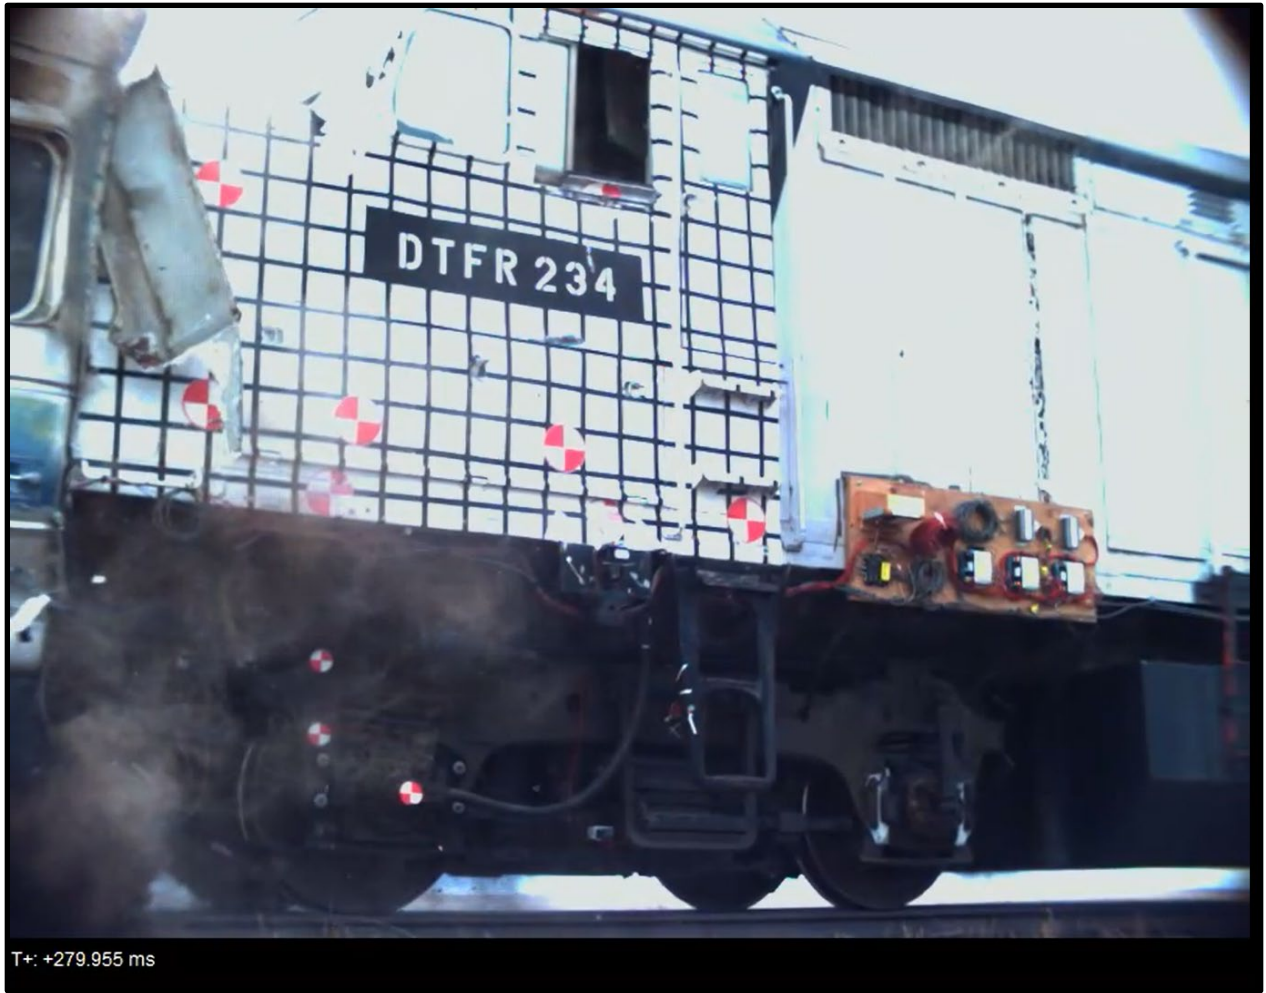
High-speed videos provided another indication of total crush. Images shown in [Figure 87](#) and [Figure 88](#), taken from one of the high-speed videos ("East Iso.mp4"), give a clear indication of the extent of crush between the end structures of the CEM locomotive and the cab car.

Figure 88. Image taken from a high-speed test video (approximately 280 msec after impact)

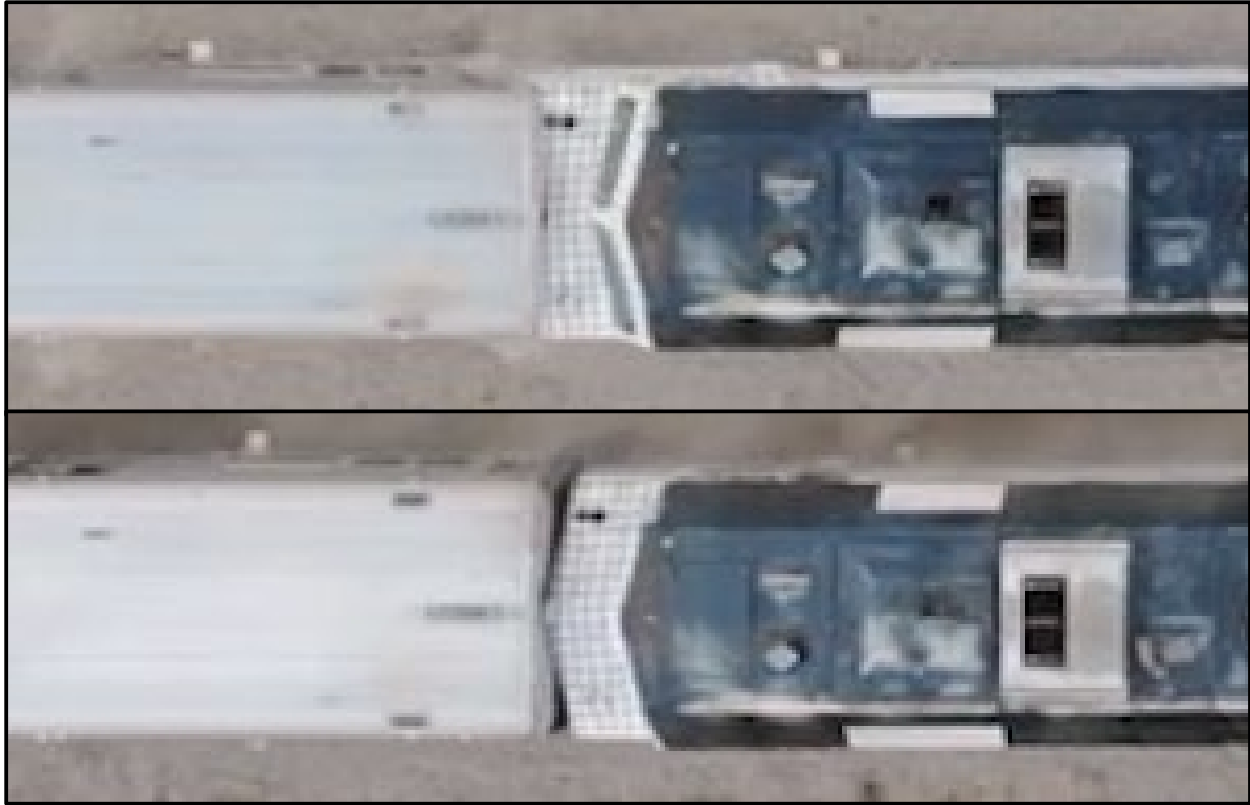
[Figure 89](#) shows still images from the overhead standing drone video taken: (1) near the point of maximum crush and (2) after elastic rebound (i.e., close to a state where the post-test photographs were taken). These images are consistent with the model results shown in [Figure 59](#), and further indicate an extent of rebound that appears to be 12" to 15" (note that the grid on the locomotive hood is 6" x 6").

**Figure 89. Still images from the overhead standing drone taken near the point of maximum crush (top) and after elastic rebound (bottom)**

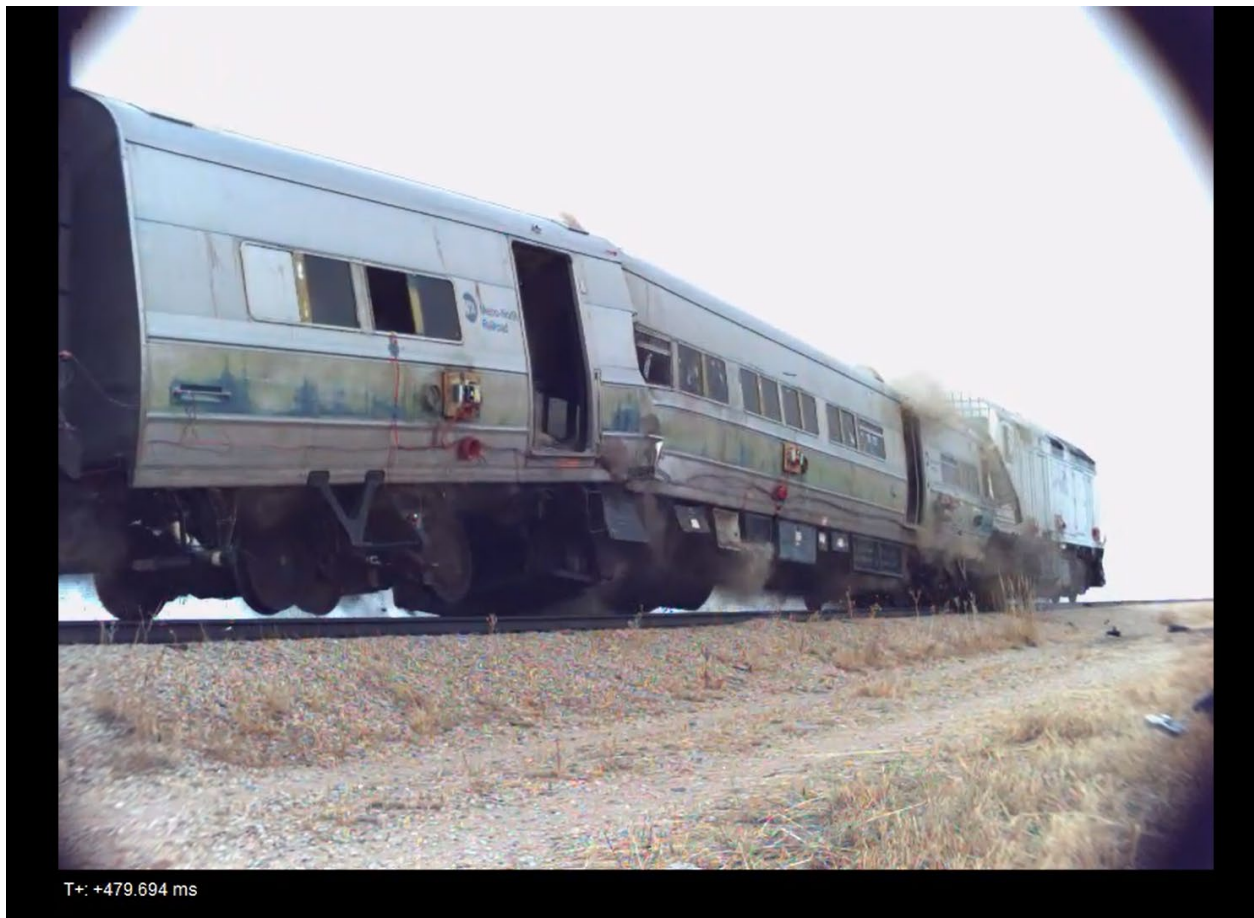
Further analysis of the “South.mp4” video indicated the buckle in the cab car underframe/body began to grow at about 140 msec after impact, peaking between 420 msec and 480 msec, and then decreasing. The absence of any significantly large acceleration signals during this time suggests that the growth of the buckle occurred at a very small longitudinal force, which was not surprising given the magnitude of the buckle, which appeared to be well over 18” and may have reached 2’ at its peak.

**Figure 95. Image captured from high-speed video approximately 480 msec after impact, showing the upward folding of the cab carbody at the induced buckle just forward of the rear doors, causing the rear truck wheels to lift off the rail**

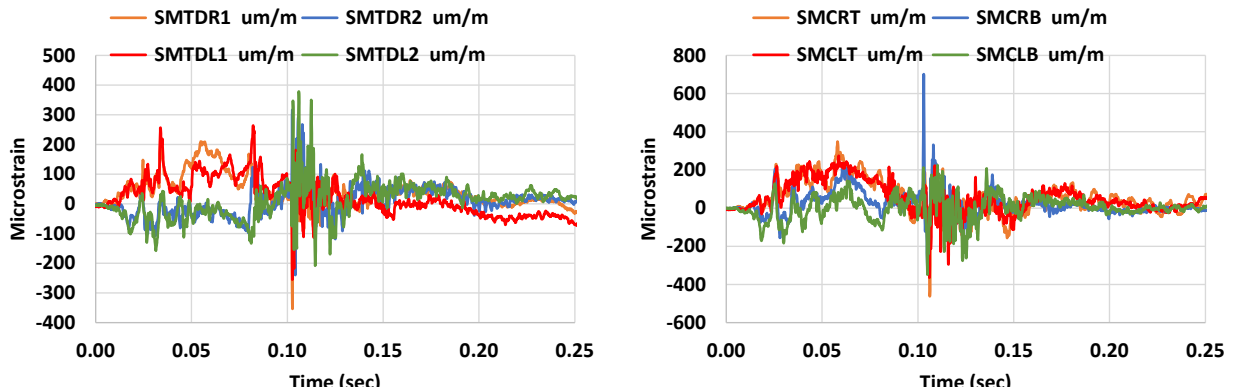
**Figure 99. Left — time-histories of strain near the top of the draft pocket side plates (‘1’ front and ‘2’ rear); right — time histories of strain along the web of the underframe main I-beams (‘T’ top and ‘B’ bottom)**

Time-histories of strain near the top of the draft pocket sides plates (one positioned near the front of the side plate and one near the rear) are shown at the left in [Figure 99](#). Time-histories of strain along the web of the underframe main I-beams, near where the lifting pads are positioned, are shown at the right. All these measured strains were relatively small, roughly 200 microstrain, until the sliding lug impacted the back of the draft pocket at about 0.105 seconds, at which point there was a large impulse applied to these strain signals. Prior to this impact, the strain levels at the front draft pocket side plate appeared to be compressive, while those at the back were tensile. The strain levels along the web of the main I-beams were mostly tensile, with the strain levels near the top of the web having a higher magnitude. It was difficult to draw conclusions based on these results, given the gradients in stress in these regions and the small magnitude of these strains. Nonetheless, they appeared to be consistent with FE model predictions, as discussed in [Section 7.2](#).

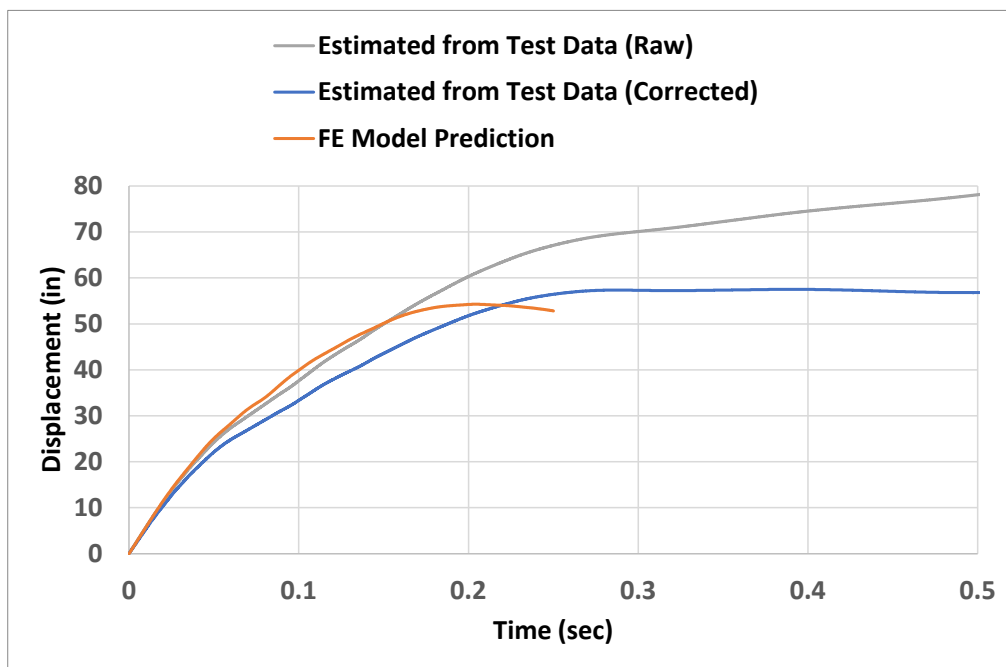
**Figure 100. Comparison of predicted relative displacement vs. time curve with raw and corrected estimates obtained from test data**

[Figure 100](#) shows the predicted relative displacement vs. time curve compared to both the raw and corrected estimates of relative displacement obtained from test data by double-integrating the longitudinal acceleration curves measured at the respective centers of each vehicle underframe, and then subtracting one from the other. Interestingly, while the corrected curve matched the predicted final crush reasonably well, the FE model prediction was actually more consistent with the uncorrected curve through the first 0.16 seconds following impact. It may have been the case that the longitudinal acceleration response of the cab car was affected by the buckling of the cab car underframe/body, which began at about this time.

The FE model's under-prediction of crush by about 10" was likely due to three factors:

1. The 7" of additional travel of the impacting couplers with little energy absorption prior to knuckle failure
2. The additional cab car end frame deformation that arose because the collision posts were weaker than anticipated.
3. The shortening of the cab car associated with the crippling of the carbody.

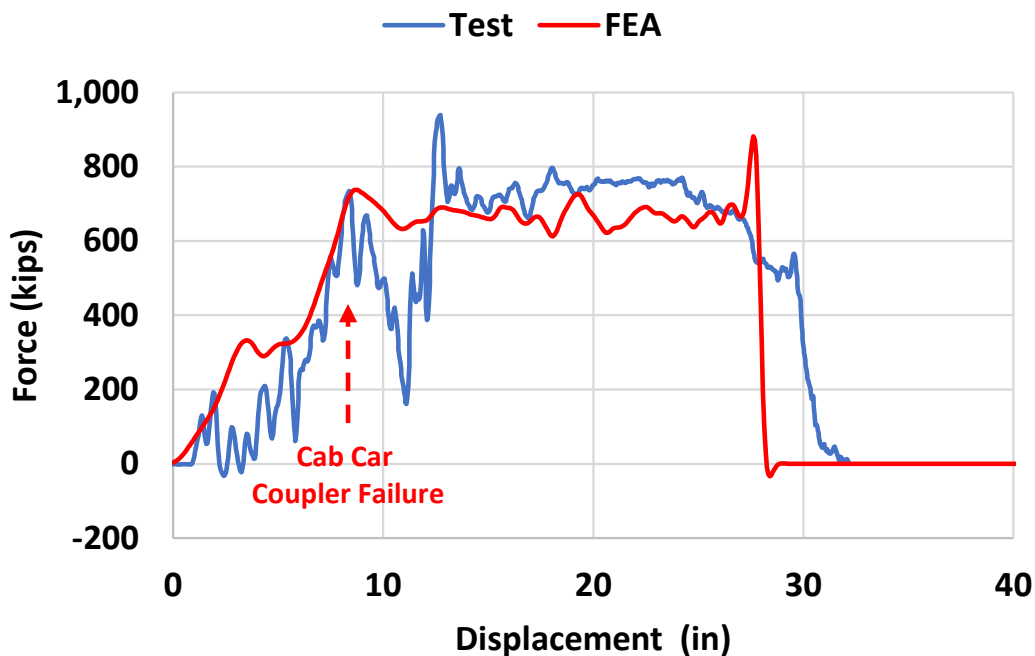
**Figure 101. Comparison of force through the CEM coupler estimated based on coupler shank strain gage readings (see Figure 96, left) with FE model predictions**

As noted above, the noise in the acceleration signals made it impossible to accurately estimate the total collision force. Moreover, the drift in the signal led to differences in vehicle velocities late in the test, when the CEM locomotive and cab car were locked together, making it difficult to accurately determine the relative displacement time-history of the colliding vehicles. At best, the force through the coupler could be compared, which was equal to the total force prior to the lower DAC tubes impacting the cab car end beam. This comparison is shown in Figure 101. The comparison was made more difficult by the failure of the cab car knuckle, which produced a large up and down spike in load between 8" and 12" of displacement and also affected the displacements associated with activation of the deformation tube. Nonetheless, there is some level of consistency between the curves.

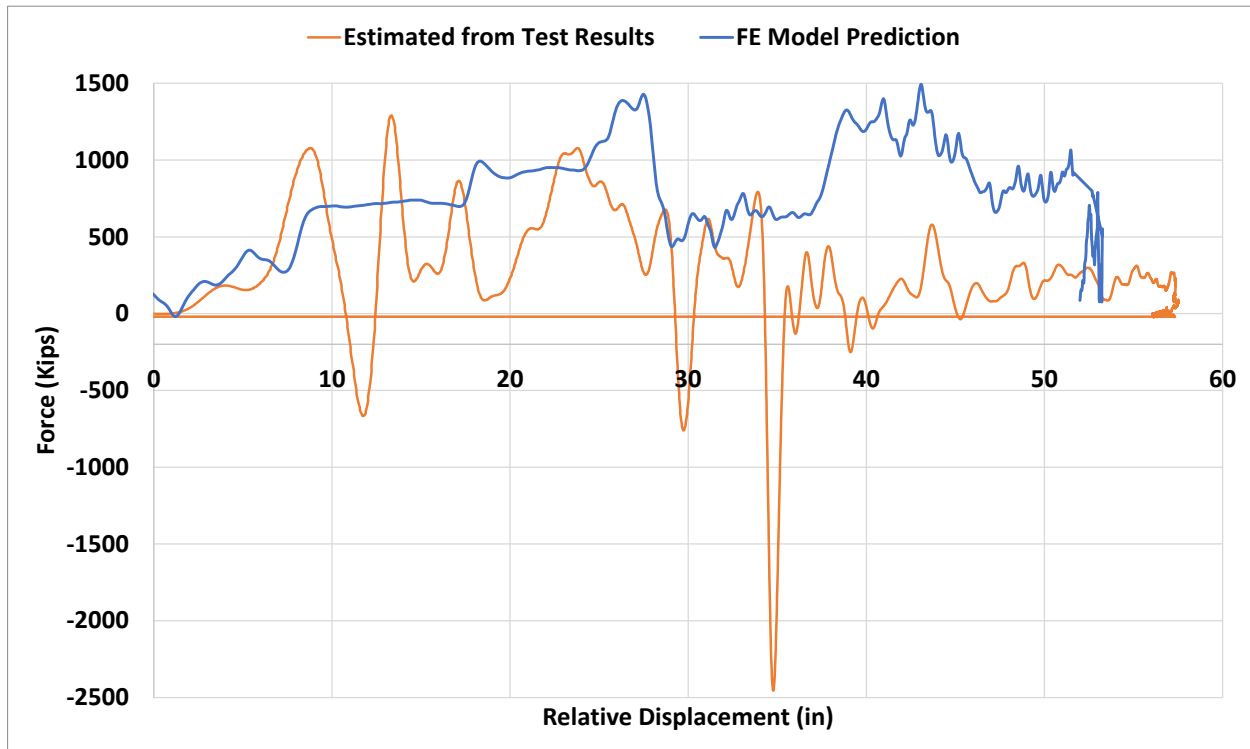
**Figure 102. Comparison of total force vs. displacement derived from CEM longitudinal acceleration pulse with FE model predictions**

For completeness, a comparison of the estimated total force vs. crush is shown in Figure 102. As is evident, and for the reasons listed above, there is little agreement between these curves. In addition to the oscillations present, it appears that the buckling of the cab car collision post, which likely occurred at about 24" of crush, completely changed the character of the subsequent

force-displacement behavior, as very little force was required to produce additional end frame deformation.

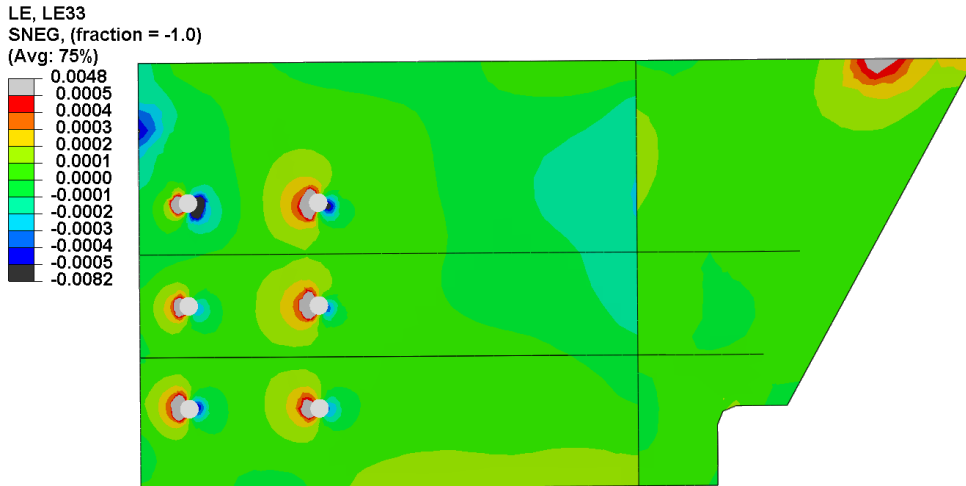
**Figure 103. Contours of strain on the side of the draft pocket during deformation tube stroke**

A contour plot of longitudinal strain in the draft pocket side plate during PBC pushback (see [Figure 103](#)) indicates the model predicted lower strain levels than were measured in the test, as was the case for VTVT1 (see [Table 3](#)). Strain levels were again greatest near the top-forward bolt hole, also contrary to test results. This is again likely the result of using connector elements to define the shear bolts and the associated difficulty in determining their influence on the stiffness of the structures surrounding the bolts.

The contour plot shows an area of compression near the top-front of the draft pocket side plate and an area of tension near the rear-top of the side plate. This is consistent with the test results. Because there was a sharp gradient away from the peak locations, it was not surprising the measured magnitudes were small.

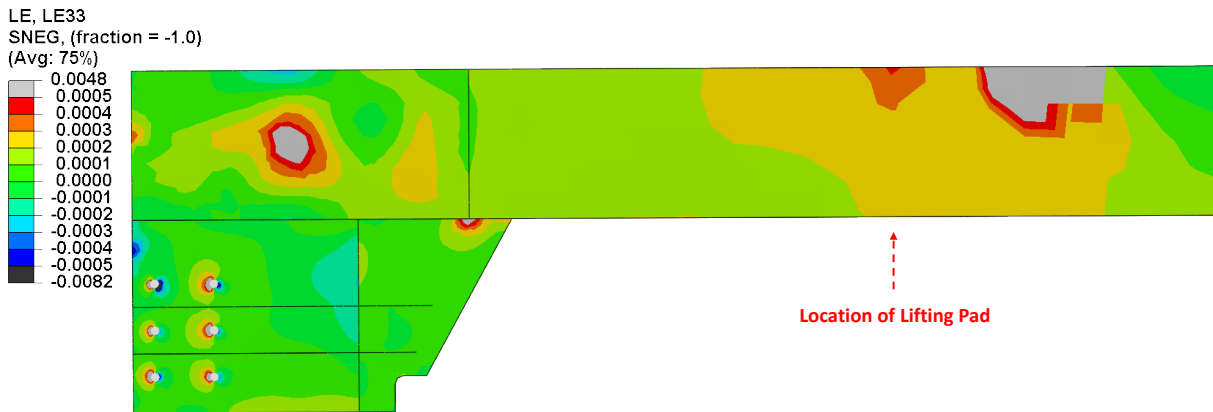
**Figure 104. Contours of strain on the side of the draft pocket during deformation tube stroke**

Expanding the contour plot to include the web of the underframe main I-beam (see [Figure 104](#)), it appeared there were pockets of tensile strain near the location of the lifting pad, as indicated. These pockets of tension, in the range 200 to 300 microstrain, seemed to be reasonably consistent with the measured values, but, because the values were small and the gradients sharp, it was not possible to make definitive conclusions regarding the consistency of model predictions and test results.

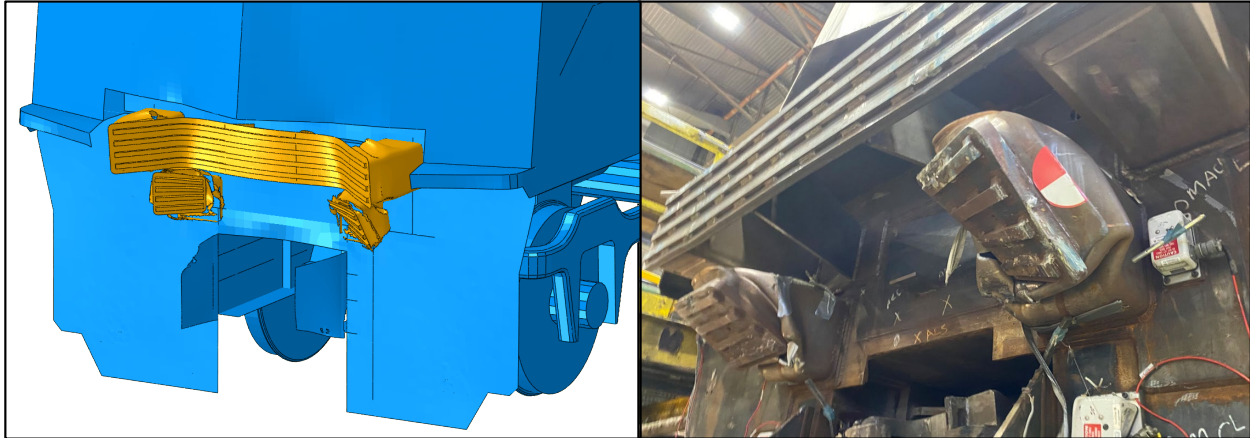
**Figure 105. Comparison of FE model prediction of CEM end frame mode of deformation with a post-test photograph of the end frame (right)**

As previously noted, key differences between the model predictions and the test results included the failure of the cab car knuckle, the extensive deformation of the cab car collision post with little deformation of the upper DAC tubes, and the crippling of the carbody near the rear door opening.

Figure 105 shows a comparison of predicted DAC crush with a post-test photograph. The noted differences are apparent. However, it appeared that the mode of deformation of the lower DAC tubes was consistent with the test result and was indicative of impact of the end beam with the lower inside regions of each lower DAC tube.

The damage to the CEM vehicle was reviewed with test site personnel. The lower DAC tubes experienced extensive damage and will be replaced prior to the next test. As noted, the upper DAC tubes appeared to have deformed very little during the test, with only minor scratches visible, and will not be replaced.

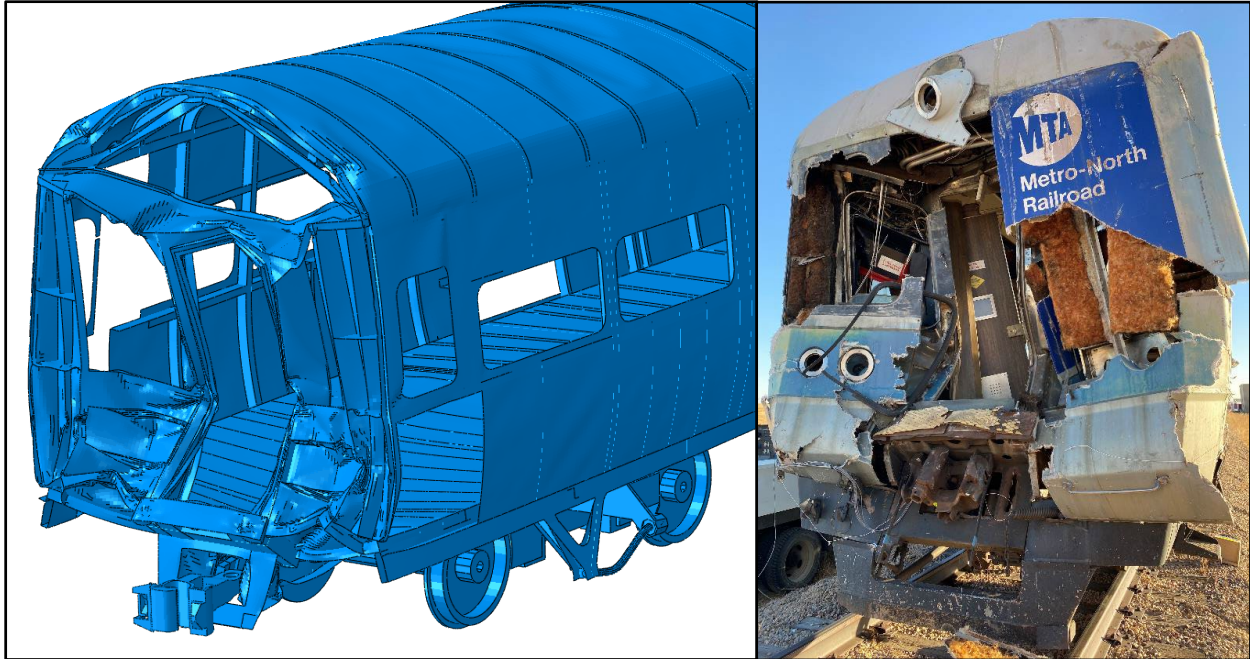
**Figure 106. Comparison of FE model prediction (left) of cab car end frame mode of deformation with a post-test photograph of the end frame (right)**

The end frame of the cab car deformed extensively, with the collision posts folding back due to impact of the upper DAC tubes, which did not deform extensively, indicating the collision posts could not support a load sufficient to initiate DAC tube-folding. Figure 106 shows a comparison of the predicted cab car end crush with a photograph of the crushed end. The predicted folding back of the collision post and associated rotation of the end beam was consistent with the test result.

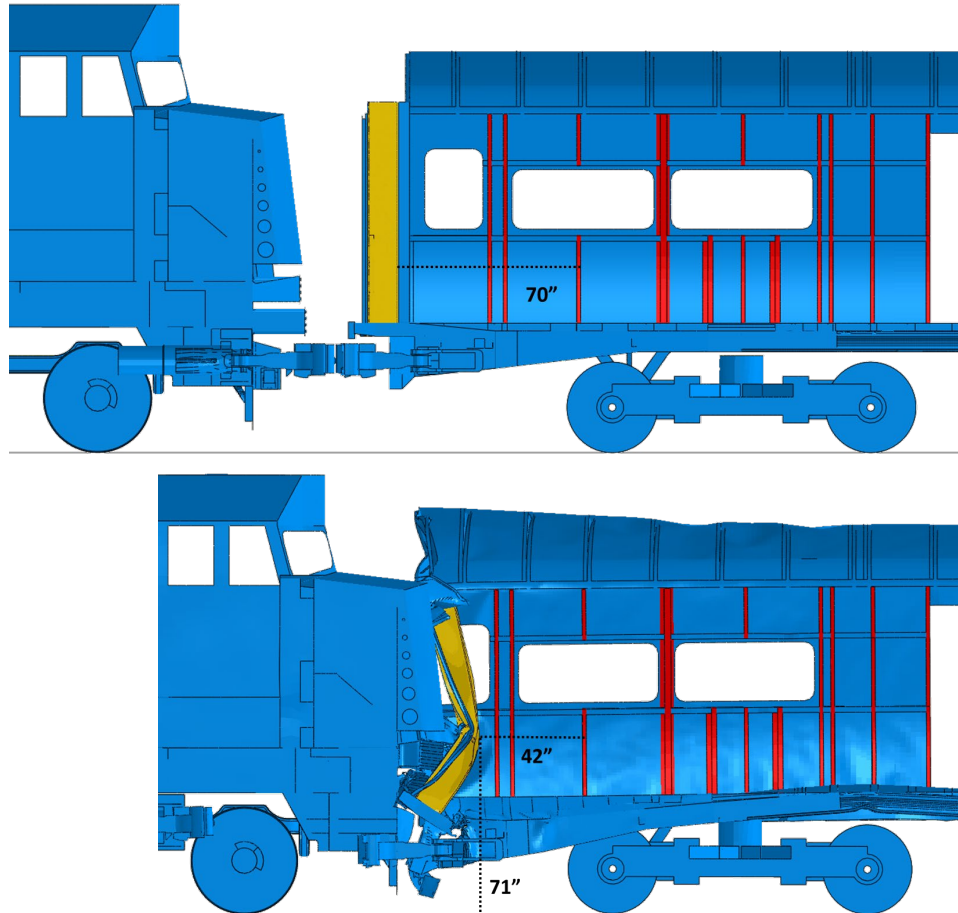
**Figure 107.** A graphic from the FE model showing the deformed cab, annotated with the undeformed distance from the back of the collision post to the middle of the endmost passenger window

A graphic from the FE model highlighting the undeformed distance (approximately 70") between the back of the cab car collision post to a vertical post below the middle of the endmost passenger window is shown at the top of [Figure 107](#). A similar graphic shown at the bottom in [Figure 107](#) highlights the predicted deformed distance (approximately 42") as well as the height above the rail (71") at which the maximum intrusion occurred. These results indicate that the predicted intrusion of the post into the vestibule of the cab car was about 28".

A post-test measurement indicated that the distance between these two points was 41.5" (compared to the 42" predicted distance). A further measurement indicated that the maximum intrusion occurred approximately 66" above the rail, about 5" less than the FE model predicted.

The deformed plot in [Figure 107](#) shows the draft sill was pushed down by the forces exerted upon it at the colliding interface. Post-test measurements indicated the minimum distance between the pushed-down draft sill and the rail was approximately 16" at a distance of 48" forward of the front wheel of the forward truck. The FE-predicted distance to the rail at this location was about 20.5". [Figure 108](#) shows a comparison of predicted draft sill deformation with a post-test photograph. The more extensive measured downward deformation of the cab car was likely the result of the more extensive deformation of the cab end relative to the model. The lower position of the fold in the collision post was consistent with this more extensive downward deformation.
