**DOT/FAA/TC-23/24**

# **Assessment of Emerging Metallic Structures Technologies through Test and Analysis of Fuselage Structure: Panel 2**

July 2023

Final report

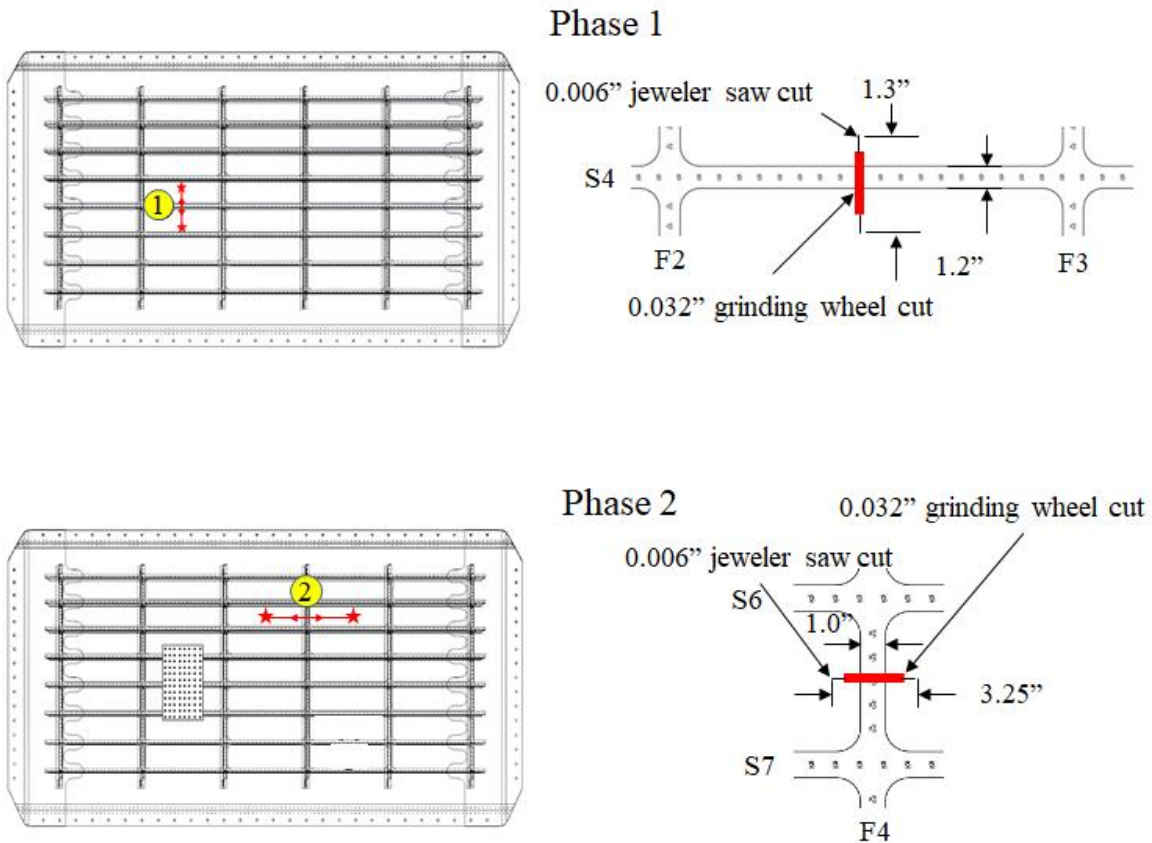
Figure 4. Initial damage scenarios used in the two test phases

**Phase 1:** Initial damage consisted of a crack-like notch having a length of 1.3 in. in the circumferential direction spanning two skin bays between frames F2 and F3, with the central stringer S4 severed (see Figure 4 Phase 1). Strain surveys were conducted to ensure proper load introduction. The panel was then fatigue tested under loads representing pressure, flight maneuver and gust accelerations, and landing loads in the forward crown section of a single-aisle aircraft. Fatigue testing was conducted until the crack extended to a final total length of 11.3 in. Afterwards, a limit load test was conducted, during which the panel was subjected to approximately 2.5 g axial load while holding the pressure constant under operational conditions. The panel was then repaired for follow-on phases (Appendix B).

**Phase 2:** Initial damage consisted of a two-bay longitudinal crack-like notch between stringers S6 and S7, with the central frame/shear tie F4 severed, as shown in Figure 4, Phase 2. A 3.25 in. long notch was inserted with the underneath frame severed. Initial strain surveys and finite element analysis (FEA) were conducted to ensure proper load introduction and to verify no effects from the repairs made in Phases 1. The panel was then fatigue tested, simulating pressure-only operational conditions, until the crack extended to a final length of approximately 16 in. A residual strength test was finally conducted to failure, measuring the load-carrying capacity of the panel.

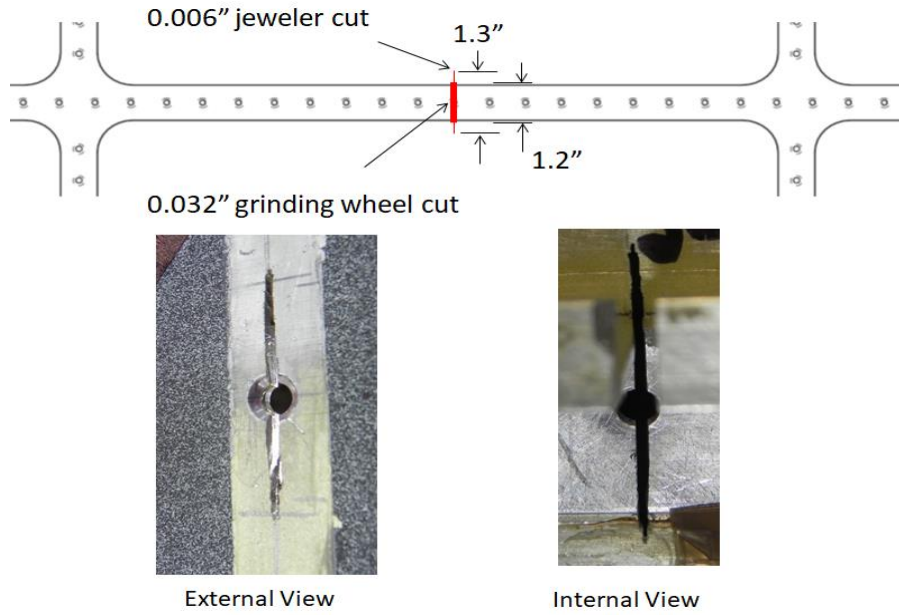
Figure 9. Configure of Phase 1 damage scenario

A central crack-like notch was machined in the skin above the severed stringer S4, which is 1.30 in. total length and 0.032 in. wide. The notch was centered about the removed fastener, having the geometry shown in Figure 9. Initial strain surveys were conducted to verify proper load introduction to the baseline panel and validate the FEA model. Representative results shown in Figure 10 reveal that axial strains measured at gages near the original notch-tip were in agreement with FEA results.

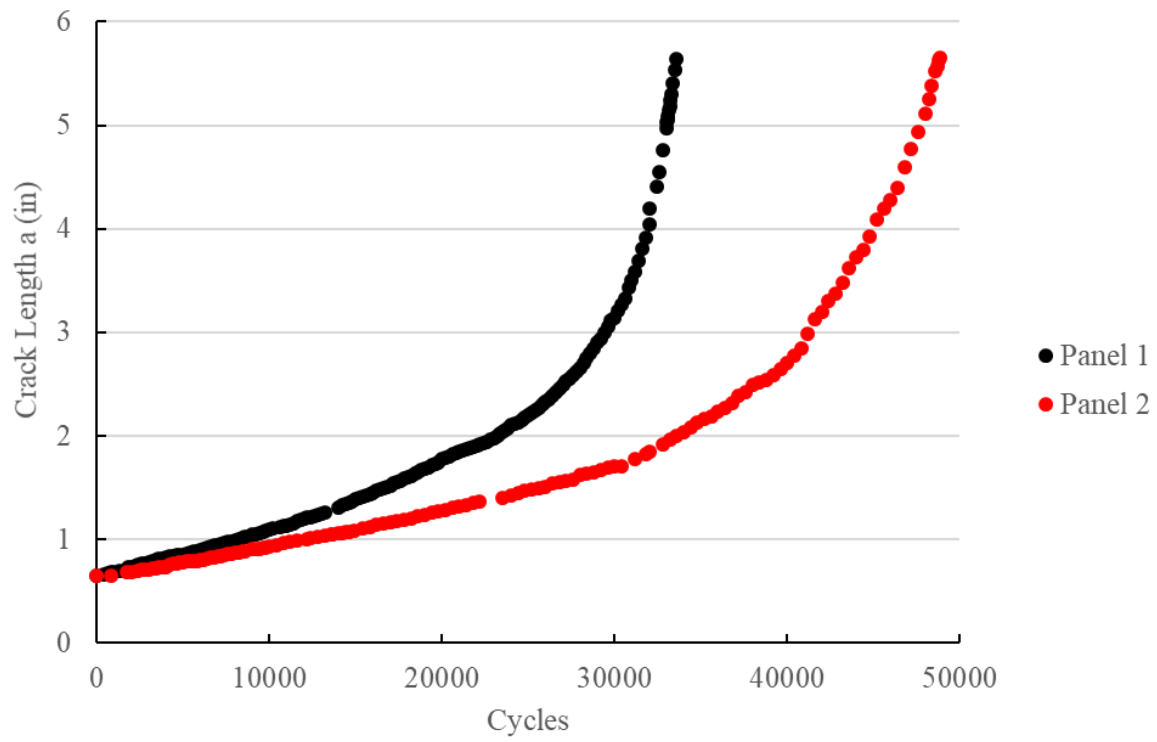
Figure 13. Circumferential crack growth comparison between panel 1 and panel 2

As shown in Figure 13, panel 2 exhibited better fatigue crack growth performance compared to panel 1. Crack extension occurred across two stringer bays to a final length of about 11 inches after 33,600 and 48,850 fatigue cycles in panel 1 and 2, respectively.

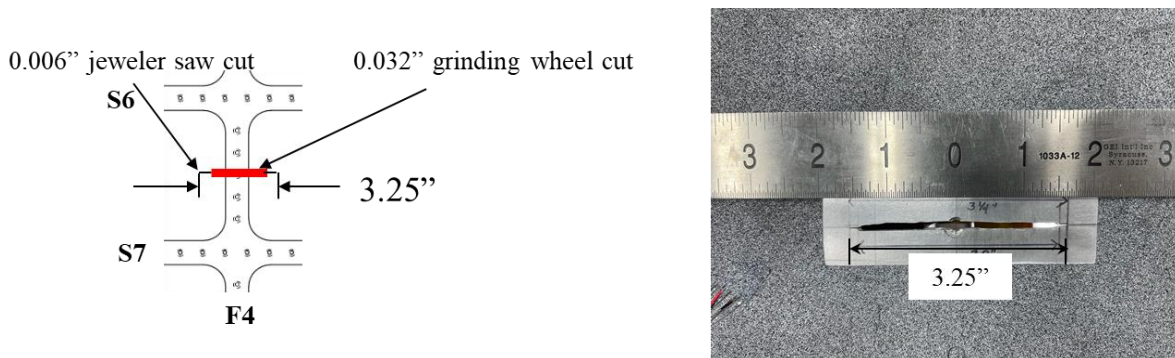
Figure 20. Configuration of Phase 2 damage scenario

The longitudinal damage scenario for Phase 2 is shown in Figure 20. The frame F4 rivet at the mid-frame location between stringers S6 and S7 was removed, and frame F4 was severed at this location. Damage was simulated by machining a 3.25-in. long notch in the skin above the severed F4 frame.

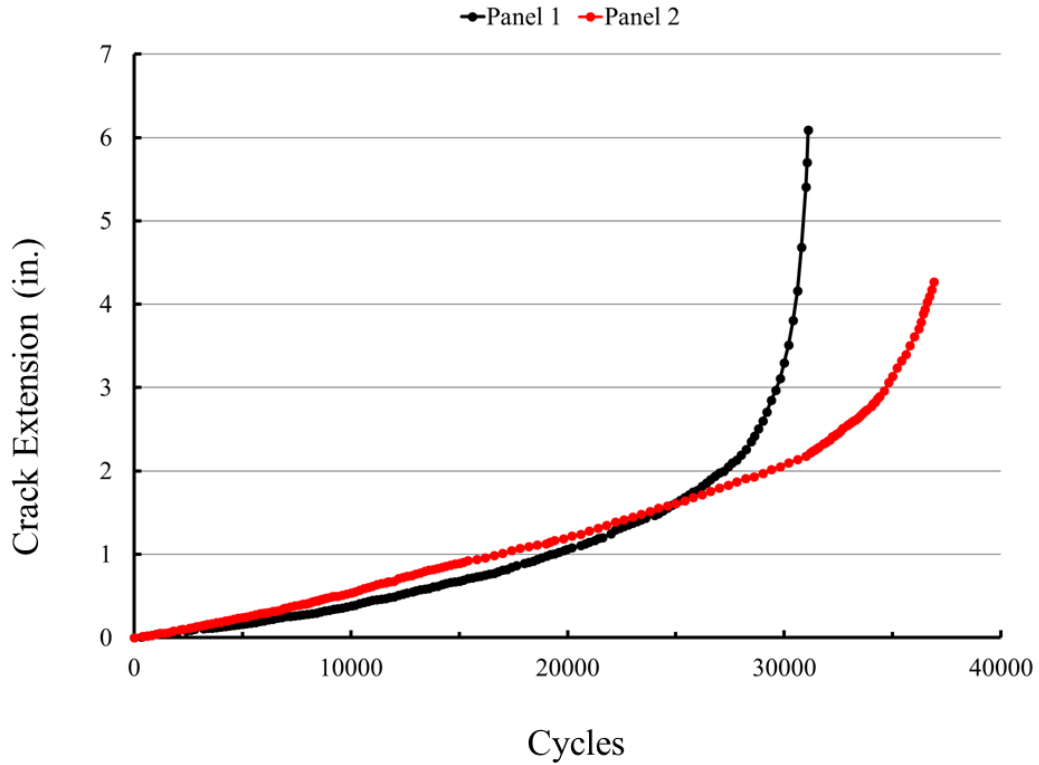
Figure 22. Average longitudinal crack growth comparison between panel 1 and panel 2

For this phase, the panel was fatigue tested under pressure load conditions for 37,070 cycles, during which the skin crack extended across two frame bays to a final total length of approximately 16 in. The crack growth was non-symmetrical as shown in solid lines in Figure 21. The fatigue test phase ended at 36,700 cycles, when the right side crack was about 5.4". The left side crack was extended using a grinding wheel to the same length as the right side. Then, the panel was fatigue cycled under the same pressure load conditions for about 800 cycles so that panel 2 has the same total crack length as panel 1 for the residual strength test.

Post-residual strength test investigation revealed that the unsymmetrical crack growth was due to the transition of crack surface morphology resulting in crack growth-rate changes as observed during Phase 1 fatigue test. The right-side crack had slanted crack surface and transitioned back and forth from +45 to -45 at approximately 24,600 cycles (1.8" crack extension), 28,600 cycles (2.24" crack extension) and 33,400 cycles (3.0" crack extension) respectively. The left side crack had slant crack surface up to 0.75" and changed to V surface for the rest of the fatigue cycles, which led to the slower crack grow. However, panel 2 exhibited better average crack growth performance compared to panel 1, as shown in Figure 22. Crack extension occurred across two frame bays to a final length of about 15.25 inches after 29,000 and 37,070 fatigue cycles in panel 1 and 2, respectively.
