# Liquefaction Damage of Harbor Facilities during the 1995 South Hyogo Earthquake

Minoru YAMANAKA\* and Keinosuke GOTOH\*

This paper describes results of field surveys about damages of harbor facilities and liquefactions mainly in Kobe City, and discusses some about the mechanism and the countermeasure.

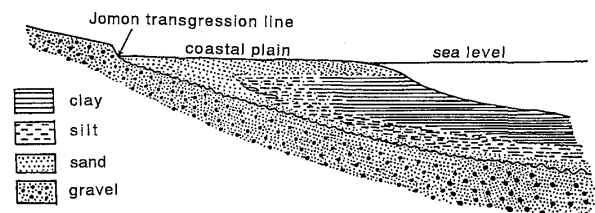
Fig. 2 Geological structure<sup>1)</sup>.

Figure 2 shows the geological structure<sup>1)</sup> near the coast line. Between the Jomon transgression cost line, located at 4m above the sea level about ten thousand years ago, and the coast line, it can be regarded that the alluvial low plane is mainly

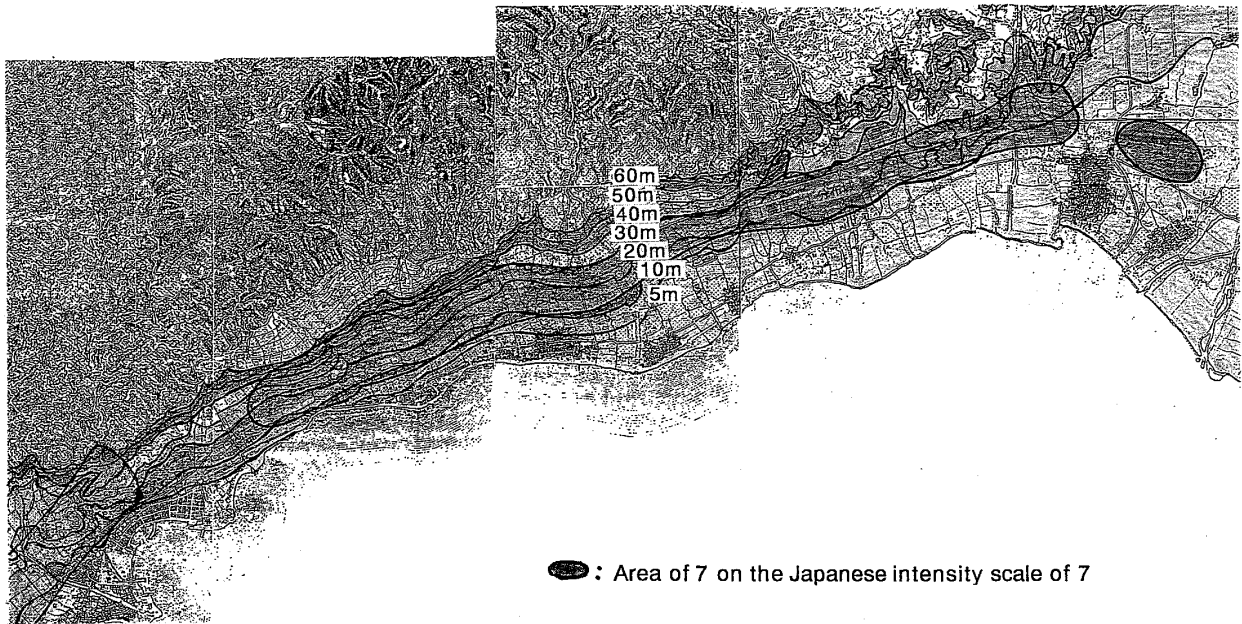
Fig. 3 Damaged area on the old map.

Figure 3 shows the relationship between the old map and the area of 7 on the Japanese intensity scale. The old map presents natural topographical features, in other words, it presents actions of erosion and deposition due to the natural forces. Regarding this matter one can get many informations from the old map. As Fig. 3 indicates, the distributed area of 7 on the Japanese intensity scale is within 20m above the sea in Hyogo Ward, is within 40m in Tyuo Ward, Nada Ward and Higashinada Ward, and is within about 20m in Ashiya City and Nishinomiya City. Besides it can be regarded that the 7 area is distributed within 5m above the sea, namely anywhere, is distribute in hilly districts or tablelands above the Jomon transgression level. It follows that there is a relation between the damaged area and the thickness of the layer.

Now we look at the damaged area from a different angle in Fig. 3. If one look at a location of a colony early in the Meiji era, a large colony indicated by dots had been developed along waterfront for a reflection of a fishery life in that days, a small colony had been dotted in a little-rise land like a natural levee. And generally, these colonies had been distributed in away from the damaged area. For the reasons mentioned above, it seems that they had chosen a safe area for the purpose of disaster prevention.

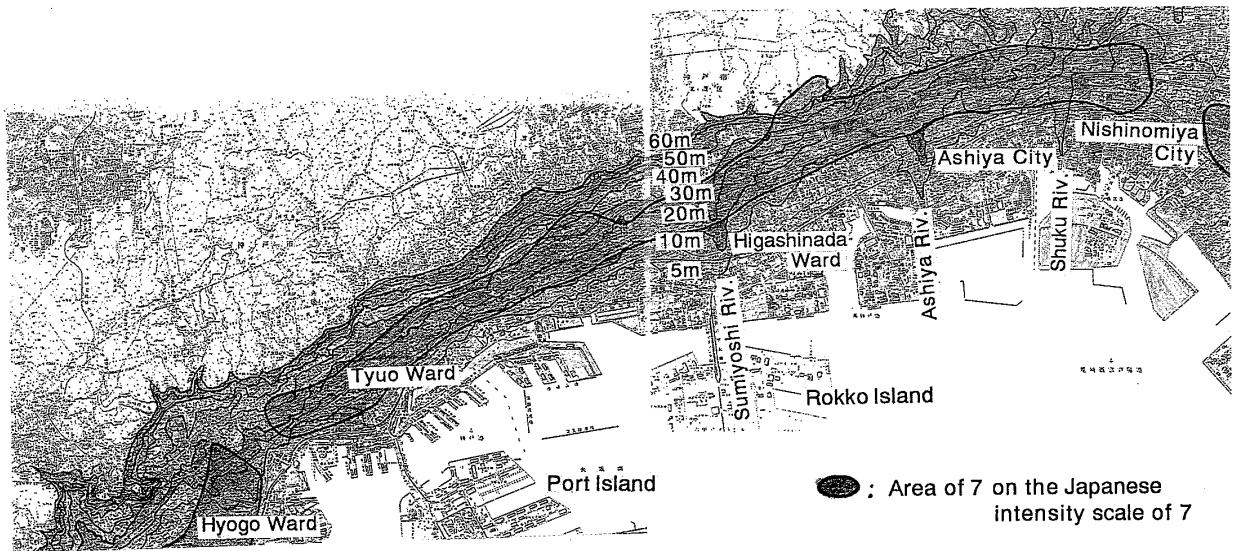
Fig. 4 Damaged area on the present map.

Figure 4 shows the result of the piled up the areas of intensity 7 on the Japanese intensity scale on the present topographical map<sup>2)</sup>. First, as compared with Fig. 3 from a topographical change point of view, we can see that topographic features of the present map, namely in Fig. 4, is quite different from Fig. 3 regarding the shape of contour lines which, is formed like a rised river bed by the aggradation along Sumiyoshi river, Ashiya river and Shuku river.

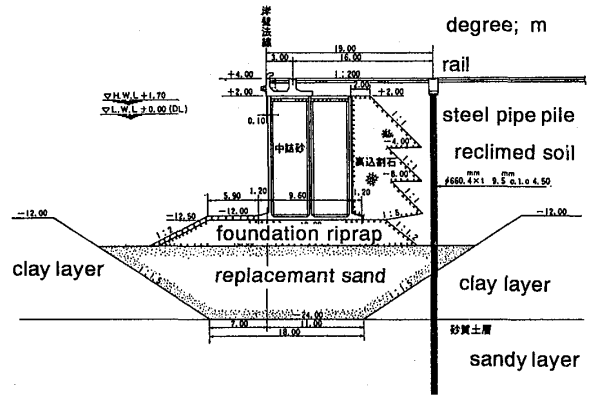
Fig. 9 A sectional diagram of the caisson quaywall<sup>5)</sup>.

The destructive mechanism of the damaged quaywall can be explained by looking at Fig. 9 which shows the cross sectional diagram<sup>5)</sup> of the caisson quaywall at the Port Island container berth. The part under the caisson was substituted by a decomposed weathered granite in stead of the weak marine clay similar to the reclaimed soil, and the part behind the caisson was back-filled by rubbles. Under the rail at seaside, steel pipe piles were placed.
