Field Reconnaissance And Observations From The February 6, 2023, Turkey Earthquake Sequence

Field reconnaissance and observations from the February 6, 2023, Turkey earthquake sequence

Gulen Ozkula¹ · Robert K. Dowell² · Tugce Baser³ · Jui-Liang Lin⁴ · Ozgun A. Numanoglu⁵ · Okan Ilhan⁶ · C. Guney Olgun⁷ · Cheng-Wei Huang⁴ · Tunc Deniz Uludag⁸

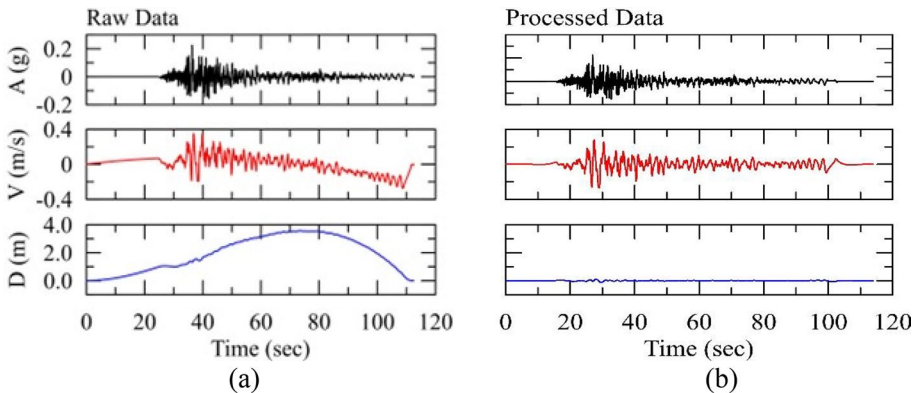
Fig. 2 Acceleration (A), velocity (V) and displacement (D) time histories recorded by station 3802 during $M_w=7.5$ earthquake, **a** raw, **b** processed

acceleration data in that (a) the downward slope and offset in velocity TH in Fig. 2a are removed and b the fictitious displacement trend in Fig. 2a is corrected in Fig. 2b.

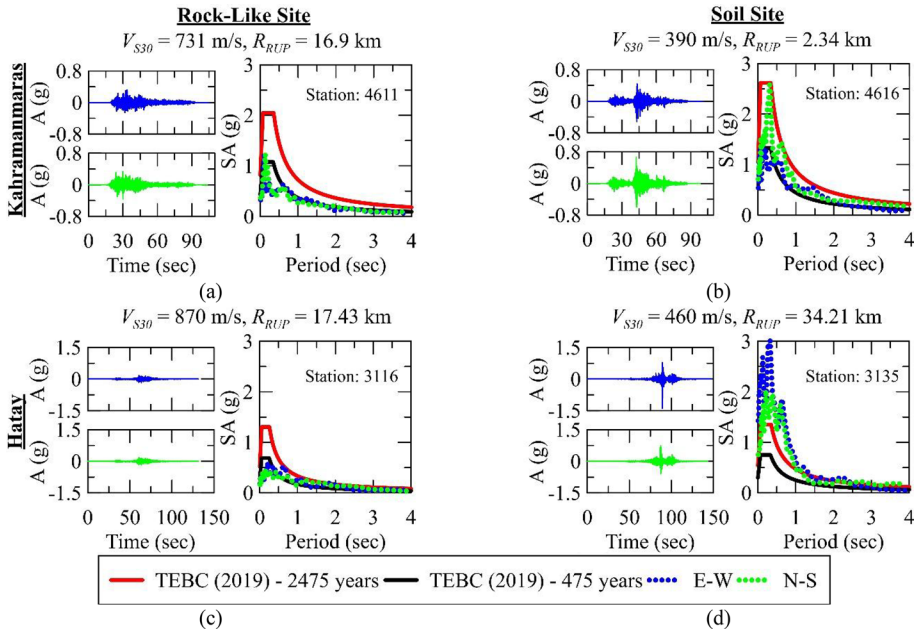
Figure 3 shows the recorded THs and compares the spectral acceleration plots with the design spectra required by the Turkish Earthquake Building Code (TEBC 2019) for return periods of 475 years (10% probability of exceedance in 50 years) and 2475 years (2% probability of exceedance in 50 years) for rock-like material ($V_{S30} > \sim 600\text{--}700$ m/s) and soil sites for the M_w 7.8 event. PGA values recorded at Station 4611 ($V_{S30}=731$ m/s and rupture distance (R_{RUP}) of 16.9 km) located in the city of Kahramanmaras are 0.32 g and 0.35 g for E–W and N–S components, respectively. Spectral acceleration (SA) plots of the two horizontal components are consistent with the 475-year design spectrum from the TEBC (2019). In the case of Station 4616 located at a soil site ($V_{S30}=390$ m/s and $R_{RUP}=2.34$ km) in Kahramanmaras, recorded PGAs for E–W and N–S components increase to 0.51 g and 0.67 g, respectively, compared to Station 4611, and the spectral curves of recorded ground motions at Station 4616 reach the TEBC (2019)-2475 years spectrum at oscillator periods (T_{OSC}) of ~ 0.5 s, ~ 0.75 s and 1.5 s. This condition is known to occur due to site effects from strong ground motion (Seed et al. 1988) and is more pronounced for the city of Hatay than at other locations, where SA values from Station 3135 ($V_{S30}=460$ m/s and $R_{RUP}=34.21$ km) exceed the TEBC (2019)-2475 years spectrum for $T_{OSC} \leq 1.0$ s, but SAs of motions recorded at Station 3116 ($V_{S30}=870$ m/s and $R_{RUP}=17.43$ km) are on the order of TEBC (2019)-475 years spectrum. The analogous evaluation to that described above is performed using the recorded motions from two stations in Kayseri during the M_w 7.5 event, as illustrated in Fig. 4. Even though the SA motion values at Station 3804 ($V_{S30}=637$ m/s, $R_{RUP}=77.77$ km) lie notably beneath the TEBC (2019)-475 years spectrum, Station 3802 ($V_{S30}=305$ m/s, $R_{RUP}=49.33$ km) is thought to have significant site amplification, leading to the exceedance of SA values for the E–W component to the TEBC (2019)-2475 years spectrum for $2.0 \leq T_{OSC} \leq 2.5$ s.

Fig. 3 The baseline-corrected acceleration (A) time histories, response spectral accelerations (SA) for E–W and N–S components and design spectra suggested by TEBC (2019) for return periods of 2475 years and 475 years for Station 4611 located in Kahramanmaraş, Station (Hatay) 4616, Station (Hatay) 3116, and station (Hatay) 3135 for $M_w = 7.8$ event

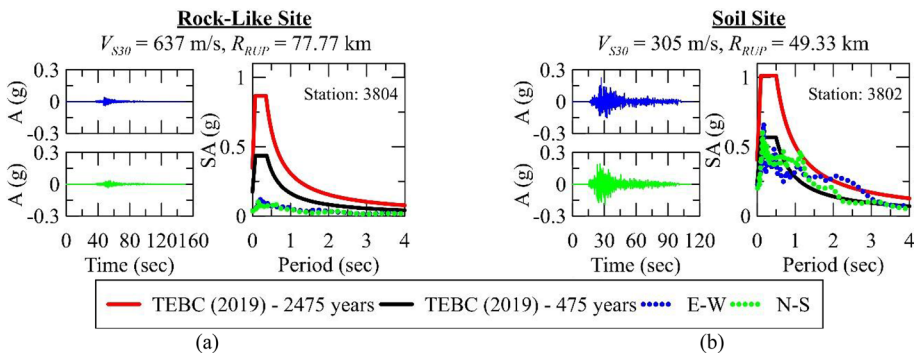
Fig. 4 The baseline-corrected acceleration (A) time histories; response spectral accelerations (SA) for E–W and N–S components and design spectra suggested by TEBC (2019) for return periods of 2475 years and 475 years for Station 3804 located in Hatay. The same information is presented for station (Kayseri) 3802 for $M_w = 7.5$ event

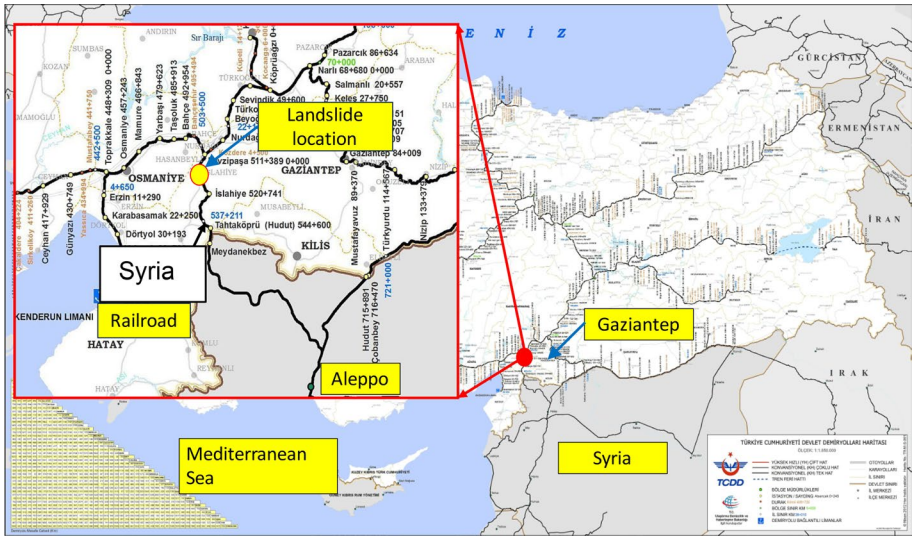
Fig. 13 Overview of the railroad map of Turkiye–Syria (obtained from rayhaber.com) and landslide location ($\sim 37^{\circ}06'43.41''\text{N}/36^{\circ} 39'34.91''\text{E}$)

Another landslide was documented in the Fevzipaşa–Meydanekbez segment running N-S from the main Adana-Gaziantep rail line towards Aleppo, Syria. The approximate location of the landslide is marked in Fig. 13. As can be seen in the map, this is a critical location and is one of the segments connecting Syria with Turkey. The collected data are not enough to report if the landslide was caused by the first or second earthquake in the sequence. Aerial footage of the landslide indicates that the head scarp is approximately 100 m long (Fig. 14a). Several backhoes were immediately sent to the site for debris removal as can be seen in Fig. 14b.

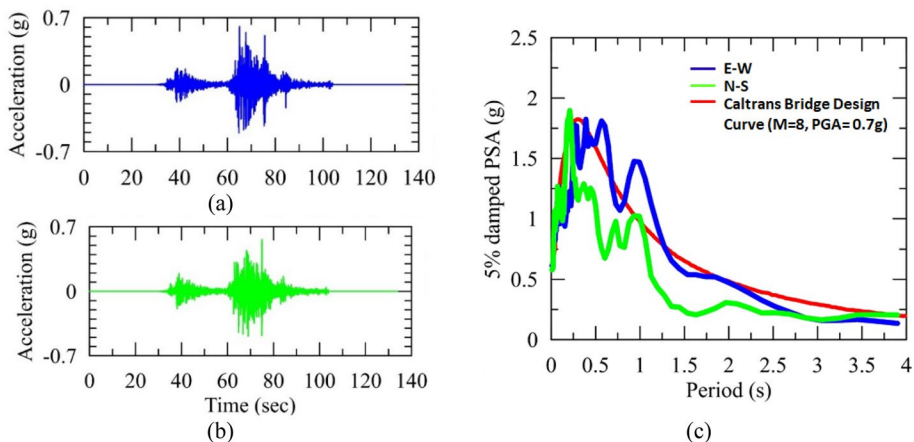
Station 2712 was the closest strong motion station to Bridge 1–2.00 miles (3.21 km) away. Free-field ground accelerations from Station 2712 during the M_w 7.8 earthquake in the horizontal east–west (EW) and north–south (NS) directions are given in Fig. 25a, b, respectively. Peak ground accelerations (PGA) are 0.607 g for the EW direction and 0.565 g in the NS direction, with PGA of 0.354 g in the vertical direction (not graphed). The 5%-damped spectral acceleration graphs for the EW and NS directions are given in Fig. 25c, with maximum values of 1.83 g and 1.90 g, respectively. Also shown in Fig. 25c is the smoothed Caltrans, 5%-damped bridge design spectral curve for a M_w 8 earthquake (plus or minus M_w 0.25) with PGA of 0.7 g and rock or stiff soil profile (Caltrans 2006), with maximum value of 1.82 g. This Caltrans design curve was obtained from an earlier version of the Caltrans Seismic Design Specifications (SDC) (Caltrans 2006) since the latest version of the SDC did not have such a graph for stiff soil and rock sites (Caltrans 2019). Station 3124 was the closest strong motion station to Bridge 2–2.14 miles (3.44 km) away. Recorded accelerations versus time at this station from the M_w 7.8 earthquake are given in Fig. 26a, b for the horizontal EW and NS directions, respectively. PGAs are 0.659 g in the EW direction and 0.581 g in the NS direction (Fig. 26a, b). In the vertical direction, the PGA was 0.589 g (not graphed). Acceleration spectrum results with 5% damping are given in Fig. 26c for the two horizontal directions. By comparing the horizontal acceleration spectra developed from ground motions measured at Station 3124 to the smoothed Caltrans bridge design acceleration spectrum for M_w 8 and PGA of 0.7 g at a rock or stiff soil site, it is clear that Station 3124 must have a deep layer of soft soil beneath it (or soft soil from the earthquake epicenter to the station) for the peak spectral responses to shift to such long natural structural periods. Therefore, Bridge 2 is probably on deep, soft soil. In the EW direction, the maximum spectral acceleration of 2.15 g (Fig. 26c) is greater than the maximum value of 1.82 g from the smoothed Caltrans design curve for M_w 8 earthquakes (Fig. 26c), demonstrating the intense level of shaking that occurred at Bridge 2.

Fig. 25 Station 2712 for Bridge 1, M_w 7.8 earthquake, measured **a** EW direction accelerations versus time, **b** NS direction accelerations versus time, **c** 5% damped spectral accelerations for EW and NS directions

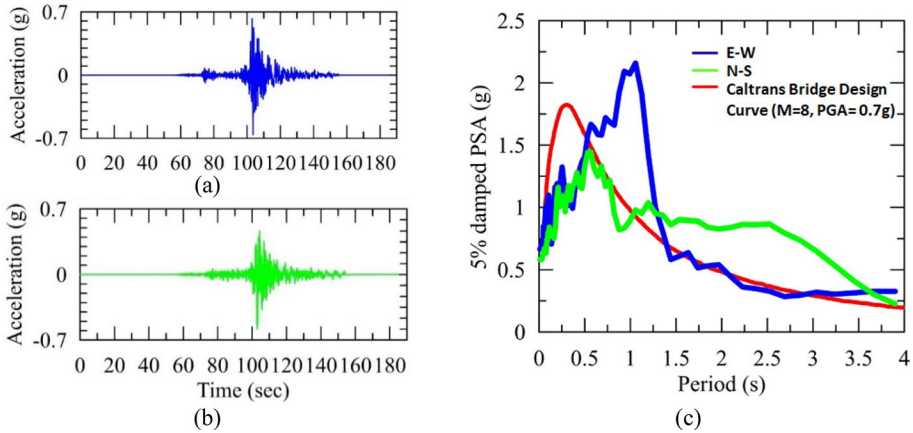
Fig. 26 Station 3124 for Bridge 2, M_w 7.8 earthquake, measured **a** EW direction accelerations versus time, **b** NS direction accelerations versus time, **c** 5% damped spectral accelerations for EW and NS directions
