## Relationships between Outside and Interior Appearance Inspection and Actual Bio-Deterioration of Structural Members in Existing Wood Houses

**Abstract.** *The inspection of the used house which is necessary to be evaluated is carried out without removal of the interior or exterior finishing materials. However, where the interior or exterior appearance was degraded, there was not always a bio-deterioration of the wooden structural member in the existing wood houses. Therefore, the interior or exterior appearance of the 103 used wood houses were inspected and the bio-deterioration of all wooden structural members were investigated after removal of the finishing materials. Then, the relationships between the appearance degradation and the actual bio-deterioration of the wooden structural members in the used wood houses were studied. The results were summarized as follows:*

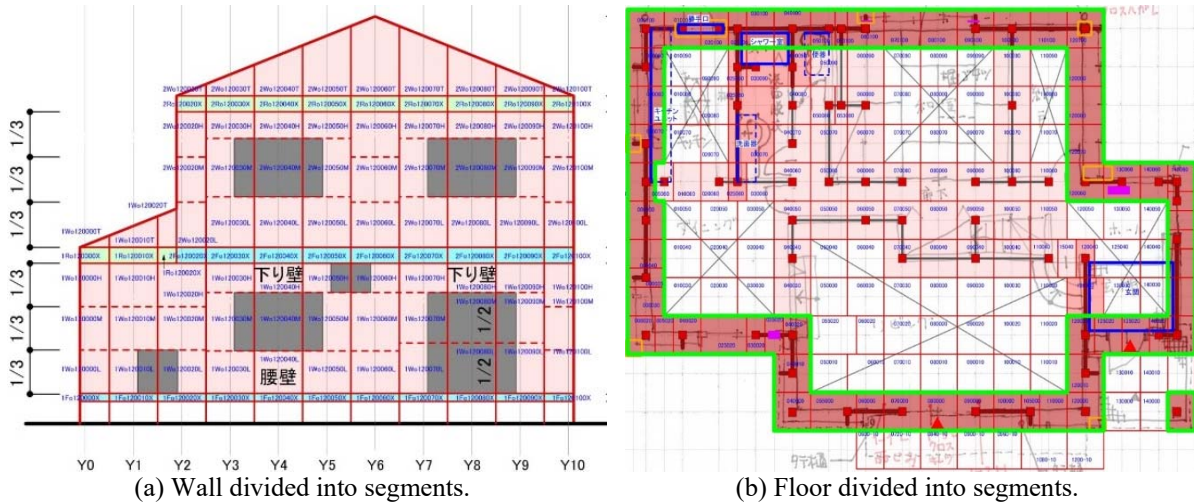
Figure 1. Dividing method of investigated house into segments.

At first, the investigated houses were divided into roofs, walls, and floors of the 1<sup>st</sup> and 2<sup>nd</sup> story, respectively. The roof segment and the 2<sup>nd</sup> floor segment include the ceiling and the 1<sup>st</sup> story's ceiling, respectively. The wall segments included the interior sheathings and the exterior finishing material. Next, as shown in Figure 1, the wall, floor and roof were divided into approximately 900 mm square segments. The wall with the opening was divided into the

hanging wall and spandrel wall segments. As a result, 103 houses were divided into approximately 65,000 segments. Each segment linked to the attribution of the investigated houses and the information of the appearance degradation and the bio-deterioration of the structural members included in it.

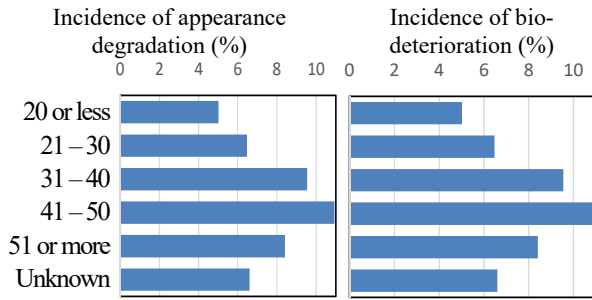
**Figure 2.** Incidence of the appearance degradation (left) and the bio-deterioration (right) for each building age.

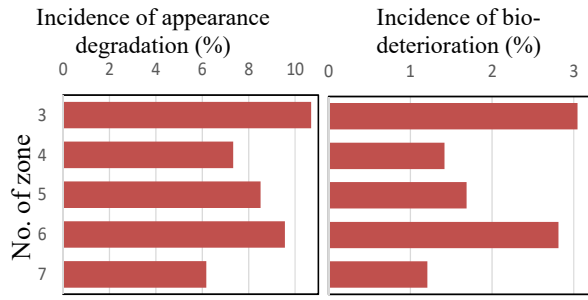
All of the 103 houses had the degradation in appearance, and 97 houses had the bio-degradation. Out of 65,000 segments, the appearance degradation was found in 5,667 segments, corresponding to 8.7 %, and the bio-deterioration of the structural members was found in 1,421 segments, corresponding to 2.2 %. In other words, most existing wood houses have the bio-deterioration of structural members, but their range is generally limited. Figure 2 and 3 shows the frequency of the appearance degradation and the bio-deterioration of the structural members for each building age and each construction area, respectively. The incidence of the appearance degradation and the bio-deterioration increased with older building age, except for over 50 years whose sample was very few. The incidence of them was lowest in zone No. 7 with high temperature and humidity. In others, the incidence increased in warmer zone, except for zone No. 3 where the sample was very small.

**Figure 3.** Incidence of the appearance degradation (left) and the bio-deterioration (right) for each building location.

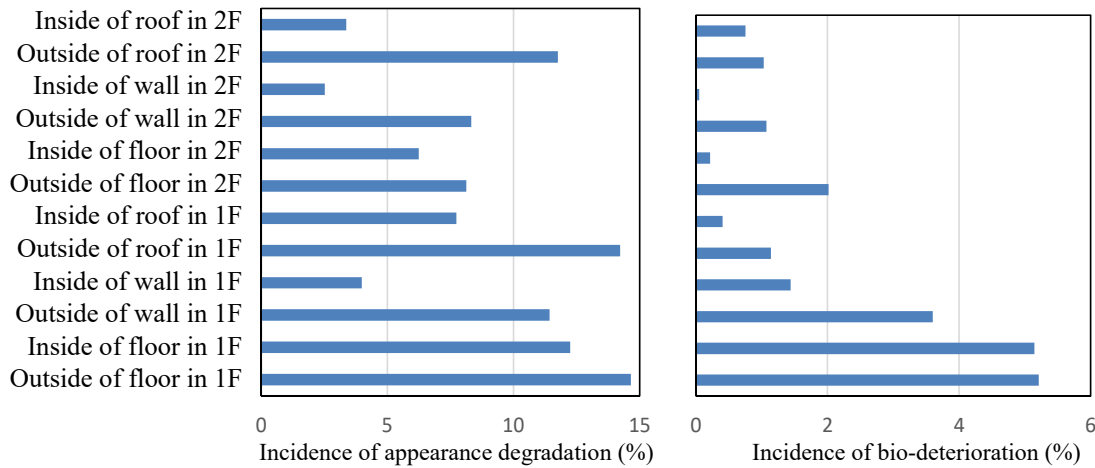
Figure 4 shows the incidence of them for each building part. Both of the appearance degradation and the bio-deterioration of the structural member often occurred on the 1<sup>st</sup> story and outside rather than the 2<sup>nd</sup> story and inside, respectively.

**Figure 4.** Incidence of the appearance degradation (left) and the bio-deterioration (right) for each building part.

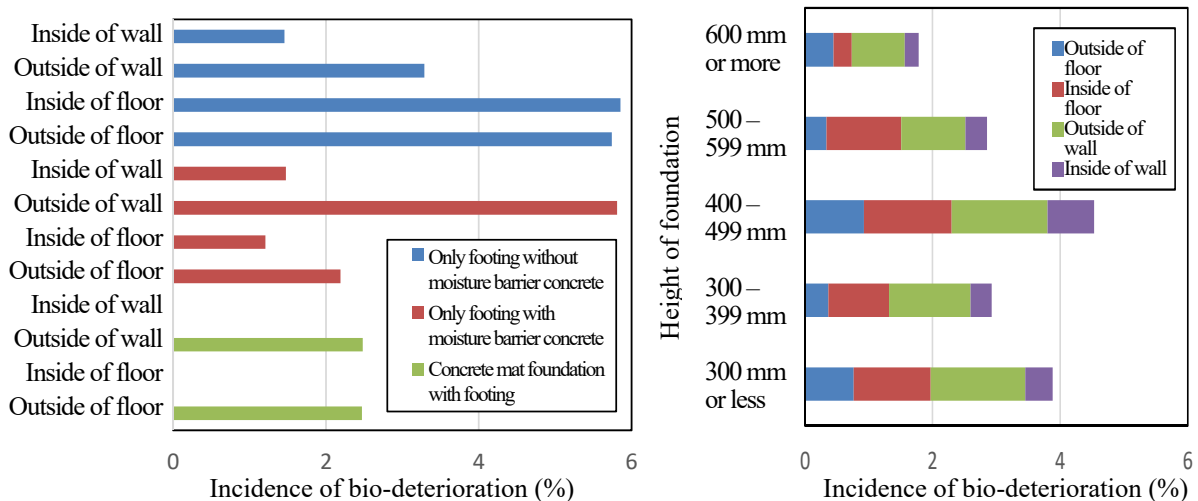
Figure 5 shows the relationships between the construction method and height of the foundation and the bio-deterioration of the structural member in the 1<sup>st</sup> story. The incidence of the bio-deterioration was lower in the order of the concrete mat foundation with footing, only the footing with the moisture barrier concrete and the one without the moisture barrier concrete. The mat foundation and the moisture barrier concrete are effective in preventing the bio-deterioration of the structural member in the 1<sup>st</sup> story. Although there were some exceptions, the incidence of the bio-deterioration almost decreased as the foundation height raised.

**Figure 5.** Relationships between the construction method (left) and height (right) of the foundation and the bio-deterioration of the structural member in the 1st story.

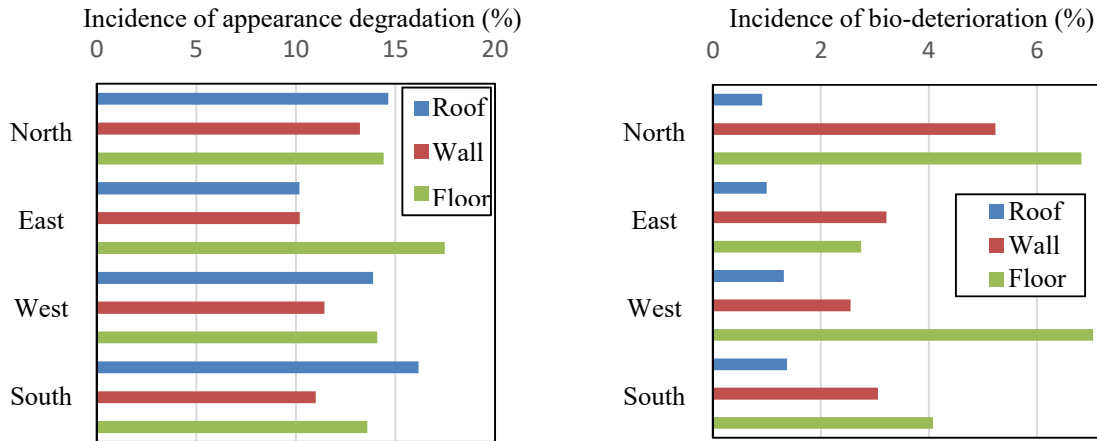
Figure 6 shows the effect of the segment orientation on the incidence of the appearance degradation and the bio-deterioration of the structural members. The orientation of the segments

had no obvious effect on the incidence of them.

Figure 6. Relationships between the incidence of the appearance degradation (left) and the bio-deterioration (right) and the orientation of the segments.

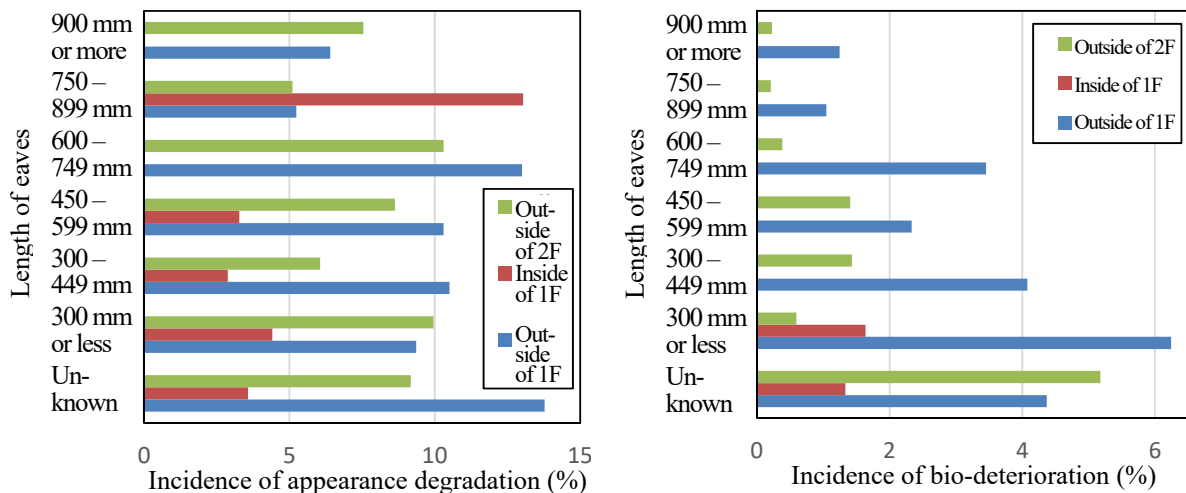
Figure 7 shows the effect of the eaves length on the incidence of the appearance degradation and the bio-deterioration of the structural members. The length of the eaves didn't clearly affect the incidence of the appearance degradation. However, as the length of the eaves increased, the incidence of the bio-deterioration almost decreased.

Figure 7. Relationships between the incidence of the appearance degradation (left) and the bio-deterioration (right) and the length of the eaves.

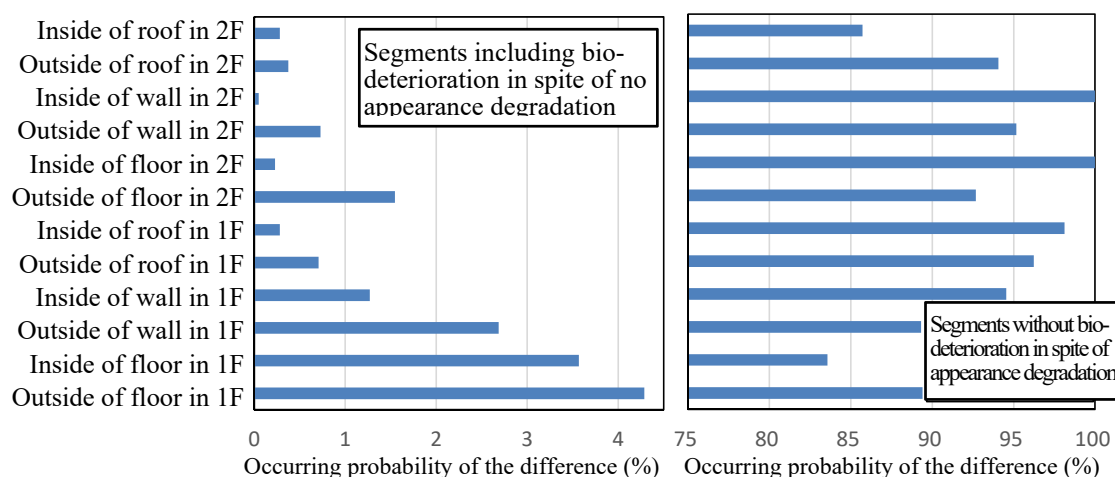
Next, the distribution of segments including those differences for each building part was studied, as shown in Figure 10. The incidence of the segments with the bio-deterioration in spite of the no appearance degradation in the 1<sup>st</sup> story was higher than that in the 2<sup>nd</sup> story and high in the order of the floor, the wall and the roof. From these, even if the occurrence rate of such differences depends on the incidence rate of biological deterioration, the appearance degradation, the structural members in the 1<sup>st</sup> story, especially in the floor, should be inspected or surveyed carefully, regardless of the appearance degradation. On the other hand, the distribution of the segments without the bio-deterioration in spite of the appearance degradation didn't have clear tendency for each building part and in each part the incidence was over 80%. One possible reason is that it takes time for the outside rain leak to penetrate the structural members, and the water evaporates before the water reaches the structural members.

**Figure 10.** Distribution in each building part of the segments including the bio-deterioration in spite of no appearance degradation (left) and without the bio-deterioration in spite of appearance degradation (right).
