## **PATHOLOGICAL AND STRUCTURAL ASSESSMENT OF A RESIDENTIAL BUILDING IN LOTA, CHILE**

*The "Anibal Pinto Building" is a 5 stories reinforced concrete and masonry structure, built in 1966. Besides of an aggressive coastal environment and poor maintenance, this building has experienced one major earthquake (Mw 8.8 in 2010). As a consequence, cracks, concrete spalling and reinforcement corrosion is observed in several structural elements.*

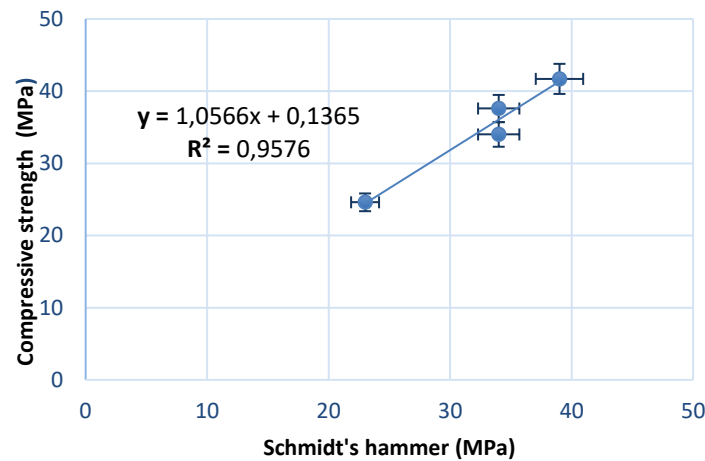
**Figure 5:** Correlation of results obtained from concrete strength

Figure 5 shows a good level of linear correlation between Schmidt's hammer measurements and compression tests [26]. From these results, it was determined that the lowest resistance (20 MPa) was observed in the critical zone (ground level columns), while the upper levels have resistances around 35 MPa.

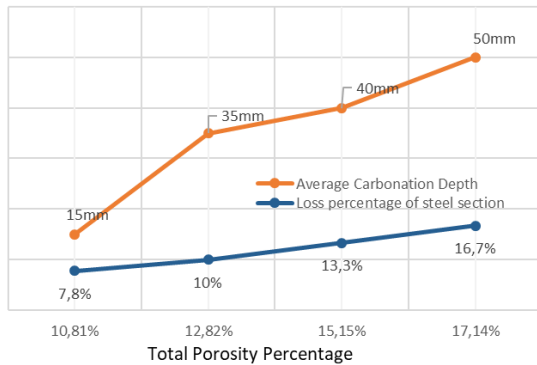
**Figure 8:** Carbonation, Porosity and Steel Corrosion Loss Ratio

Figure 8 shows the relation between carbonation, porosity and percentage of cross-sectional loss of steel rebars. It becomes evident that the greater is the concrete porosity, a deeper carbonation is generated. This situation facilitates corrosion in the reinforcements, with the subsequent increment in the loss of steel rebars cross section. On the other hand, Figure 9 illustrates how concrete porosity affects the material strength. Therefore, carbonation not only produced rebars corrosion, but also generates a loss of strength in the elements of the critical zone.
