POINT-LOAD TEST ASSESSMENT AS STUDY OF ADOBE BUILDINGS DAMAGED AFTER THE 2017 PUEBLA EARTHQUAKE

Keywords: Adobe Masonry, Point-load test, Vernacular architecture, Seismic affectation

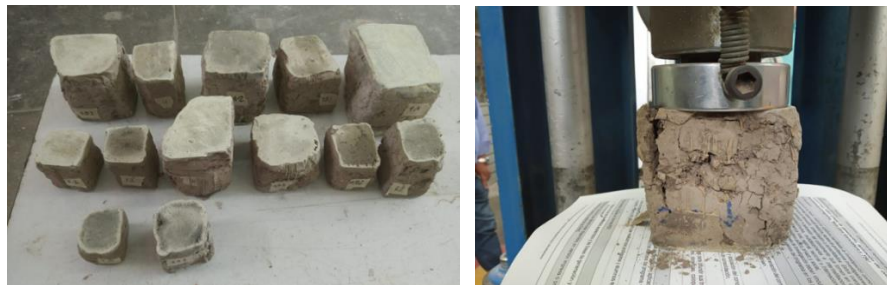
Figure 4: Preparation and compressive testing of the adobe samples

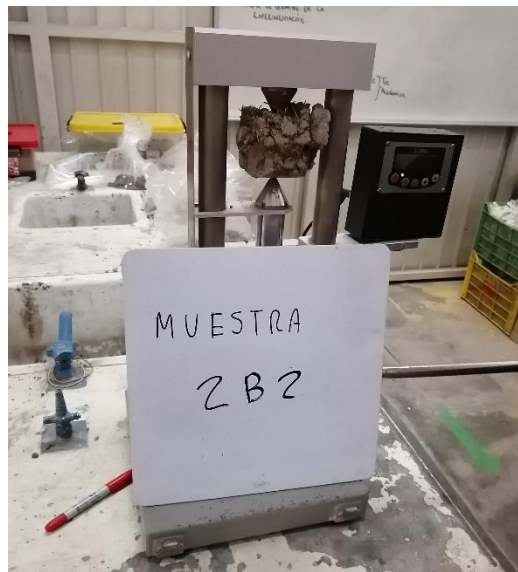
Figure 5: Adobe sample in the point-load equipment

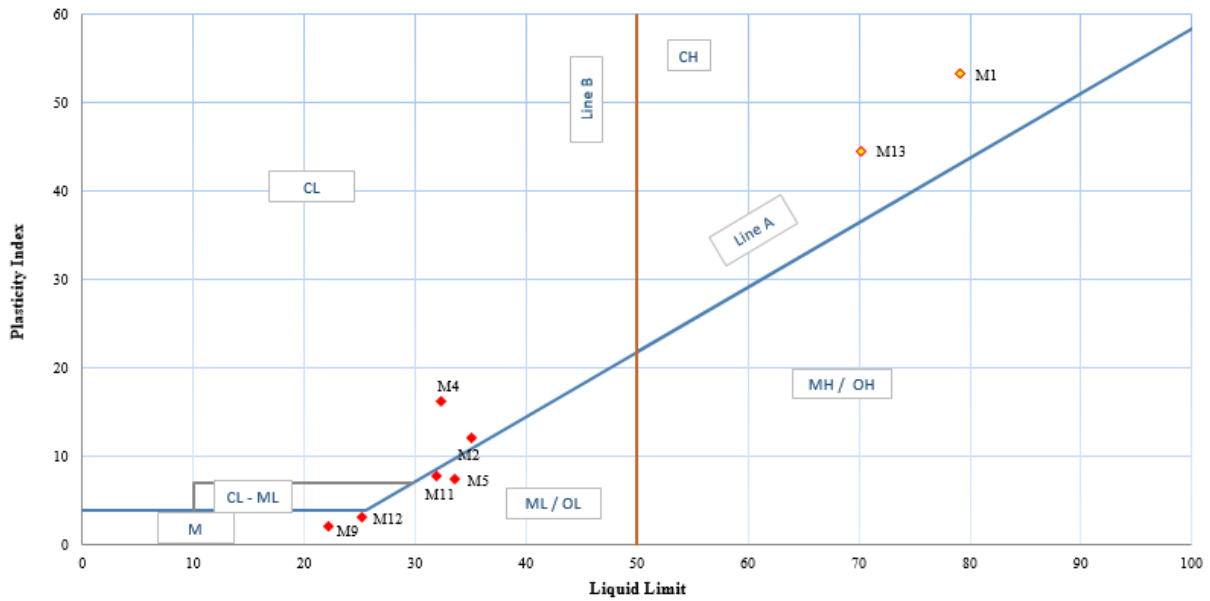
Figure 7 shows the classification of all the samples, including the adobes and the soils of the region, by the Unified Soil Classification System (USCS); while Table 1 shows the results of the soil classification and the grading of each one of the specimens which were subdued to the mechanical analysis. M1 and M13, the two soil samples from the clay material quarry were classified as high plasticity clays, while the adobes vary from clays of low plasticity to mods. The low plasticity was probably due to the stabilization with other materials, for example, lime was found by RXD in some specimens.

Figure 7: Plasticity graphic and position of the adobes and soil samples

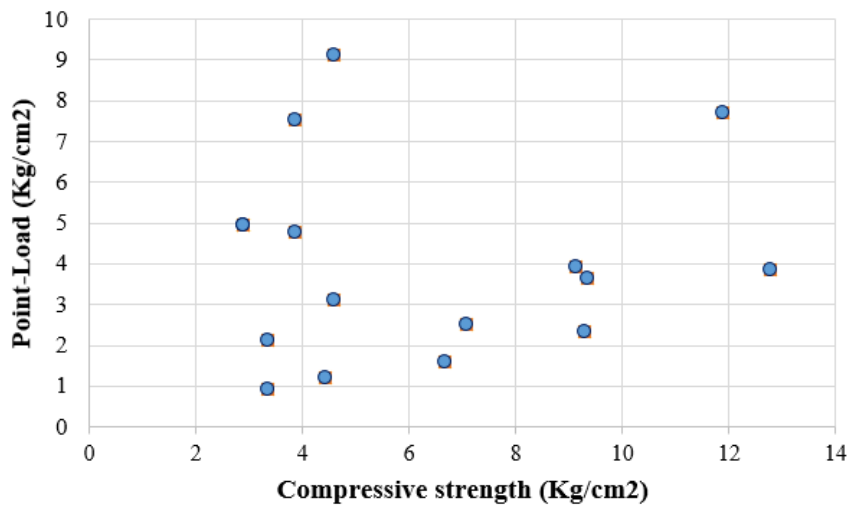
The compressive strength and point-load values were compared (See Figure 8) in a graphic to observe the correlation between the two tests. Considering the compressive strength values slightly higher, most of the samples shown a lineal reciprocity, while some shown deviation, near the 2:1 ratio calculated for the tests.

Figure 8: Correlation between the Compressive strength and the point-load tests
