## SEISMIC BEHAVIOUR OF LA MERCED TEMPLE IN MORELIA, MEXICO

LIDIA MEJIA<sup>1</sup>, GUILLERMO MARTINEZ<sup>1\*</sup>, BERTHA OLMOS<sup>1</sup> AND JOSE  
MANUEL JARA<sup>1</sup>

<sup>1</sup>Civil Engineering Department  
Universidad Michoacana de San Nicolás de Hidalgo (UMSNH)  
Av. Gral. Francisco J. Mújica S/N, Felcitas del Río, 58004 Morelia, Mich., Mexico  
e-mail: guillermo.martinez@umich.mx (\*corresponding author)

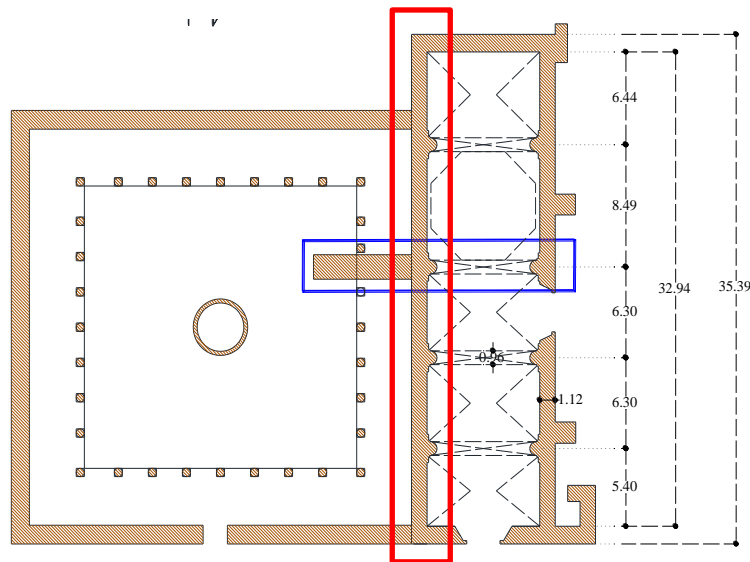
**Figure 13:** Macroelement definition. Transversal macroelement (blue) and longitudinal macroelement (red)

Figure 13 shows the macroelements considered in the analysis; in the longitudinal direction is the located over the nave south wall and in the transverse direction the one corresponding to the nave connected to an existing flying arch, which, at the moment is inserted in the two old cloister levels of the David G. Berlanga elementary school. This macroelement was considered due to it has a high stiffness wich can concentrate major damages.

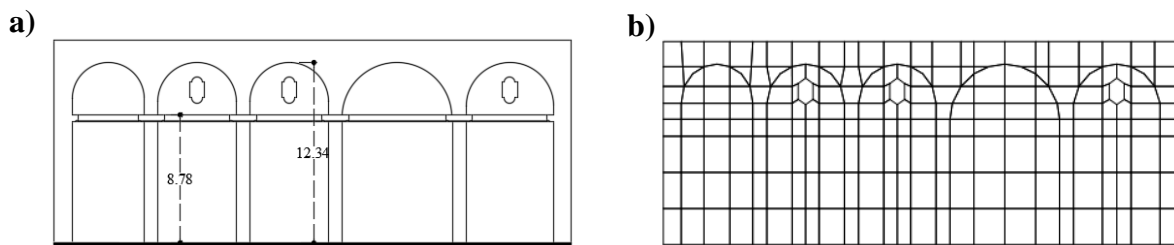
**Figure 14:** a) Longitudinal macroelement and b) Rigid element mesh

The longitudinal macroelement has a high resistance and a high lateral stiffness as shown in Figure 15, and for the whole seismic demand no damages were obtained, so that the considered seismic demand does not cause any traction, compression or shear damages.

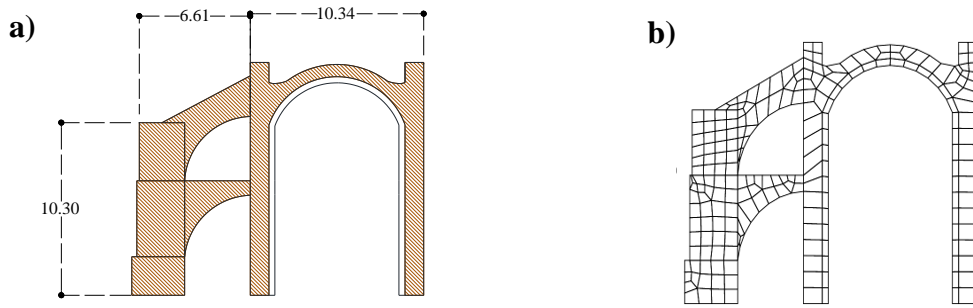
Figure 14: a) Longitudinal macroelement and b) Rigid element mesh

In the nave transverse direction, the structural behavior was similar for all the considered seismic demand in terms of damage distribution, with moderate to extensive damage degrees at the key and springers of the vaults and arches. Such damages can be associated to the crack pattern observed in the vaults, and it is appreciated that the damage pattern does not change significantly when the earthquake vertical component is involved in the analyses, attributing such a situation to the reduced span of the nave of only 6.69m.
