## SEISMIC VULNERABILITY ASSESSMENT OF A 17<sup>TH</sup> CENTURY COLONIAL ADOBE CHURCH IN THE CENTRAL VALLEY OF CHILE

**Abstract.** *This paper focuses on the seismic vulnerability assessment of the San Judas Tadeo's church in Malloa (Chile), an iconic example of Colonial Chilean architecture. This small adobe structure is a single-nave building consisting of the main nave, a bell-tower located in the façade, two external wooden galleries and additional units such as the sacristy, chapel, and two services areas.*

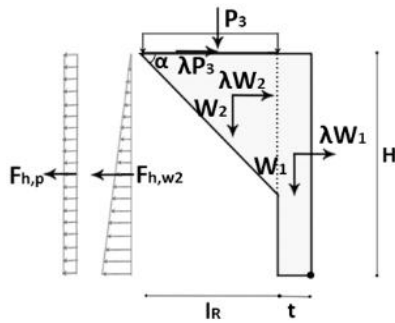
**Table 3:** Compound overturning of main façade (COC-FA) considering the cohesionless Coulomb's failure criterion with frictional capacity expressed at all bed joints identifying the crack.

The crack pattern of the Malloa façade, in which diagonal cracks (inclination of the crack slope to the vertical equal to  $\beta = 1.052\text{rad} \sim 60.25^\circ$ ) are visible on the orthogonal walls, denotes a good interlocking among them. The contribution of the timber reinforcement is considered and slope to the horizontal that fracture forms is identified through the minimum angle  $\alpha$ . The contribution of friction in the analysis of façade compound overturning is considered according to [17, 19, and 20] through limit analysis applied to non-standard materials. An added system of forces [17, 19, and 20] acting in the direction opposed to that of the earthquake action, and proportional to self-weights and overburden loads through the friction coefficient has been modelled:  $F_{h,w2}$ , the horizontal force offered by dry friction and due to self-weight, which depends on the compression found at each block interface and equal to  $F_{h,w2} = \{[H(H \tan \theta + t)]/2\} \gamma b \mu$ ; and  $F_{h,p}$ , the contribution offered by dry friction due to overburden loads, and equal to  $F_{h,p} = p H \tan \theta b \mu$ , where  $\gamma$  is the specific weight of masonry;  $\mu$  is the friction coefficient related to masonry;  $H$  is the height of the façade macro-element;  $b$  is the thickness of the considered wall;  $\theta = v/t$  is the staggering ratio angle with  $v$  overlapping length among two blocks and  $t$  block thickness; and  $p$  is the force per unit surface of the slab (Table 3).

The inclinations of crack slopes to the horizontal, characterising mechanism layouts and identified through complementary angles of  $\alpha$ . For  $\mu = 0.2, 0.3$  and  $0.4$ , the complementary angles of  $\alpha$  obtained minimizing  $\lambda_{t-\mu}$  are respectively  $1.176\text{rad} (\cong 67^\circ)$ ,  $0.833\text{rad} (\cong 48^\circ)$  and  $0.670\text{rad} (\cong 38^\circ)$ . Considering the case of lower friction coeff ( $\mu = 0.2$ ), which already leads to non-conservative values, it can be observed that the mechanism layout is remarkably close to the staggering mechanism ( $\theta = 1.165\text{rad} \cong 67^\circ$ ), showing that the contribution of friction might be less relevant. This consideration supports the hypothesis that the resistive forces necessary to understand the actual mechanism are cohesive forces as investigated in [17].
