STRUCTURAL EVALUATION AND MAINTENANCE OF BROOKS AQUEDUCT HISTORIC SITE

ALIREZA ROUHI¹, NIGEL G. SHRIVE^{2*}

Keywords: Reinforced Concrete, Aqueduct, Structural Evaluation, Durability, Numerical Modeling, Damage

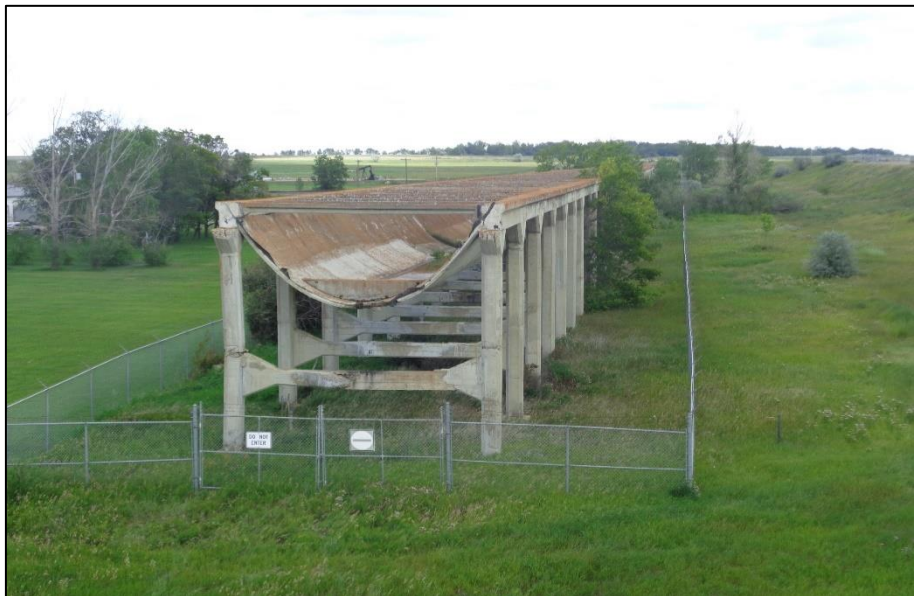
The aqueduct was abandoned in 1979 after 65 years of service and was replaced with a larger earthen canal built to the south of the aqueduct. Brooks Aqueduct is a nationally significant civil engineering achievement because of its design, materials, and large size. The Canadian Society for Civil Engineering named Brooks Aqueduct as a National Historic Civil Engineering Site in 2000 [1][2]. An interpretative centre has been constructed and a part of the aqueduct has been removed to improve access for the public. More than 3 km still remains with various problems in terms of cracking and spalling of the concrete, and some sections of the flume missing patches of concrete.

Figure 1 : A view of Brooks Aqueduct
