THE RESTORATION INTERVENTIONS OF “FORTE MARGHERA” IN VENICE

FILIPPO CASARIN¹, RICCARDO CIANCHETTI^{2*}, TOMMASO DALLA VIA²,
MARTINA MEGGIATO² AND MARCO MOCELLINI¹

Keywords: Venice Lagoon, military architecture, fort, Marghera

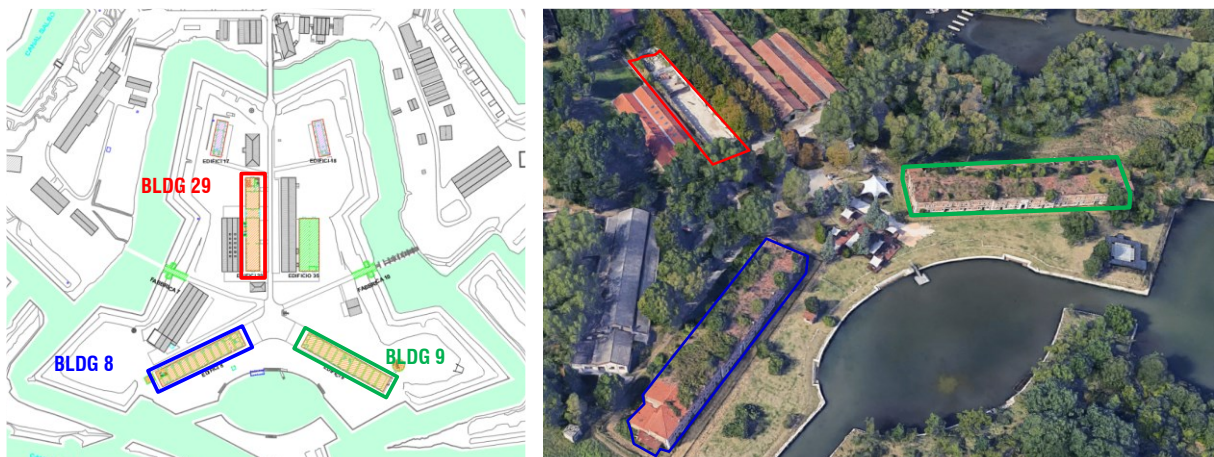
Figure 3: the three buildings object of the intervention: building nr. 8, 9 and 29

These are the two Napoleonic "barracks" located on the lagoon side, called "Building 8" (west) and "Building 9" (east), and a building that has not been covered for years following the collapse of the roof due to deterioration, called "Building 29", located in the center of the islet of the fortress. Tests aimed at the definition of the structural elements' composition (walls and vaults inner arrangement), the geometrical and crack pattern detailed survey (hidden structural portions, foundations) and material characterization (mechanical characteristics). A relevant part of the diagnostic effort was directed to the geotechnical characterization of the soil, being this the obvious suspect of the evident differential settlements pattern resulting in visible structural distortion and masonry walls cracking, especially in the west barrack.

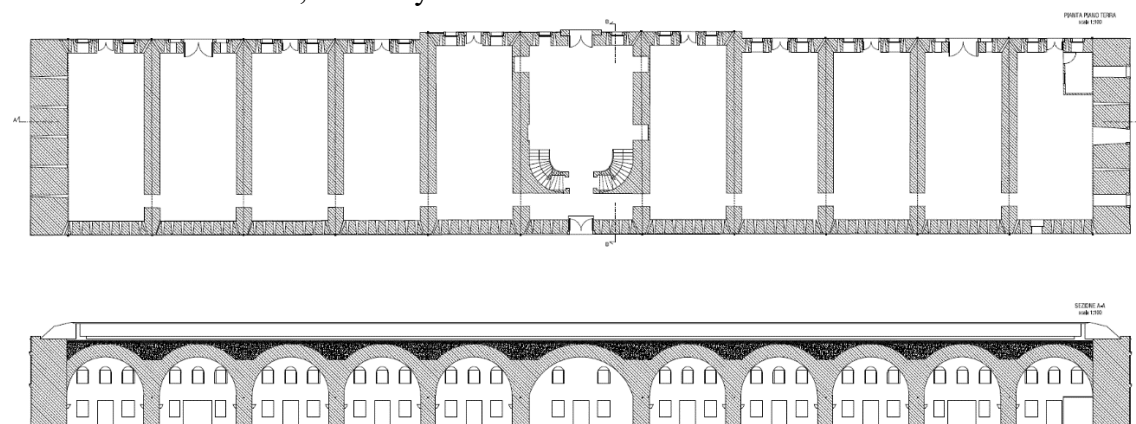
The two French barracks nr. 8 and 9 have a rectangular plan, 85x15 m in size, and are made by transversal thick walls (about 110 cm thickness the internal walls, more than 280 cm the head walls), which support the barrel vaults (Figure 6). The longitudinal facades, also in brick masonry about 110 cm thick, are simply juxtaposed to the vaults, and not clamped to the transverse walls, as highlighted by some cracks visible on site. Walls and vaults are all made in solid bricks masonry, with lime mortar joints.

Figure 6: building nr. 9 – plan and cross section

The current situation of both buildings highlights a significant state of decay; the external facades are damaged by the growth of vegetation, especially on the top cornices, where some stone pieces are fallen. Vertical walls present cracks in correspondences of the chimneys and diagonal cracks near the entrance portals. There are also systematic cracks between the vaults and the facade walls, due to the absence of connections between facades and transversal walls. Furthermore, the building nr. 8 presents several and evident deformations, with wide cracks on facades and inner walls, remarkably in the central portion which appears lowered than the north-west corner, as described earlier.

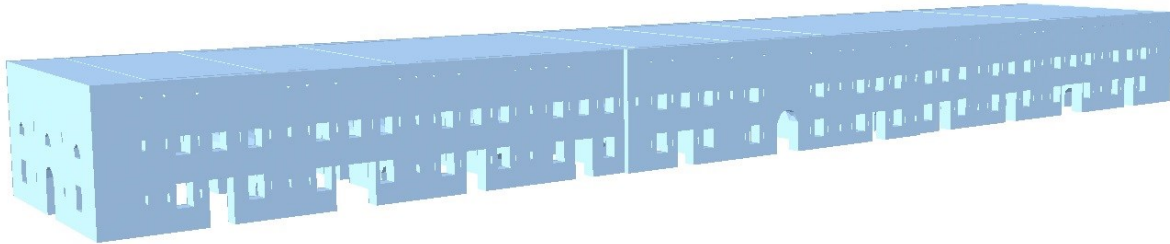
The global FE models of the barrack buildings (nr. 8 and 9) have been used to perform both static and seismic (dynamic) analysis (**Figure 8**).

The self-weight analysis – carried out according the current Italian Construction Standard NTC2018 – has confirmed the soundness of the vertical structures, built to resist to cannon attacks. The great thickness of vaults and of vertical walls can distribute easily the heavy loads from the roof, made with large layers of soil and with perimetral ramparts.

Results obtained in terms of σ_{ZZ} stress (compression) indicate that the average value of compressive stress at the ground level corresponds to approximately 0,4-0,5 N/mm² (**Figure 9**). Average compression stress on vaults is lower than 0,2-0,45 N/mm². The seismic behaviour of the building is characterized by the large thickness of masonry walls, which can easily absorb the seismic actions. The main vulnerability is due to the construction method of the facades, which are juxtaposed to the transversal walls and to the barrel vaults and may be subject to hammering effects. Out-of-plane vulnerability is connected only to non-structural elements, such as chimneys or stone cornices. Regarding the interaction between soil and foundation, considering only gravity loads, the inner walls, which are loaded by the vaults, present an average stress about 0,25 N/mm², instead in the longitudinal facades, which are loaded only by their self-weight, the calculated stress at the ground level is about 0,18 N/mm². This difference in soil stresses, due to the constructive discontinuity between facades and inner walls that do not allow any stress distribution, may have caused differential settlements, which may partially explain the actual crack pattern.

Figure 8: 3D FE model of the barrack buildings
