How to reduce craters in the painting process of a PIM company?

Gustavo Rodrigues Guimarães;Dr. Jonas Gomes da Silva;Dr. Mariana Sarmanho de Oliveira Lima

Dept. of Industrial Engineering, Federal University of Amazon (UFAM)

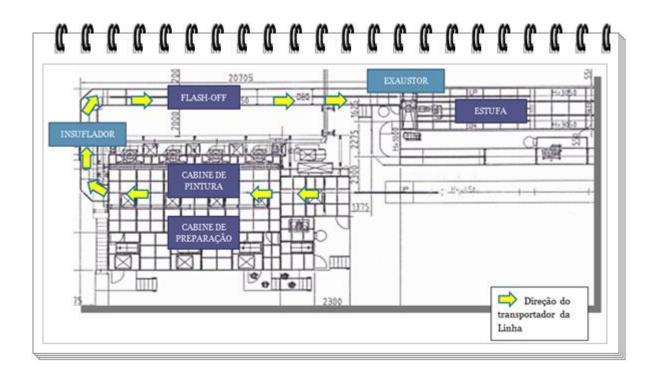
Figure 3: Varnish Paint Line Source: Author

The study was done at the Varnish Paint Line, where the crater defect was identified. The Line is composed of the following elements (Figure 3):
