# Thermal failure in a clamping bolt of a shunt reactor

This article presents the detection and analysis of a thermal failure produced in a core clamping bolt of a 5 MVAR gapped three-phase shunt reactor. Gases were detected in this shunt reactor during its operation at a substation in Mexico. Using dissolved gas analysis (DGA) and Duval's triangle method, temperatures up to 700°C were estimated in the shunt reactor. Overheating evidence was detected in one of the core clamping bolts during an internal inspection of the shunt reactor. The author and the reactor manufacturer believe that

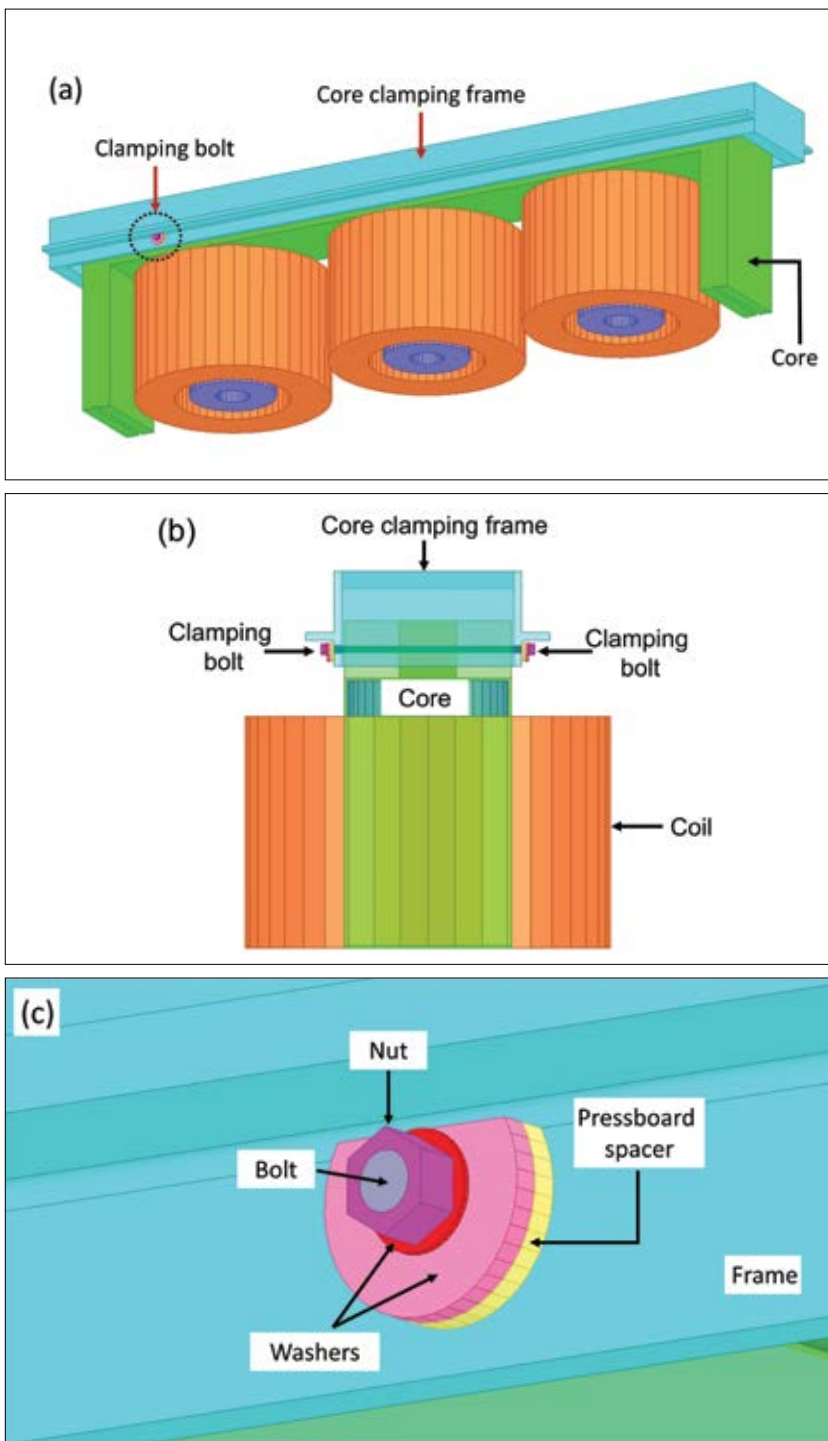
Figure 3. a) shunt reactor model, b) lateral view of the shunt reactor model, c) view of the clamping bolt region

is made of laminations of grain-oriented electrical steel. The clamping frames are made of low-carbon steel, while the bolts, nuts, and flat washers are made of non-magnetic stainless steel.
