Effects of Ground Failure on Bridges, Roads, and Railroads

The long duration and strong velocity content of the motions produced by the 27 February 2010 Maule earthquake resulted in widespread liquefaction and lateral spreading in several urban and other regions of Chile. In particular, critical lifeline structures such as bridges, roadway embankments, and railroads were damaged by ground shaking and ground failure. This paper describes the effects that ground failure had on a number of bridges, roadway embankments, and railroads during this major earthquake. [DOI: 10.1193/1.4000024]

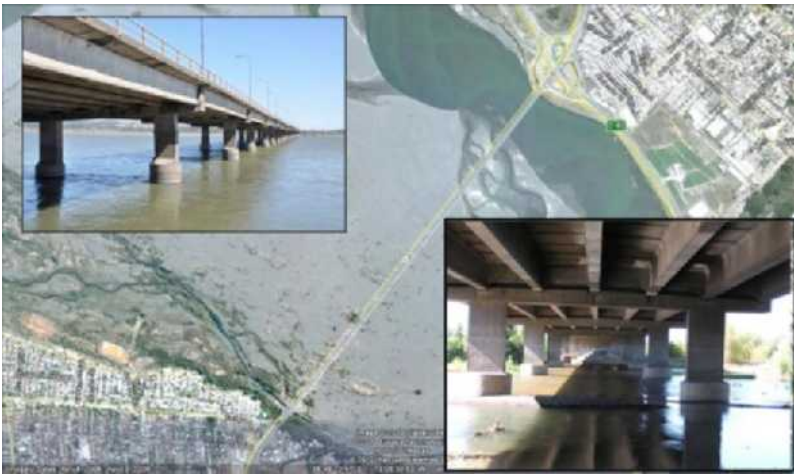
Paz across the Bío-Bío River. The bridge opened to the public in 1974. The bridge consists of 70 spans (length = 33 m, width = 21.9 m), each composed of 7 reinforced concrete girders and a concrete deck. Each span sits on reinforced concrete bents with drilled pier supports (see Figure 8).

Figure 8. Juan Pablo II Bridge connecting the cities of Concepción and San Pedro de la Paz across the Bío-Bío River. Typical bridge bent configuration shown in photograph inset.
