**The 11 March 2011 East Japan Earthquake and Tsunami:
Tsunami Effects on Coastal Infrastructure and Buildings**

Abstract: The 11 March 2011 East Japan Earthquake and Tsunami caused unprecedented damage to well-engineered buildings and coastal structures. This report presents some notable field observations of structural damage based on our surveys conducted along the Sanriku coast in April and June 2011. Engineered reinforced concrete buildings failed by rotation due to the high-velocity and deep tsunami inundation: entrapped air in the buildings and soil liquefaction by ground shaking could have contributed to the failure. The spatial distribution pattern of destroyed and survived buildings indicates that the strength of tsunami was affected significantly by the locations of well-engineered sturdy buildings: weaker buildings in the shadow zone tended to survive while jet and wake formations behind the sturdy buildings enhanced the tsunami forces. We also found that buildings with breakaway walls or breakaway windows/doors remained standing even if the surrounding buildings were washed away or destroyed. Several failure patterns of coastal structures (seawalls) were observed. Flo

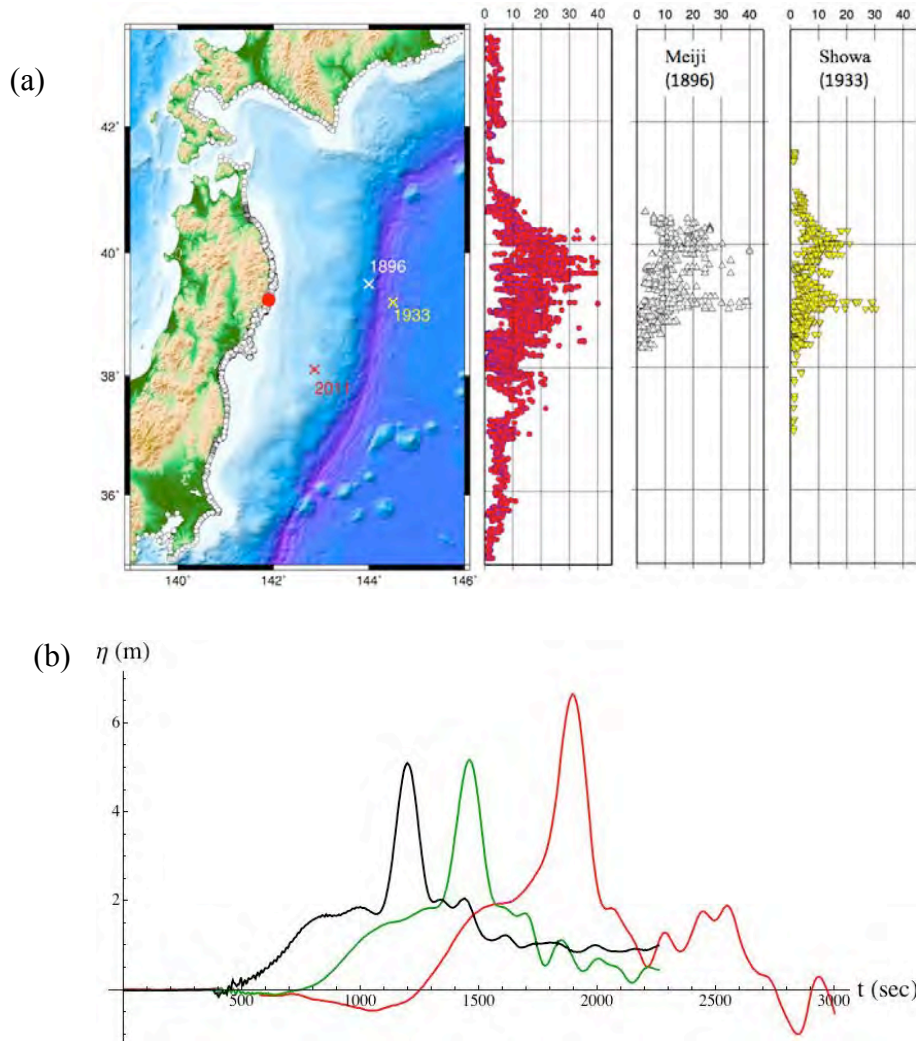
Wave profiles of the 2011 Tsunami were recorded at several locations along Japan's continental shelf with GPS buoys (PARI, 2011) as well as seafloor pressure transducers (ERI, 2011). Figure 1b shows compiled data of tsunami waveforms along the west-to-east transect line from the town of Kamaishi. Two of line-plots are data captured with seafloor pressure transducers (ERI, 2011) located at 45 km offshore in water depth of 1013 m, and at 73 km offshore in 1618 m of water. The other is measured by the GSP buoy (PARI, 2011) located at 15 km offshore in 204 m of water. The compiled plots demonstrate the tsunami evolution during its approach toward the shore. The temporal waveform closest to the shore (the GPS buoy) shows that the leading wave was a small negative wave with about 0.4 m wave height, followed by a gradual increase in water surface elevation, and then a rapid rise to reach a 6.7 m wave height. According to Synolakis (1991), tsunami's shoaling amplification can be estimated with Green's law: Green's law says that wave height is proportional to $^{-1/4}$ power to the water depth (e.g. Lighthill, 1978). Based on the measured wave amplitude of 6.7 m in water depth of 204 m, Green's law predicts a tsunami height of 14 m in a depth of 10 m, which is very large but comparable to the values obtained from field surveys – average tsunami height in the outer coast of Kamaishi is 15.7 m (extracted from The 2011 Tohoku Earthquake Tsunami Joint Survey Group, 2011). (Note that tsunami wave height predicted by Green's law at the water depth of 10 m is often used as a representative tsunami height at the shore: e.g. Takahashi (2011). From hereinafter, all of the runup heights presented in the paper are obtained from the 2011 Tohoku Earthquake Tsunami Joint Survey Group (2011) unless otherwise stated, and for brevity, this reference will be called Joint Survey Group.) The 2011 Tsunami was evidently very large and the presence of the sharp peak in the waveform must have played a primary role in creating high-velocity flows and transient inundation processes (Yeh et al., 2011).

Figure 1. (a) Survey data of tsunami runup height from the 11 March 2011 East Japan Earthquake and Tsunami. Also shown are the runup height distributions of the 1896 Meiji Tsunami and the 1933 Showa Tsunami (Japan Tsunami Trace Database: <http://tsunami3.civil.tohoku.ac.jp/tsunami/mainframe.php>). In the map, the locations of the earthquake epicenter that generated those tsunamis are shown. (b) Temporal tsunami waveforms η captured at the location ($39^{\circ}14'56.0''\text{N}$ $142^{\circ}26'28.1''\text{E}$) 15 km deep in a water depth of 204 m off Kamaishi (red line) and at ($39^{\circ}13'52.3''\text{N}$ $142^{\circ}46'06.1''\text{E}$) 45 km deep in 1013 m of water offshore (green line) and at ($39^{\circ}15'31''\text{N}$ $142^{\circ}05'49''\text{E}$) 73 km deep in 1618 m of water offshore (black line). Those data are extracted from PARI (2011) and ERI (2011). The location of Kamaishi City is marked as the red circle in (a).

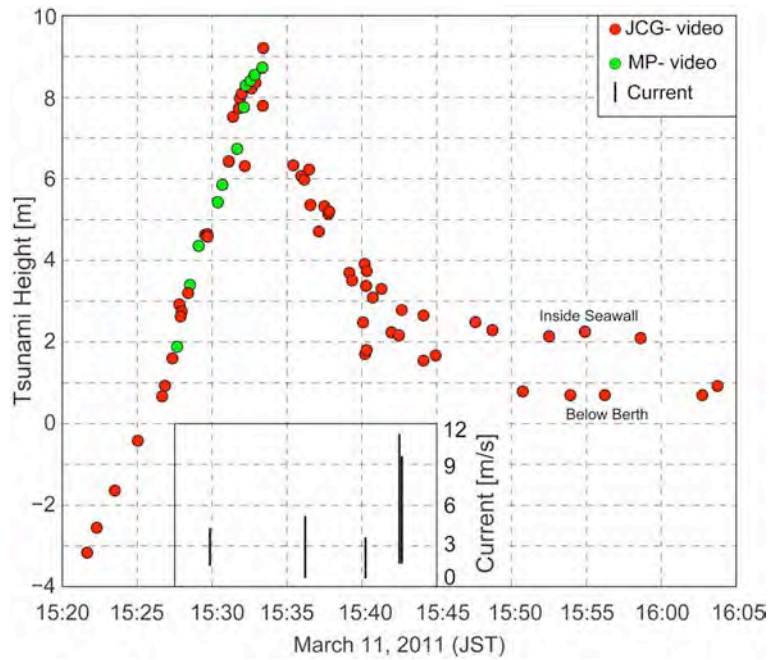
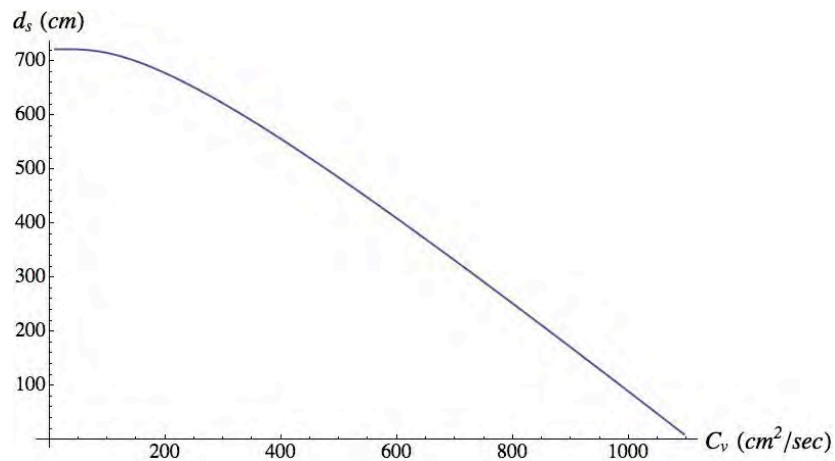
Applying (4) to the tsunami runup-and-return-flow data measured in the town of Kesen-numa (Fritz *et al.* 2011), a layer thickness of fluidized soil d_s is calculated and the results are presented in Fig. 7. Note that Fritz *et al.* (2011) extracted the temporal variations of flow velocities and water-surface elevations from the video footage with the aid of ground based Lidar measurements. Here we used $\Delta p/\rho g = 8.5$ m and $\Delta T = 10$ minutes taken from the inundation history shown in Fig. 7, and the buoyant specific weight of the soil $\gamma_b = 880$ dynes/cm³. Creating the condition to test for (3) and monitoring the pore pressures in the laboratory, Yeh *et al.* (2004) obtained the average value of consolidation coefficient $c_v = 750$ cm²/sec with a range from 400

to $1200 \text{ cm}^2/\text{sec}$ for Ottawa Fine Sand with $D_{50} = 0.26 \text{ mm}$. Such a wide range of the variations is attributed mainly to a variety of soil compaction used in the experiments. The uncertainty in the value of the consolidation coefficient c_v as well as its high sensitivity to the fluidization depth d_s – see Fig. 7 – does not allow us to make an accurate estimate for the fluidized soil layer. Nonetheless, the result in Fig. 7 demonstrates that the rapid return flow of the 2011 Tsunami is capable of fluidizing the sandy soil down to a substantial depth. For example, the fluidized layer thickness is $d_s = 290 \text{ cm}$ for $c_v = 750 \text{ cm}^2/\text{sec}$, $d_s = 410 \text{ cm}$ deep for $c_v = 600 \text{ cm}^2/\text{sec}$, and $d_s = 520 \text{ cm}$ for $c_v = 450 \text{ cm}^2/\text{sec}$. The maximum possible liquefaction depth is $d_s \rightarrow \Delta p / \gamma_b = 720 \text{ cm} > 7 \text{ m}$! Therefore, the results suggest that the substantial development of excess pore-pressure gradients can trigger upward forces from underneath, which could have caused the scenes of ripped-out asphalt slabs shown in Fig. 4, as well as the severe scour hole and the undermined road (Fig. 6) in the town of Tohni: recall that flow velocities in those areas could not have been large judging from the surrounding damage conditions.

The traditional scour mechanism for steady flow is the bed shear stresses, but the excess pore-pressures play little role in the soil instability. On the other hand, tsunami flows are transient with the timescale of tens of minutes. The result shown in Fig. 7 demonstrates that the effects of pore-pressures can be substantial for the 2011 Tsunami. It is likely that the excess pore-pressure gradients contributed the damages such as the scour holes between the buildings shown in Fig. 3a and Fig. 4c, as well as the seawall failure in Kirikiri (Fig. 5c).

pressurized and saturated soils at the time of maximum inundation; such condition occurred unlikely in the 2011 event because the runup process was not slow as shown in Fig. 7. In other words, the soils must have been less pressurized than the assumption, which could overestimate the fluidized depth d_s .

Figure 7. (a) Time history of tsunami inundation depth in the town of Kesen-Numa, extracted from video footage (after Fritz et al., 2012). (b) Predicted liquefaction thickness vs. the consolidation coefficient c_v , due to rapid reduction of the tsunami inundation depth as described in equation (4).
