Bourne Leisure Ltd. Thermal Performance Measurement Report

Professor David Johnston, Centre for the Built Environment, Leeds Beckett University

May 2016

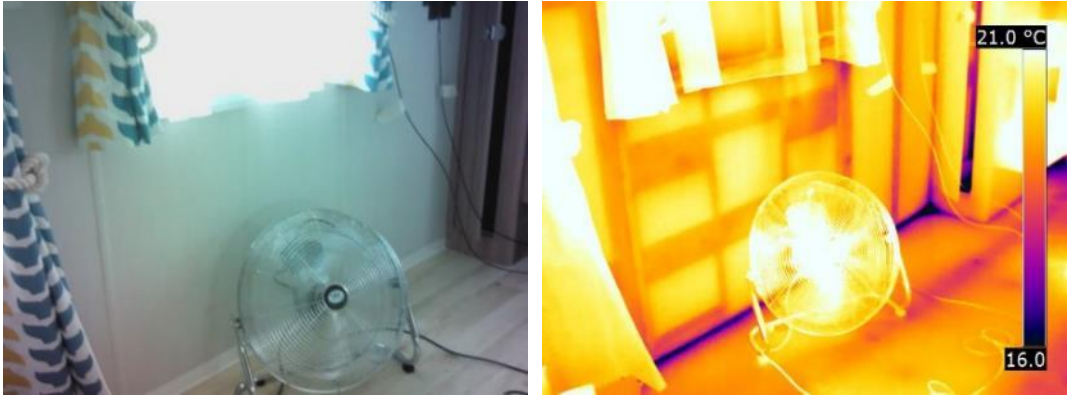
Figure 39 Thermal bridging below the kitchen/living area window in caravan E.

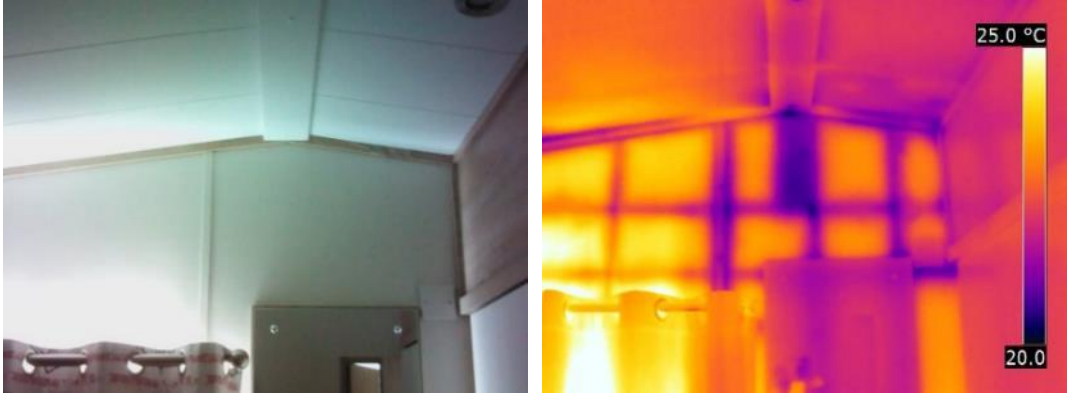
Figure 40 Thermal bridge close to the ridge on the end wall of caravan A.

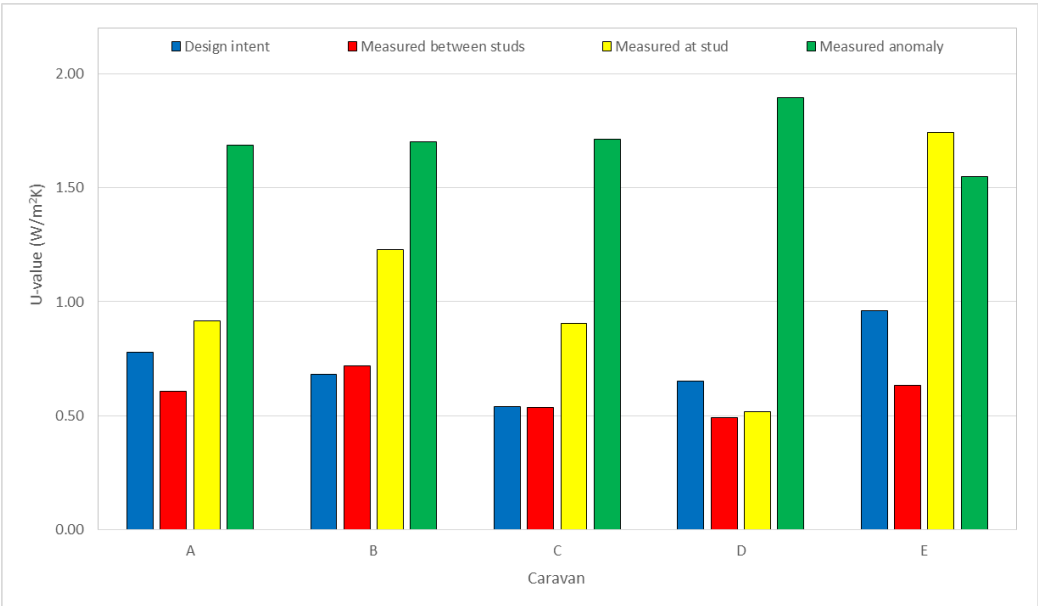
- 46 It is also clear from Figure 46 and Figure 48 that the *in situ* U-values measured at the external wall and roof anomalies are significantly higher than the design intent steady-state U-values. This can be attributed to the excessive thermal bridging that was observed at these locations. In the case of the external wall anomaly, the thermal bridging was caused by the insertion of additional timber at this location to enable the mounting of an external aerial. With respect to the ceiling anomaly, removal of the ceiling extract grille revealed either a lack of, or the omission of insulation surrounding the extract grille (see Figure 51).

Figure 46 Average *in situ* external wall U-value for each test caravan.

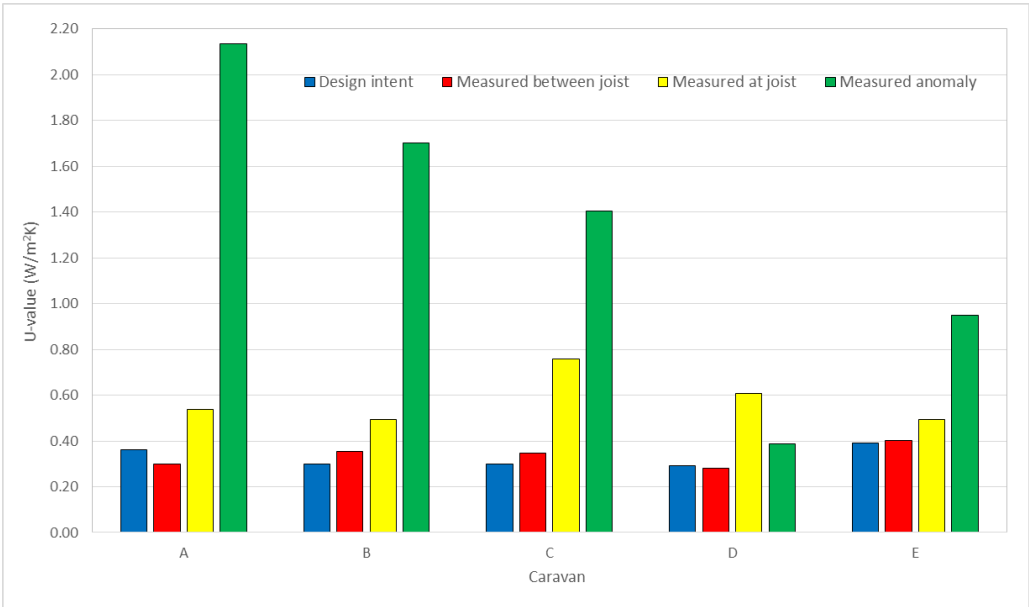
Figure 48 Average *in situ* roof U-value for each test caravan.

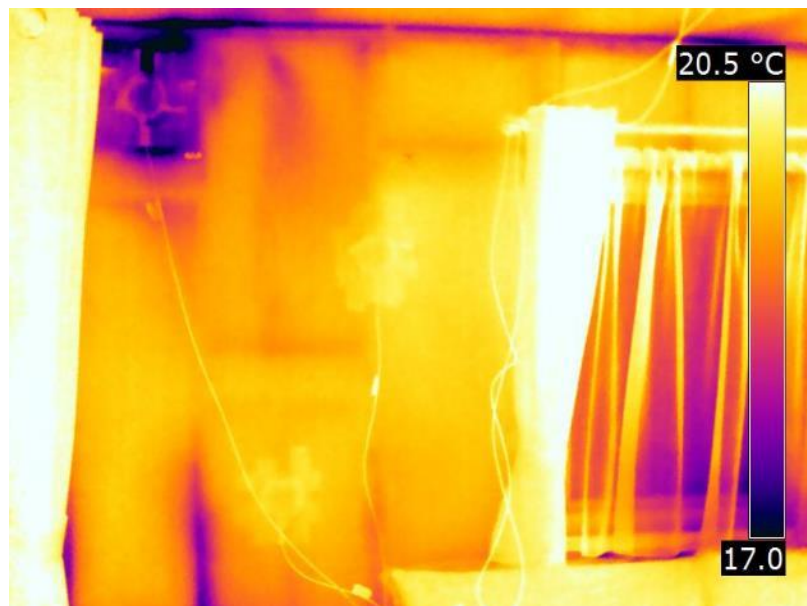
Figure 50 Location of HFP 2 in test caravan D.

- 45 In terms of the measurements undertaken at the studs and joists, the analysis reveals that in the majority of cases the measured *in situ* U-values are considerably higher than the design intent steady-state U-values. This is to be expected, as the timber studs and joists represent a thermal bridge through the fabric of the test caravans. However, in the external wall of test caravan D, the measured *in situ* U-values at the stud were lower than the design intent steady-state U-values and only marginally higher than the value obtained between the studs. This suggests that this HFP was not accurately positioned directly across the stud within this caravan. An analysis of the thermal image undertaken once the HFPs were installed within test caravan D reveals that this HFP was positioned slightly off-centre to the stud (see Figure 50).

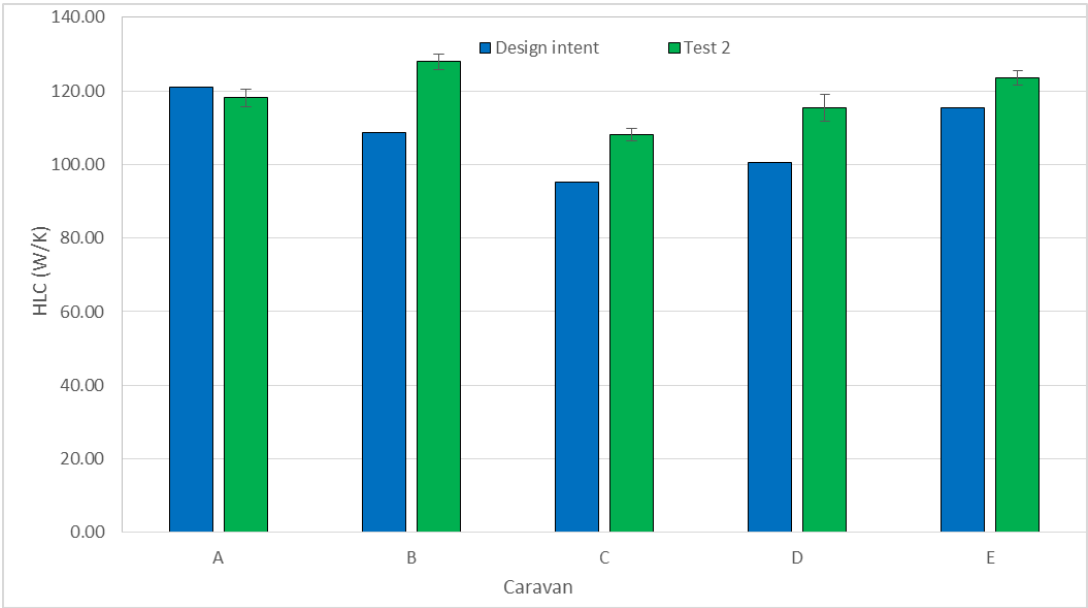
- 52 As can be seen from Figure 56, in the majority of cases, the measured HLC obtained from Test 2 is greater than the design intent HLC, indicating a building fabric performance gap. The only instance where this is not the case is in caravan A, where the measured HLC is comparable to the design intent HLC. However, such a comparison can be misleading, as the design intent HLC figure incorporates background ventilation heat losses which have been calculated based upon the air permeability figures incorporated with the NCC calculator. In all of the tested caravans, a difference was observed between the air permeability figures measured and those inserted into the NCC calculator and, in some cases, this difference was considerable.

Figure 56 Comparison of the electric coheating test results with the design intent HLCs.

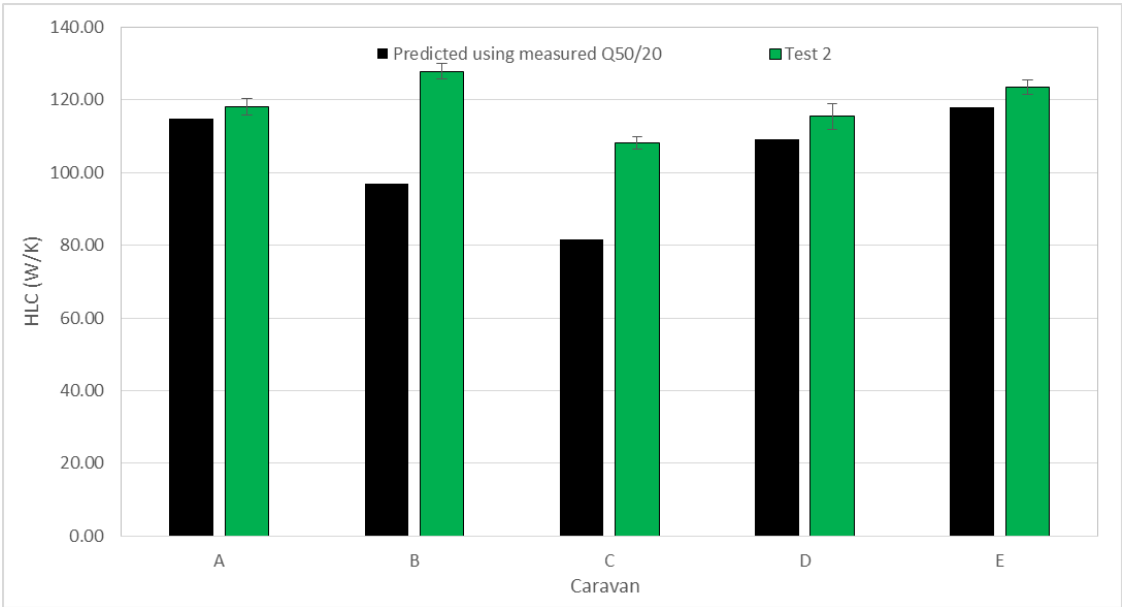
53 A more appropriate comparison would be to compare the results from Test 2 with the predicted HLC, as is illustrated in Figure 57. This comparison shows that in all of the test caravans, the measured HLC obtained from the electric coheating test is greater than the predicted HLC, indicating that a building fabric performance gap exists within all of the test caravans. Closer analysis of the data reveals that the scale of the gap varies considerably between the various test caravans. For caravans A, D and E the size of the gap is small (3.3 W/K, 6.2 W/K and 5.5 W/K, respectively). However, for caravans B and C, the size of the gap in performance is considerable. For caravan B the measured HLC is 31.0 W/K greater than predicted and for caravan C the measured HLC is 26.6 W/K greater than predicted. This represents an increase in HLC of just over 30% for both of these caravans.

Figure 57 Comparison of the electric coheating test results with the predicted HLCs.

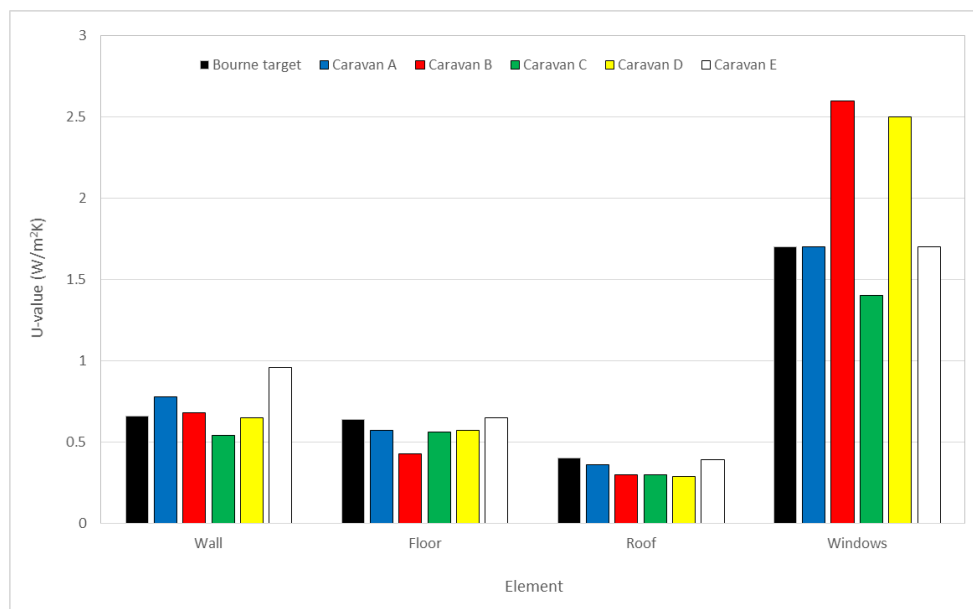
Figure 60 Comparison between the design intent U-values and the Bourne specification.

57 As can be seen from Figure 60, four of the five caravans failed to meet one or more elements of the U-value specification, resulting in only the caravan meeting all of the U-value specifications (caravan C). The caravans that failed to meet the greatest number of elements of the specification were caravans B & E, which failed to meet 50% of the U-value specification. In terms of the individual fabric elements, although all of caravans met the roof U-value specification, caravans A,

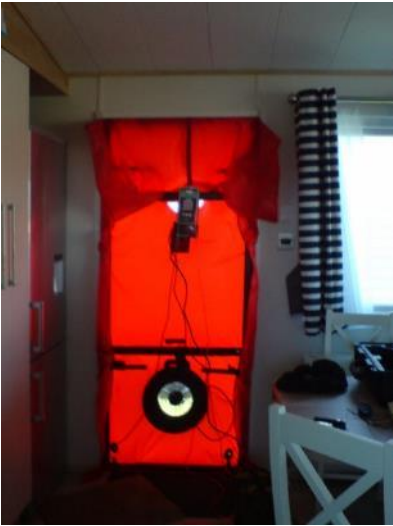
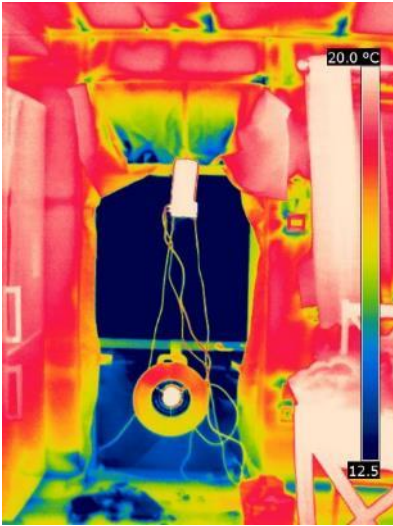
Caravan A – 18 th February 2016		
External temperature 6.7 °C, Internal mean temperature 18.1 °C, $\Delta T \approx 11.4$ °C

Room – Lounge/Kitchen Span – 7.5 °C

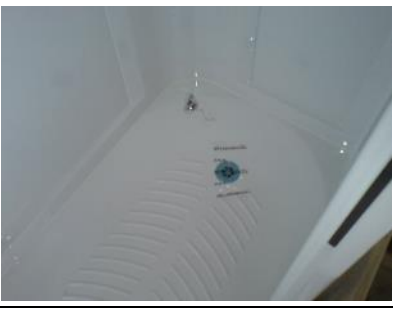
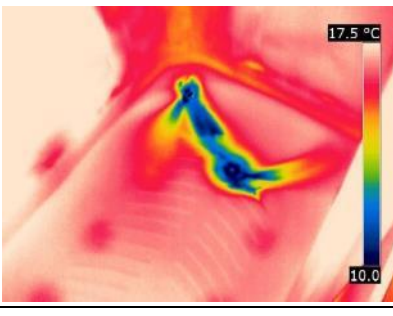
<p>Room – Bathroom Span – 7.5 °C Daylight visible through a gap at the waste pipe penetration – a photo of this detail from beneath is shown at the end of this section.</p>

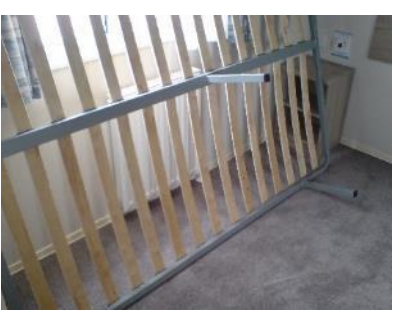
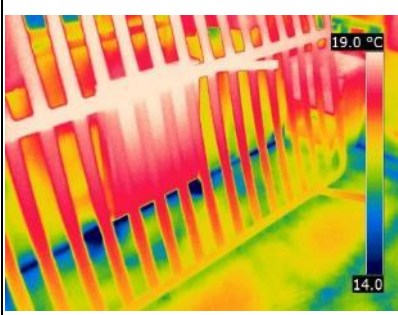
<p>Room – End Bedroom Span – 5 °C Under depressurisation, at higher pressures, the carpet in this room was seen ballooning upwards; air can be seen moving beneath the carpet in the thermal images.</p>

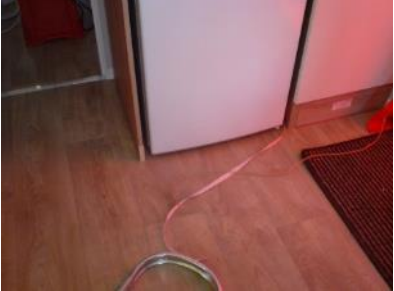
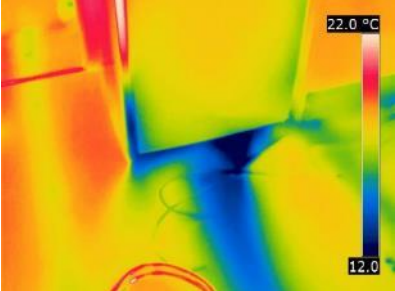
<p>Room – Lounge/Kitchen Span – 10 °C Excessive air leakage observed from under the fridge.</p>

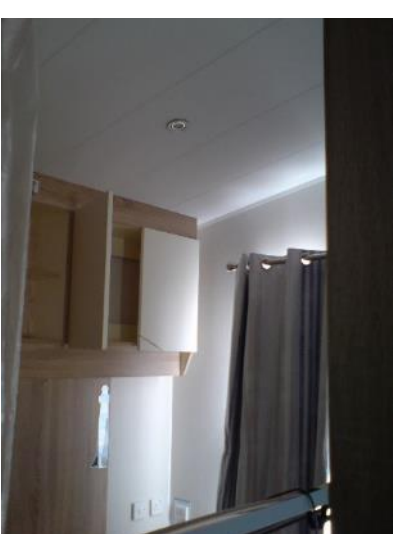
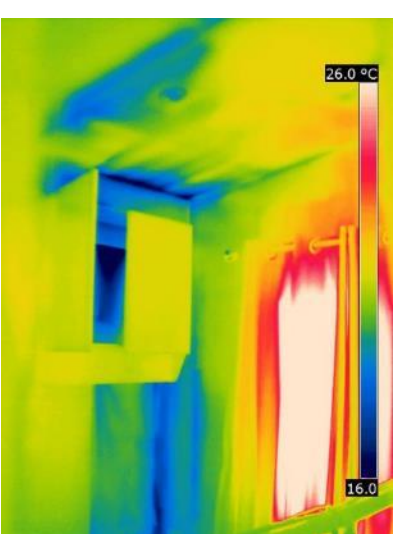
<p>Room – End Bedroom Span – 10 °C Higher span in the thermal images in this room is due to direct sunlight creating warmer internal surface temperatures rather than cooler air emerging.</p>
