Christ Child Bearing the Instruments of the Passion Technical Study and Treatment of a Painting on Copper from the Viceroyalty of Peru

Christ Child Bearing the Instruments of the Passion
**Technical Study and Treatment of a Painting on Copper from the
Viceroyalty of Peru**

CNS 695 Master's Project

Daniela González-Pruitt

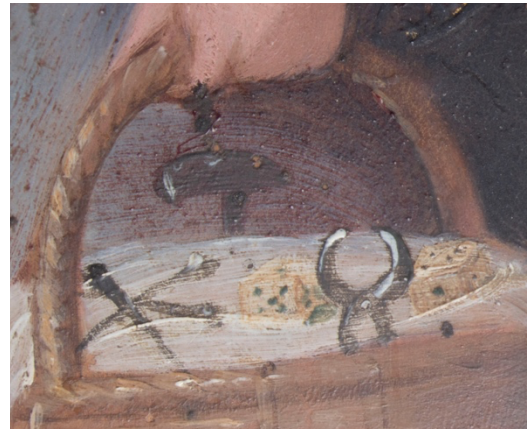
Figure 5. Recto, normal illumination. Detail instruments in the basket held by Christ.

The painting appears to have maintained its original tonality; no obvious color degradation is noticeable in normal viewing conditions. Under microscopic examination the paint surface appears to be heavily overpainted in the black background surrounding the figure. There are several fine scratches throughout the flower laid path and beside the basket that extend to the copper support (fig. 6). Upon first inspection overall, the paint losses are relatively minor and amount to less than 10% of the painted surface. In addition, there are minor accretions and splatters on the surface of the painting.

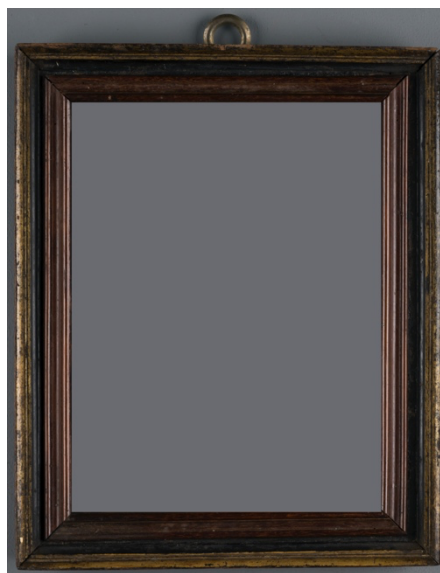
The painting was housed in a historic reproduction frame, made of carved wood with gold painted accents (fig 8). Despite minor losses to the paint, the frame was in generally good condition.

Figure 8. Frame, photograph under normal illumination.

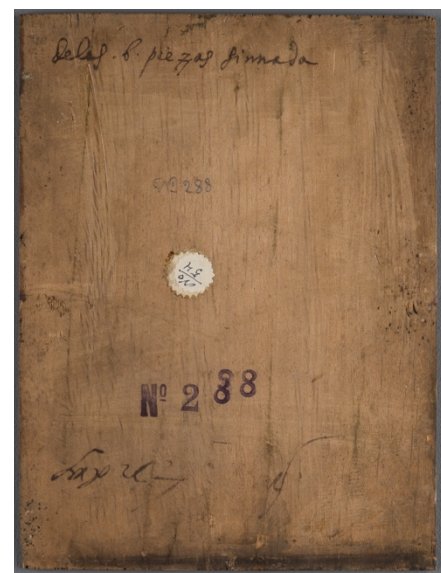
The painting was accompanied with a thin wood panel on the back (though not secured). The panel contains a stamp, an adhesive label, and writing in both graphite and dark media. The text located at the top of the panel reads “de las sies piezas firmadas” (from the six signed

Figure 9. Recto, normal illumination. Overall panel backing board with writing and labels.

works), while the text at the bottom appears to have been a possible signature that is now illegible

A fitted backing board constructed of blue board had been attached to painting when it arrived. The board will be kept as it protects the work from any impacts to the back that may occur during handling and transport. It will also minimize air flow, prevent dust accumulation on the verso, and provide additional support to the work. Works on copper are robust and are not affected to environmental changes as drastically as works on canvas. However, it is recommended that a work on copper still be kept in a sealed environment, it recommended that the Thoma Foundation consider adding a glazing the work as a preventive measure. After leaving the department, the painting will be returned to the Thoma Foundation's Santa Fe location in the same custom-made blue board box in which it came. In preparation for travel, the painting has been wrapped in polyethylene sheeting sealed with tape, which will reduce exposure to abrasion, moisture, and limit environmental fluctuations.

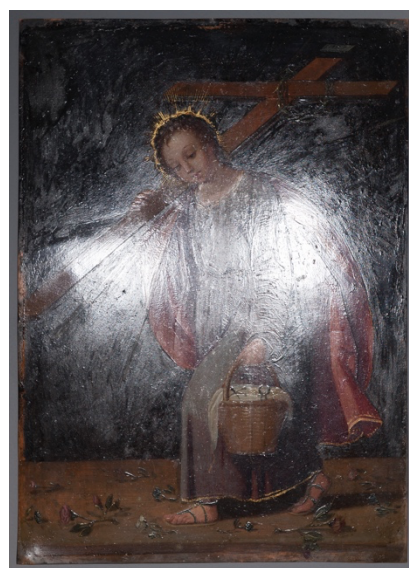
Figure 11. Recto, Overall visible axial specular illumination showing the texture of the brushwork.

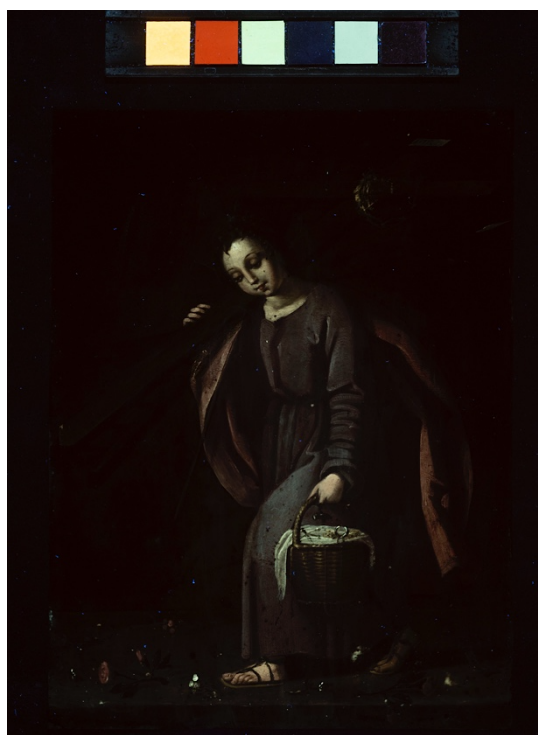
Following varnish removal, UVA- induced visible fluorescence imaging revealed that the blue-green hue from the surface coating was no longer present and that the original applied paint layers did not process any fluorescent properties and therefore did not fluoresce (fig.12). The lack of fluorescent properties in the original media proved challenging when attempting to capture a UVA induced image of the painting. The image captured appears dark but does demonstrate that there is no evidence of any fluorescent containing media proving that the work is from its estimated time period.

Figure 12. During Treatment, Overall UVA induced visible fluorescence illumination. No fluorescence observed.

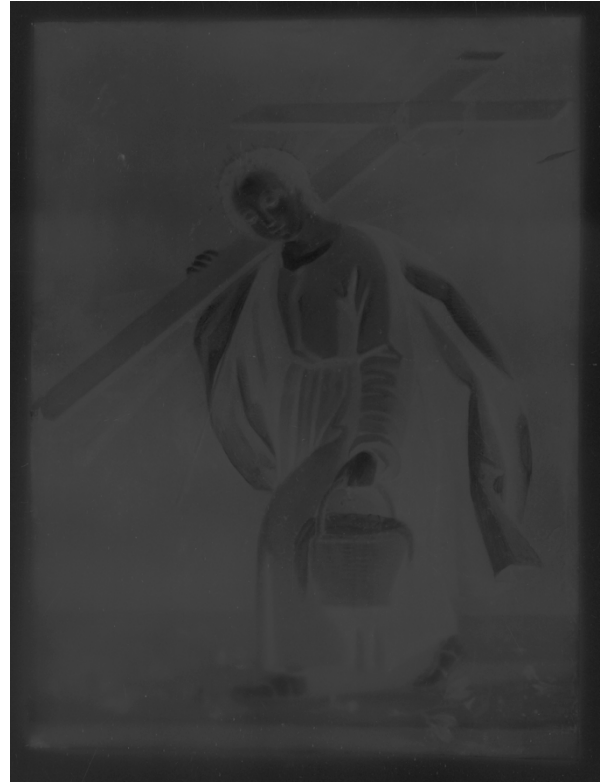
Figure 14. DT, X-radiograph taken on the work showing lighter areas of higher atomic weight

The x-radiograph was performed after the liberal overpaint in the background had been reduced revealing a thin brown ground layer and significant expanses of paint loss to the bare copper plate. These areas of the subject appear lighter in tone in the radiograph due to the copper containing a higher atomic weight thus absorbing more x-rays, diminishing penetration (fig. 14). Regions contained lead white seen in the mantle also appear lighter in contrast to the flesh tones of the figures. The subject was penetrated by a beam of x-rays and the extent of x-ray penetration was recorded on a digital imaging plate, the was recorded to be kV: 300 mAS: 5.00.

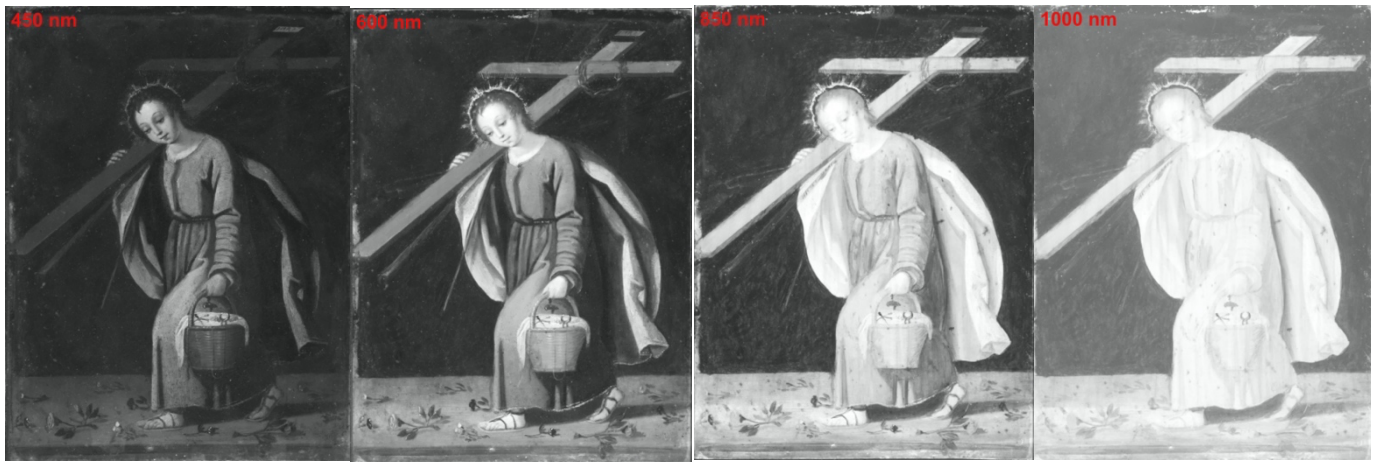
Figure 15. a-d. Images of the painting at 450, 600, 850, and 1000 nm.

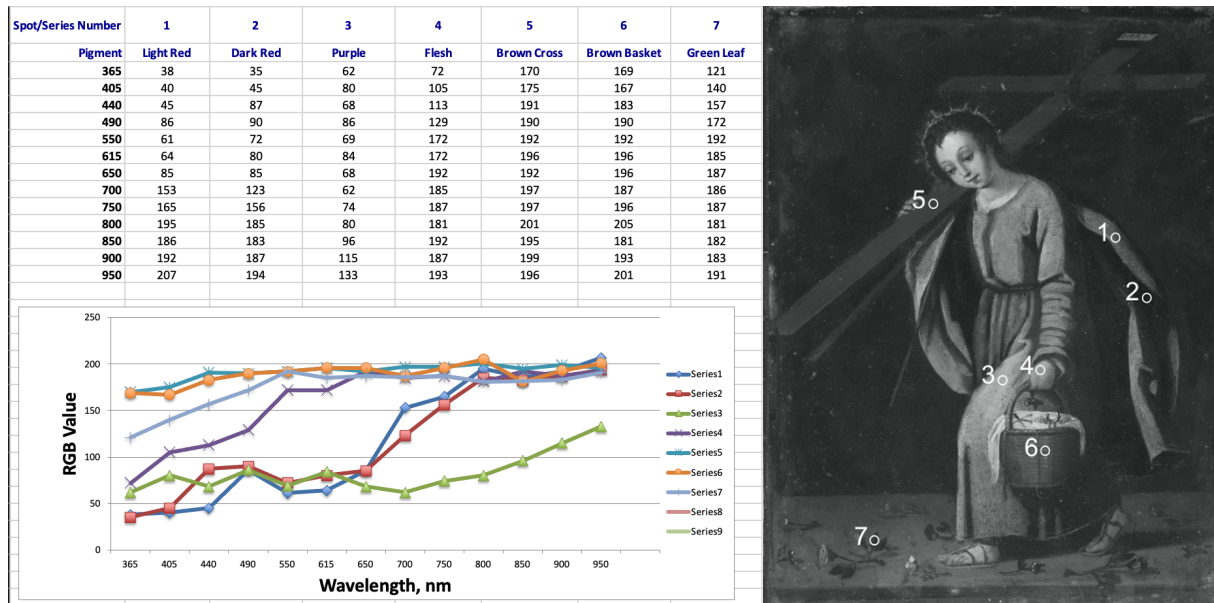
Figure 16. Reflectance spectrum and sample locations on the painting for comparing and contrasting similar pigments

Spots 5 and 6 are from the brown regions found in the cross and the basket that are original paint. Whereas spot 4 in the figures hand is likely in an area of overpaint, as revealed under UVA and has a different spectral response.

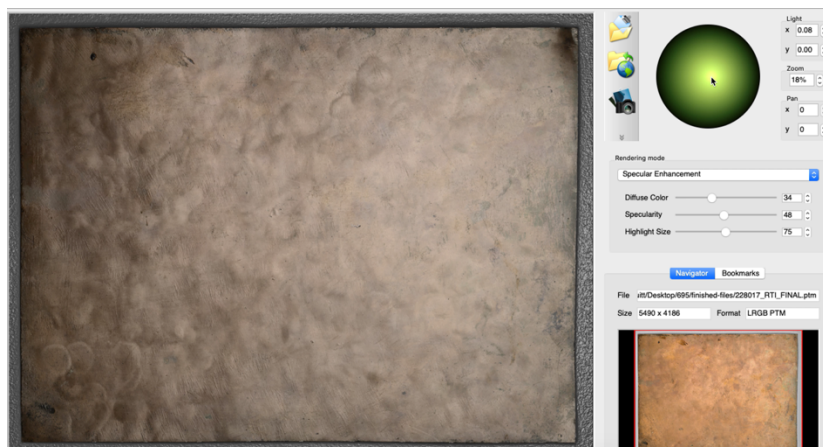
to better understand and observe the hand tooling that went into preparing this support for painting (fig.18).

Figure 18. Reverse of painting as seen in RTI in viewing software with specular enhancement applied. Note the enhanced

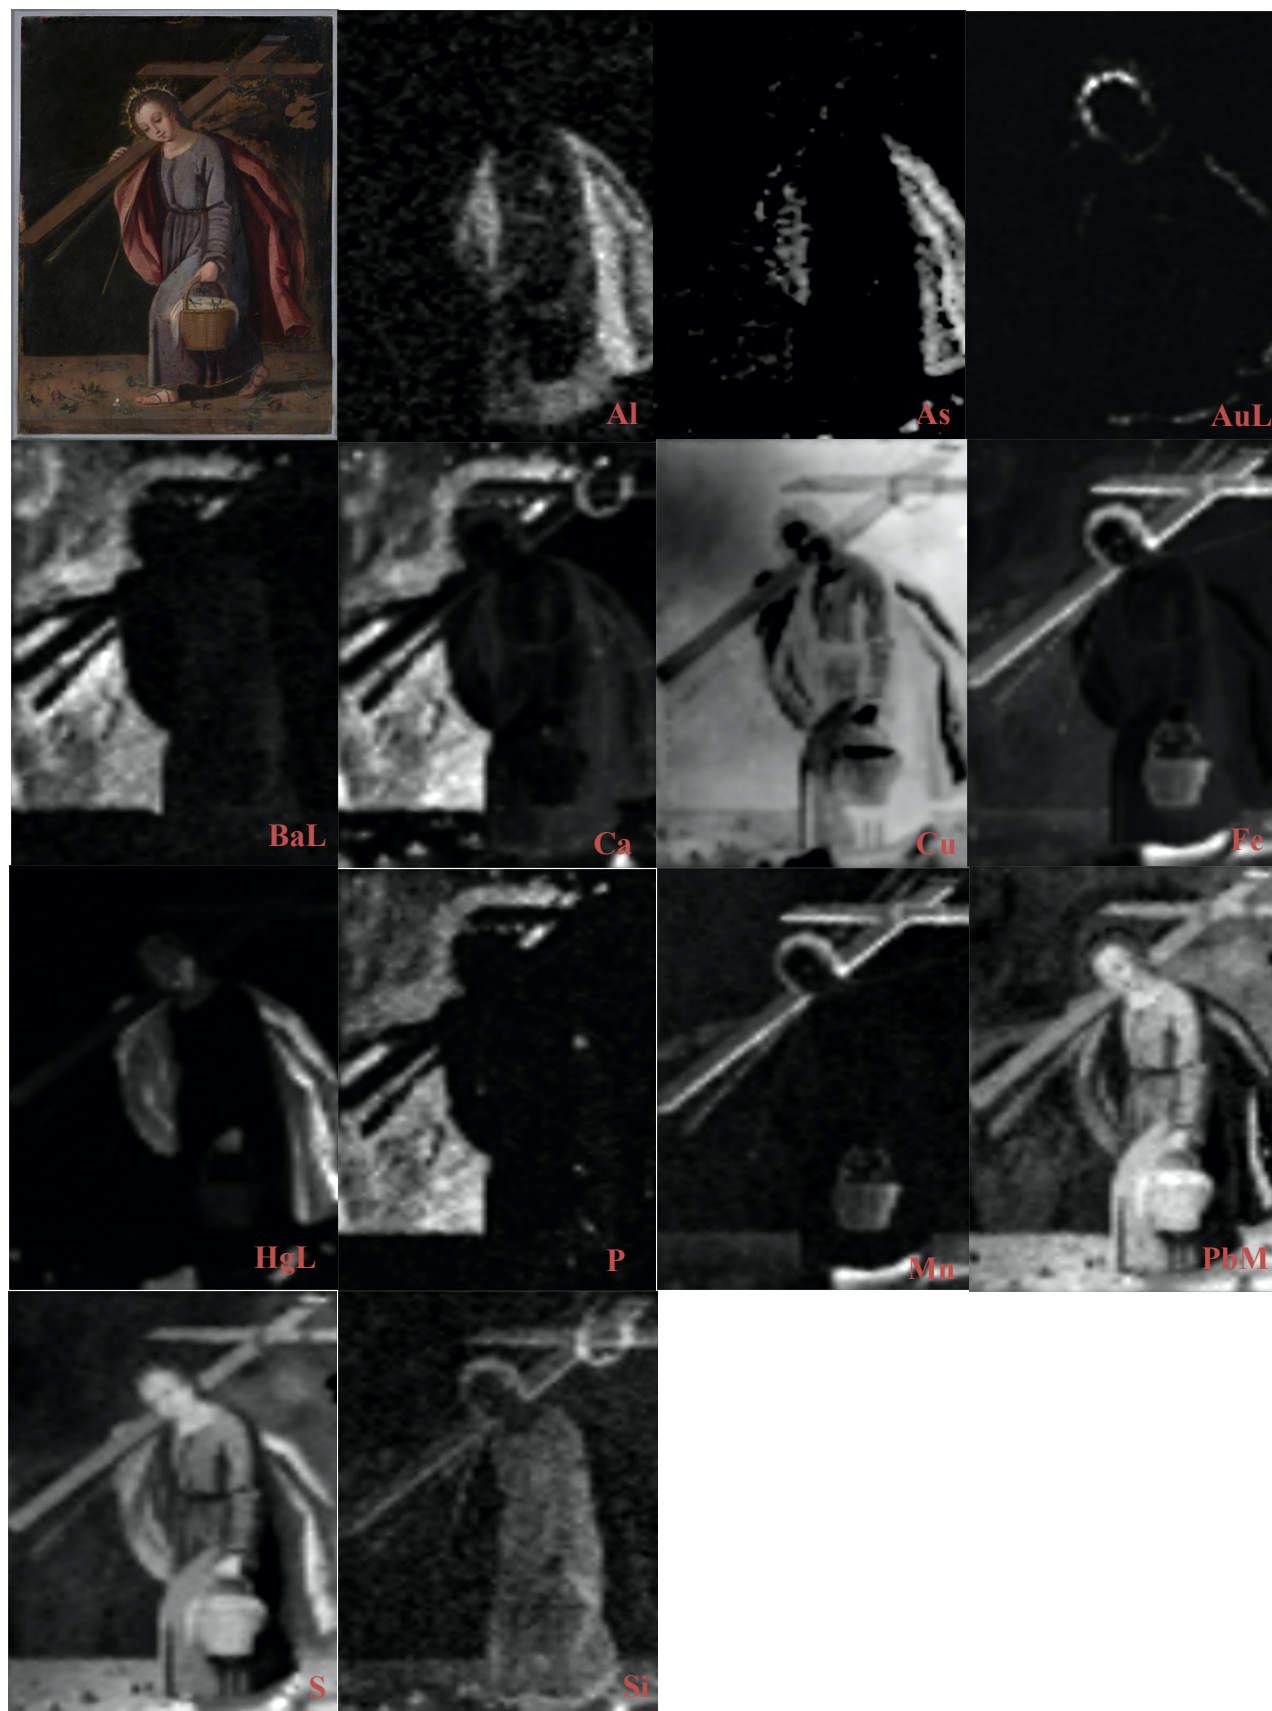
Figure 19. a-p. Top: Scanned area, Aluminum (Al), Arsenic (As), Gold (Au) L-lines. Second row: Barium (Ba) L-lines, Calcium (Ca), Copper (Cu), Iron (Fe). Second row: Lead (Pb) M-lines, Sulfur (S). Second row: Potassium

(K), Silicon (Si), Calcium (Ca), Aluminum (Al). Third row: Mercury (Hg) L-lines, Phosphorus (P), Manganese (Mn), Lead (Pb) L-lines. Fourth row: Sulfur (S), Silicon (Si).

XRF revealed the palette to include lead white, earth colors, vermillion, carbon black, and bone black; all pigments that would have been used in workshops in the Spanish Americas during the 17th century. Mercury (Hg) was found on Christ's red cape. This suggests mercuric sulfide: either the natural mineral form, which is simply ground cinnabar, or the synthetic form, vermillion. Phosphorus was found in background of the work that had a section intact overpaint. In conjunction with visual examination, this presence suggests bone black. Phosphorous distinguishes bone black from carbon black, though both are made from burned materials.

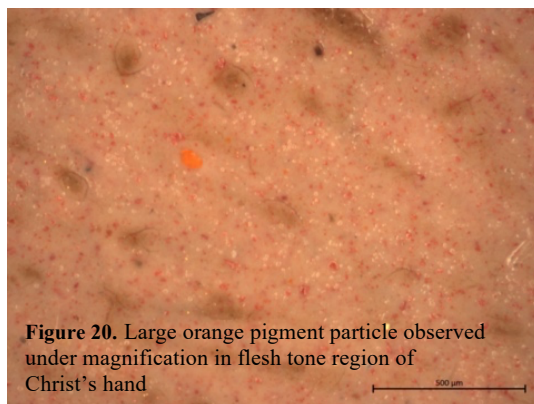
Figure 20. Large orange pigment particle observed under magnification in flesh tone region of Christ's hand

This finding was valuable and reassured the possibility that most of the black background had been liberally overpainted with an opaque layer bone black during its previous restoration campaign.

is also present in the painting, most notably in in the red robe of Christ. Orpiment and Realgar are two arsenic-containing pigments that were used in colonial art during the 17th century, they both are arsenic sulfides and differ in color (Siracusano 2011). Orpiment is described as lemon yellow in color, while realgar is typically red or orange (Seldes 2002). Visual examination suggests that realgar is the likelier of the two: orange particles are visible under magnification in the red robe (fig. 20).

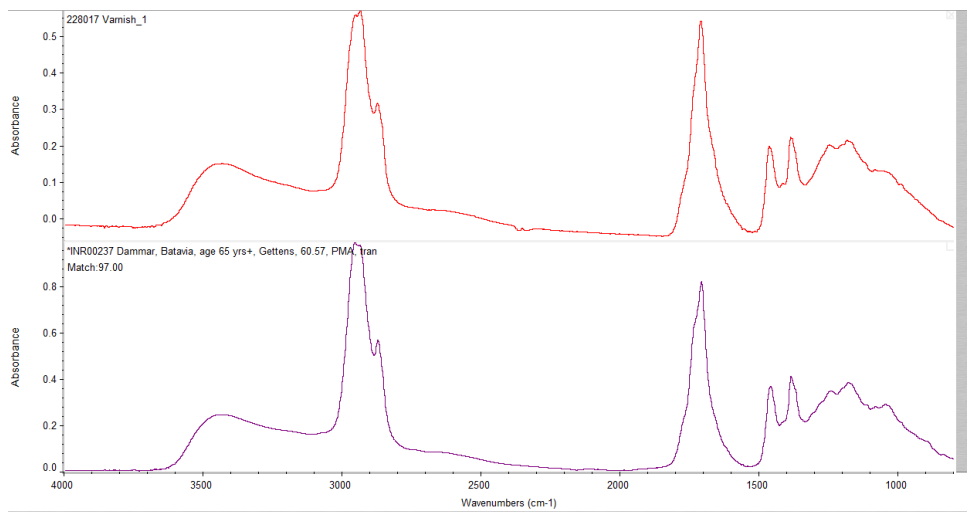
The varnish was revealed to be a natural resin varnish matching spectrums for dammar. The sampled surface coating although not original does inform that the original varnish was most likely removed during a previous conservation campaign and that this most recent coating is part of the restoration campaign because it was applied over the retouching.

Figure 21. Comparative spectra of the surface coating sample taken from the artwork (upper spectrum) matching a library spectra for a natural resin such as dammar (lower spectrum).

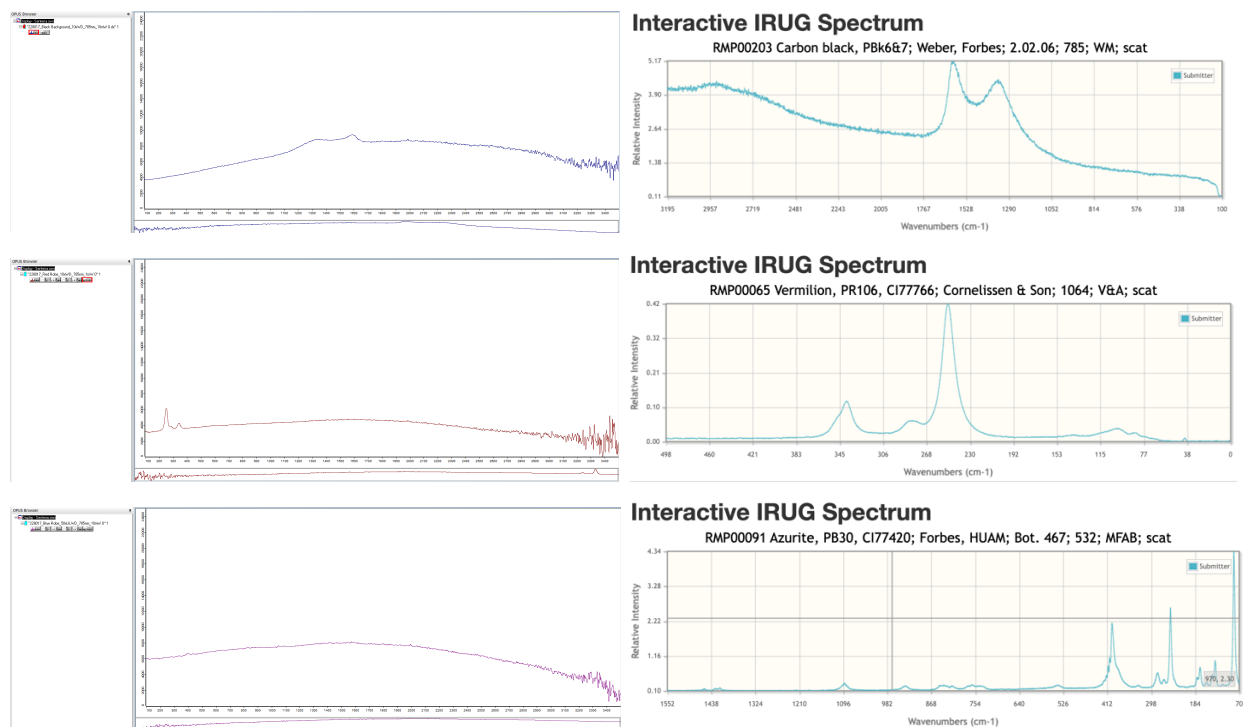
Figure 22. a-c Comparative spectra of the three examined regions viewed with library spectra from IRUG. More info needed here, what are we looking at and what samples are you analyzing

The black paint samples produced spectra revealing the overpaint to be carbon black and signifying that the overpaint is bone black based off XRF analysis. A location on the cape was analyzed and found to have significant peaks that aligned well with a reference spectrum, indicating that the red paint is vermilion. The robe was found to be a combination of both a blue and red pigment, an area with blue particles was analyzed and found to have peaks matching to azurite.

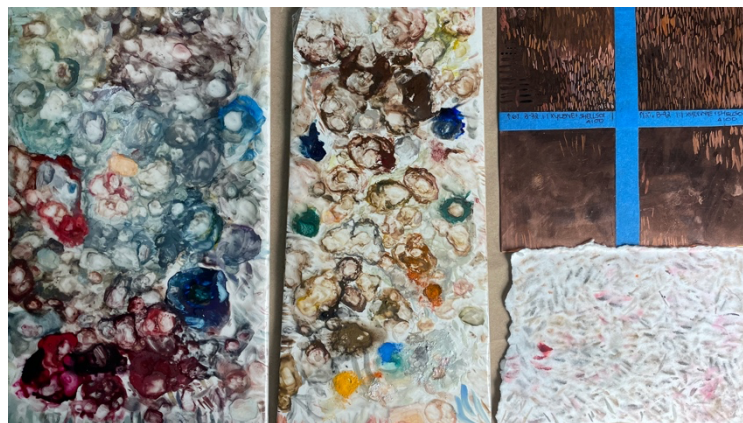
Figure 26. Inpainting mockups and mark making practice alongside

abrasion, hard-edge losses, corrosion, and spots, the approach was tailored to each specific issue using many mockups and testing various inpainting techniques on pieces of copper panel before commencing on the artwork (fig.

completed with a microscope to ensure precision and gloves properly handling the copper surface. Abrasions necessitated inpainting to reintegrate affected areas, focusing on color and texture matching. Hard-edge losses required meticulous inpainting to recreate missing details and respect the surrounding context. Corrosion and spots, which were prominent throughout the

work and distracted from the composition, only required pinpoint toning to push them back. For challenging scratches and spots, a conservative approach was adopted, addressing only what was essential to the artwork's overall visual integrity and authenticity while leaving select minor scratches without intervention to retain the age and natural wear of the copper painting.
