Ref : EUCL-IBO-TR-7-007  
Issue : 1.0  
Date: 09/06/2021  
Page: 1/37

<b>TITLE:</b>	<b>Test Report of NISP dedicated test activities during the CSL campaign - DCU-SCE Communication issue</b>		
<b>Date:</b>	09/06/2021	<b>Issue:</b>	1.0
<b>Reference:</b>	EUCL-IBO-TR-7-007		
<b>Custodian:</b>	Eduardo Medinaceli

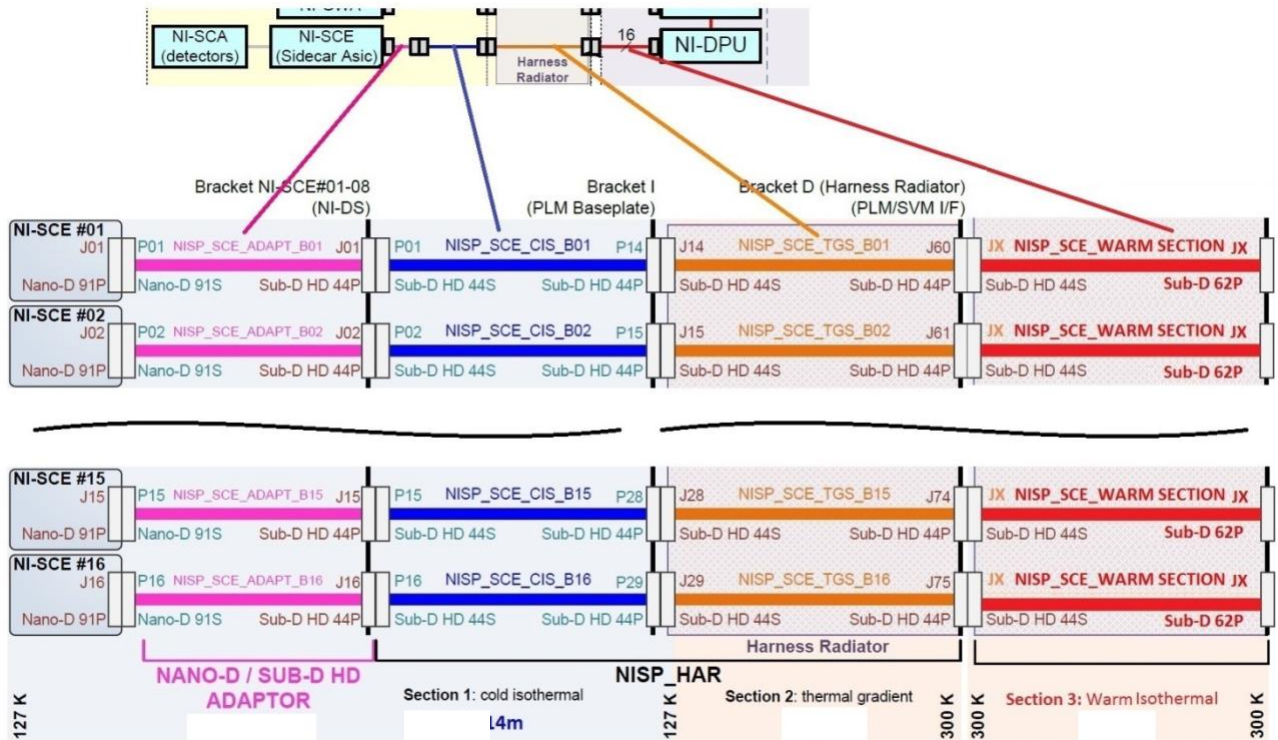
The 3m extension cable added to Section 3 – warm isothermal is not shown in the scheme above

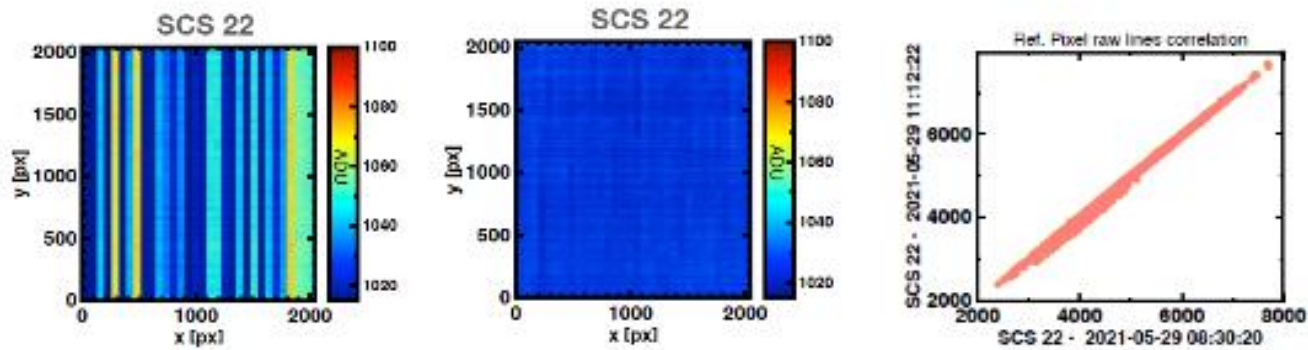
Reference pixels signal from raw lines comparison

the same figure is plotted the comparison of reference pixels signal from raw lines showing the expected correlation (same values).

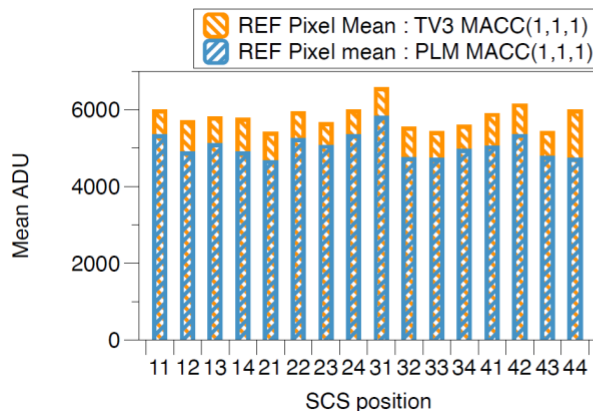
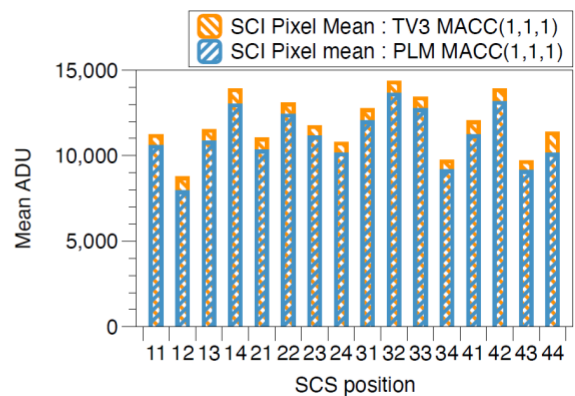
Also, the baseline was verified and found compatible with TV3 (considering the Temperature differences – slightly hotter than TV3 ~ 3K at SCA level); the following histograms shows the comparison between PLM and TV3 baselines, on the left for the reference pixels, while on the right for science pixels.

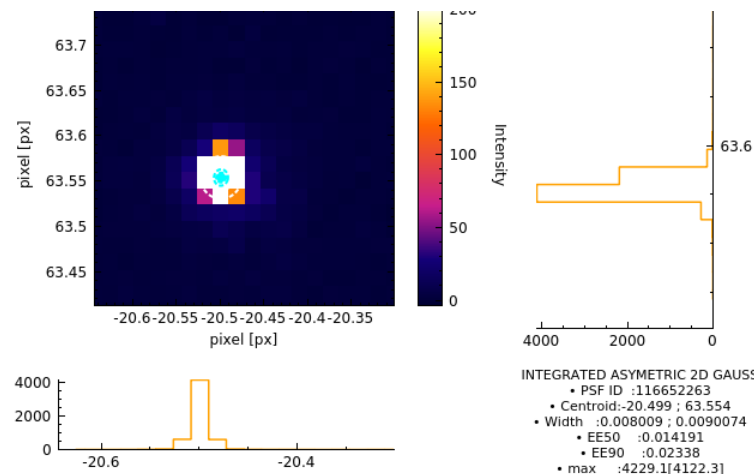
This configuration is being used since the 1<sup>st</sup> of June intensively, no errors related to the images were found. Detectors were even used successfully for performances tests, e.g. next figure show the NISP PSF in the Y photometric band.

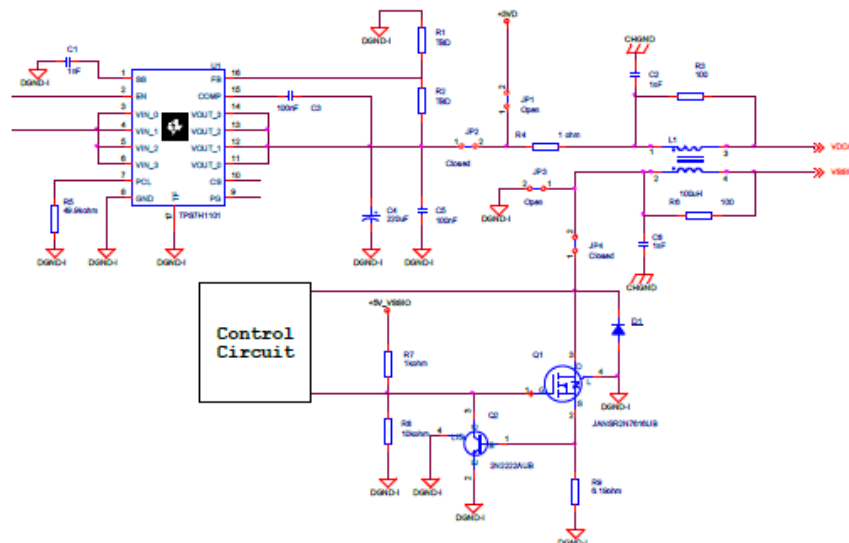
Figure 6-6: VDDIO and VSSIO power supply simplified circuit diagram

The VSSIO value can be set using resistors to be soldered on the DCU board. VSSIO current is drained by the DCU.

VSSIO power supply can be bypassed to provide 0V output at the SCS with a jumper on the DCU.

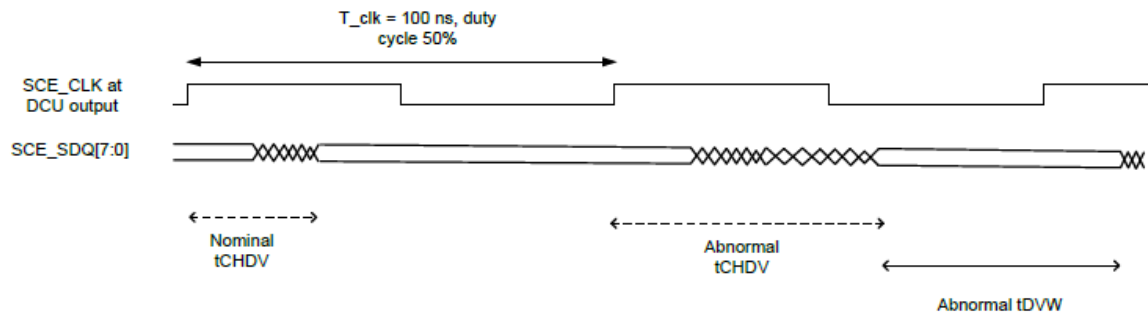
Figure 6-6: SIDECAR science IF abnormal waveform model

The communication uses a parallel interface with two FIFOs sampling asynchronously with a delay of 50ns between them. SCE clock is 10 MHz (100 ns).

Examples of nominal and non-nominal IF between DCU and SCE

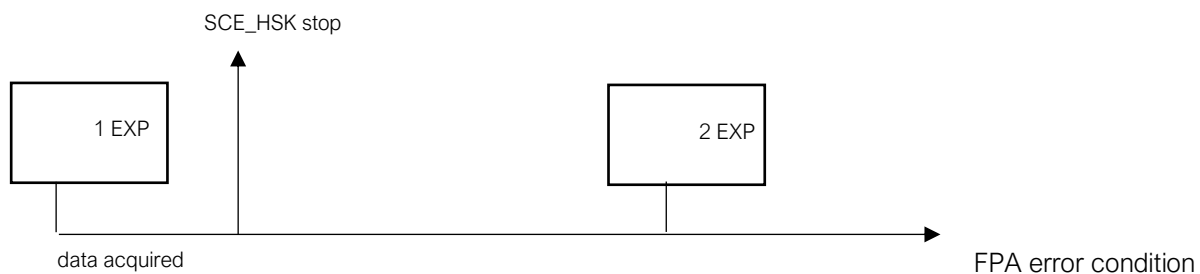
The usual sequence triggering the error condition was applied to the Focal Plane Array (FPA) of the ADS TB/TV setup. This condition is the final state after the following sequences: a first broadcast exposition was executed which generated data (no quality analysis presented here), nevertheless the DCUs signals non-blocking errors during transmission in the LVDS data link. ASIC TLM (during the acquisition) taken from the first frame stored in the scientific file is nominal (separated report). But two seconds after the exposure started, the SCE housekeeping retrieval stopped working for 9 out of 16 units. This operation is done by a SW task – HSK scanner, that periodically access SCE TLM registers using the DCU TM/TC I/F. Then, a second exposure was issued but the command was not executed (no data generated); this could happen because the serial TM/TC interface is down, or because the ASIC is in a non-nominal state unable to communicate with the DCU. Below is a scheme of the sequence leading to this error condition.

This condition is reproducible, even when the software HSK scanners are not enabled. The same error condition was reached also when operating with the single units that already showed failures during broadcast exposures.

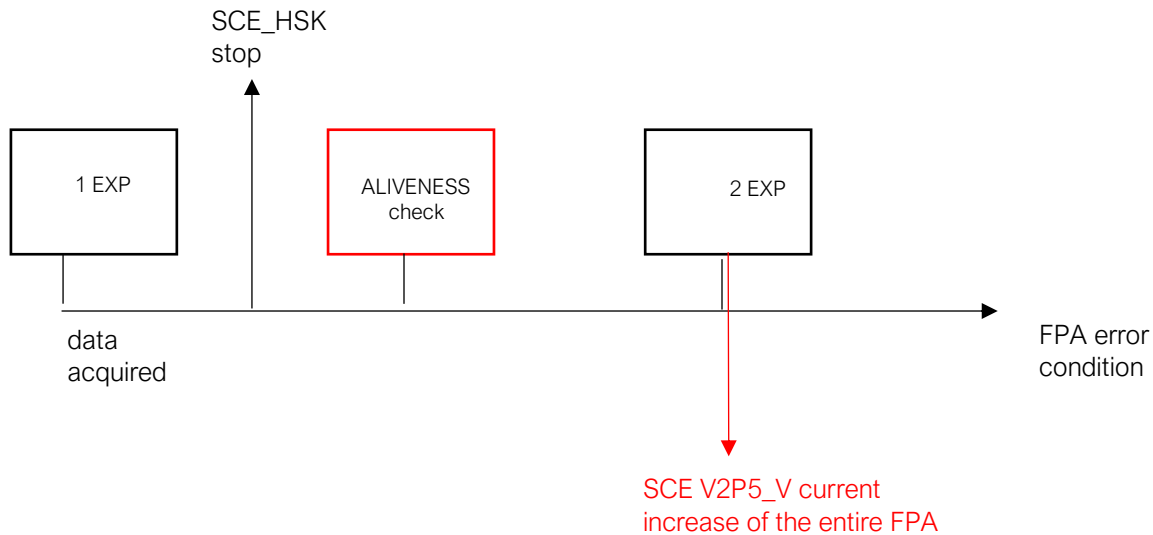
Results of the previous sequence are summarized in the following table:

After the first exposure, 7 out of 16 DCUs signal errors during transmission, and give an error during the Aliveness check execution. Later, the second exposition failed for the entire FPA.

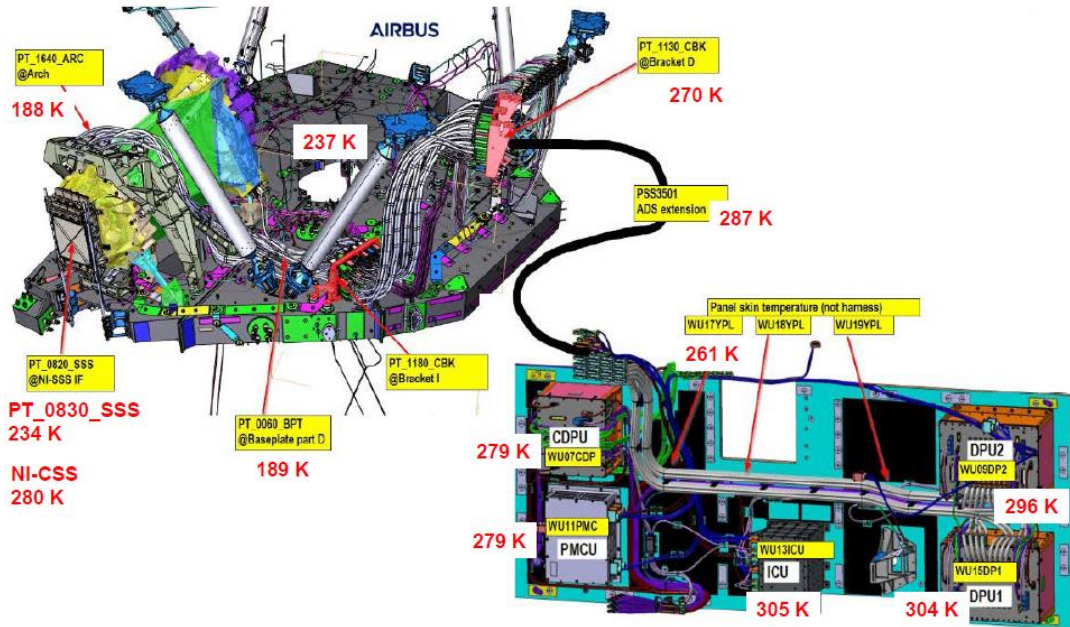
First Occurrence: 04/07/2021 – 08:40 UTC Phase 80

A dependence of the number of detector chains working nominally (without entering in the error condition described above, nor in the two consecutive exposures error condition) with the Temperature was found.

Results are given in the following pictures (courtesy of ADS), where the Temperatures of the different components are indicated; as well as a table with the DCU ID (from 1-8 for DPU1 and from 9-16 for DPU2) and the STATUS which indicates units correctly operating (OK) and the ones entering in the error condition (FAULTY).
