Behavior of hydropower plant "La Yesca" Mexico, after two year of built

This paper presents the program instrumentation, monitoring and performance of Hydropower Plant "La Yesca", which is a concrete face rockfill dam, with 207,5 m high (inaugurated on November 6, 2012). During de filling of the reservoir, high leaks where measured on the drainage gallery of the curtain and on the injection and drainage galleries, particularly on the right bank. To reduce the anomalous seepage in the galleries a series of studies were done to define the source of the leaks and implement corrective measures. Currently the embankments of the dam and the concrete face show a good behavior. They present less than 20 cm of maximum settlement from the reservoir filling and two years

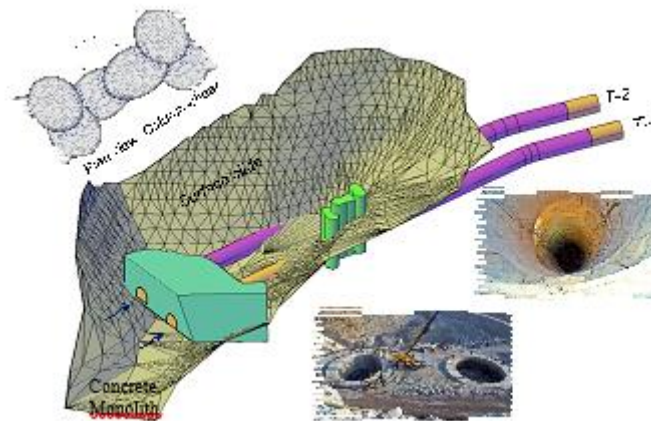
Figure 5. Implemented stabilization structures: concrete monolith; anchor plugs diversion tunnels 1 and 2 and shear-piers.

Due the rapid drawdown, water levels in the dam and the seismic stability conditions in the rock block were critical. It was necessary to design and construct additional stabilization works as the case of a wall formed by six plain concrete piers 9 m diameter each one and varying depths between 60 and 85 m (Figures 5 and 12), which crossed the fault Collapse and were embedded in the underlying bedrock. Additionally, diversion tunnels were filled with reinforced concrete in a certain length (190 m in the tunnel 1 and 175 m in the tunnel 2), at its intersection with environment collapse failure, to make them work as a large anchor (Figures 5 and 12).
