Path of Knowledge for the Assessment of Structural Safety of the Pisan Tower of the Royal Palace of Palermo in Italy

Abstract: This paper presents the path of knowledge developed for assessing the structural safety of the Norman-age Pisan Tower, which is mostly incorporated into the Royal Palace in Palermo, Italy. Historical, geomatic, and mechanical investigations were conducted and the most relevant results are herein collected and presented. The research path was addressed to specific tasks: identification of the building, geometric surveys, recognition of the sequence of phases of building transformation, detection of the components of the load-bearing structure, structural diagnostic surveys, and investigation of the subsoil and foundations. The explicit vulnerabilities found were mostly confined to the Piazza library floor, while implicit vulnerabilities were identified in the presence of false walls and in high loads and fillings on the vaults of the last levels. The results of the analyses allowed the individuation of the confidence factors to use in structural analysis models aimed at the assessment of the seismic safety of the building.

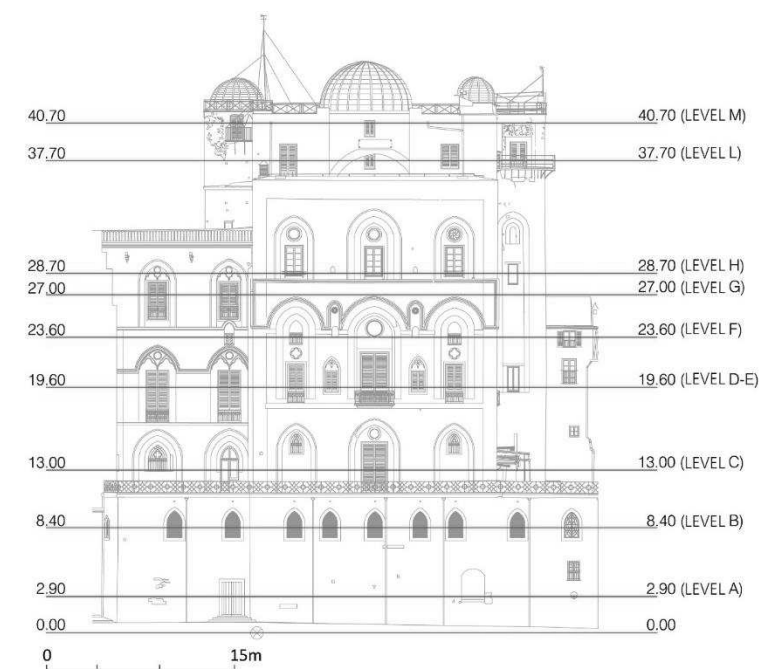
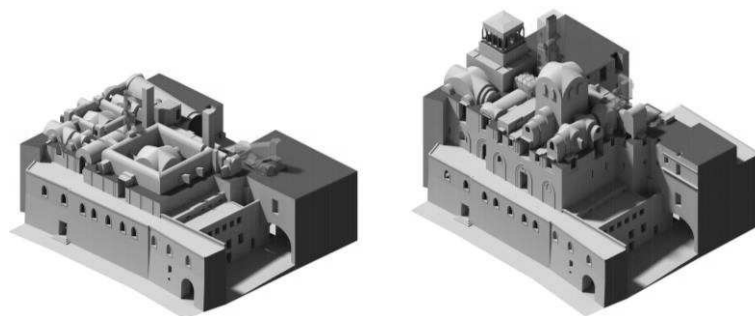
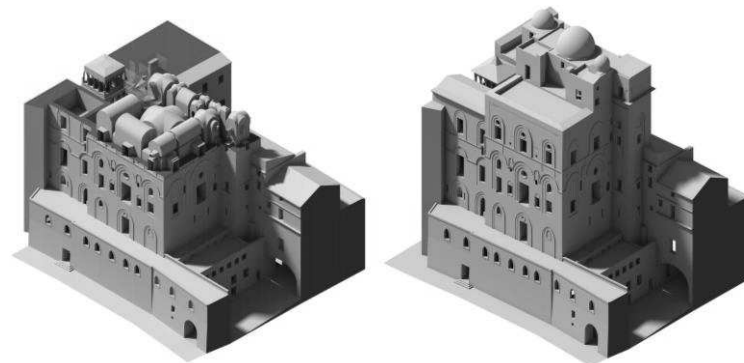
In addition to the available data and those obtained from direct observation of the current state and in-depth historical research, data related to the geometry and typology of the most damaged structural elements were acquired through endoscopic surveys; they were all located in the most damaged areas of the Tower.

The results of these integrative surveys allowed the determination of both qualitative and quantitative data. In particular, a mostly incoherent infill was found above the vaults, in the northwest corner of the ambulatory surrounding the Treasure Room, also called the Mint Hall (sample S103), in correspondence with an edge of the interior wall of the south

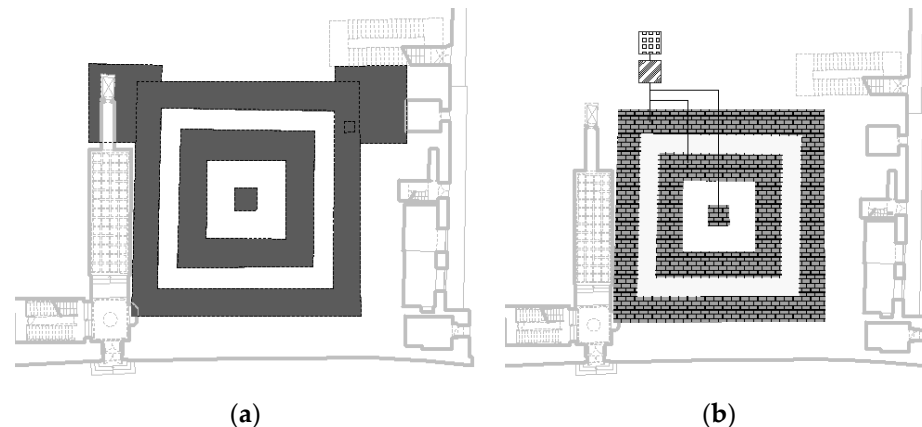
Figure 15. Identification of the structure of the Tower on level A (height 2.90 m); (a) hypothesized vertical load-bearing structure; (b) hypothesized materials.

The surveys performed and the information collected showed that the vertical load-bearing structure of the Tower consists, on level A, of two concentric quadrilaterals in the planimetry, with walls wider than 2 m, and two turrets at the vertices of the west side of the Tower, as represented in Figure 15a. These walls have been realized with a wall in large (70–100 cm) calcarenite ashlar, dry-placed and/or with low-width mortar joints. The wall was considered to show good workmanship and the ashlar have excellent mechanical properties, as shown by the high value of the compression strength of the extracted core samples. The material between the two squares of the Tower can be associated with an infill, mainly constituted by crushed ashlar, masonry with scarce mechanical properties, and incoherent materials (Figure 15b).

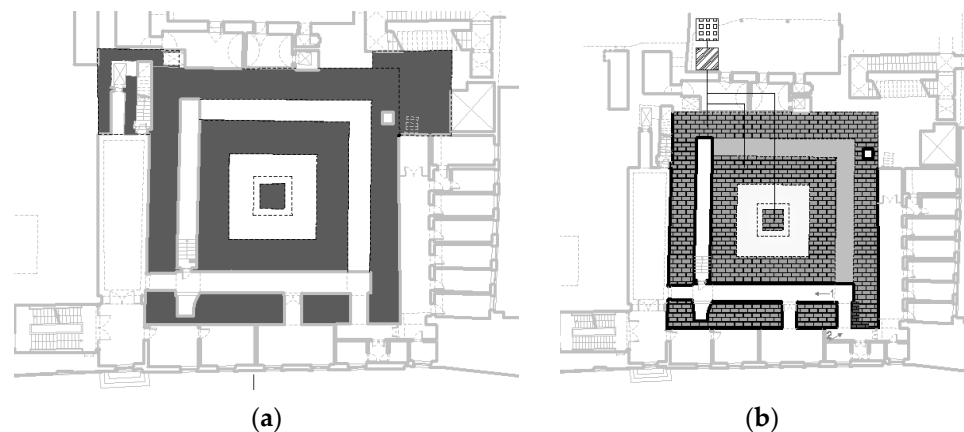
Figure 16. Identification of the structure of the Tower on level B (height 8.40 m): (a) hypothesized vertical load-bearing structure; (b) hypothesized materials.

The surveys performed and the information collected at level B repeated and confirmed the same structural layout as the lower level, consisting of two homothetic quadrilaterals with wall widths above 2 m, in calcarenite ashlar, dry-placed and/or with mortar (Figure 16a). Today, as in the Norman layout, the south turret is mainly used for vertical connections. The structural layout of the Tower has been presumably subjected to modifications during the complex and intricate evolution of the Norman Palace. At this level, the wall, which is partly visible, consists of calcarenite ashlar and variable-width lime mortar joints. The performed tests showed that the ashlar have good mechanical properties; however, these were lower than the values found at the lower level. The infill of the core between the two masonry squares is heterogeneous and incoherent, while in the internal core it is constituted by crushed ashlar with variable size and resistance (Figure 16b).

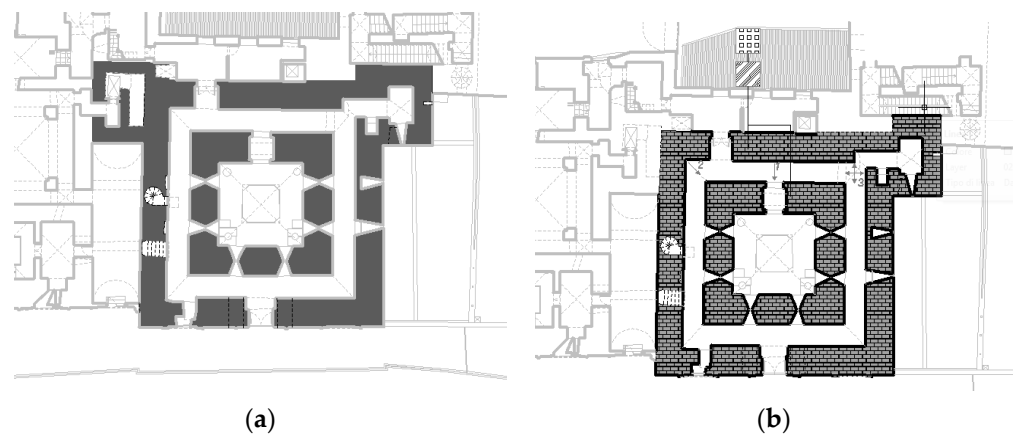
Figure 17. Identification of the structure of the Tower on level C (height 13.00 m): (a) hypothesized vertical load-bearing structure; (b) hypothesized materials.

Level C has a completely exposed structural layout, consisting of two concentric quadrilaterals, divided by an ambulatory with a barrel vault covering and two side turrets (Figure 17a). The masonry walls are in large calcarenite ashlar and lime mortar. The mechanical parameters of the ashlars were only available for the exterior of the east wall, and the resistance values were aligned with those of the lower level. The values for the operating tension of the masonry wall of the external square were very high; this is probably incompatible with the resistance of the masonry (Figure 17b).

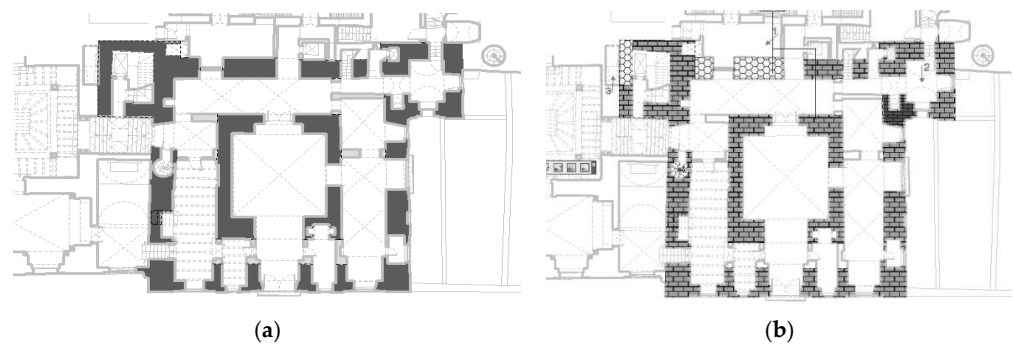
Figure 18. Identification of the structure of the Tower on levels D-E (height 19.60 m): (a) hypothesized vertical load-bearing structure; (b) hypothesized materials.

On levels D-E, the structural layout of the concentric quadrilaterals can be detected even if the walls are significantly set back from the lower level (Figure 18a). Moreover, the walls of the external square are intermitted by wide and numerous openings (doors, windows, rooms, and staircases). The President's Room has two different heights, while the other rooms are mainly double-height or have timber roofs. Superintendent Valenti, during the 1929 restoration intervention, performed several modifications to the structural layout. He demolished many mezzanine rooms, which had presumably been realized in the period of the Spanish Viceroyalty, and relocated some masonry walls to restore the Norman layout. The numerous performed interventions and the finishing with exposed faux masonry plaster were an obstacle to the precise definition of the wall typologies. Figure 18b shows a possible hypothesis, reconstructed solely on the basis of the historical documentation found.

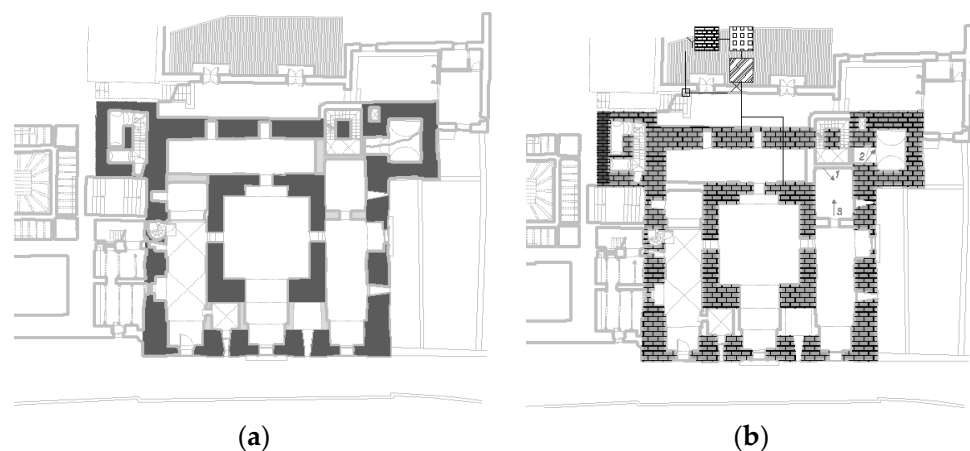
Figure 19. Identification of the structure of the Tower on level F (height 23.60 m): (a) hypothesized vertical load-bearing structure; (b) hypothesized materials.

At level F, the two mezzanine rooms used as offices were examined. The structural layout and related considerations (Figure 19a) were the same as for the lower level (19.60 m). During the 1929 restoration intervention, Superintendent Valenti performed several modifications to the structural layout. He demolished many mezzanine floors on this level and only left the ones that are currently being examined. Several extensive reinforcement interventions were performed on the vertical load-bearing structure through local rebuilding and, sometimes, demolition and reconstruction. The masonry walls used in these interventions were both in aerated bricks and calcarenite blocks (Figure 19b); however, the large number of interventions and the use of an exposed faux masonry plaster finishing complicate the precise definition of the wall typologies.

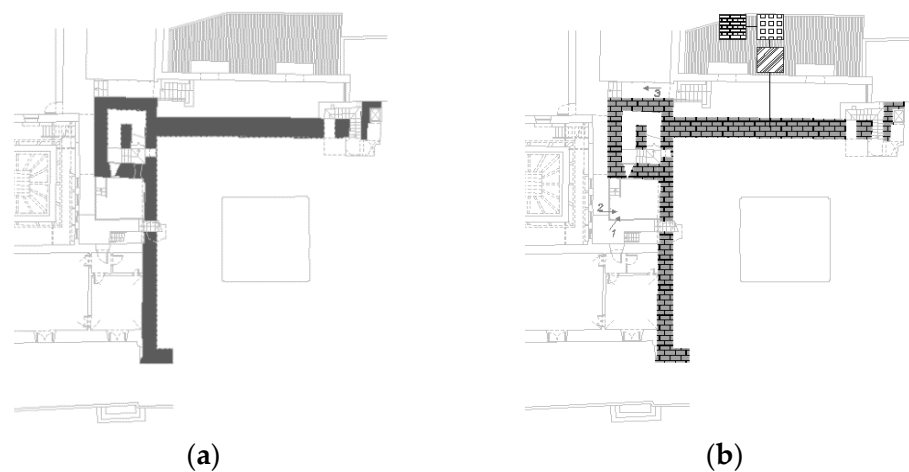
Figure 20. Identification of the structure of the Tower on level G (height 27.00 m): (a) hypothesized vertical load-bearing structure; (b) hypothesized materials.

Level G includes the rooms of the Astronomical Observatory adjacent to the south and west sides of the Tower. As has been mentioned, these were involved in the restoration intervention in the 1990s by Boscarino and Cottone. The intervention exposed the load-bearing structure on this level, allowing us to observe that it can be substantially associated with the original Norman construction (Figure 20a) and that it consists of large calcarenite ashlars and lime mortar (Figure 20b).

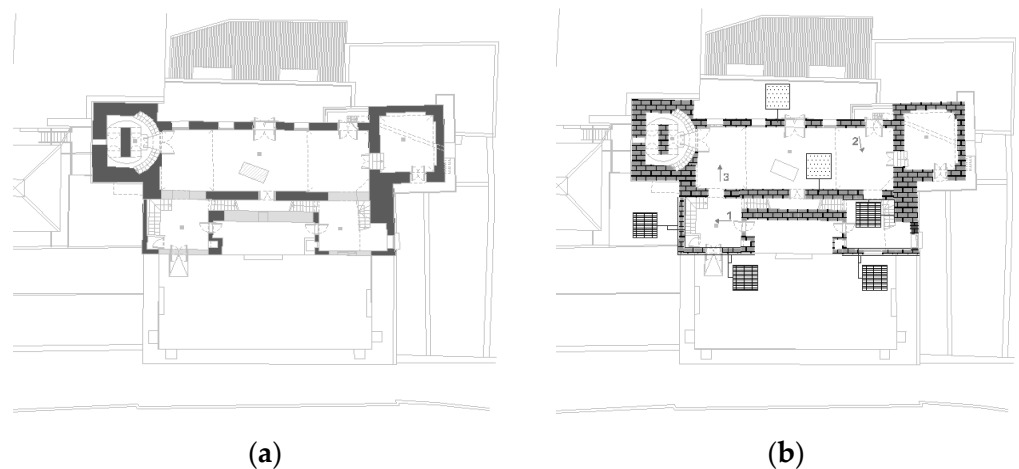
Figure 22. Identification of the structure of the Tower on level L (height 37.70 m): (a) hypothesized vertical load-bearing structure; (b) hypothesized materials.

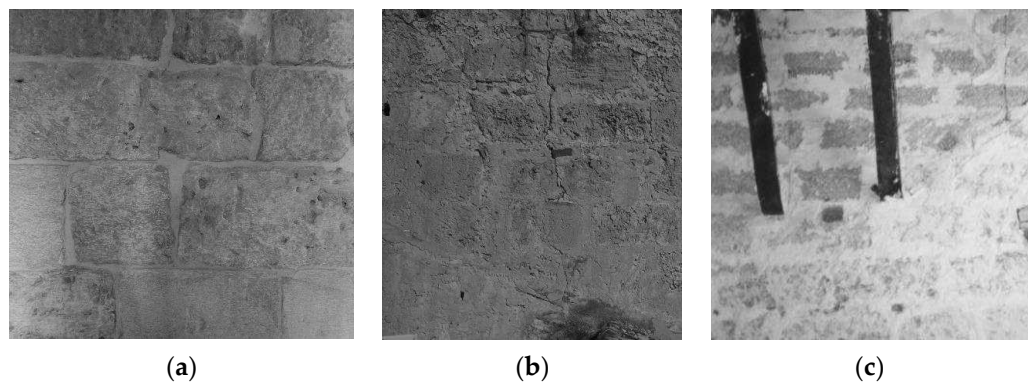
- Masonry in soft stone ashlar (tuff, calcarenite, etc.) of the Norman period (Figure 23a);
- Masonry in soft stone ashlar (tuff, calcarenite, etc.) of the period of the Spanish Viceroyalty (Figure 23b);
- Masonry in soft stone ashlar (tuff, calcarenite, etc.)—19th century—Astronomical Observatory (Figure 23c).

Figure 23. Masonry typologies: (a) Norman era; (b) Spanish era; (c) 19th century.

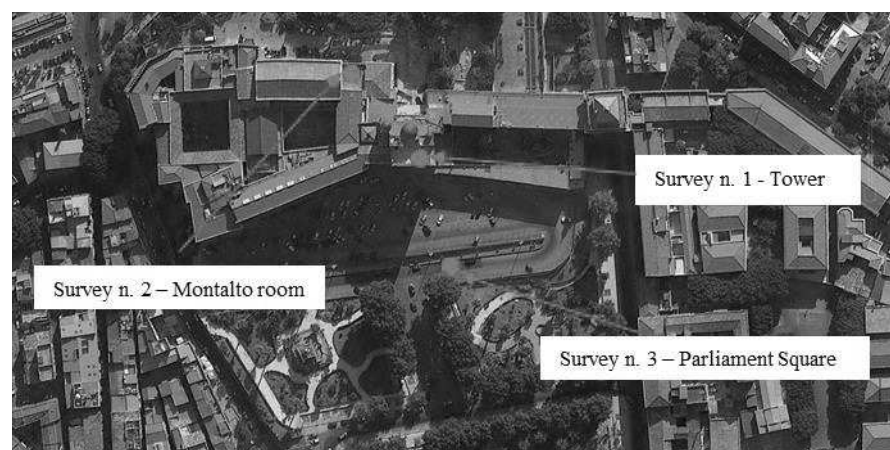
The surveys were performed at the points shown on the planimetry in Figure 27; the first one was inside the Tower at the lowest height (n. 1), the second one was outside the Tower, but at a lower height corresponding to the Montalto Room (n. 2), and the third one was in Parliament Square (n. 3), just beyond the caretaker's office at the entrance. Survey n. 1, named "Tower", obtained a value of $V_{S,30} = 342 \text{ m/s}$ and a width of 8 m for landfill on the sandy–calcarenite complex. Survey n. 2, named "Montalto room", obtained a value of $V_{S,30} = 345 \text{ m/s}$ and a width of 5 m for landfill on the sandy–calcarenite complex. Survey n. 3, named "Parliament Square", obtained a value of $V_{S,30} = 352 \text{ m/s}$ and a width of 5 m for landfill on the sandy–calcarenite complex.

Figure 27. Planimetry with the location of the surveys.

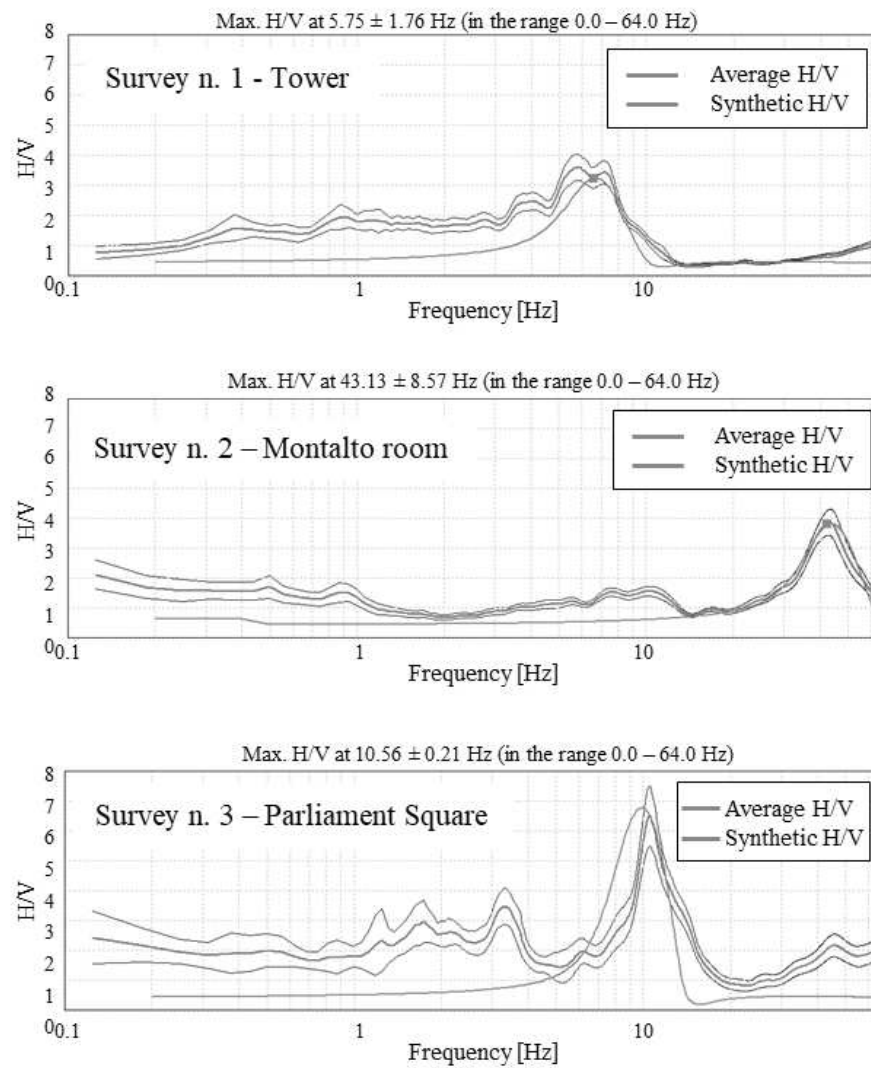
In accordance with chapter 3 of *Guidelines*, which defines seismic action with reference to Section 3.2.2 of NTC2018, and hence according to the value of $V_{S,30}$ obtained in the three tests, the soil class to be assumed for the definition of the response spectra was Class C—coarse-grained, medium-dense soil deposits or fine-grained soils with a medium consistency, thicker than 30 m, characterized by a gradual improvement of mechanical properties along with the depth, and by values for $V_{S,30}$ between 180 m/s and 360 m/s (that is, $15 < N_{SPT,30} < 50$ in coarse-grained soils and $70 < c_{u,30} < 250 \text{ kPa}$ in fine-grained soils). Figure 28 shows the details of the interpretations of the experimental data obtained.

Figure 28. Results of single-station passive seismic tests.
