Study on deformation characteristics of underground pipeline corridors and uneven settlement factors of foundations in sandy chalky soil layer

2 Overview of the pipeline corridor project

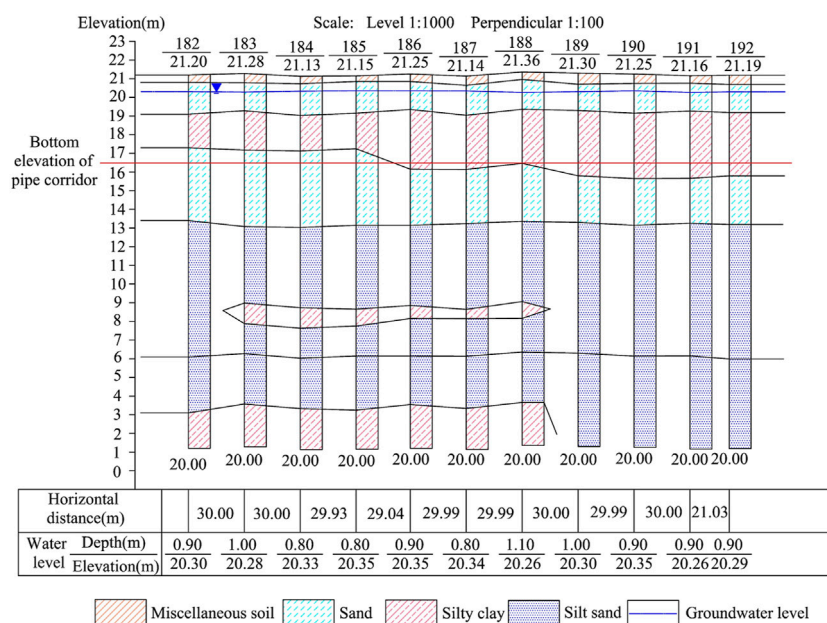
The stratigraphy of the pipeline corridor site is a sandy chalky soil stratum. The groundwater belongs to the hydrogeological zone of the Yellow River alluvial plain, and the lithology of the aquifer is generally dominated by fine and powdery sand and silt, and the aquifer is mostly distributed horizontally in the form of bands and lenses, and vertically in the direction of staggered distribution of the aquifer and the relative waterproof layer. The type of groundwater dynamics is precipitation infiltration evapotranspiration. Groundwater depth ranges from 0.40 to 2.80m, groundwater level elevation is 20.31m, and annual variation of groundwater level is 1.50 m. Figure 1 shows the engineering geologic profile.

FIGURE 1 Engineering geological profile.

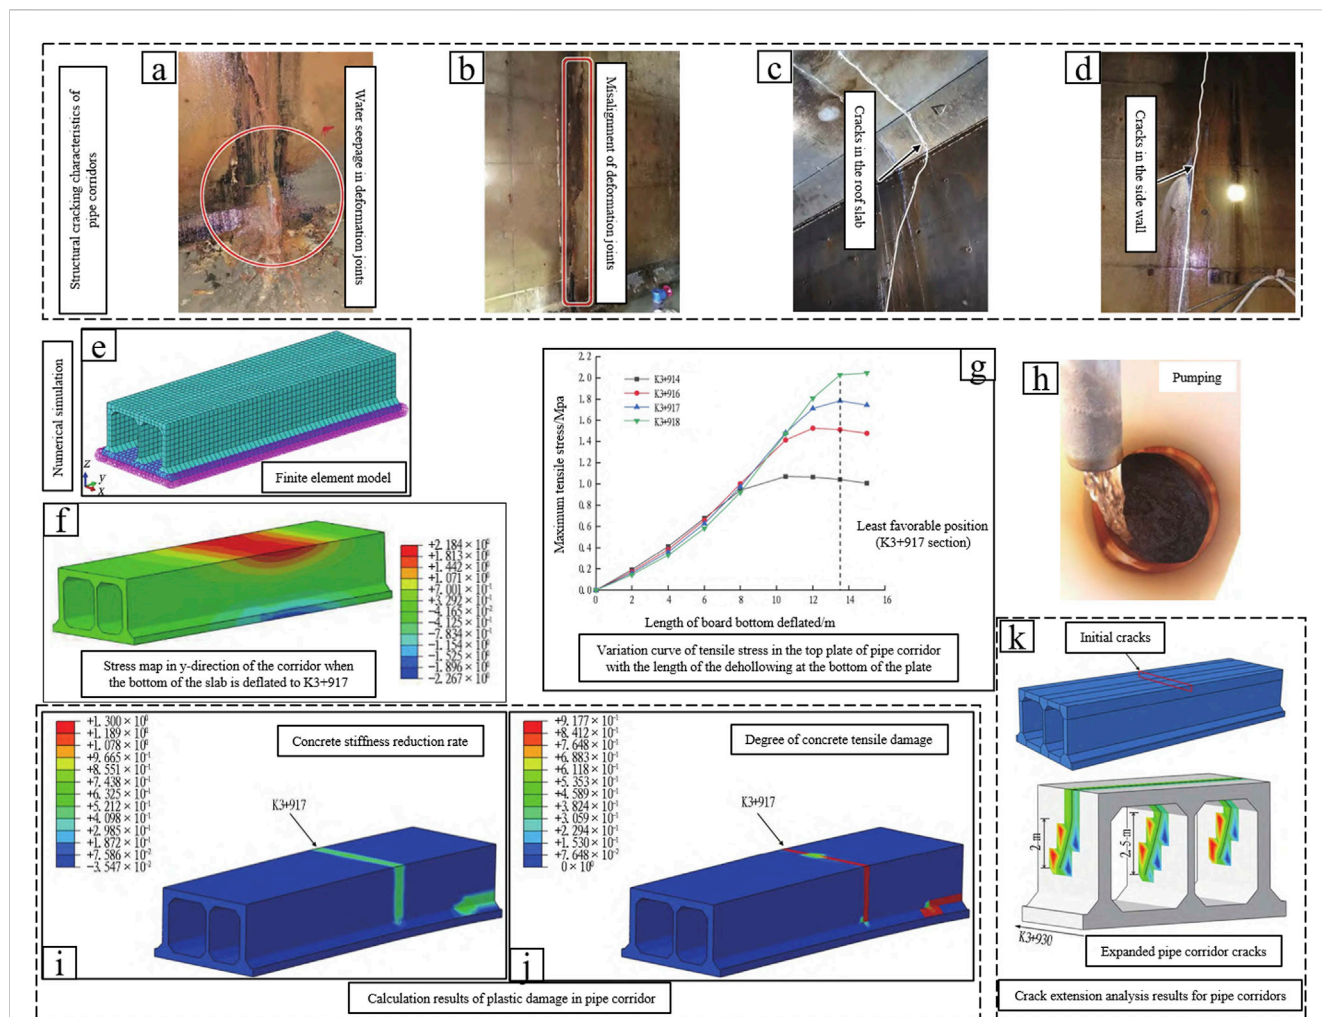
FIGURE 8 Uneven settlement cracking characteristics and Numerical Simulation Analysis of Comprehensive Pipe Corridor in Fuzhou Southeast Expressway (Zhao et al., 2021).

findings of Yang Zhao (Zhao et al., 2021). Yang Zhao analyzed the cracks triggered by the uneven settlement of the comprehensive pipeline corridor of Fuzhou Southeast Expressway and its causes, and used numerical simulation methods to analyze the plastic damage area and crack expansion process of the corridor (shown in Figure 8). Figures 8A, B show water seepage in the deformation joints and misalignment of the deformation joints, respectively, and Figures 8C, D show cracks in the top slab and cracks in the sidewalls; Figure 8E shows the finite element model of the corridor, Figure 8F shows the Y-direction stress cloud diagram of the corridor, Figure 8G shows the curve of variation of the tensile stress of the top slab of the corridor with the length of dehiscence at the bottom of the slab, and Figure 8H shows the on-site drainage from the precipitation wells; Figure 8I shows the rate of decrease in the stiffness of the concrete, Figure 8J shows the degree of tensile damage of the concrete, and Figure 8K shows the results of the analysis of crack extension in the corridor. It was found that the main cause of cracking in integrated pipe corridors is uneven settlement of foundations. The pumped water carries a large number of fine sand particles, and the soil on the outside of the pit is partially hollowed out, leading to uneven settlement and misalignment of the deformation joints in the later stage
