Seismic upgrading of cultural heritage – A case study using an educational building in Croatia from the historicism style

Antonela Moretić^a, Mislav Stepinac^{a,*}, Paulo B. Lourenço^b

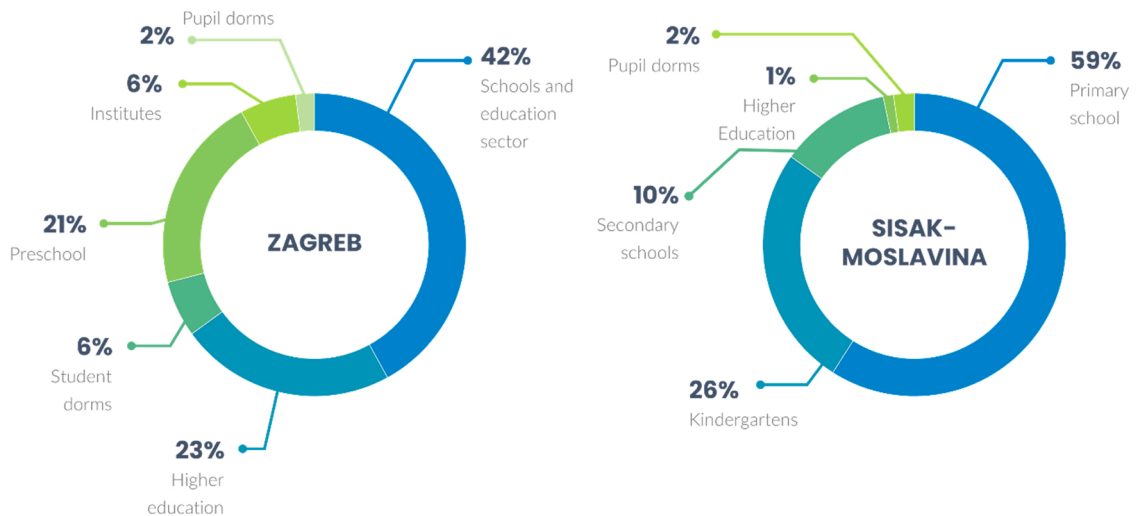
Fig. 2. Damaged buildings of the education sector in the 2020 Croatia earthquakes and two different regions [3,4].

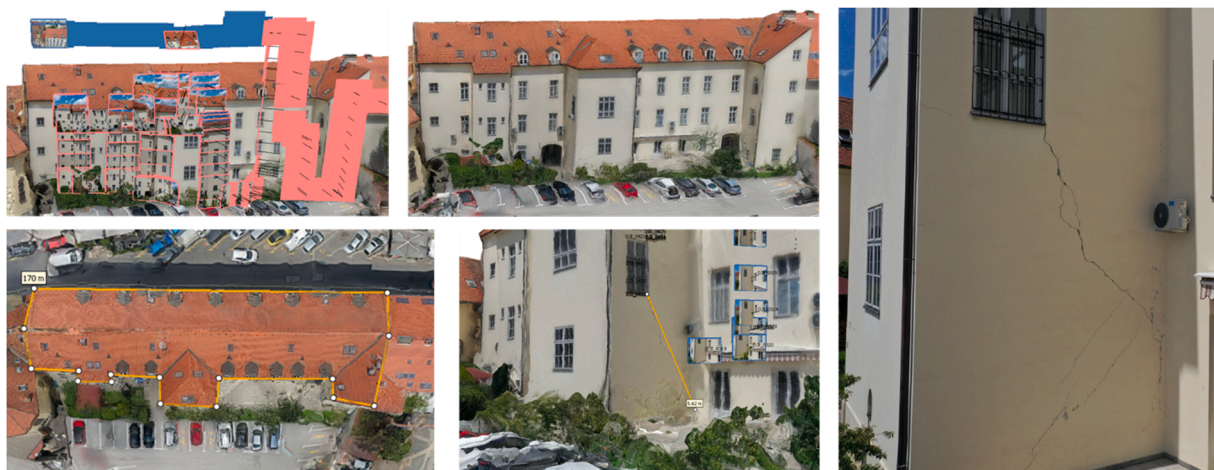
Fig. 9. Photogrammetric view of the building, respectively with positions of the camera, photogrammetric model, measuring of the roof geometry, measuring of a crack, photo of a crack.

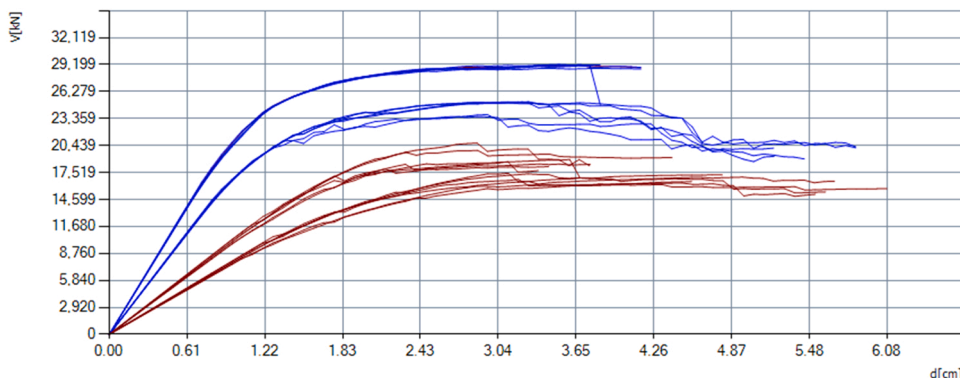
Fig. 13. Pushover curves for model strengthened by the FRCM system for x (blue) and y direction (red).

For the strengthening variant in which shotcrete is used, Q503 reinforcement mesh, steel class B500B, has been selected. The mesh is composed of bars with a diameter of 8 mm with 10 cm spacing. Steel class B500B is a standard reinforcing steel, with yield strength of 500 MPa and B ductility class. Since the model whose façade walls were strengthened only on the inner face met all the required checks, such a solution has been accepted. On the remaining walls, the reinforcing mesh is placed on both faces. In this way, the external appearance of the building is not disturbed and the need for the use of scaffolding is reduced, which ultimately results in a lower cost of renovation. The authors are aware that the application of shotcrete with steel reinforcement is a controversial solution but, precisely because of this, it was considered. The capital of Croatia is at the moment being under major reconstruction and is going to be for a few years more at least. So far shotcrete is the most used technique, even in the case of historical construction. The authors estimate that at least 80% of the renovated buildings will be strengthened with concrete shotcreting. In this paper, the downside of this solution was highlighted and the advantages of less “popular” techniques among engineers in Croatia, and also across the world, were emphasized. Environmental impact at the end of the paper is going in favor of the mentioned statements.

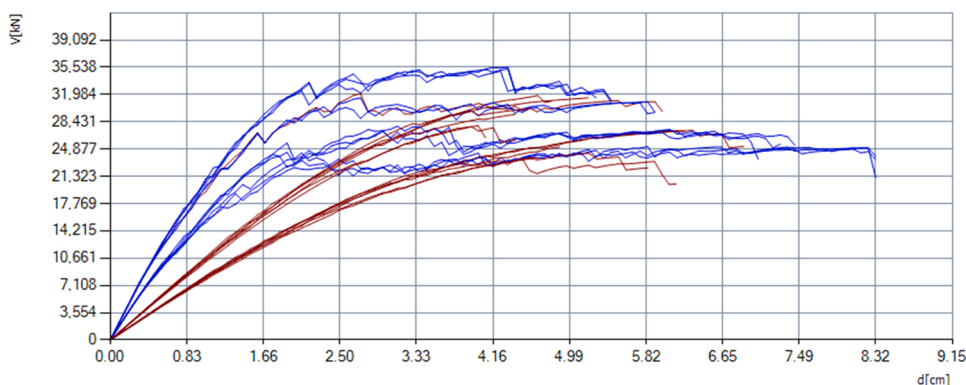
Fig. 14. Pushover curves for model strengthened by shotcrete for x (blue) and y direction (red).

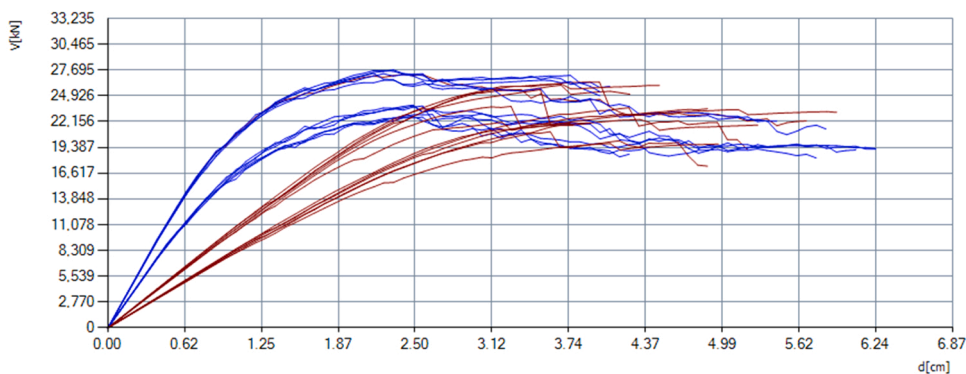
Fig. 15. Pushover curves for model strengthened by FRCM systems and shotcrete for x (blue) and y direction (red).

In the last and third variant, a combination of shotcrete and FRCM system was used (Table 5, Fig. 12). The shotcrete was used on the façade walls and stairwell walls, while the FRCM system was used on the remaining interior walls. Reinforcement meshes Q503 were used for shotcrete application. On the façade walls, they are placed only on the inner face. On the inner walls of the central core and wings, the shotcrete is placed on both faces, because according to the calculations, they are the most critical parts of the building, and it is impossible to strengthen them on one side only. As for FRCM, five different systems were used. The composite is placed on both faces of the walls.

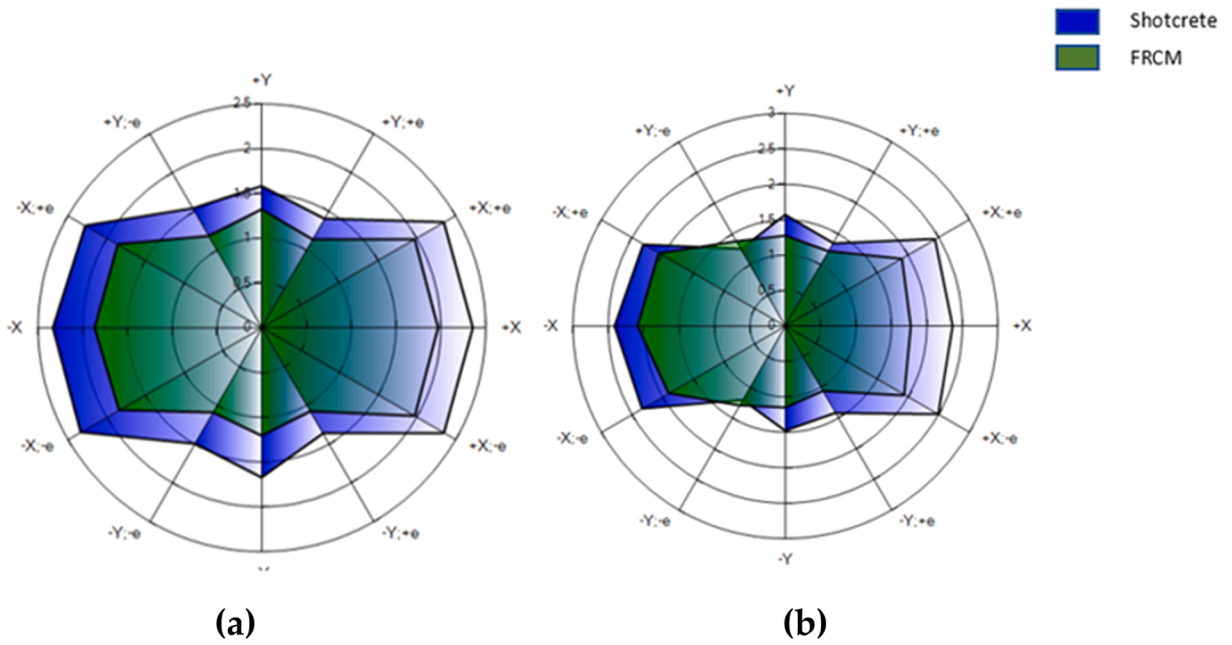
Risk indices vary for each direction, but if the average risk index is taken as the capacity indicator, it is reasonable to conclude that the strengthening by shotcrete is the most favorable variant (Figs. 17, 18).

Fig. 17. Comparison of risk indices of models strengthened by FRCM and model strengthened by shotcrete (a) uniform load distribution; (b) modal load distribution.

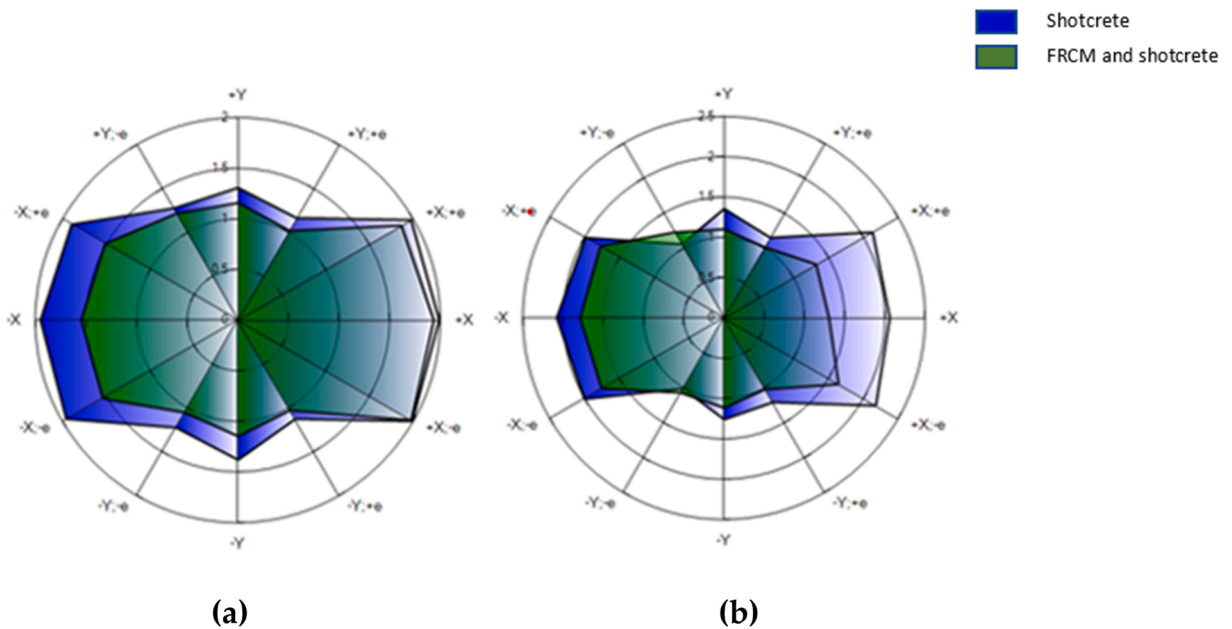
Fig. 18. Comparison of risk indices of model strengthened by FRCM and model strengthened by combination of shotcrete and FRCM (a) uniform load distribution; (b) modal load distribution.

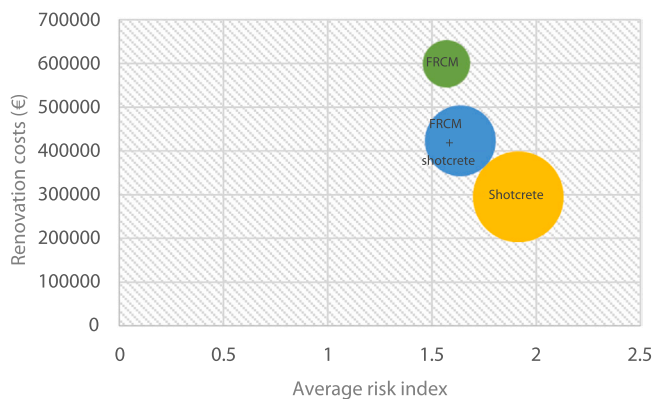
Fig. 19 shows the comparison of strengthening variants considering capacity and renovation costs. Given that the requirements of sustainability in the construction sector are becoming more and more important, the approximate environmental impact was also calculated. The diameter of the circles represents the ratio of CO₂ emissions during the production of the required quantities of materials for each variant of strengthening. It must be noted that ratios do not include the emissions of CO₂ during the phases of transportation, construction, use and demolishing or recycling but only during the material production phase. Carbon dioxide emissions are calculated using software SimaPro [44]. The following values were taken (referring to climate change impact category only): 3,91 kg CO₂/kg fibers, 282 kg CO₂/m³ concrete, 5,01 kg CO₂/kg steel (Table 12). Carbon cost in Croatia in 2020 was estimated to 25,6 €/t CO₂, while it is expected to increase to 93,1 €/t CO₂ by 2050 [45]. Total carbon costs for each strengthening variant are displayed in Fig. 20. Although the application of shotcrete is often used in practice and is the only variant by which the resistance of the structure is brought to the level 4 defined by the relevant codes, in this case, its invasiveness and environmental impact should not be neglected.

Fig. 19. Renovation costs, average risk indices and environmental impact.
